BROTHERHOOD OF LOCOMOTIVE ENGINEERS AND TRAINMEN

BEFORE THE NATIONAL TRANSPORTATION SAFETY BOARD

NTSB Accident Number: RRD-18MR003

Proposed findings, probable cause, and safety recommendations, in connection with the head-on collision, derailment and subsequent employee fatalities involving a CSX Transportation (“CSXT”) freight road switcher Train No. F777-03 and a National Railroad Passenger Corporation (“Amtrak”) passenger Train No. P091-03 near Cayce, South Carolina on February 4, 2018

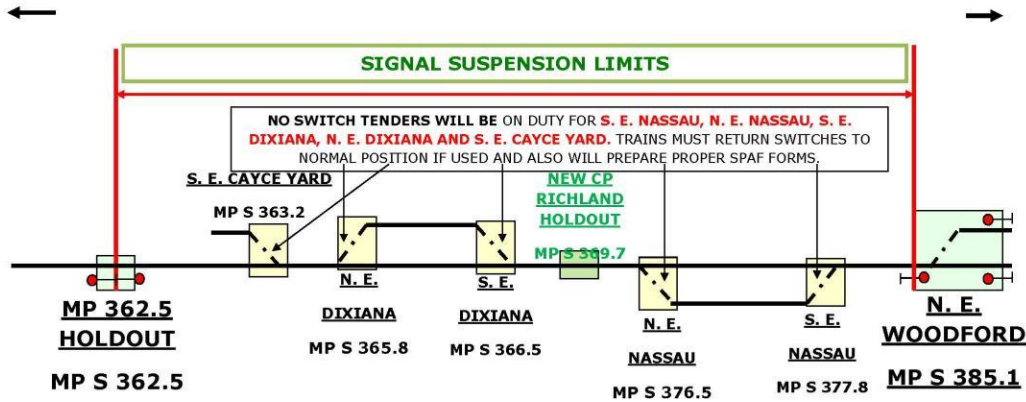
Figure 1 below recreates the map provided by CSX reflecting the limits of the signal suspension area the day of the incident.

TEMPORARY SUSPENSION BETWEEN N. E. WOODFORD AND MP S362.5 HOLDOUT

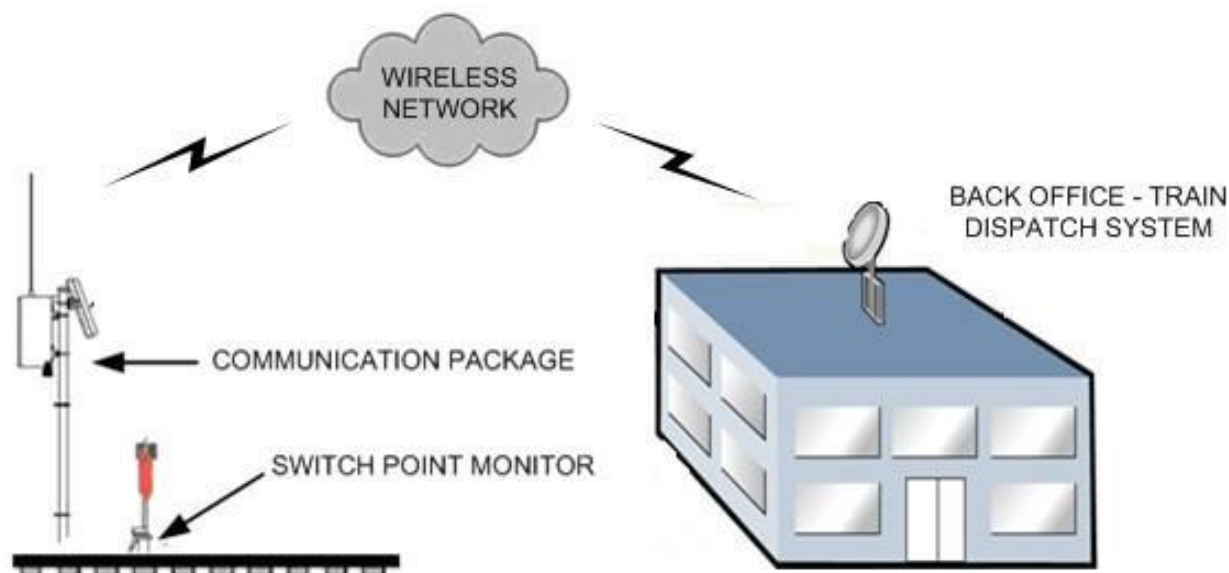
Figure 1. High-Speed Wireless Data Network for Railroad Operation

The key objective of the Switch Point Monitoring System (SPMS) is to monitor, detect, and report improperly aligned switches on main tracks, which could compromise the safe movement of trains in non-signaled territory. When an improper switch point alignment is detected, the system will convey the information through a wireless network to the train dispatch system, allowing the train dispatcher to provide safe mitigation of the reported switch anomaly. SPMS provides an innovative, low-cost, closed-loop technology for improvement of freight and passenger train railway safety, affording a safer transportation environment at the community and industry levels by preventing train collisions and derailments.

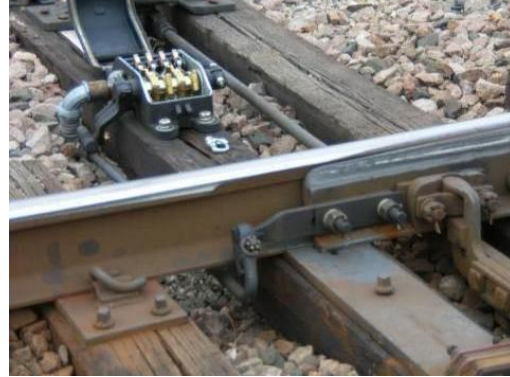
Figure 2. Apparatus at the Switch

The demonstration system involves the installation of switch position monitoring devices on areas of track where switches are outside of signal systems and restricted limits operations. These monitoring devices communicate through a data radio to a data network, then onto a train dispatching system. The dispatching system software checks the position of the switches before allowing the issuance of track warrants, thus eliminating the potential of issuing a track warrant over a switch that was not properly lined for train movement.

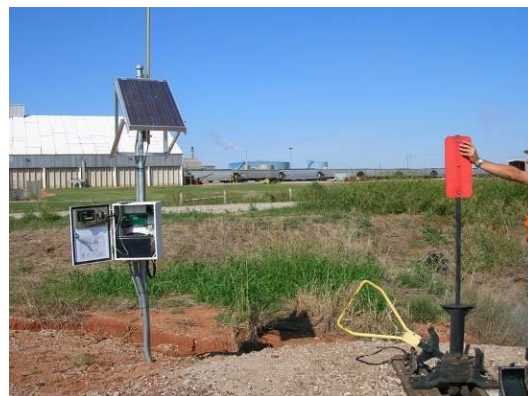
Figure 3. Solar-Powered Wayside Interface with Radio

Closed-loop methodology safeguards against loss of communication from the wayside to the back office and assures that the switch position reported from the wayside is timely and not latent information. In the event that the communication

link with the wayside is lost, the safest mode of operations is assumed from an operating rules perspective to protect train movements over a non-communicating switch monitoring device.

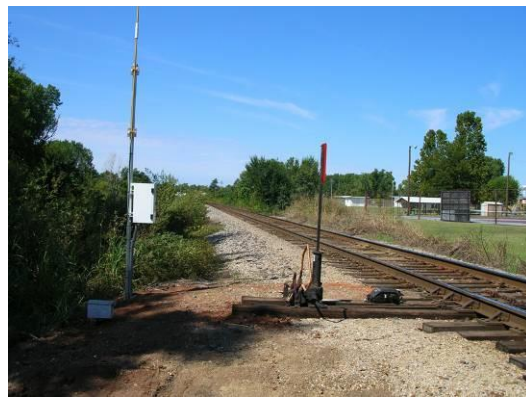
Figure 4. A Typical Installation

The infrastructure required to support SPMS is comprised of wayside switch monitoring equipment, office dispatch system software, and data communication equipment. Propagation studies have identified the distribution of the radios required for system operation.
