**AERONAUTICAL ACCIDENT INVESTIGATION  
AND PREVENTION CENTER**

**FINAL REPORT  
A-022/CENIPA/2008**

**ACFT REGISTRATION: PR-GTD and N600XL**

**MODELS: B-737 8EH and EMB-135 BJ LEGACY**

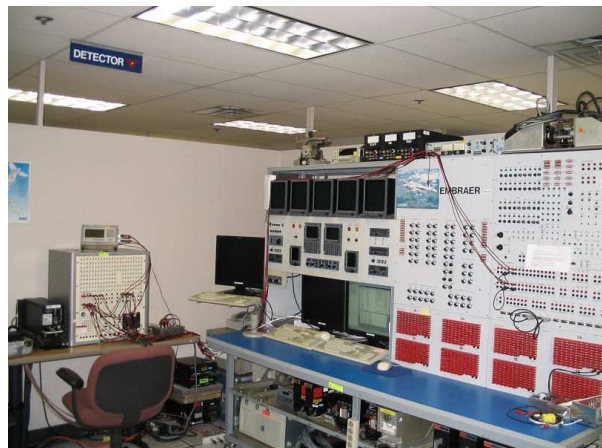
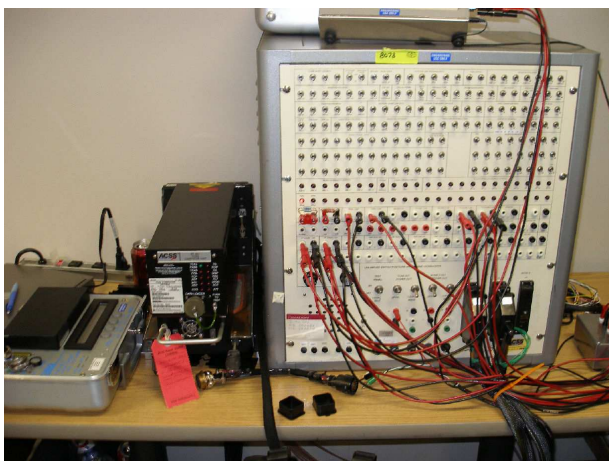
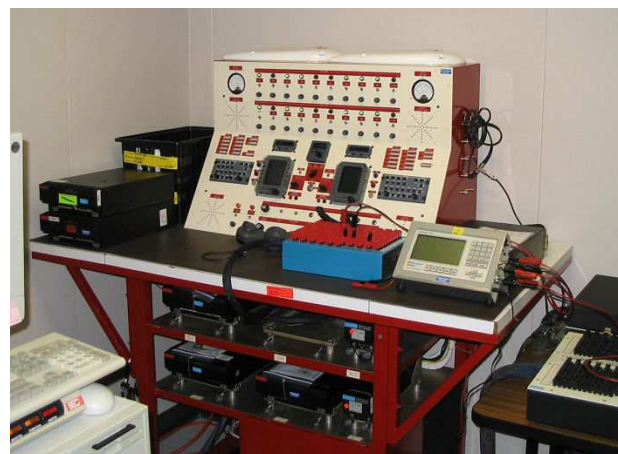
The second phase consisted in the execution of the procedure already validated, this time using the TCAS, RCZ and RMU units removed from the N600XL. This phase was successfully conducted, and the results did not indicate any unexpected behavior, or in discordance with the technical specifications, which could affect the adequate transmission of the Transponder signals. No change of the Transponder mode of operation was identified.

In addition, it was confirmed that the system being tested did not present the problem associated to the subject addressed by the AD 2005-0021 issued by EASA “*Transponder Reversion to Stand-By Mode*”, and by the AD 2006-19-04 issued by the FAA “*To prevent transponder of the Honeywell COM unit from going into standby mode*”. The members of the CIAA and other participants had the opportunity to randomly apply successive commands in the control panels, mainly in the RMUs, trying to create an unexpected abnormal behavior. Nothing abnormal in the functioning of the equipment was observed.

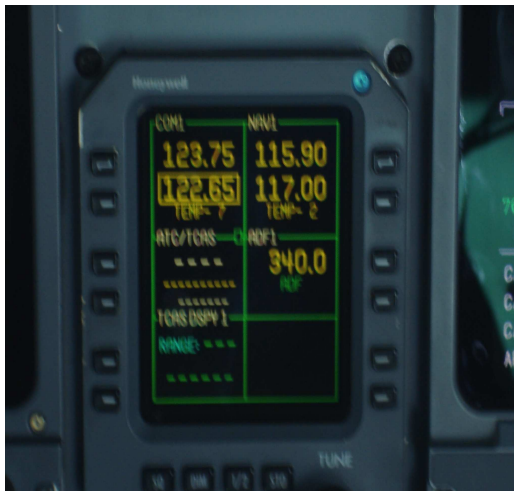
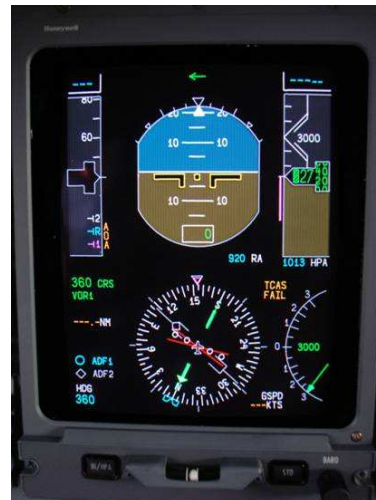
In case there is a *Transponder* failure, the operation mode and code selected are replaced by dashes in the RMU. An orange message “TCAS FAIL” will appear on both Primary Flight Displays (PFD) precisely in front of the visual field of view of both pilots, as shown by the pictures bellow.

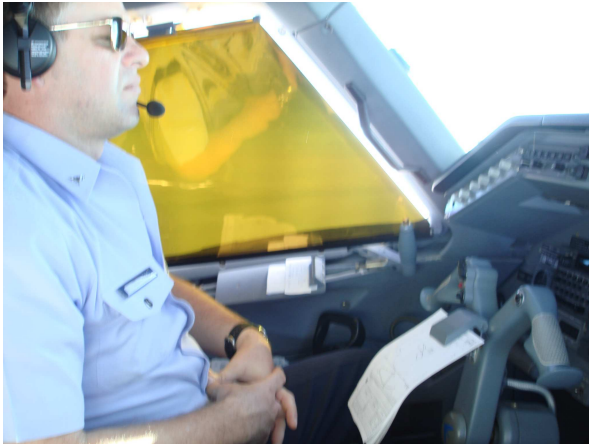
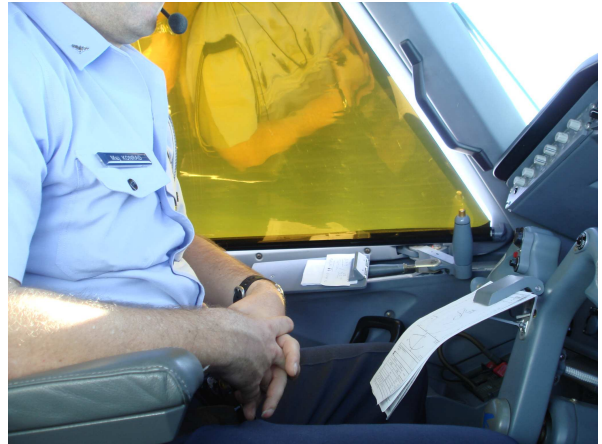
- i) Aspects related to the influence of the sunshine on the visualization of the aircraft panels and their respective instruments (with the use of the sunshade, lateral view of the PIC, same magnetic headings and same time of the accident flight):
- The aircraft possesses an amber color sunshade which proved efficient for preventing the incidence of the sunshine directly on the pilot or on the aircraft panels (Figures 45 and 46);
  - With the sunshade lowered, probably in the same position of the Day of the accident, the comfort of the pilot was rather improved, as the sunshine did not touch his chest directly (Figure 45);
  - The visualization of the instruments improved on account of the lower intensity of the sunlight in the cockpit (Figures 45 and 46).

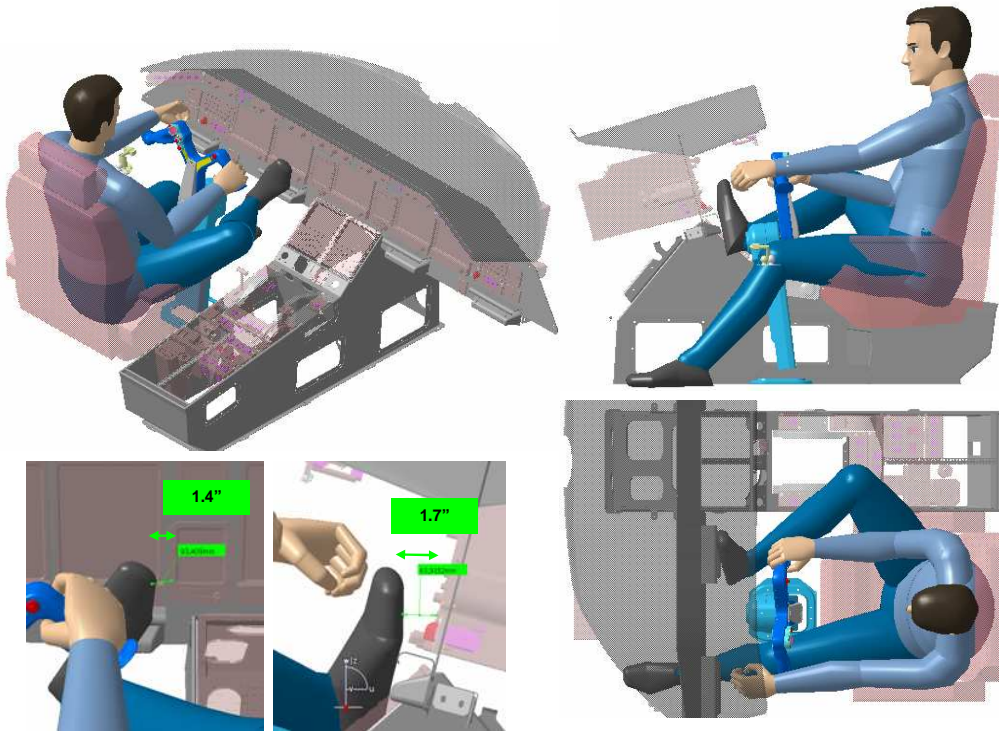
**Situation (b):** Figure 50 represents the position of the virtual human model, similar to the PIC, trying to utilize the *footrest* with the seat moved 2" back from DEP without reclining the seat and still having access to the primary flight controls (control wheel and pedals):

From this table, the posture of the pilot in this position eliminates the possibility of an inadvertent command from the foot on the RMU, because it is unnatural and uncomfortable.

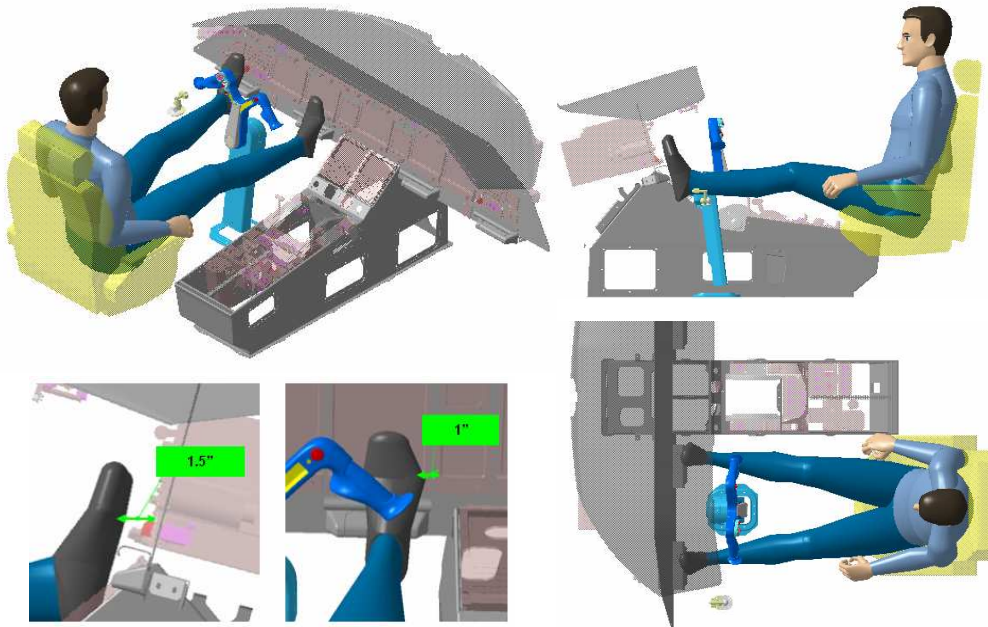
**Situation (d):** Figure 52 represents the position of the virtual human model, equivalent to the PIC, trying to utilize the footrest with the seat all the way to the back and without reclining the seat:

Simulation Foot on footrest	Simulation attempt Foot on RMU	Comfort Range
<b>Thigh Flexion</b>	74,8°	80.3°	60° to 85°
<b>Thigh Abduction</b>	6,5°	10.4°	0° to 20°
<b>Thigh Rotation</b>	0°	<b>-23.8°</b>	-15° to 15°
<b>Leg Flexion</b>	<b>17°</b>	<b>19.8°</b>	45° to 85°
<b>Leg Rotation</b>	0°	<b>-17.6°</b>	-5° to 5°
<b>Plantar Flexion</b>	-13,9°	<b>-45°</b>	0° to 25°
<b>Inversion</b>	0°	3.3°	0° to 13°

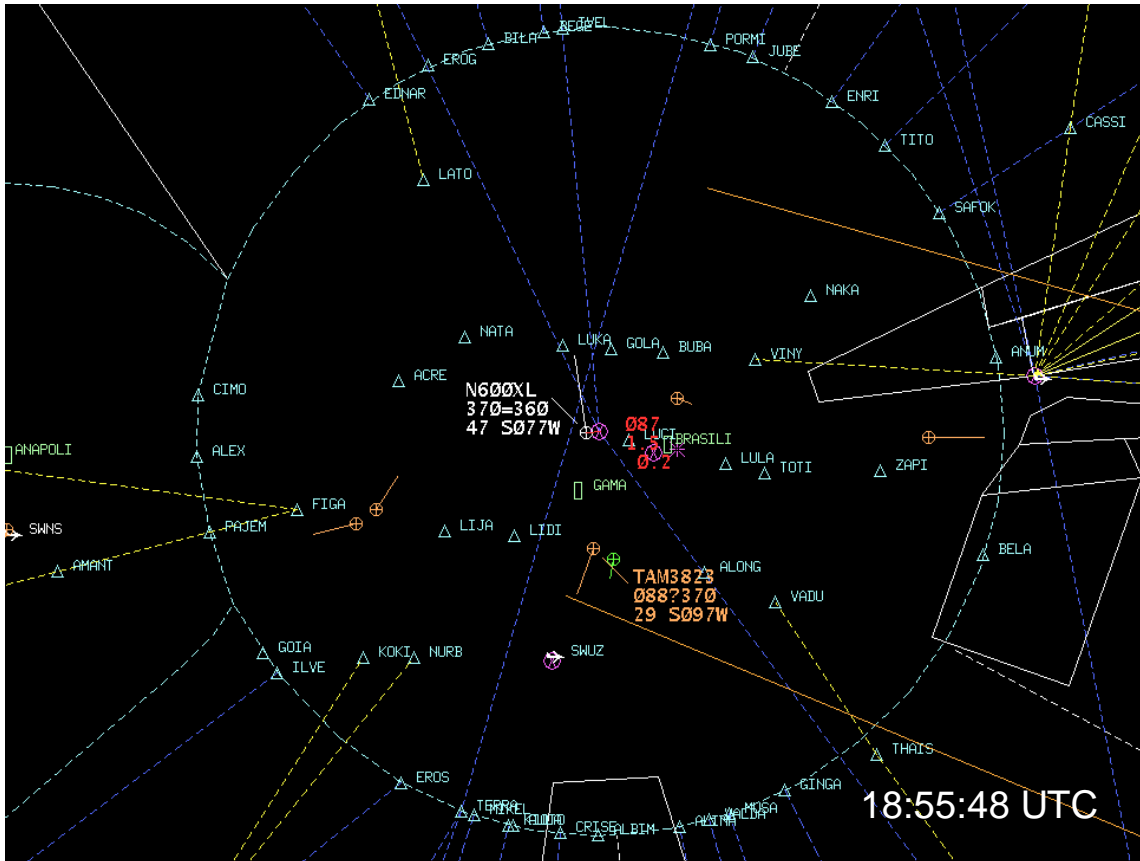
**Figure 56**

The information of the data block was that the aircraft, from that point on, **was flying at a flight level that was different from the flight level requested in the active flight plan**, as shown in Figure 56 below.

The controller's failure to act may have been caused by a lack of perception or a mistaken perception of the information conveyed by the data block.

The failing to act, on the part of the controller, leads us, then, to the possibility of an inadequate situational awareness to react correctly to the pieces of information presented by the equipment, something that contributed to the N600XL maintaining of the FL370 after passing BRS VOR.

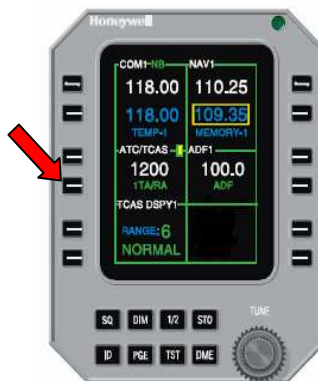
Figure 58

According to the information available, the loss of the Transponder signal on the screen of the air traffic controller occurred around 19:02 UTC, indicating that the STANDBY feature of the transponder had probably been selected.

For the Standby mode to be selected, it is necessary to press the fourth top to bottom left button, in one of the RMUs (it has to be pressed twice in a 20-second interval).

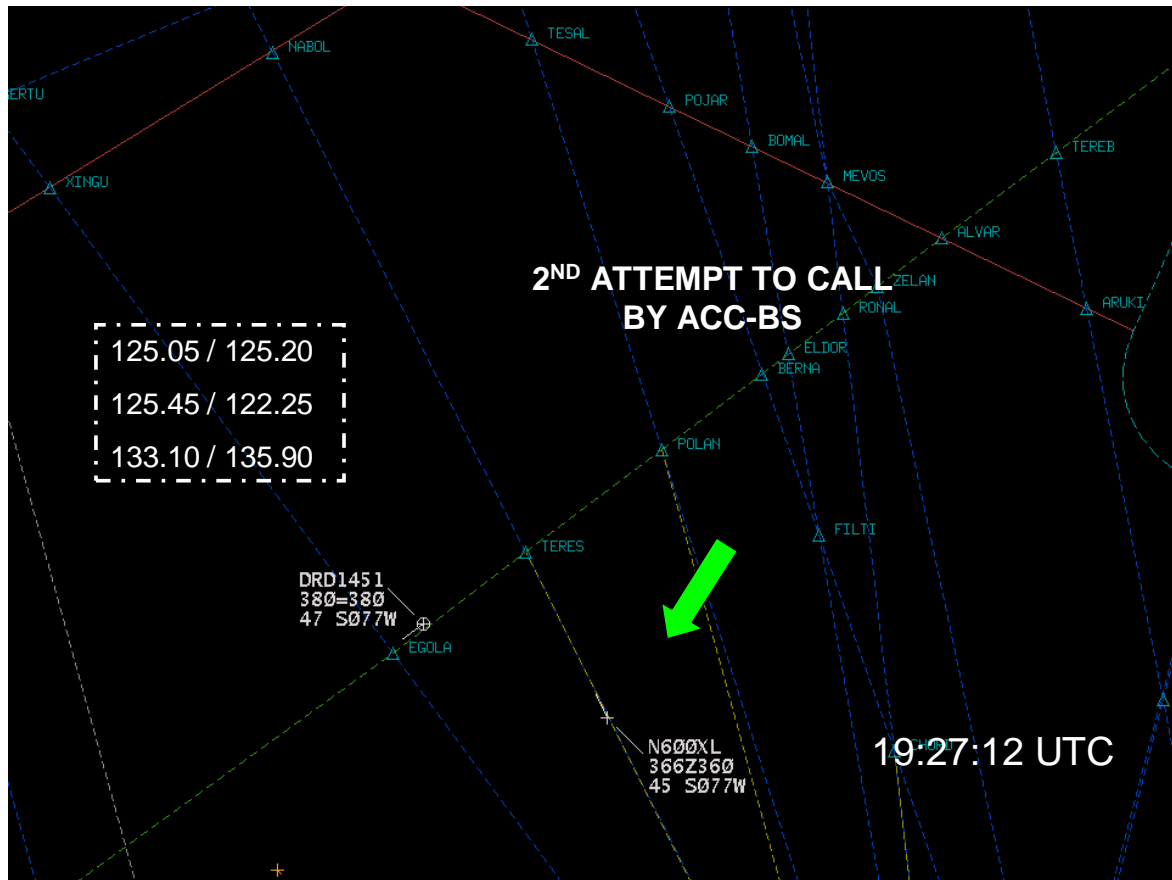
Figure 61

At the **second attempt, at 19:27:12 UTC**, for the **first time** a frequency change to **135.9 MHz** was commanded. Such a command should have been given, at least, 30 minutes earlier.

The aircraft was already at **218.5 NM from BRS VOR**, still with primary radar contact and correlation.
