AIR SAFETY INVESTIGATIONS ENGINE FIELD INSPECTION REPORT

ENGINE MODEL: IO-550-N (EXP)

AIRCRAFT MODEL: Lancair Legacy

REGISTRATION: N121J

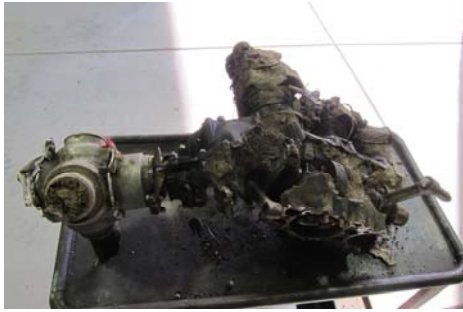
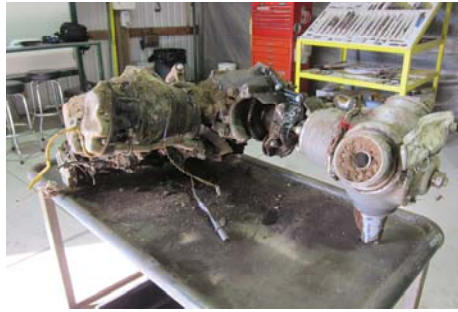
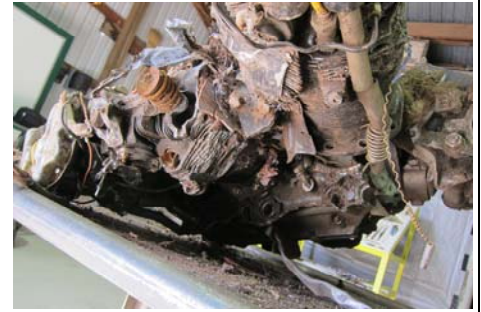
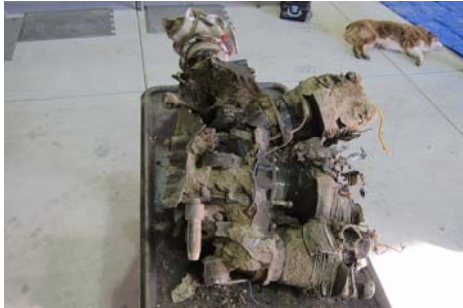
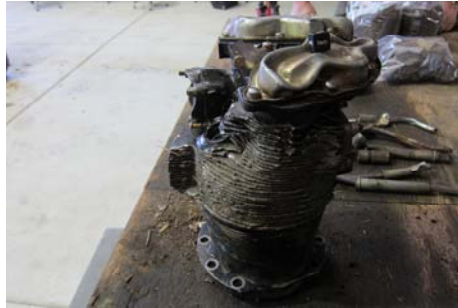
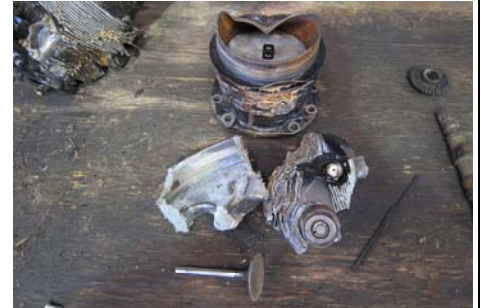
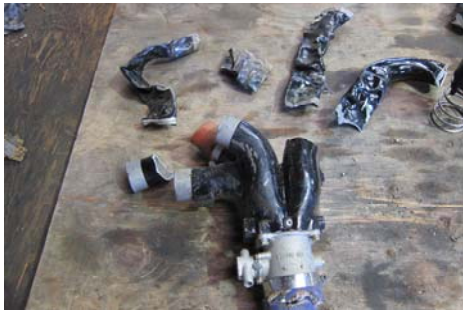
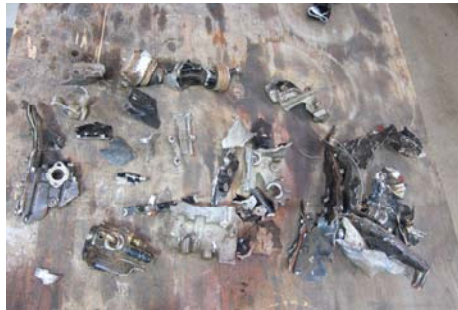
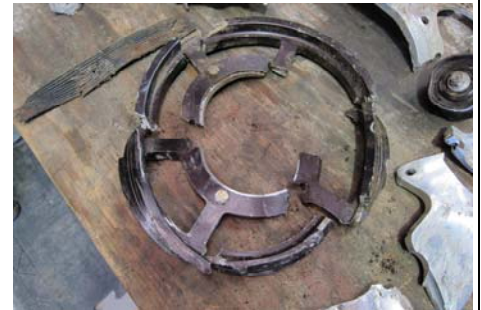
The engine inspection took place at Plain Parts in Pleasant Grove, California on 10-12-2011. The engine separated from the airframe and had excessive impact damage. The 2, 4 and 6 cylinders separated from engine and were found in the wreckage path. The crankcase had missing material from all sides. The propeller hub and portions of the propeller shanks was attached to the crankshaft propeller flange. All of the accessories separated from the engine. The supercharger main drive pulley and tensioner pulleys and a section of the belt were found in the wreckage. The compressor housing was not found in the wreckage. The crankshaft, connecting rods and counterweight assemblies remained attached and had impact damage. Several main bearings were visible and no thermal discoloration or distress was noted. The inspection of the wreckage was under direct supervision of the NTSB investigator in charge.

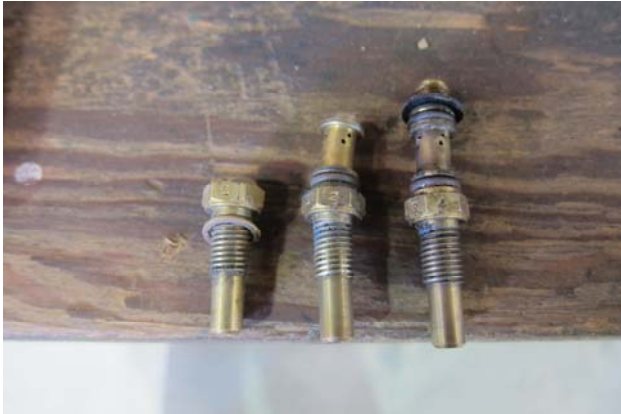
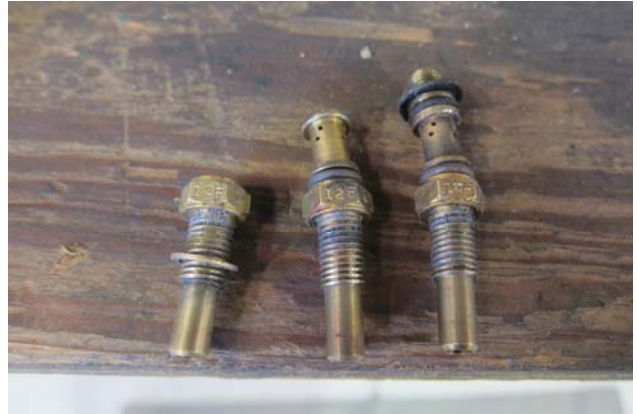
Fuel Nozzles and Lines Manufacturer: TCM Size: 3 each – 12E

Condition: The no. 1, 2 and 4 fuel nozzles were removed from their cylinders and had impact damage.

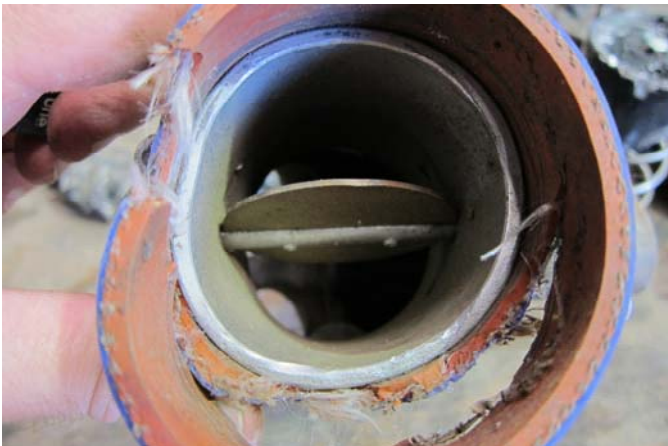
Throttle Body Fuel Control Manufacturer: TCM Part No.: (652179)

Condition: The throttle body fuel control had impact damage and was found with the main wreckage. The throttle linkage separated and the valve was found in the open position.

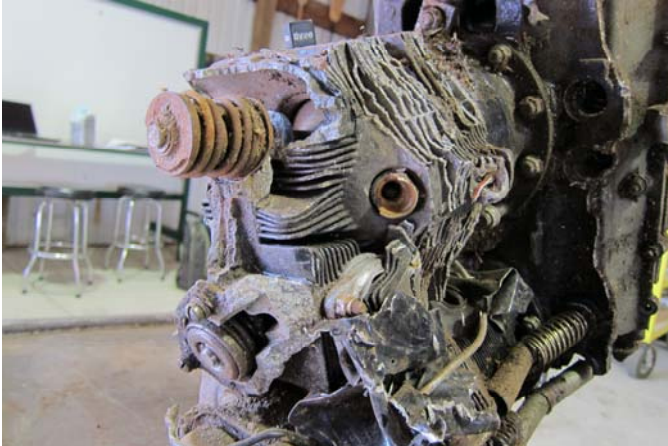
Condition: The cylinder remained attached to the crankcase and had impact damage to the overhead, induction and exhaust flanges, cooling fins and pushrod assemblies. The rockers and rocker bore material separated from the cylinder head. The damaged spark plugs could not be removed from the cylinder.

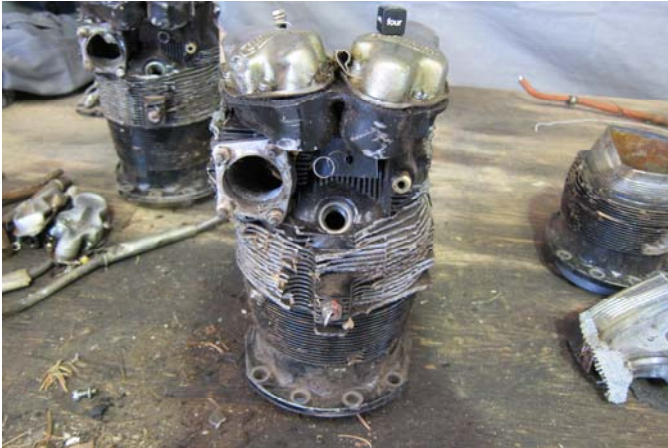
Cylinder #4

Condition: The cylinder separated from the engine and was found with the main wreckage. The cylinder rocker covers, cooling fins and pushrod assemblies had impact damage. The cylinder overhead components were lubricated and undamaged. The combustion chamber had a layer of light grey deposits and the cylinder barrel had corrosion deposits. The valve heads were undamaged and had no signs of abnormal thermal discoloration.

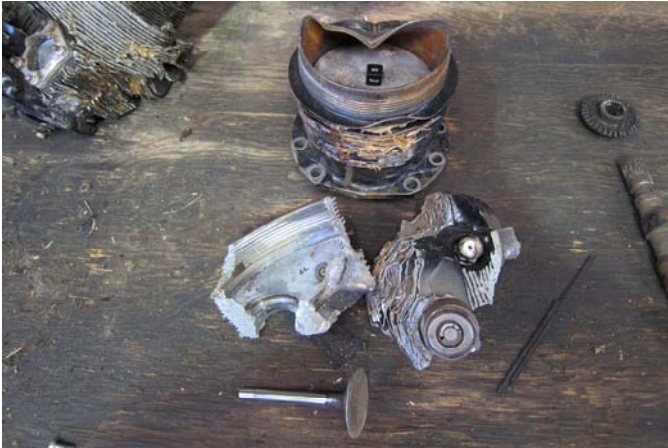
Condition: The cylinder separated from the engine and was found in several sections with the main wreckage. The cylinder overhead components were not found during the inspection. The cylinder head separated from the barrel and was found in two large sections. The combustion chamber had a layer of light grey deposits and the valve heads showed no signs of abnormal thermal discoloration. The spark plugs remained in the cylinder head and showed (Worn out-Normal) wear conditions when compared to a Champion AV-27 chart.

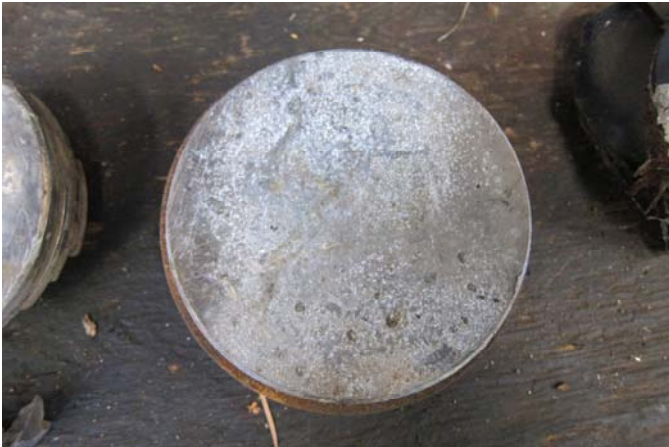
Pistons, Rings and Pins Piston Part No.: Not checked.

Condition: Two piston heads were found with the main wreckage and had impact damage. Both had missing rings and separated skirts.

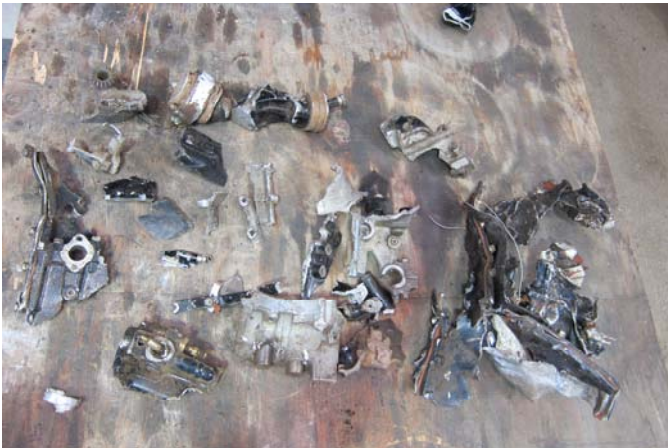
CRANKCASE ASSEMBLY:

Condition: The crankcase had impact damage and the majority of the material was found with the main wreckage. The crankshaft had impact damage and remained in the damaged crankcase. Several crankcase mating surfaces were visible and no fretting was noted.

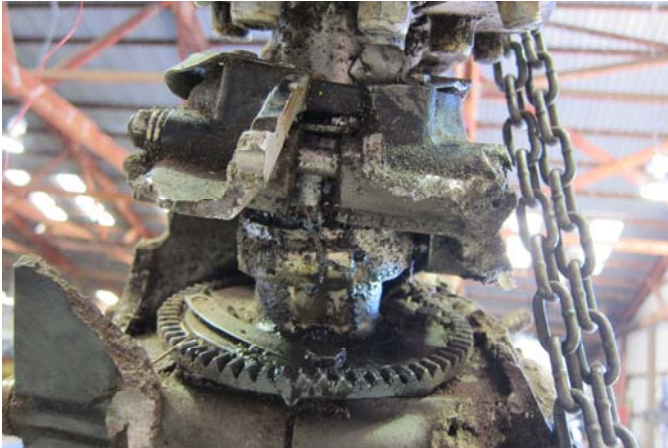
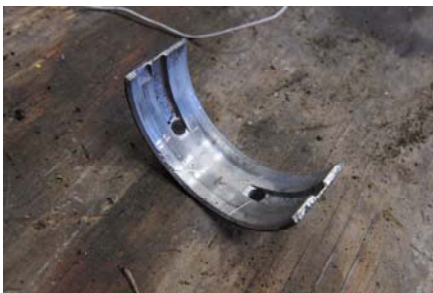
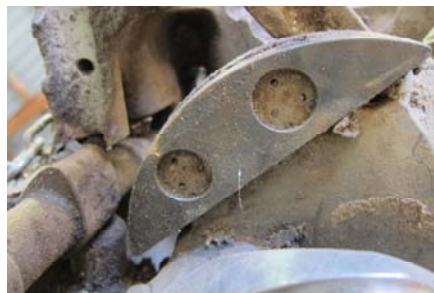
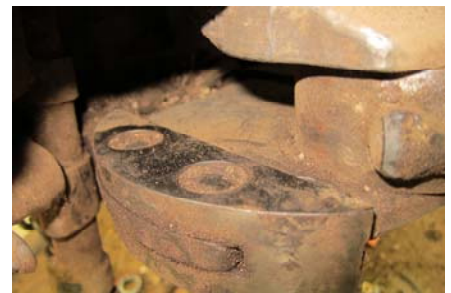
CRANKSHAFT ASSEMBLY:

Condition: The crankshaft and counterweight assemblies had impact damage and showed no signs of thermal damage or lubrication distress. The crankshaft remained intact from the propeller flange to the aft gear attachment. Multiple bending and cracking was noted near several of the crankshaft cheeks. The connecting rod journals, main journals and thrust surfaces had impact damage. The crankshaft counterweight pins, plates and snap-rings were intact. The counterweights had movement on the hanger blades.

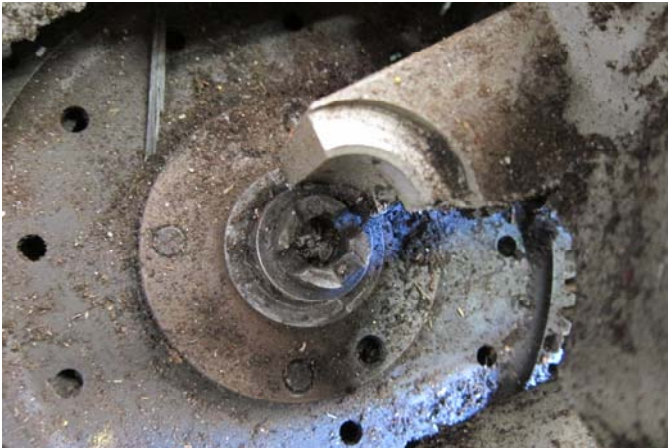
CAMSHAFT:

Condition: The camshaft had impact damage and was found in three sections. The aft camshaft gear and camshaft gear flange remained attached to the separated crankcase accessory section. A section of the camshaft from the no. 1 to the no. 3 main journal remained in the crankcase. The forward section of the camshaft and the forward drive gear was found in the main wreckage. The camshaft lobes showed normal operational signatures and the forward and aft gears showed normal operation.

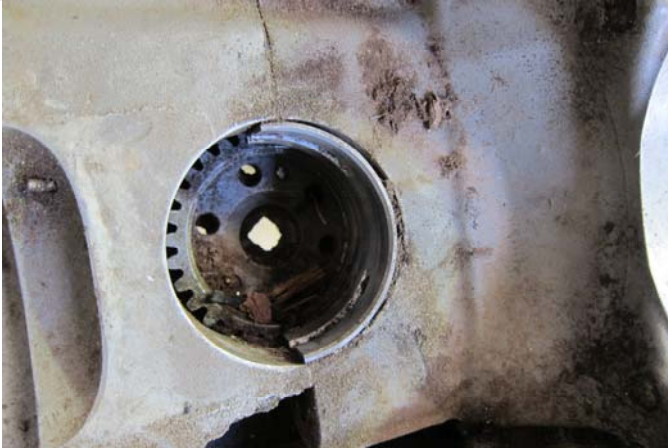
Accessory Gears

Condition: The accessory gears had impact damage. The gear teeth were intact and there were no anomalies noted.

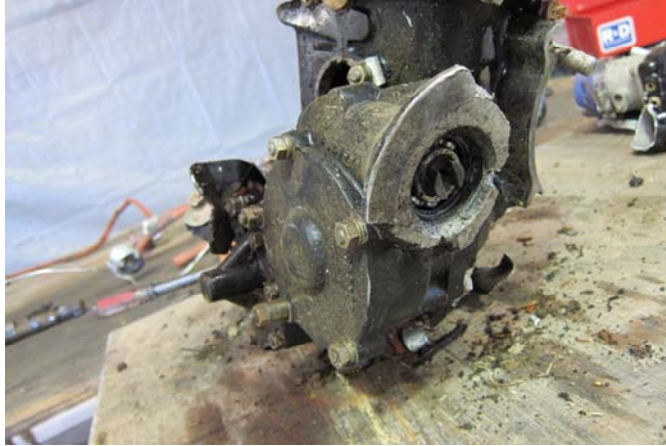
Starter Adapter

Condition: The starter adapter had impact damage to its starter mounting flange. The starter adapter was not removed during the inspection.

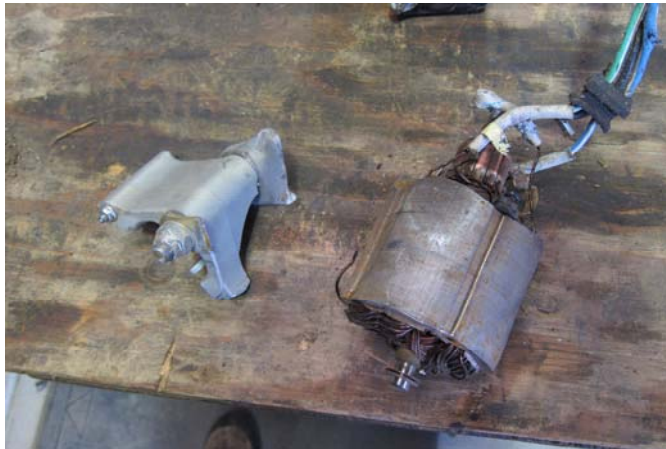
Alternator

Condition: The alternator had impact damage and was found in two sections.

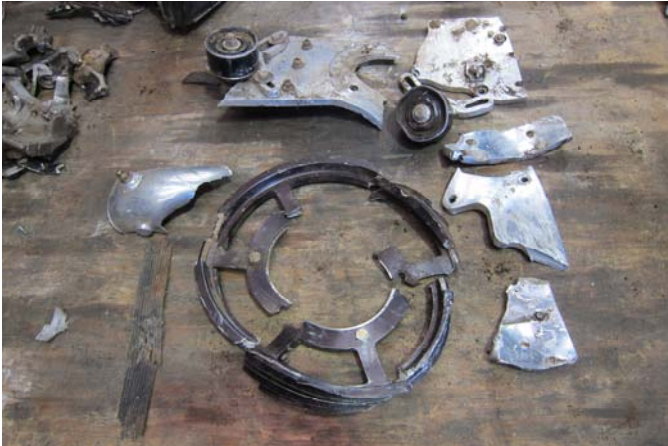
Supercharger

Condition: The supercharger assembly separated from the engine. The bracket assembly, main drive pulley, belt tensioners and a small section of the drive belt was found in the main wreckage. The compressor and compressor housing were not found during the inspection.
