**Continental Motors, Inc.**

## **ENGINE OPERATIONAL TEST REPORT**

<b>DATE</b>	December 6, 2011
<b>REGISTRATION #</b>	N227TX
<b>ENGINE MODEL</b>	TSIO550K
<b>ENGINE SERIAL</b>	1002510
<b>INSPECTOR</b>	Phillip Grice
<b>SEARCH CODE</b>	15-12-68

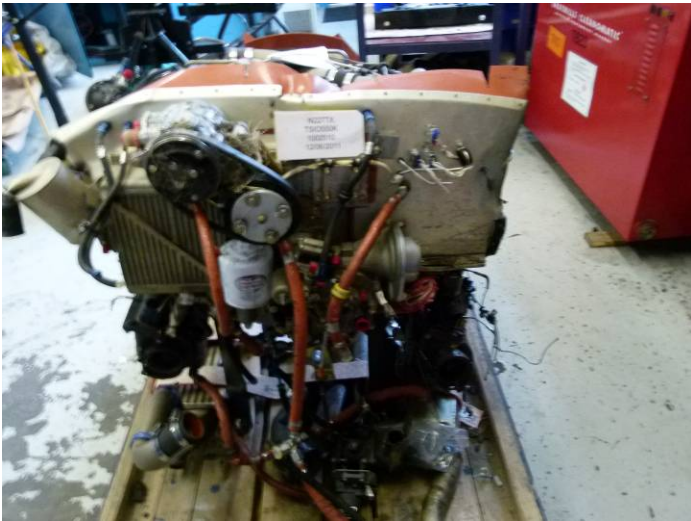
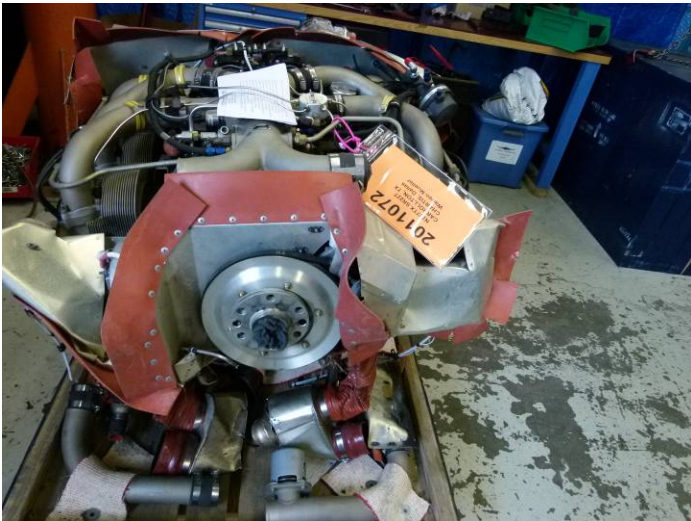
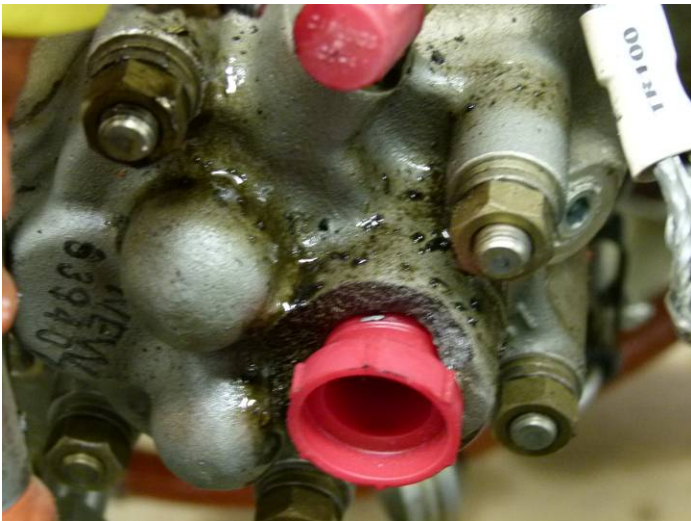
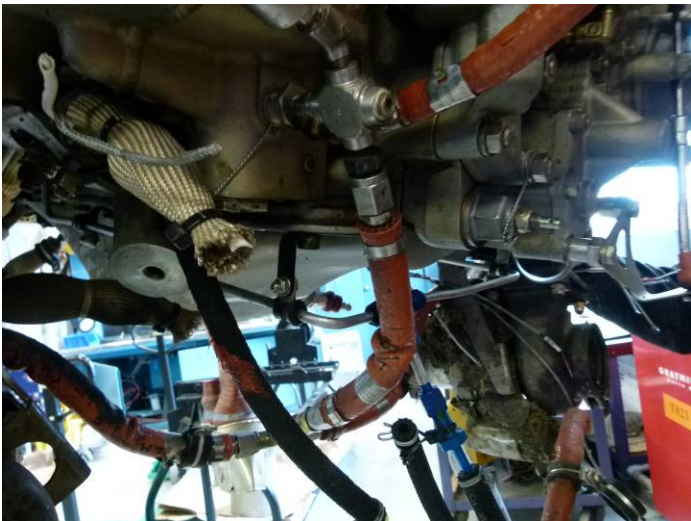
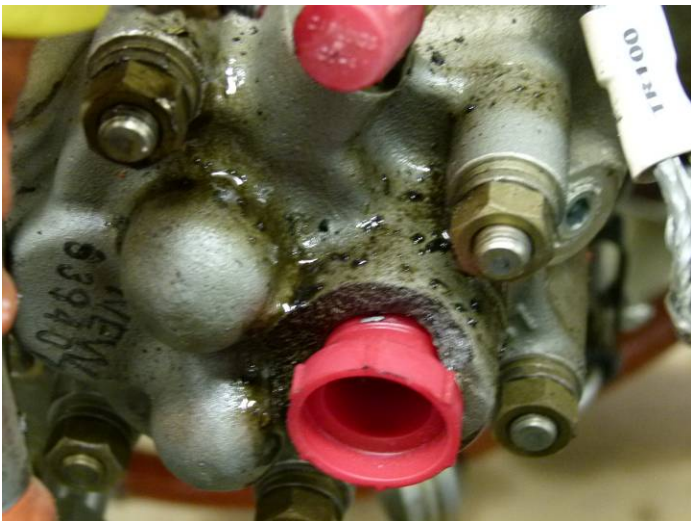
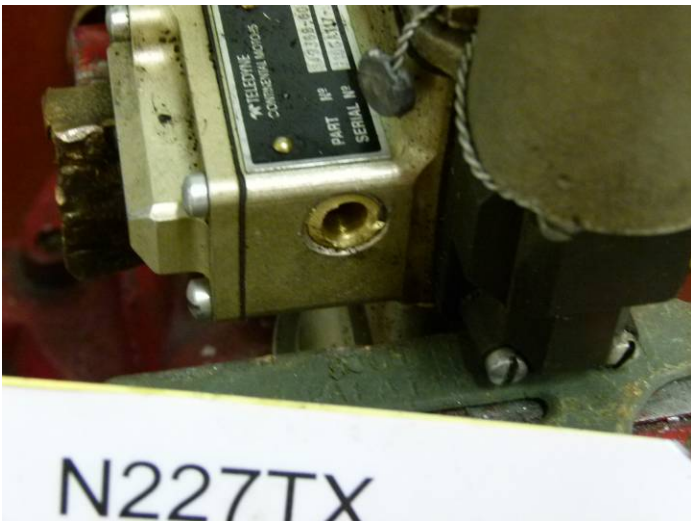
The engine exhibited impact damage concentrated at the Lower part of the engine. The external surfaces of the engine were undamaged. Both engine mount legs were replaced on the right side of the engine before the test run. The exhaust system was crushed and replaced for the engine run. The original turbo chargers were cleaned and reattached to the replacement exhaust system. The fuel Pump Inlet fitting was broken from the pump during the accident. The remainder of the fitting was removed and replaced and the fuel pump reinstalled. The starter and starter adapter were impact damaged and replace before the engine test.
