# Continental Motors

## ENGINE FIELD INSPECTION REPORT

<b>ENGINE MODEL</b>	E225-8
<b>ENGINE SERIAL NUMBER</b>	35818-D-0-8-R
<b>AIRCRAFT MAKE &amp; MODEL</b>	Beechcraft 35G Bonanza
<b>AIRCRAFT SERIAL NUMBER</b>	D-4863
<b>AIRCRAFT REGISTRATION</b>	N394CW
<b>CMI FILE NUMBER</b>	15-238

<b>EXAMINATION</b>		<b>ACCIDENT DATA</b>	
<b>DATE</b>	10-13-2015	<b>NTSB ACCIDENT #</b>	CEN16FA011
<b>FACILITY</b>	Beegles Aircraft Services	<b>NTSB INVESTIGATOR</b>	Josh Lindberg
<b>ADDRESS</b>	[REDACTED]	<b>FAA INVESTIGATOR</b>	Wesley R. Dollahite
		<b>ACCIDENT DATE</b>	10-13-2015
		<b>ACCIDENT LOCATION</b>	Eaton, Colorado

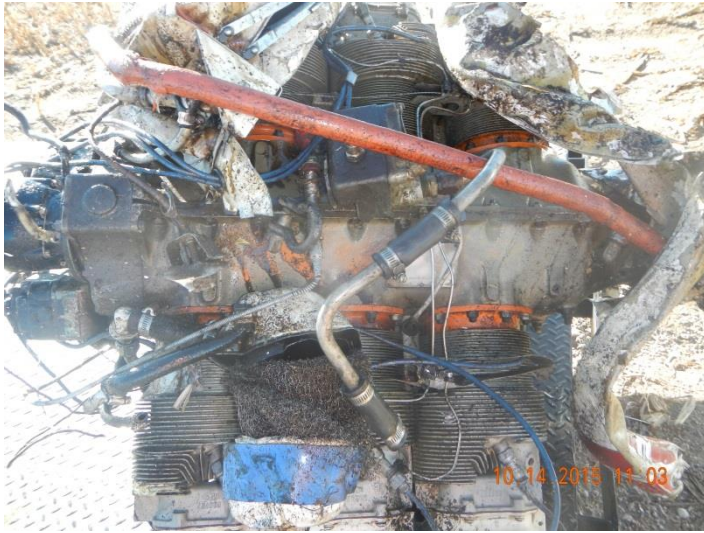
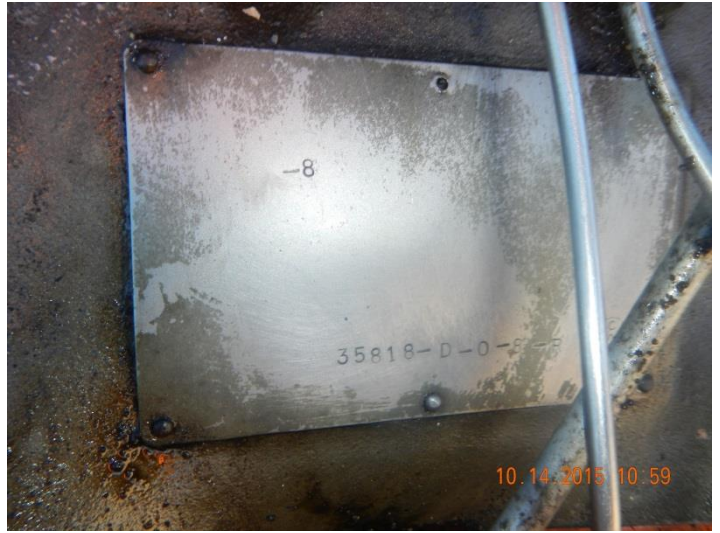
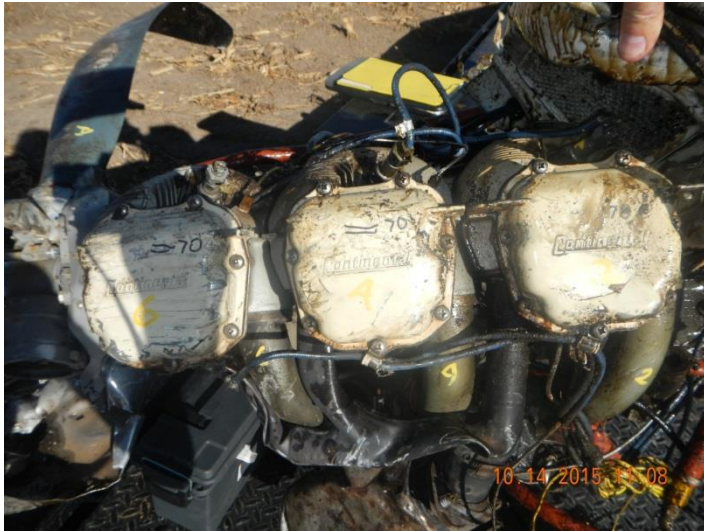
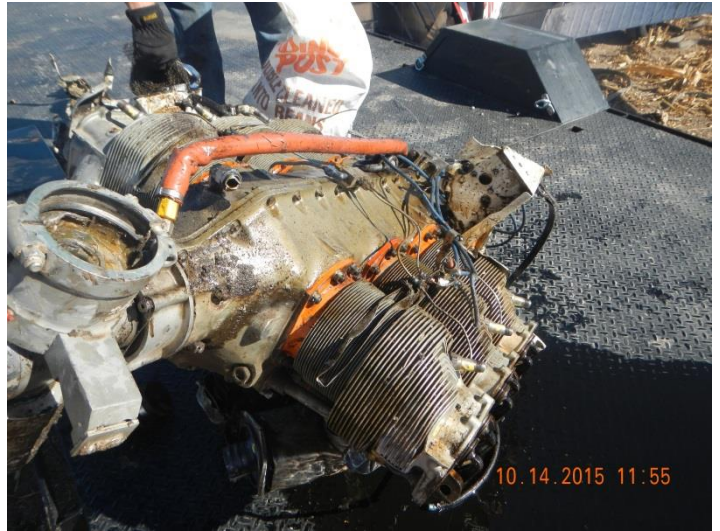
**PAGE 6 of 19**

Right and left exhaust components were impact damaged and crushing was noted to the mufflers. The induction system exhibited impact damage. The air box and induction filter separated and were impact damaged.

The induction system was impact damaged but remained attached. The front mounted air box and induction filter was impact damaged

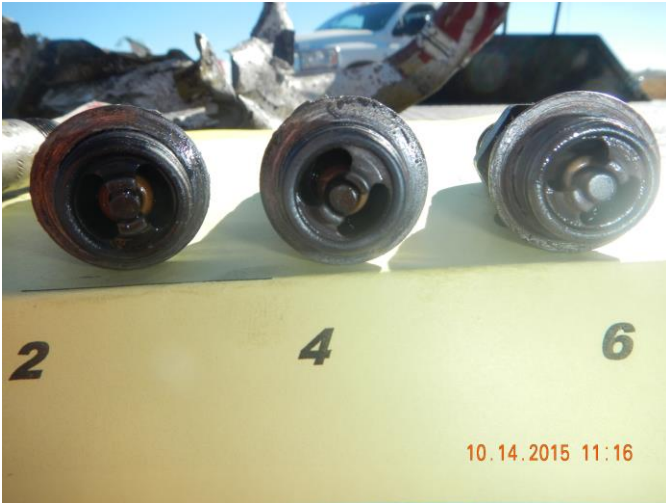
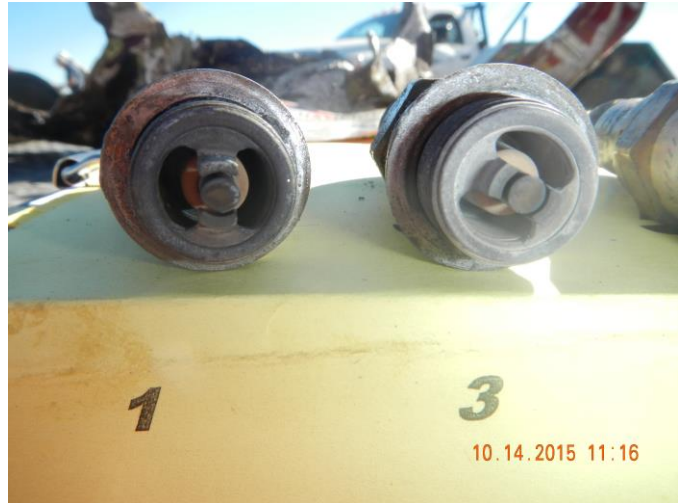
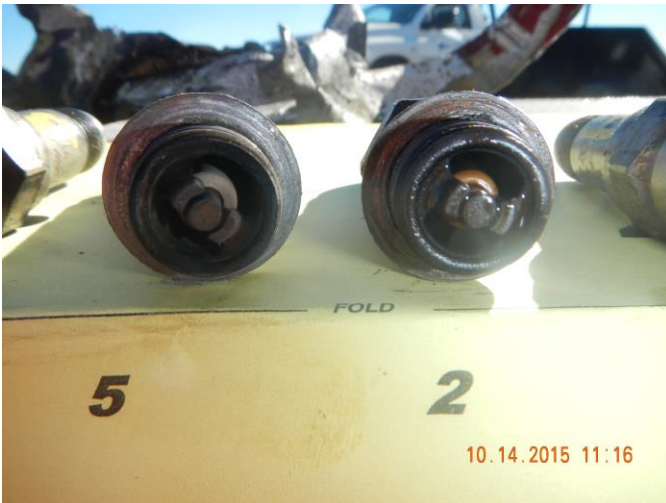
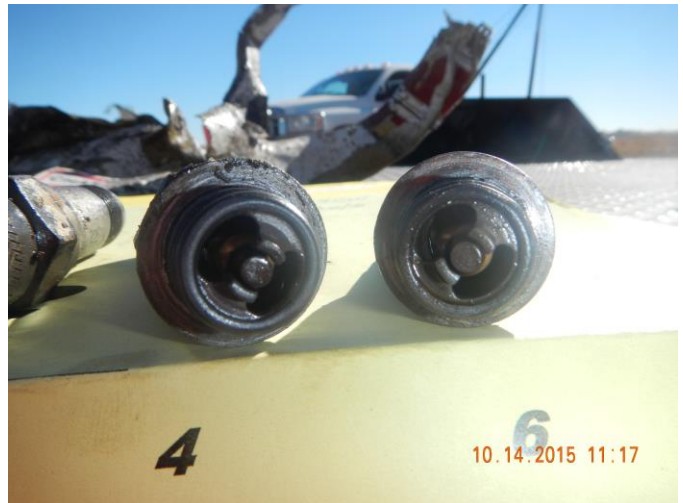
PAGE 11 of 19

<b>LEFT MAGNETO</b>	Manufacturer: TCM	P/N: S6LN-21	S/N: E189201DR
Condition:	The magneto received impact damage. The bushing cup was cracked. The magneto was removed and manually rotated using a drill motor. Spark was produced to each ignition lead.

<b>RIGHT MAGNETO</b>	Manufacturer: TCM	P/N: S6LN-???	S/N: Undetermined
Condition:	The magneto did not display damage. The magneto was removed and manually rotated using a drill motor. Spark was produced to each ignition lead. The data decal was damaged and the serial number was not legible.

**Condition:** The ignition harness remained intact with the exception of leads to cylinders one and six which were separated. (top sparkplugs)

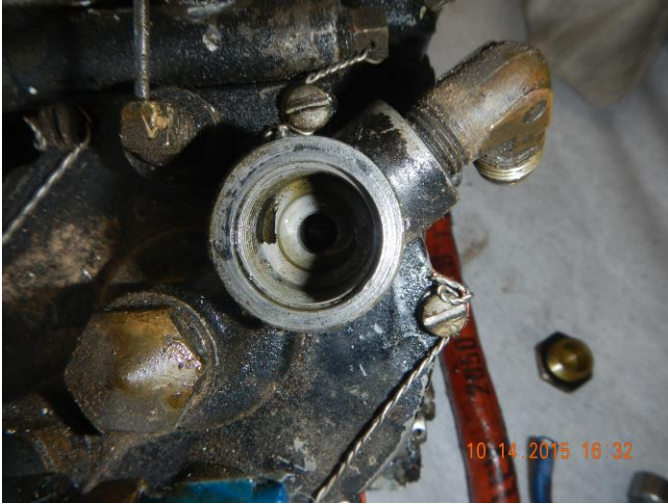
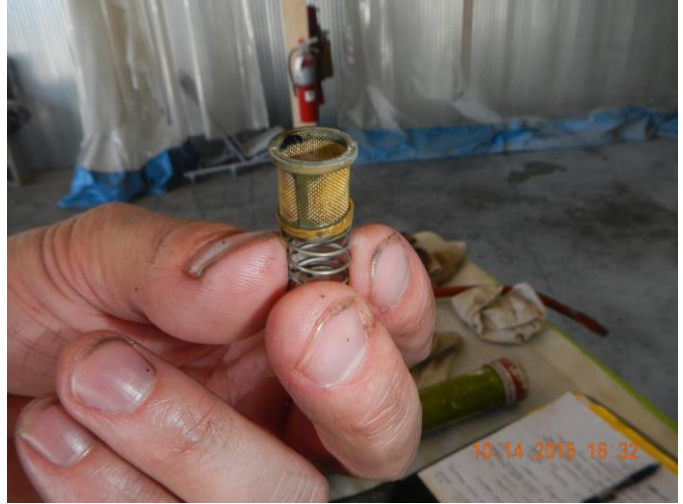
**PAGE 13 of 19**

<b>OIL SCREEN</b>	Manufacturer: TCM	P/N:A25131
Condition:	A small amount of carbon was found on the screen surface.

The combination oil tank and cooler was impact damaged

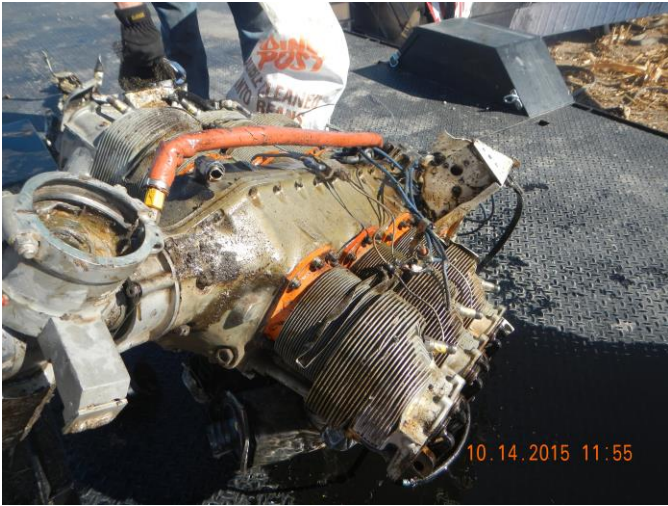
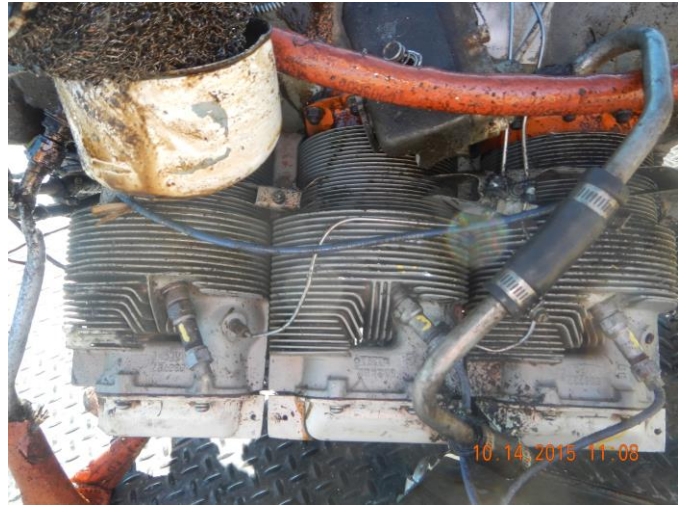
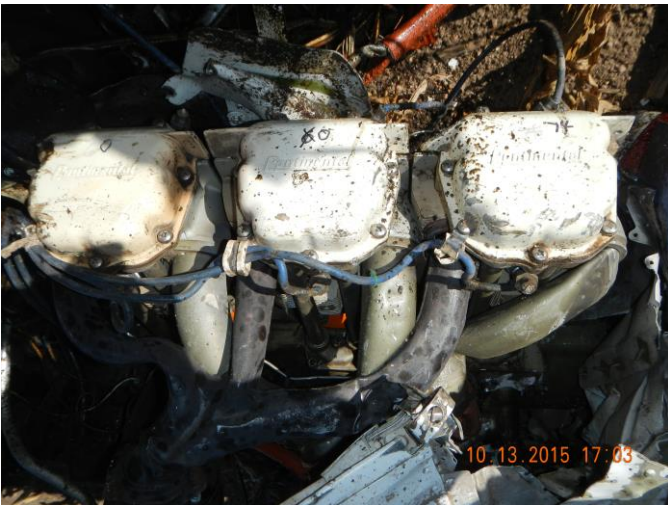
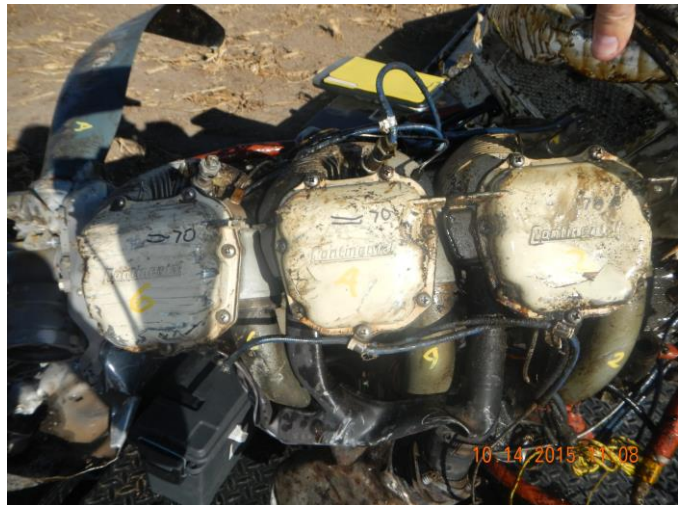
**PAGE 15 of 19**

<b>ALT/GEN #1</b>	Manufacturer: Delco Remy	P/N: 11018885	S/N: 5428
<b>Condition:</b>	The engine driven generator remained attached and intact
