Continental Motors

ENGINE EXAMINATION REPORT

ENGINE MODEL	O-470-R
ENGINE SERIAL NUMBER	84391-3-R-4
AIRCRAFT MAKE & MODEL	Cessna 182F
AIRCRAFT SERIAL NUMBER	18254796
AIRCRAFT REGISTRATION	N5738F
FILE NUMBER	15-098

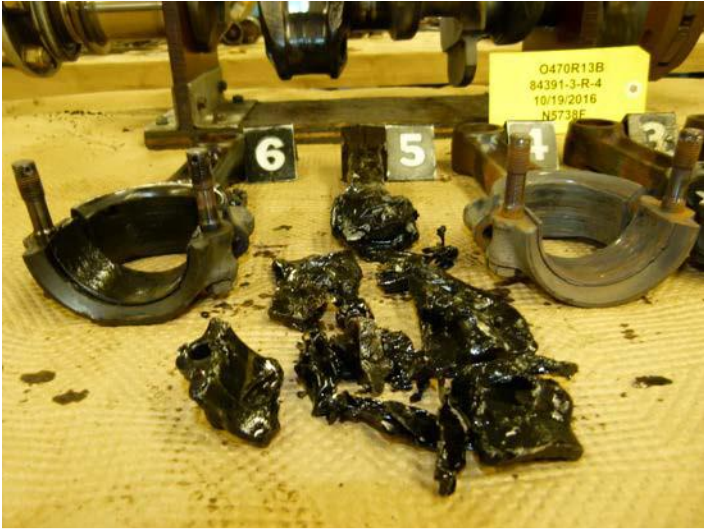
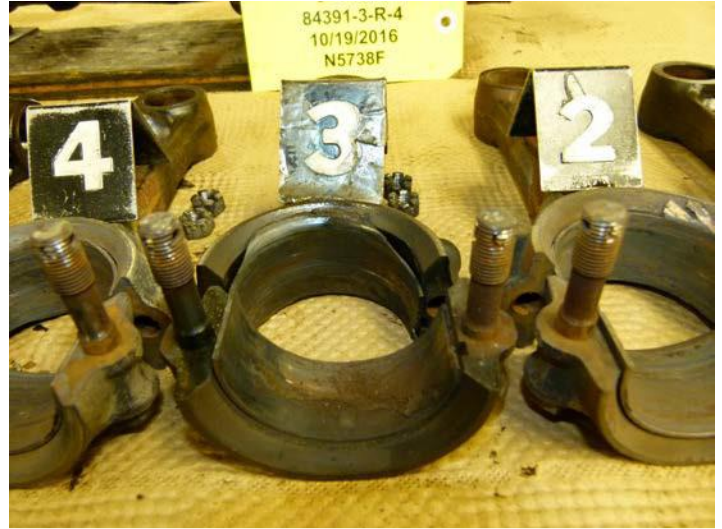
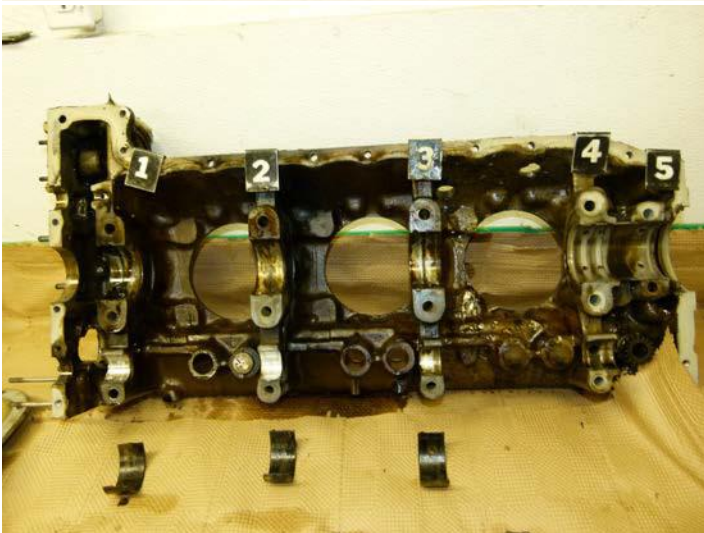
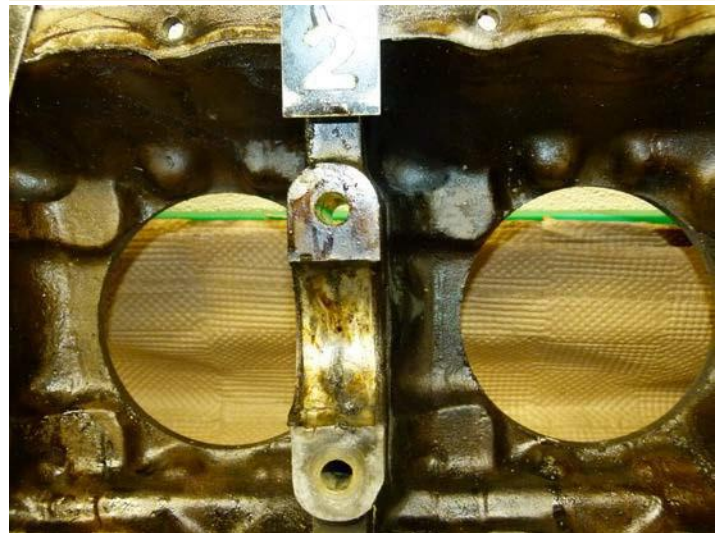
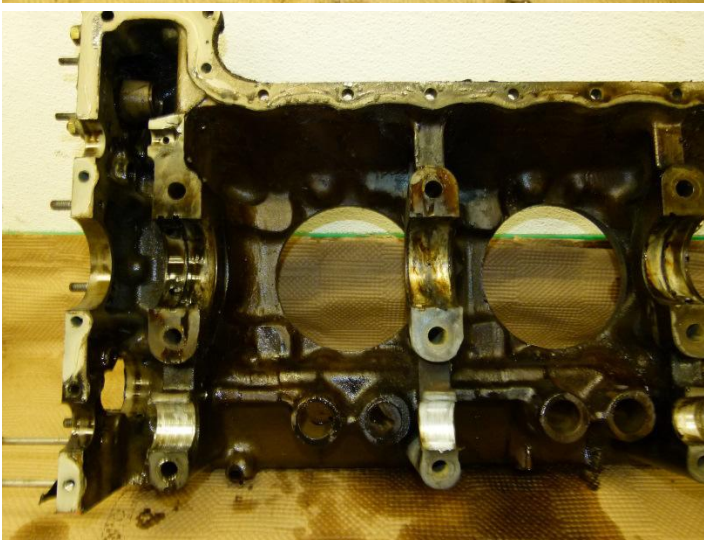
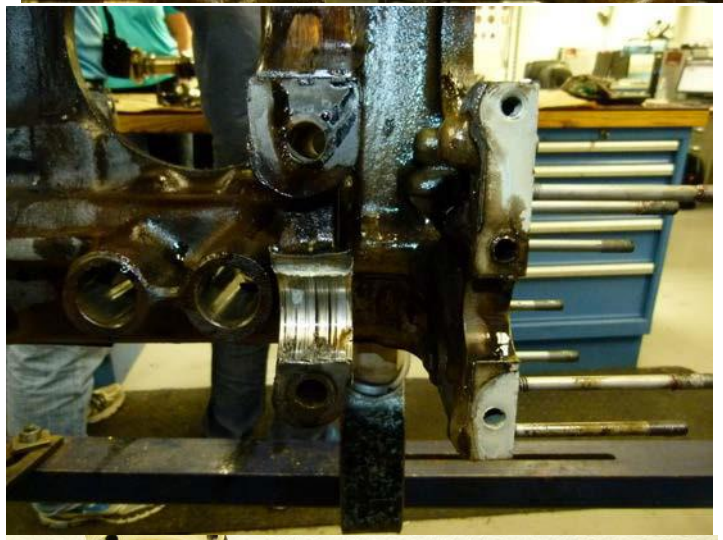
The engine was mount on a stand and disassembled. The number five connecting rod had fractured and separated from the crankshaft causing internal damage. Metal was located in the oil sump. The camshaft, connecting rods, crankshaft journals and bearings exhibited signs of oil starvation. The cause of this oil starvation could not be determined during the engine teardown examination. The Textron Aviation investigator reported the belly of the aircraft was coated with fresh oil at the scene of the accident.
