Evidence to support Flowline from Coors 6-14Ji was not excavated from the wellhead to the cut end at the house. I would hope this photo log is evidence enough.

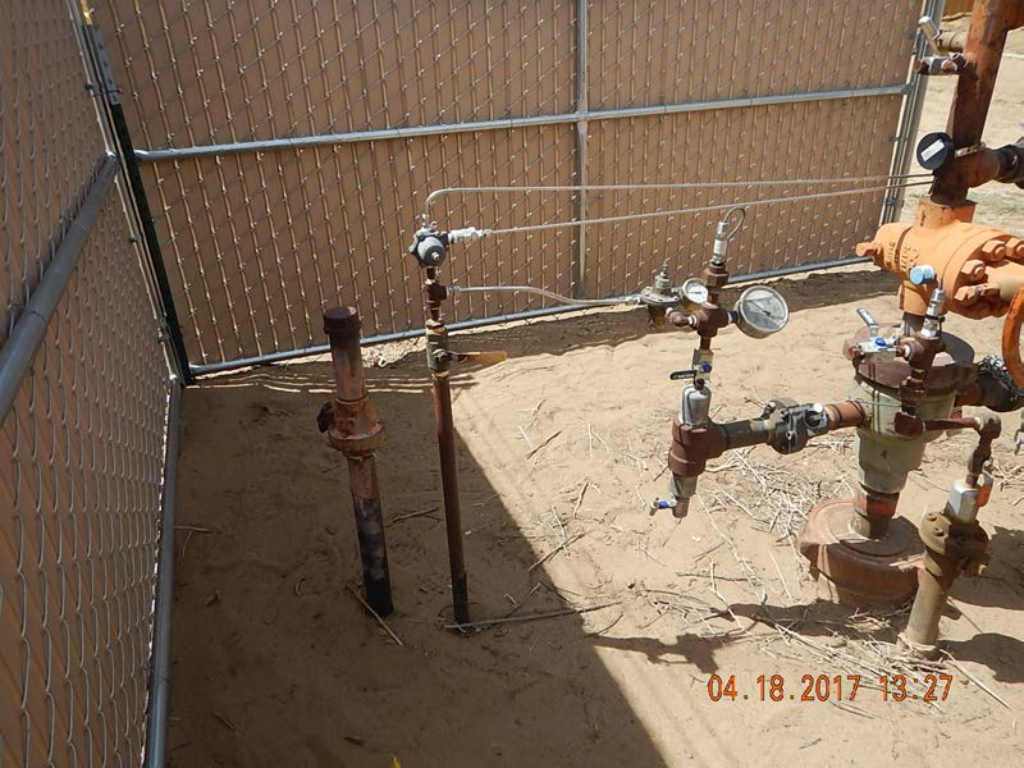
04.18.2017 13:27

- 1) Photo 013(2) is looking from south of the home to the well. Notice the building trusses on the right side of photo and time stamp of 04.18.2017
- 2) Photo 019 shows Abandoned flowline and 1" PE return line on 04.18.2017

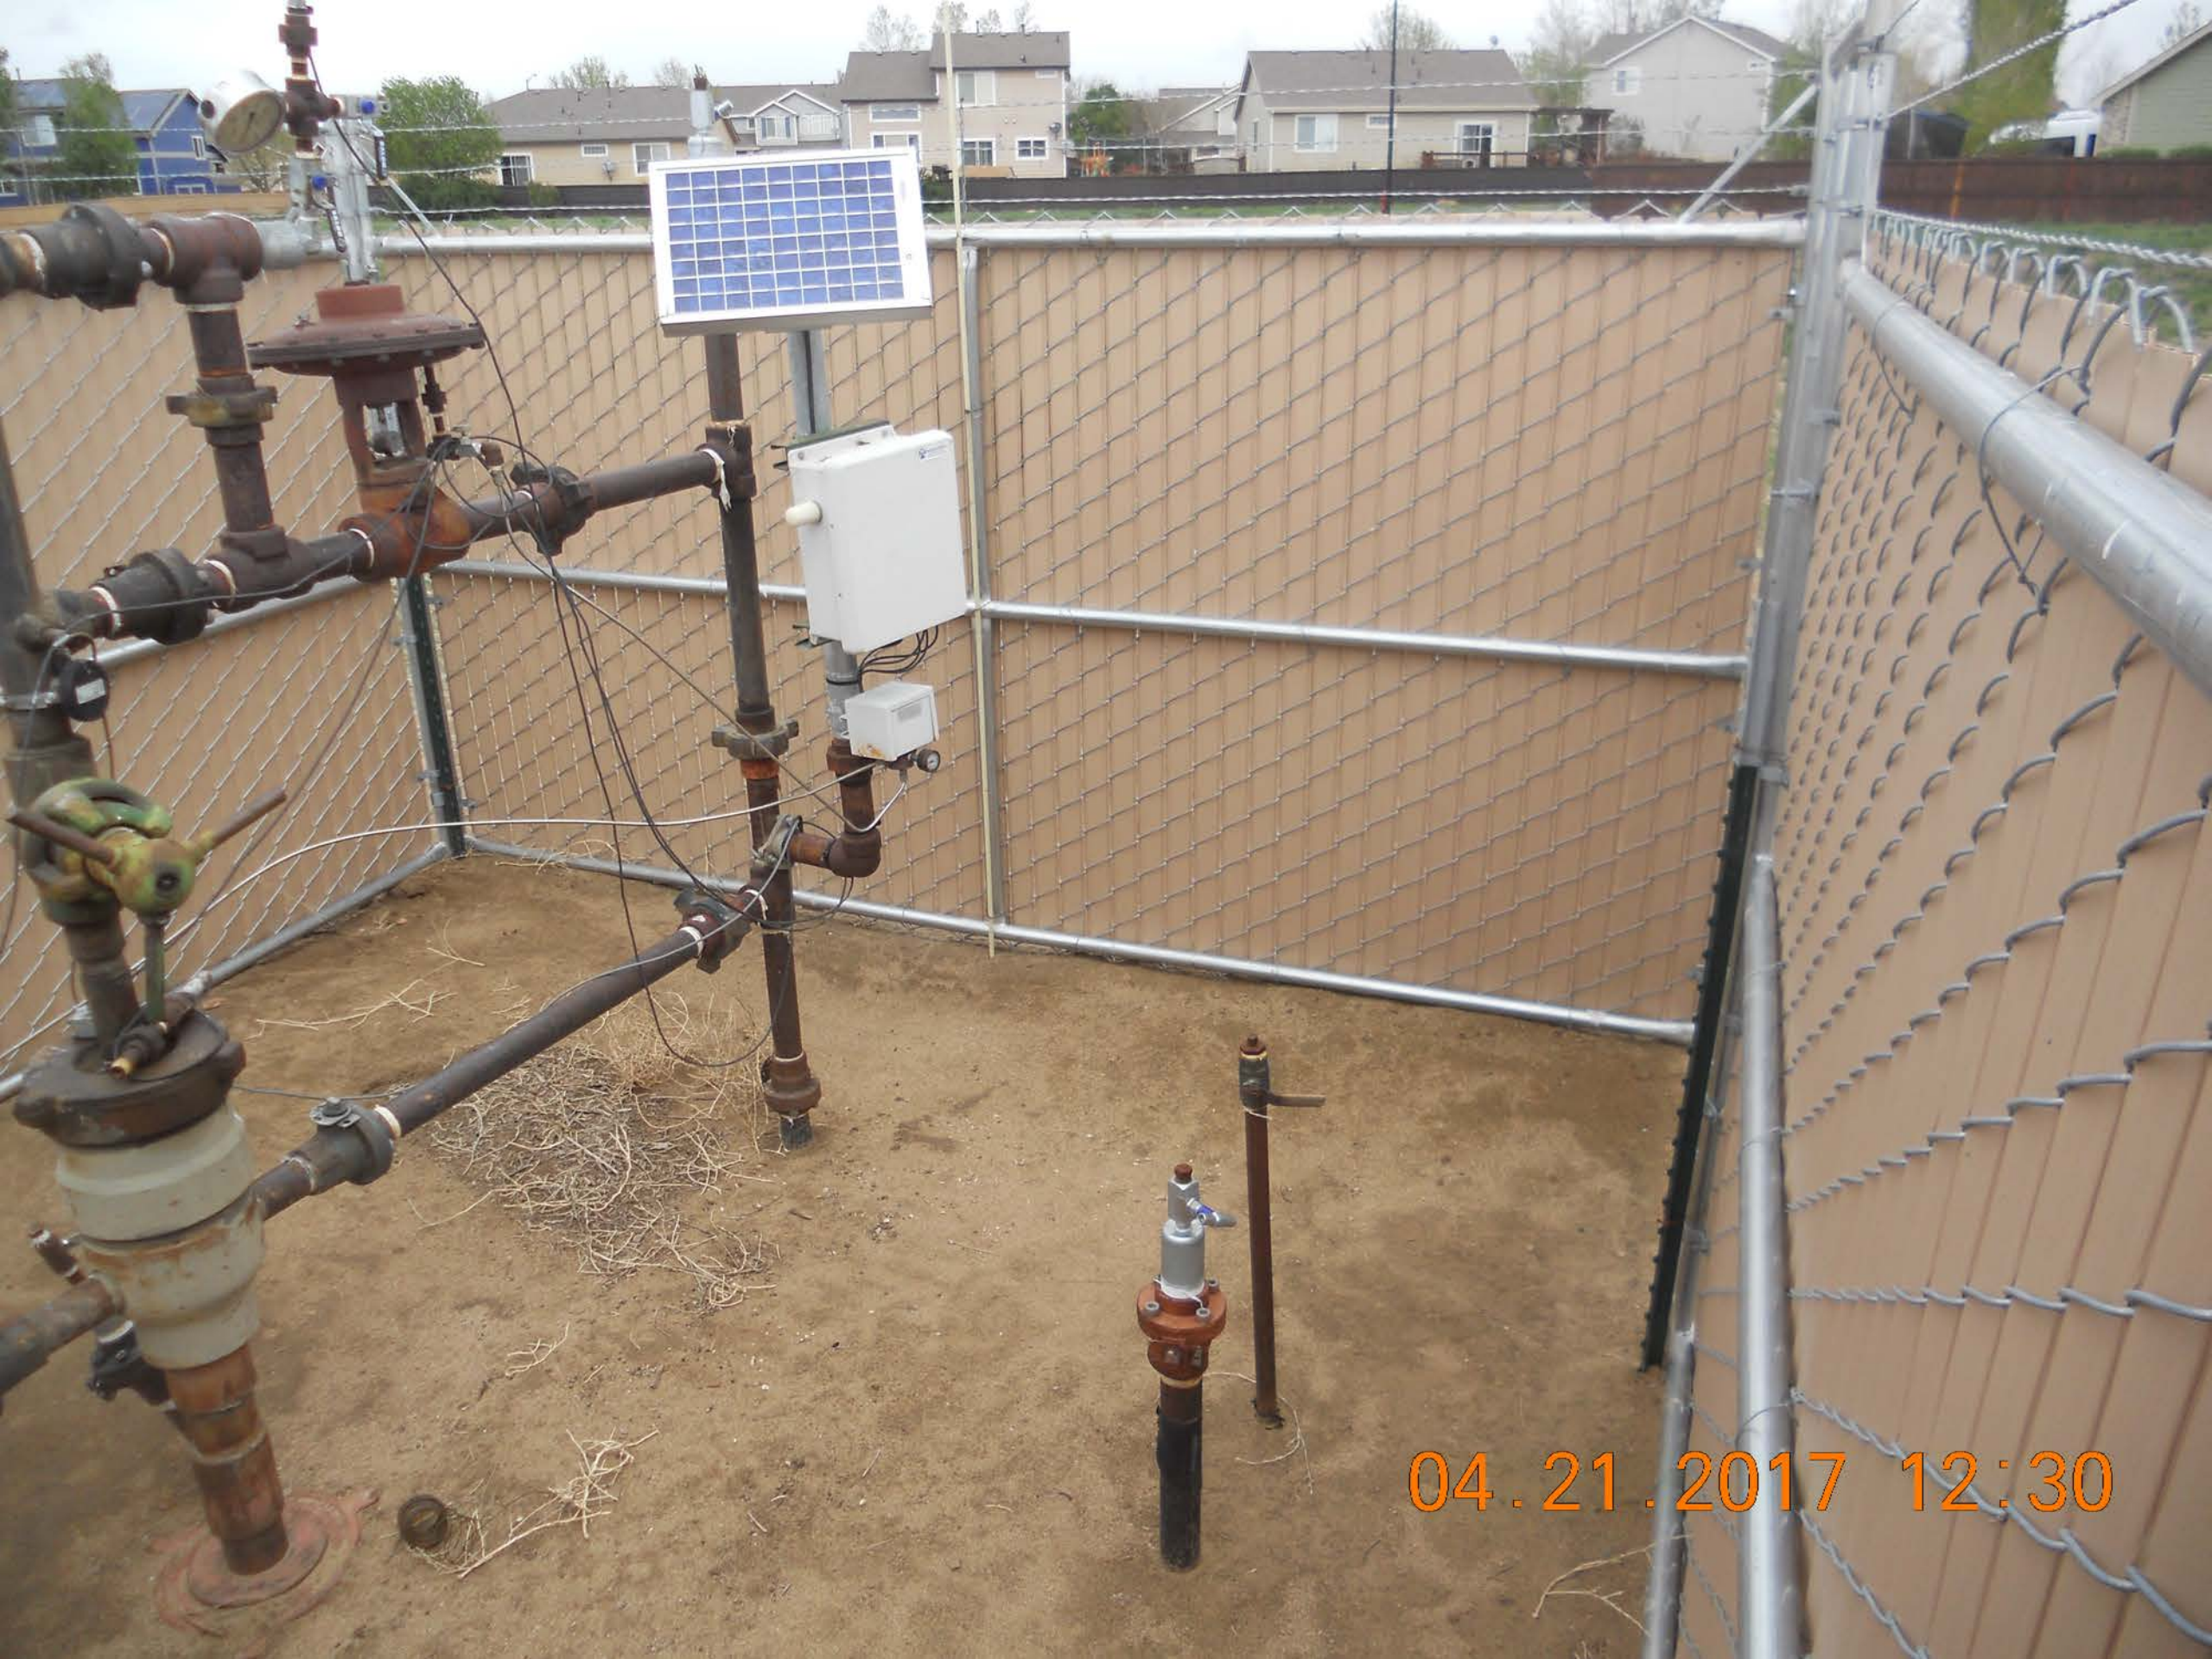
04.21.2017 12:30

- 6) Photo DSCN1541 show wellhead of Coors 6-14 Ji on 04.21.2017. Abandoned flowline and return 1" in bottom left of photo. No evidence of excavation. Notice trusses beyond for reference.
