Carson Helicopters Flight Evaluation with S61N Helicopter

RE: Weaverville Helicopter Accident N612AZ; Summary of 3 November 2009 Flight Test

Sikorsky S-61N C-FHHD

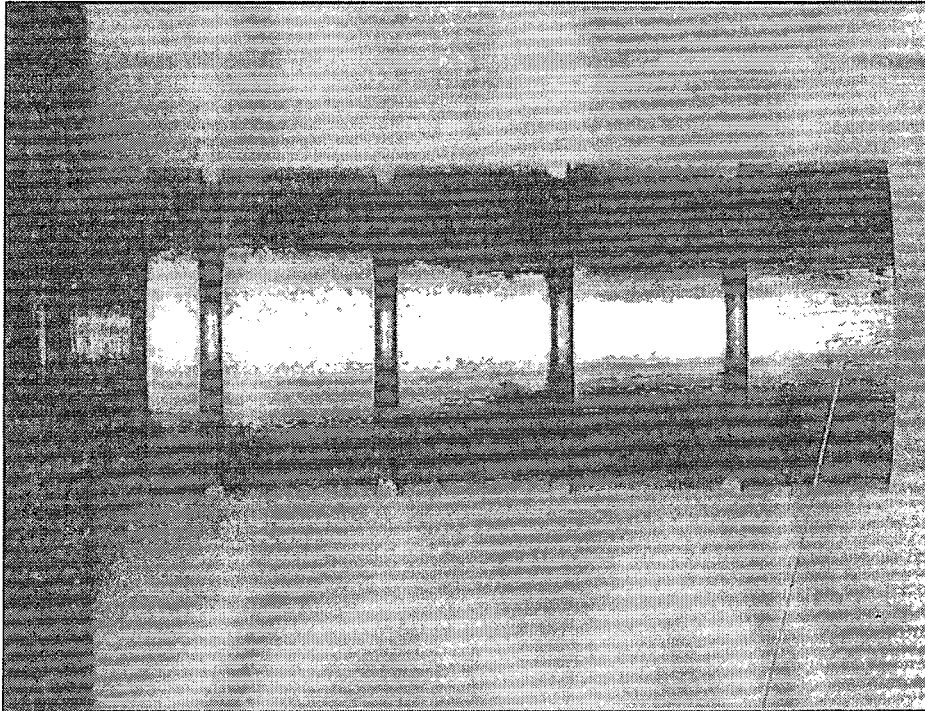
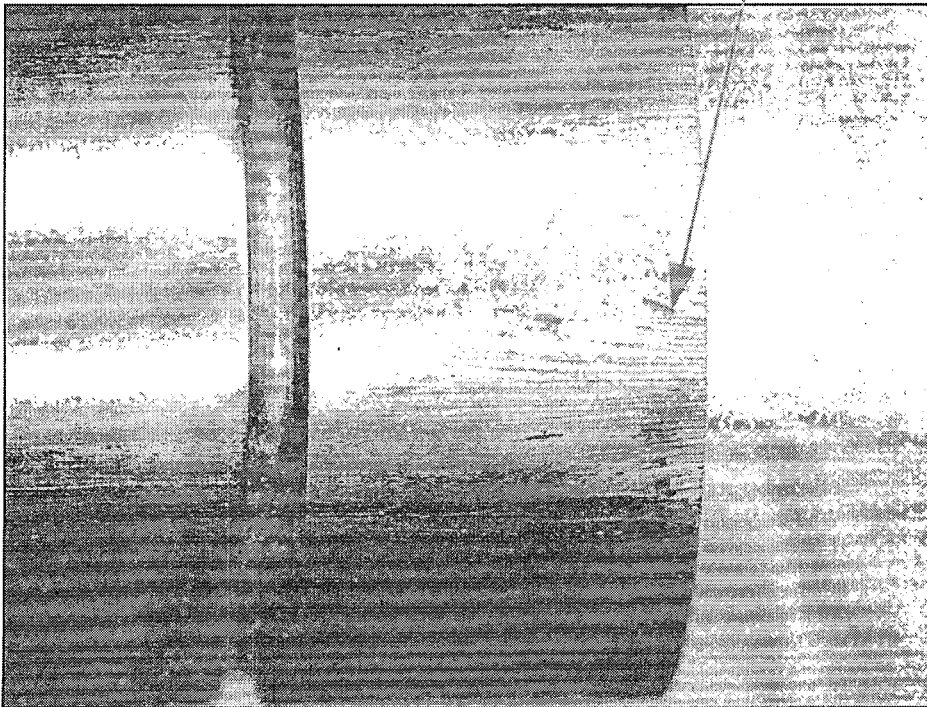
Initial examination of the spool under an optical microscope revealed several patches of abrasive-type wear around the finished outer diameter. As shown in Figure 2, these areas of wear extended from the diaphragm end to roughly the midpoint of this interrupted diameter. Closer examination showed that the appearance of these wear sites varied from fine, uniform abrasion to more distinct axial score marks, or grooves. The former is characteristic of service wear for this valve induced by side loading of the spool relative to the sleeve. The sites of rougher abrasion were indicative of surface distress caused by hard debris/particulate. Also noteworthy on the spool were three sites of apparent erosive wear that were equally spaced around and confined to the outer land (i.e. the land at the free end of the spool), and a considerable amount of debris that had collected in the four balance grooves and in the smaller diameter at the diaphragm end of the spool. Chemical analysis of a sampling of this debris revealed mainly abrasive mineral oxides of silicon, aluminum, calcium and magnesium, as well as silica (glass) fibers roughly 0.0001" in diameter, iron-base fines, aluminum alloy fines and scattered organic material, Figure 3. The size of the angular oxides was roughly 25 μ , or 0.001" (note that the specified diametral clearance between the spool and sleeve is 0.0004"-0.0008"). The diameter of the spool in a relatively unworn area measured 0.3770", which is in accordance with the drawing requirement of 0.3770"/0.3772".

Overview of the two submitted JFC26 Pressure Regulating Valves.

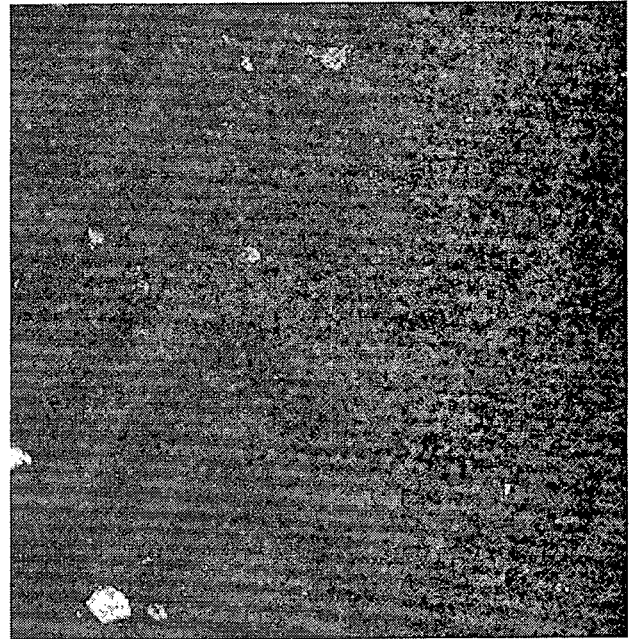
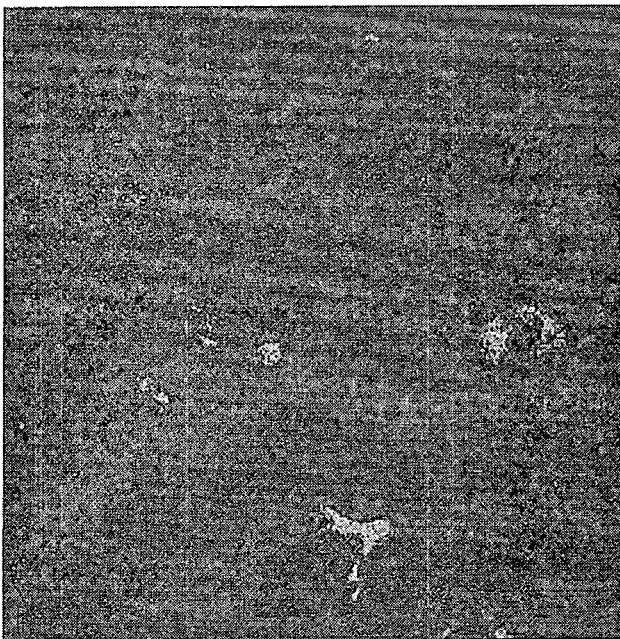
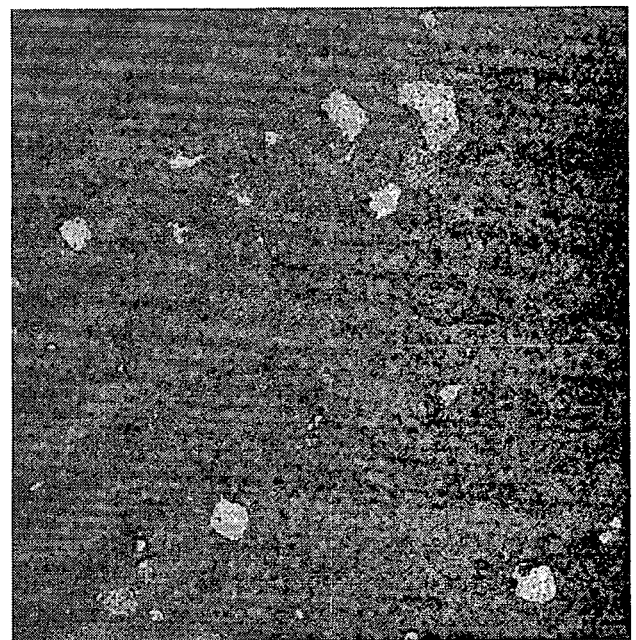
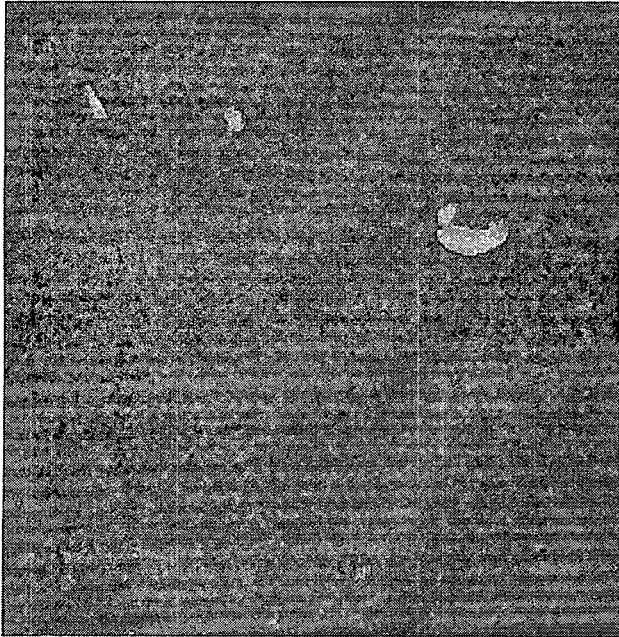
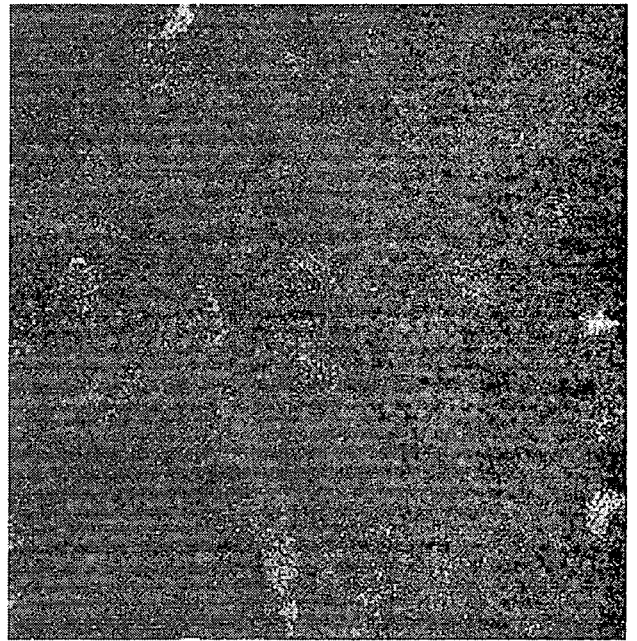
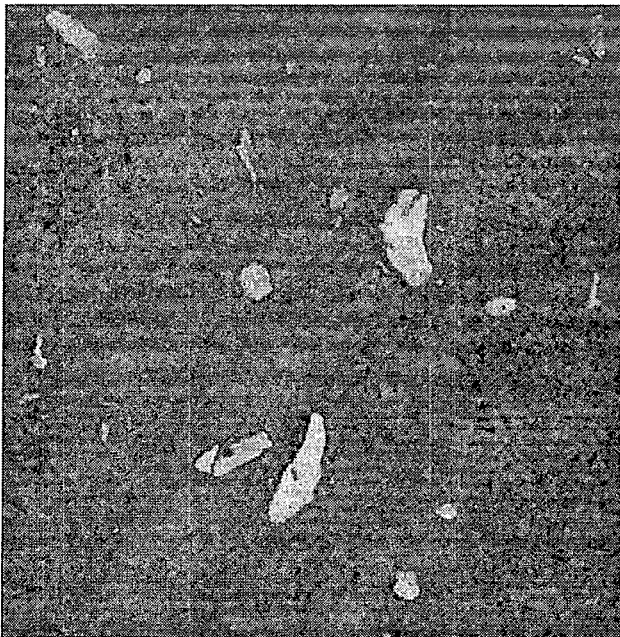
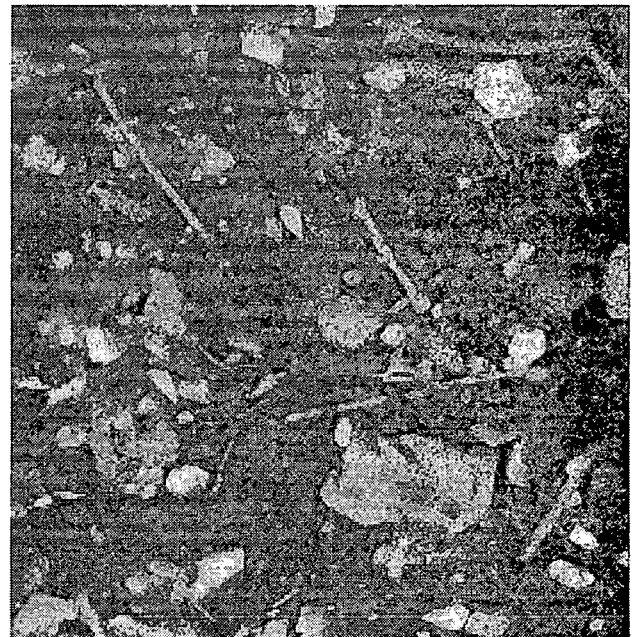
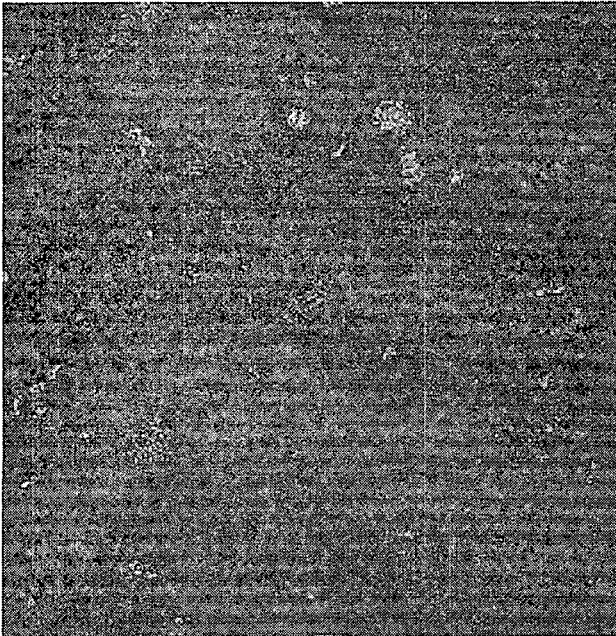
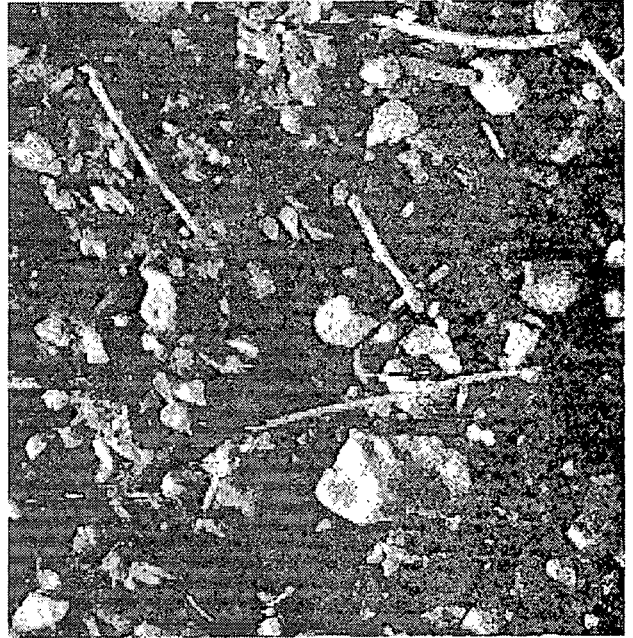
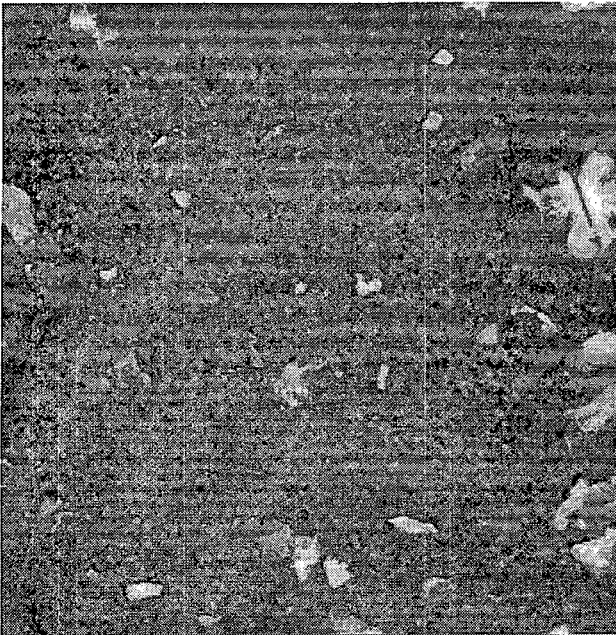
Figure 3 – cont.
Additional elemental distribution maps.

Figure 3
EDS spectrum obtained for contamination collected from the Hayes PRV spool.

Additional elemental distribution maps (note that some of the Carbon distribution is attributable to the medium used to secure the sample).

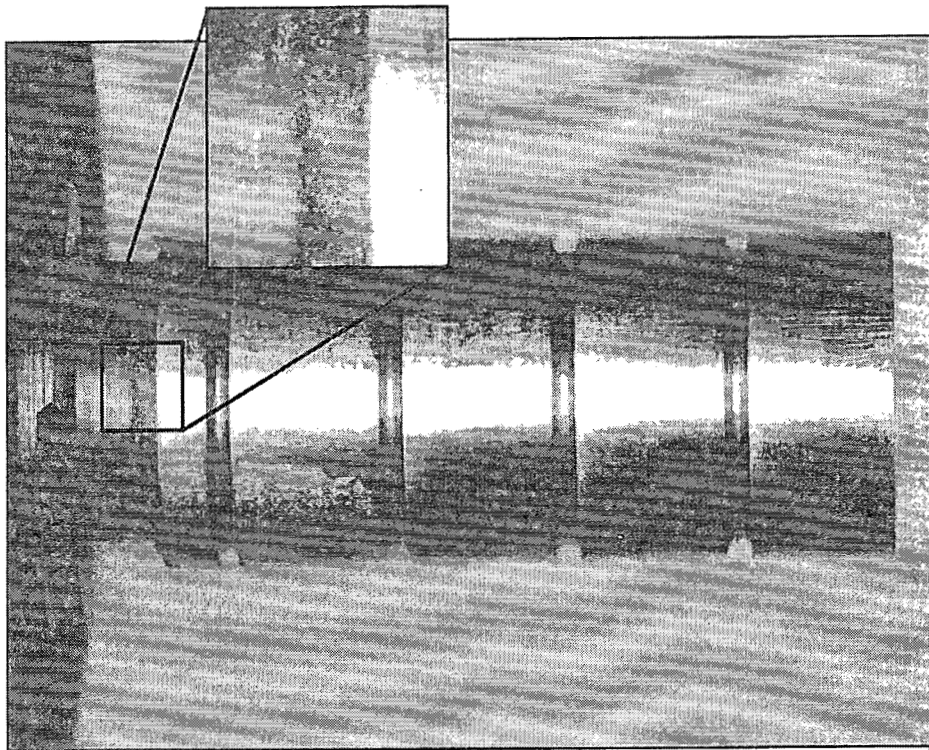
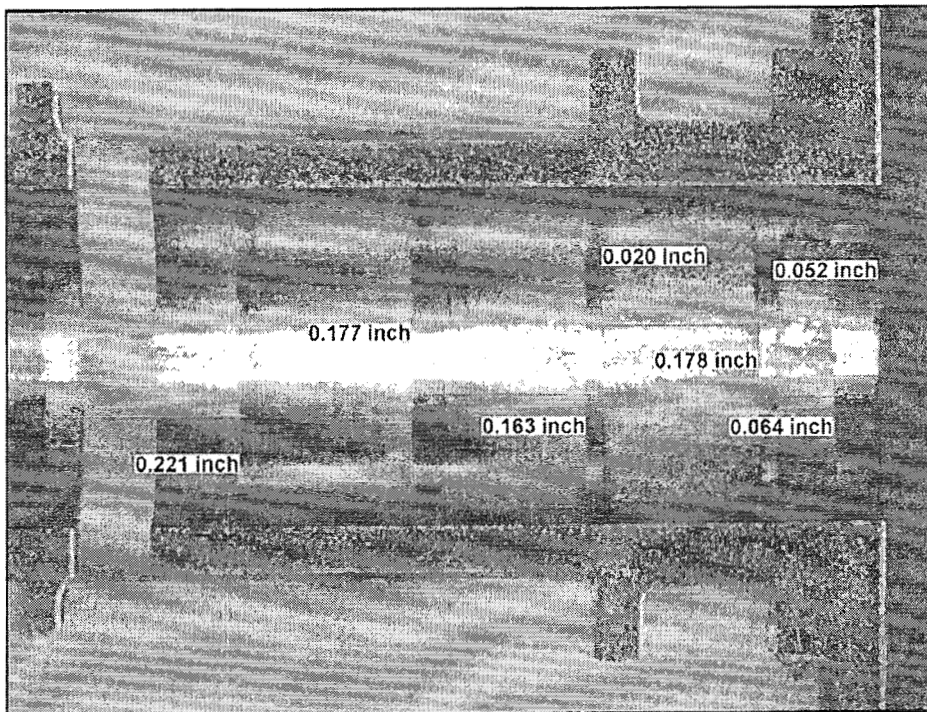
Silt-like debris on the mating diameters of the Carson PRV.

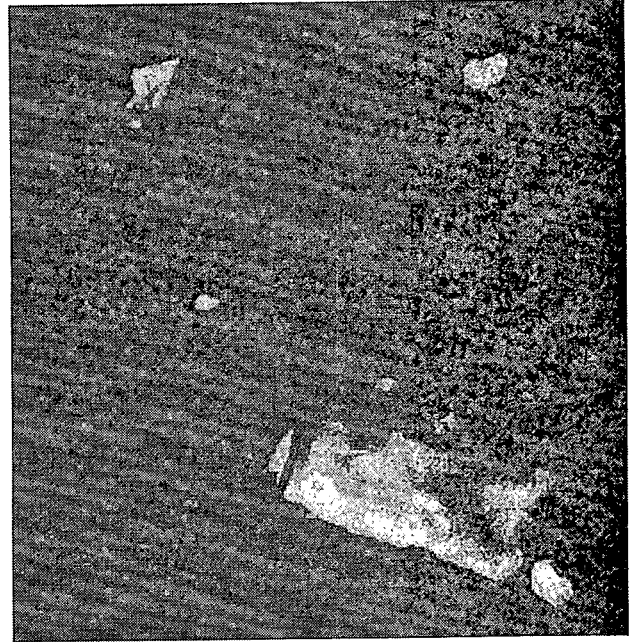
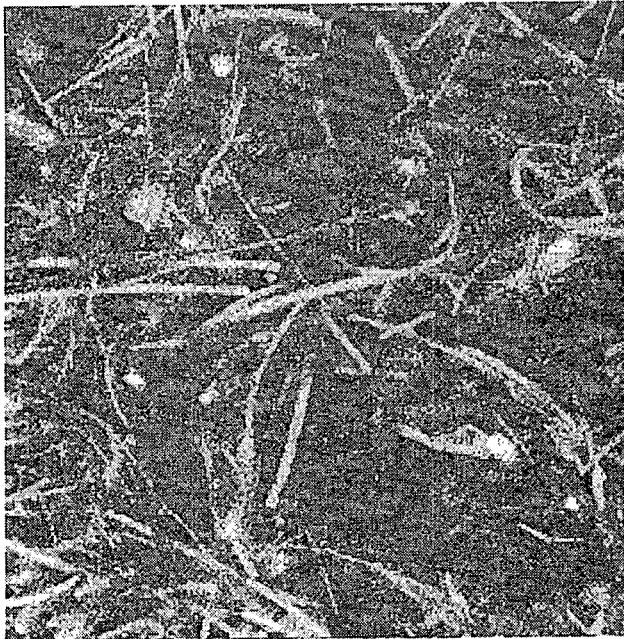
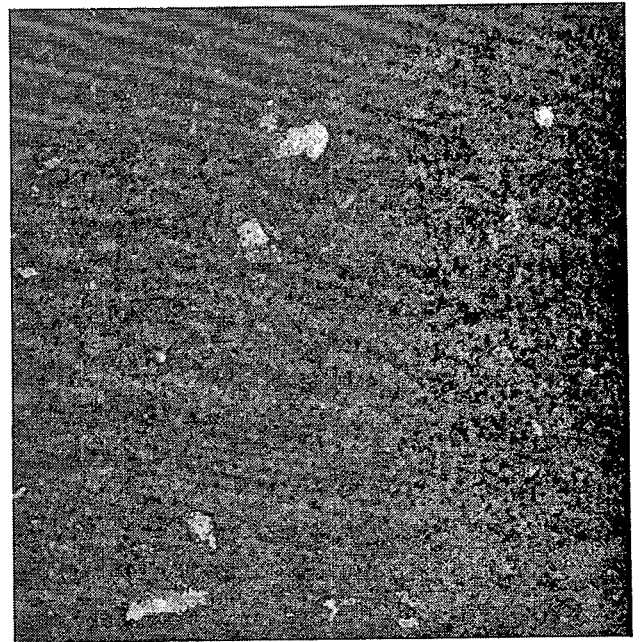
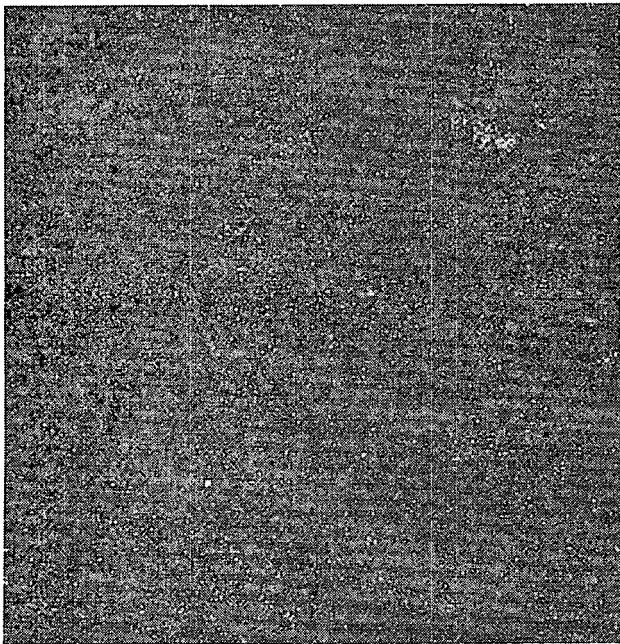
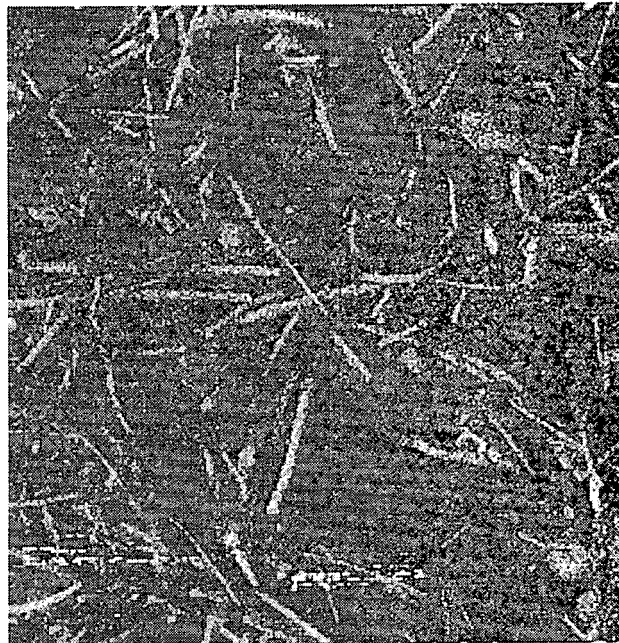
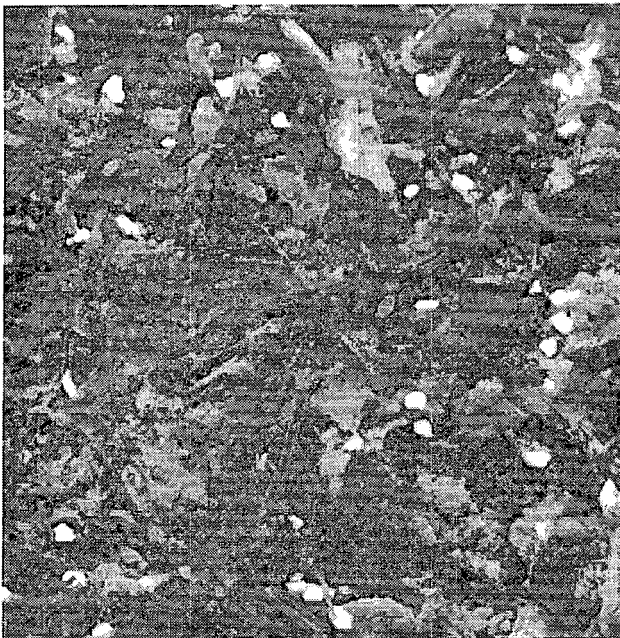
Figure 8 – cont.
Additional elemental distribution maps.

Chemical analysis of a sampling of the debris found on the spool showed a significant quantity of silica (glass) fibers, Figure 8. The analysis also showed the presence of oxides of aluminum and silicon, molybdenum disulfide (dry film lubricant) particulate, iron-base fines, discrete zinc and carbon particles, and a presence of potassium.

Figure 8
EDS spectrum obtained for contamination collected from the Carson PRV spool.
