REPORT TITLE: Examination of a Bellcrank Assy-Roll Control p/n 6260347-12 and Box Assy-Spoiler Mixer p/n 6261282-1; 650-7063; N877G

REPORT #: 12-359-072

DATE: 3/19/12

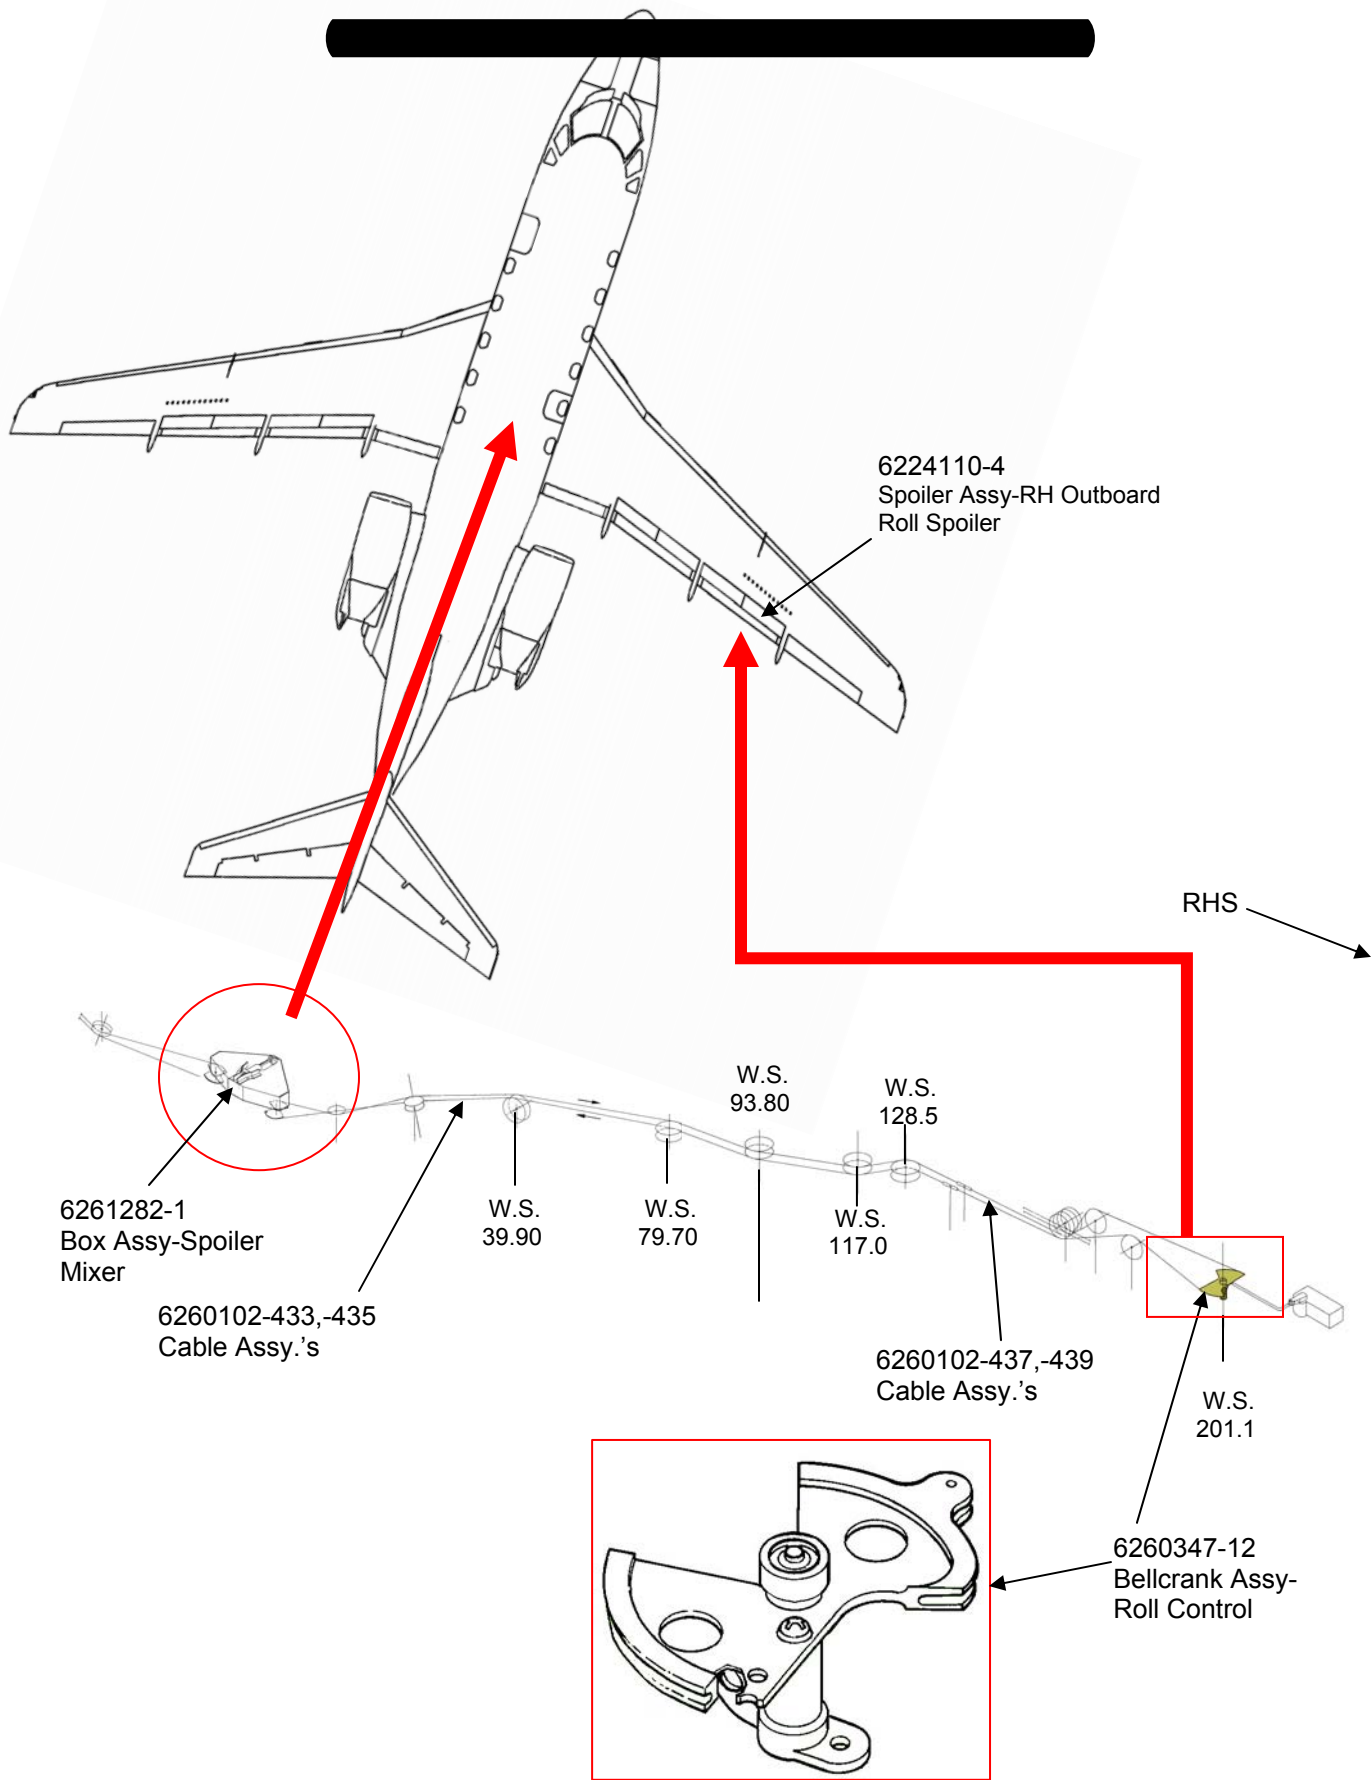
Figure 1. Sketch showing the arrangement of the 6261282-1 Box Assy-Spoiler Mixer and 6260347-12 Bellcrank Assy-Roll Control in Model 650 aircraft.

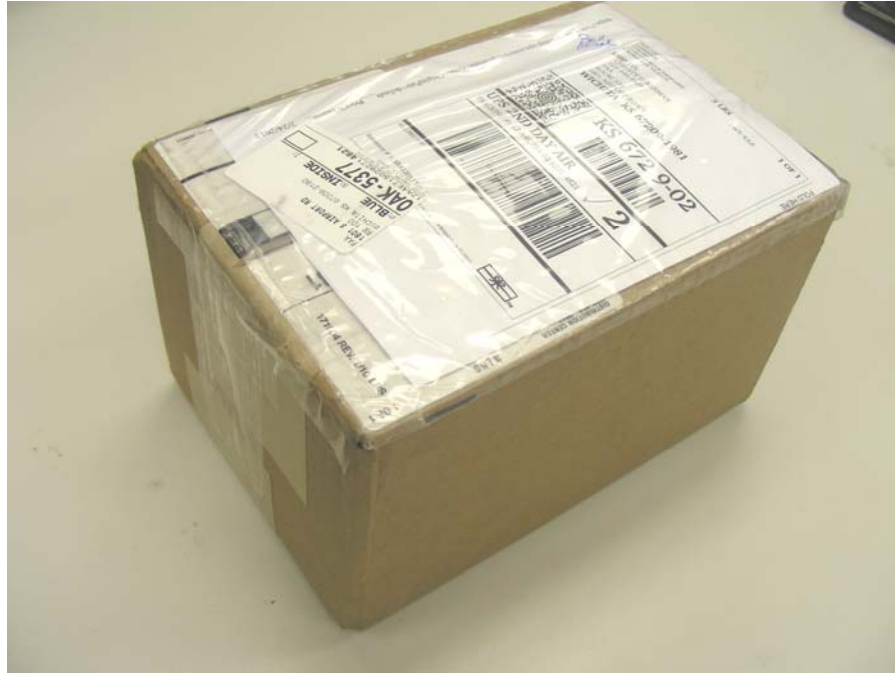
The bellcrank was removed from the aircraft and was brought to Cessna 3-6-2012 in a sealed shipping carton by a representative of the FAA as shown in Figure 2. Views of the as-received bellcrank are shown in Figures 3 and 4. The bellcrank had a slightly dirty appearance, but did not display any visible damage or corrosion. Some slight wear of the cable groove was noted due to contact with the cable (Figure 5), but this did not appear to be excessive. Press fit into the upper and lower surfaces of the bellcrank were two KP3AL bearings. Both of these bearings had a somewhat greasy appearance with some dirt present, however the snap ring and bearing seals appeared to be intact, Figure 6. The lower bearing displayed the ball insertion grooves which are machined into the inner and outer bearing races, as shown in Figures 6b) and 7. The upper and lower KP3AL bearings appeared to rotate freely by hand through approximately 90 degrees of rotation, at which time they could not be made to rotate any further by hand, see Figure 8. No effort beyond manual hand pressure was applied to force bearing rotation. Rotation of the upper bearing coincided with rotation of the lower bearing, likely due to frictional contact of both bearing inner races with the NAS43HT3-125 spacer situated between the two bearings.

Figure 2. The bellcrank assembly was brought to Cessna by representatives of FAA in a sealed shipping carton.

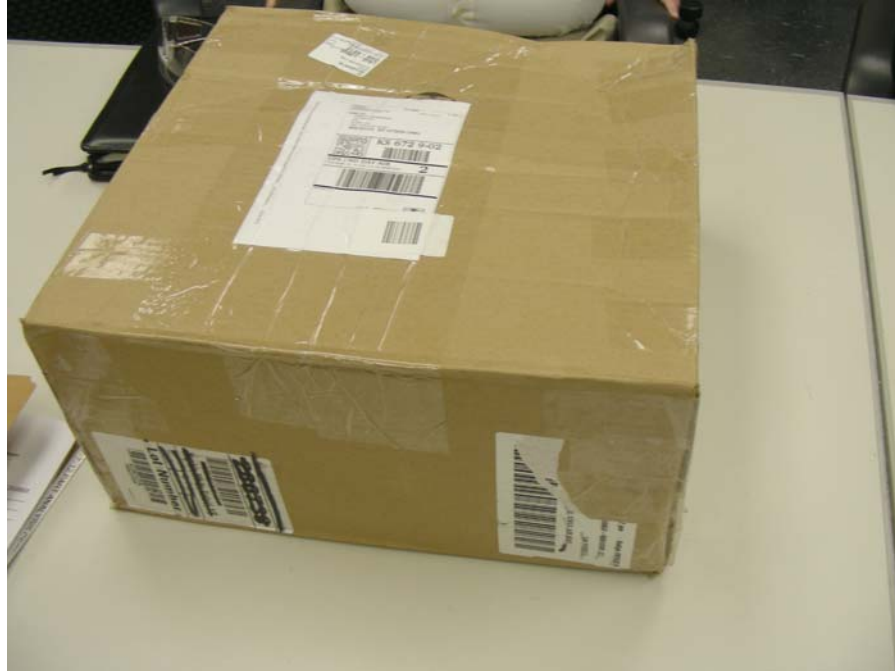
The Box Assy-Spoiler Mixer p/n 6261282-1 was removed from the aircraft and was brought to Cessna 3-12-2012 in a sealed shipping carton by a representative of the FAA as shown in Figure 11. Views of the as-received mixer box are shown in Figures 12 and 13. The mixer box had a slightly dirty appearance, with some grit material within. Visual inspection of the mixer box did not reveal any missing or loose component parts. Rotation of the 6261293-1 cam assembly was easily accomplished manually, with no perceived sticking or binding of the internal mechanism. Rotation of the 6261293-1 cam assembly resulted in the expected output movements of the 6261060-5, -6 quadrants. The nickel plated steel cam assembly (p/n

Figure 11. The mixer box assembly was brought to Cessna by representatives of FAA in a sealed shipping carton.
