THE CESSNA AIRCRAFT COMPANY  
P.O. BOX 7704  
WICHITA, KS 67277

MODEL NO: 560XL

REPORT NO: PR-560XL-009

560XL-5599 FOLLOW-ON INVESTIGATION  
(NETJETS TAIL N613QS)

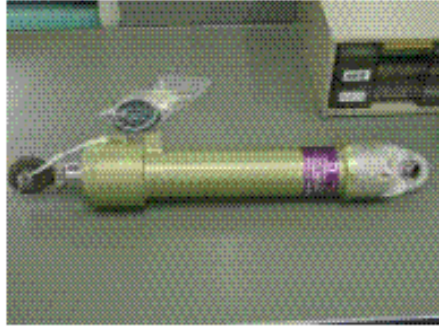
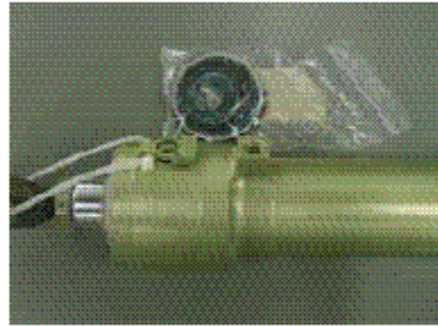
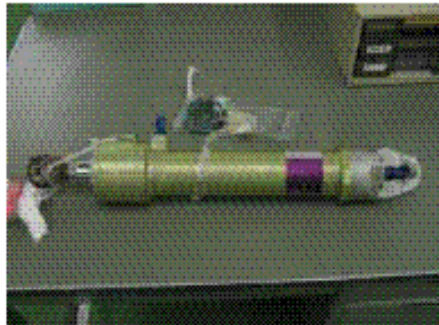
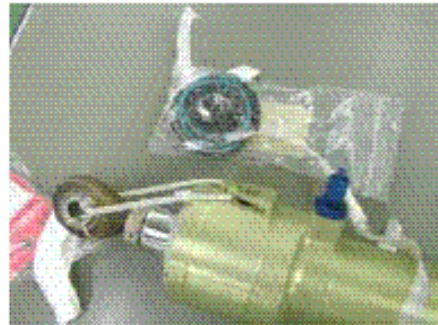
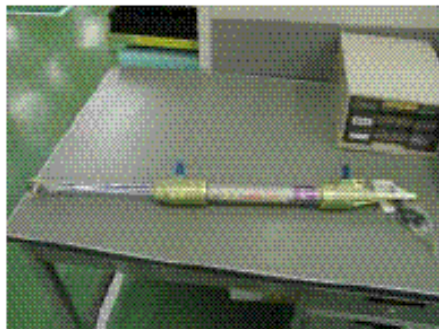
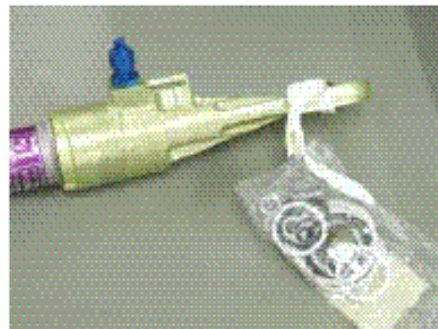
**Photo 1 - Returned Actuators**

**S/N 1011- No abnormalities noted**

**S/N 0523- No abnormalities noted**

**S/N 1003- No abnormalities noted**

The following was noted for three actuators upon receipt at NTS Receiving Inspection department.

Following the teardown and dimensional inspection and with Cessna's concurrence NTS replaced all packings, backup rings and Teflon seals, replaced the ball for the NLG unit and installed new switches prior to conducting the ATP's on each unit.

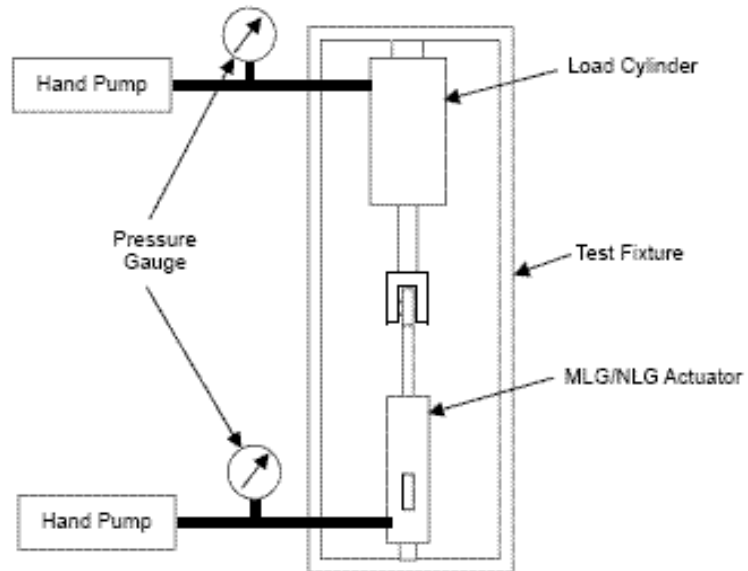
**Figure A-1 – Test Setup**

Back pressure at actuator locked position is 5 to 15 psig since those are specified as leakage test pressure at locked position in Cessna SDs 9912491 and 9912537. The additional tests requested by Cessna show that piston unlock pressures remained virtually unchanged or increased slightly under loads in both the unlock and opposing directions. In both cases the piston never unlocked at pressures below the minimum unlocking pressure specified in the Cessna specifications

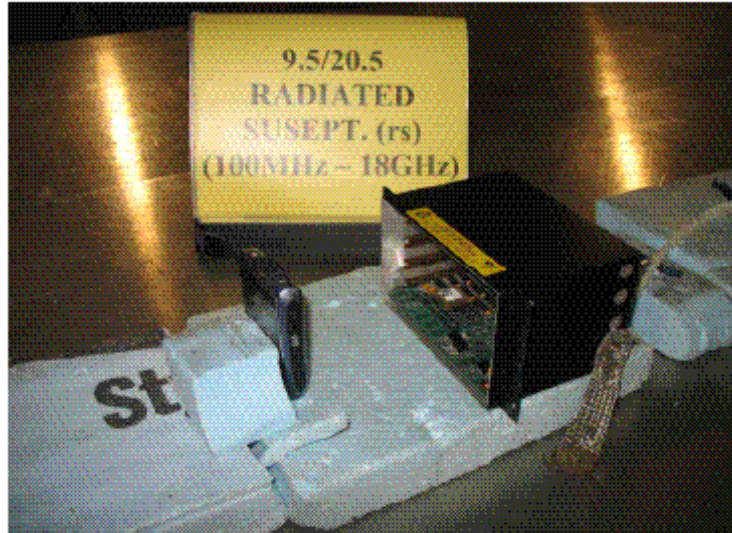
Figure 3-1: Blackberry Placed Perpendicular to the PCB

Testing of the Landing Gear Control PCB with the Blackberry cell phone was successfully performed. The cell phone was placed in various orientations facing the PCB and wire bundle. During testing the cell phone was called to verify the antenna was transmitting. Emissions tests were first run on the Blackberry cell phone to see what frequencies the antenna transmitted at. The cell phone operated at two different frequencies, one at 700 MHz and another at 1.9 GHz. Both of these frequencies were also covered in the radiated susceptibility tests. Testing was repeated twice; once with the HIRF chamber door closed and once with the door open. Testing with the doors closed removed all background noise and only fields emitted from the Blackberry would affect the Landing Gear Control PCB. Testing with the doors open exposed the chamber and PCB to all noise in the environment (i.e. Radio Towers). With the doors open, the spectrum analyzer showed fields from the environment much stronger than emissions from the Blackberry cell phone. First the cell phone was placed about 6.2 inches away perpendicular to the PCB as seen in Figure 3-1. 6.2 inches is about one wavelength of 1.9 GHz. Next the cell phone was placed 2" above, parallel to the wire bundle as seen in Figure 3-2. Lastly, the cell phone was placed parallel to the PCB on top of the enclosure as seen in Figure 3-3. All three tests passed with no anomalous signals seen on the extend or retract line.

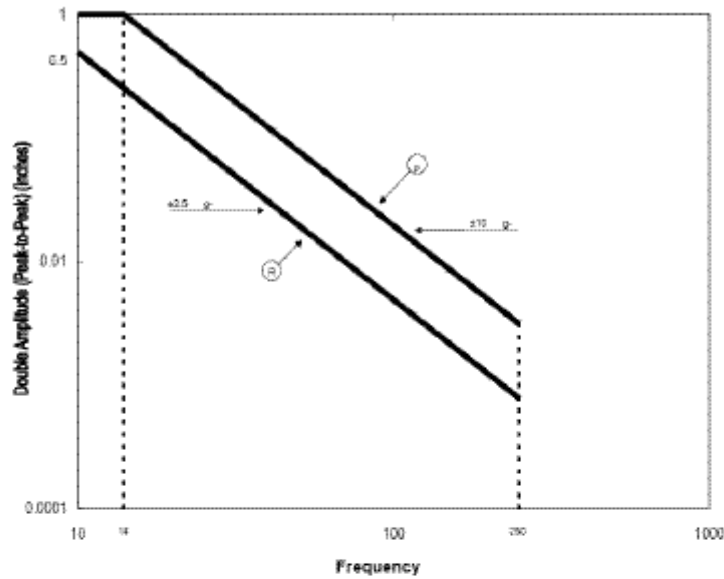
Figure 3-4: High-Level Short Duration Sinusoidal Vibration Test Curves

Vibration testing was successfully performed as specified in section 3.1.2 of the Test Plan. The specified curve, curve R, can be seen in Figure 3-4 from RTCA/DO-160E. Test Results are located in Appendix A, Section 1.1, 1.2, and 1.3. The board performed as intended and no anomalies were found.

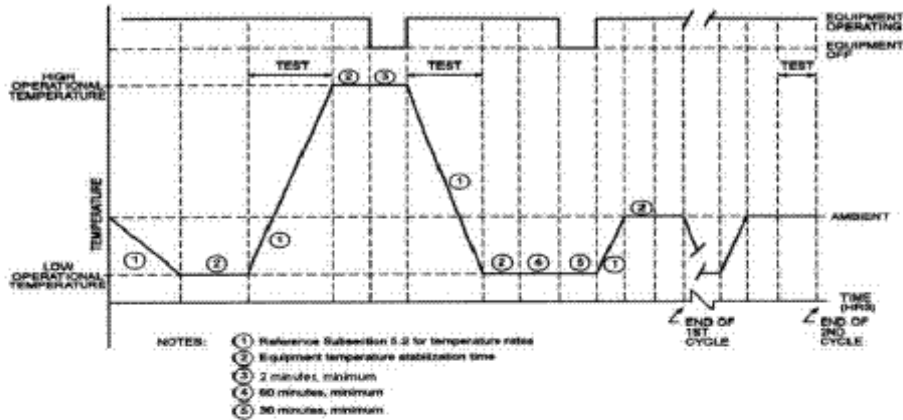
Figure 3-5: Temperature Variation Test

Temperature Variation testing was successfully performed as specified in section 3.1.1 of the Test Plan. Note 2 seen in Figure 3-5 was set to 30 minutes for equipment temperature stabilization time. 30 minutes gave the PCB adequate time to stabilize. Note 1 seen in Figure 3-5 deviated from the specification of 5°C/Min by having a significantly higher rate of change. This was due to the HALT chamber used being equipped with liquid nitrogen. The rate of change going from -40°C to 110°C ranged from 67.3°C/Min to 110°C/Min. The rate of change going from 110°C to -40°C was about -20°C/Min. The rate of change was very rapid compared to the specification which can be seen below in Appendix A, Section 1.4. Having a greater rate of change in temperature provided a more stringent test for the PCB. The Landing Gear Control PCB performed as intended and no anomalies were found.
