TECH NOTE

No. 011

Cessna Pilots Association

Vapor Lock Problems in 210 Series From 1964 thru 1981 Model Year

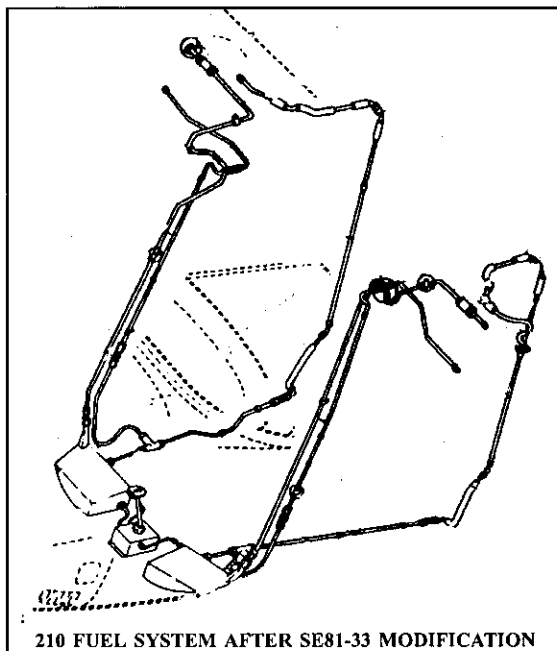
The fuel feeding system for the Cessna 210/T210/P210 was completely redesigned beginning with the 1982 model year. The changes included:

1. A single reservoir tank replaced the dual tanks.
2. Fuel selector has a "BOTH" position for the first time on a 210.
3. A vent inter-connect line is installed between the two
