SR2X Service Bulletin

Number:
 SB2X-32-22

# SNS SUBJECT: 32-20 NOSE GEAR - Nose Landing Gear Strut Assembly Inspection

# SNS SUBJECT: 32-20 NOSE GEAR - Nose Wheel Shimmy Reduction

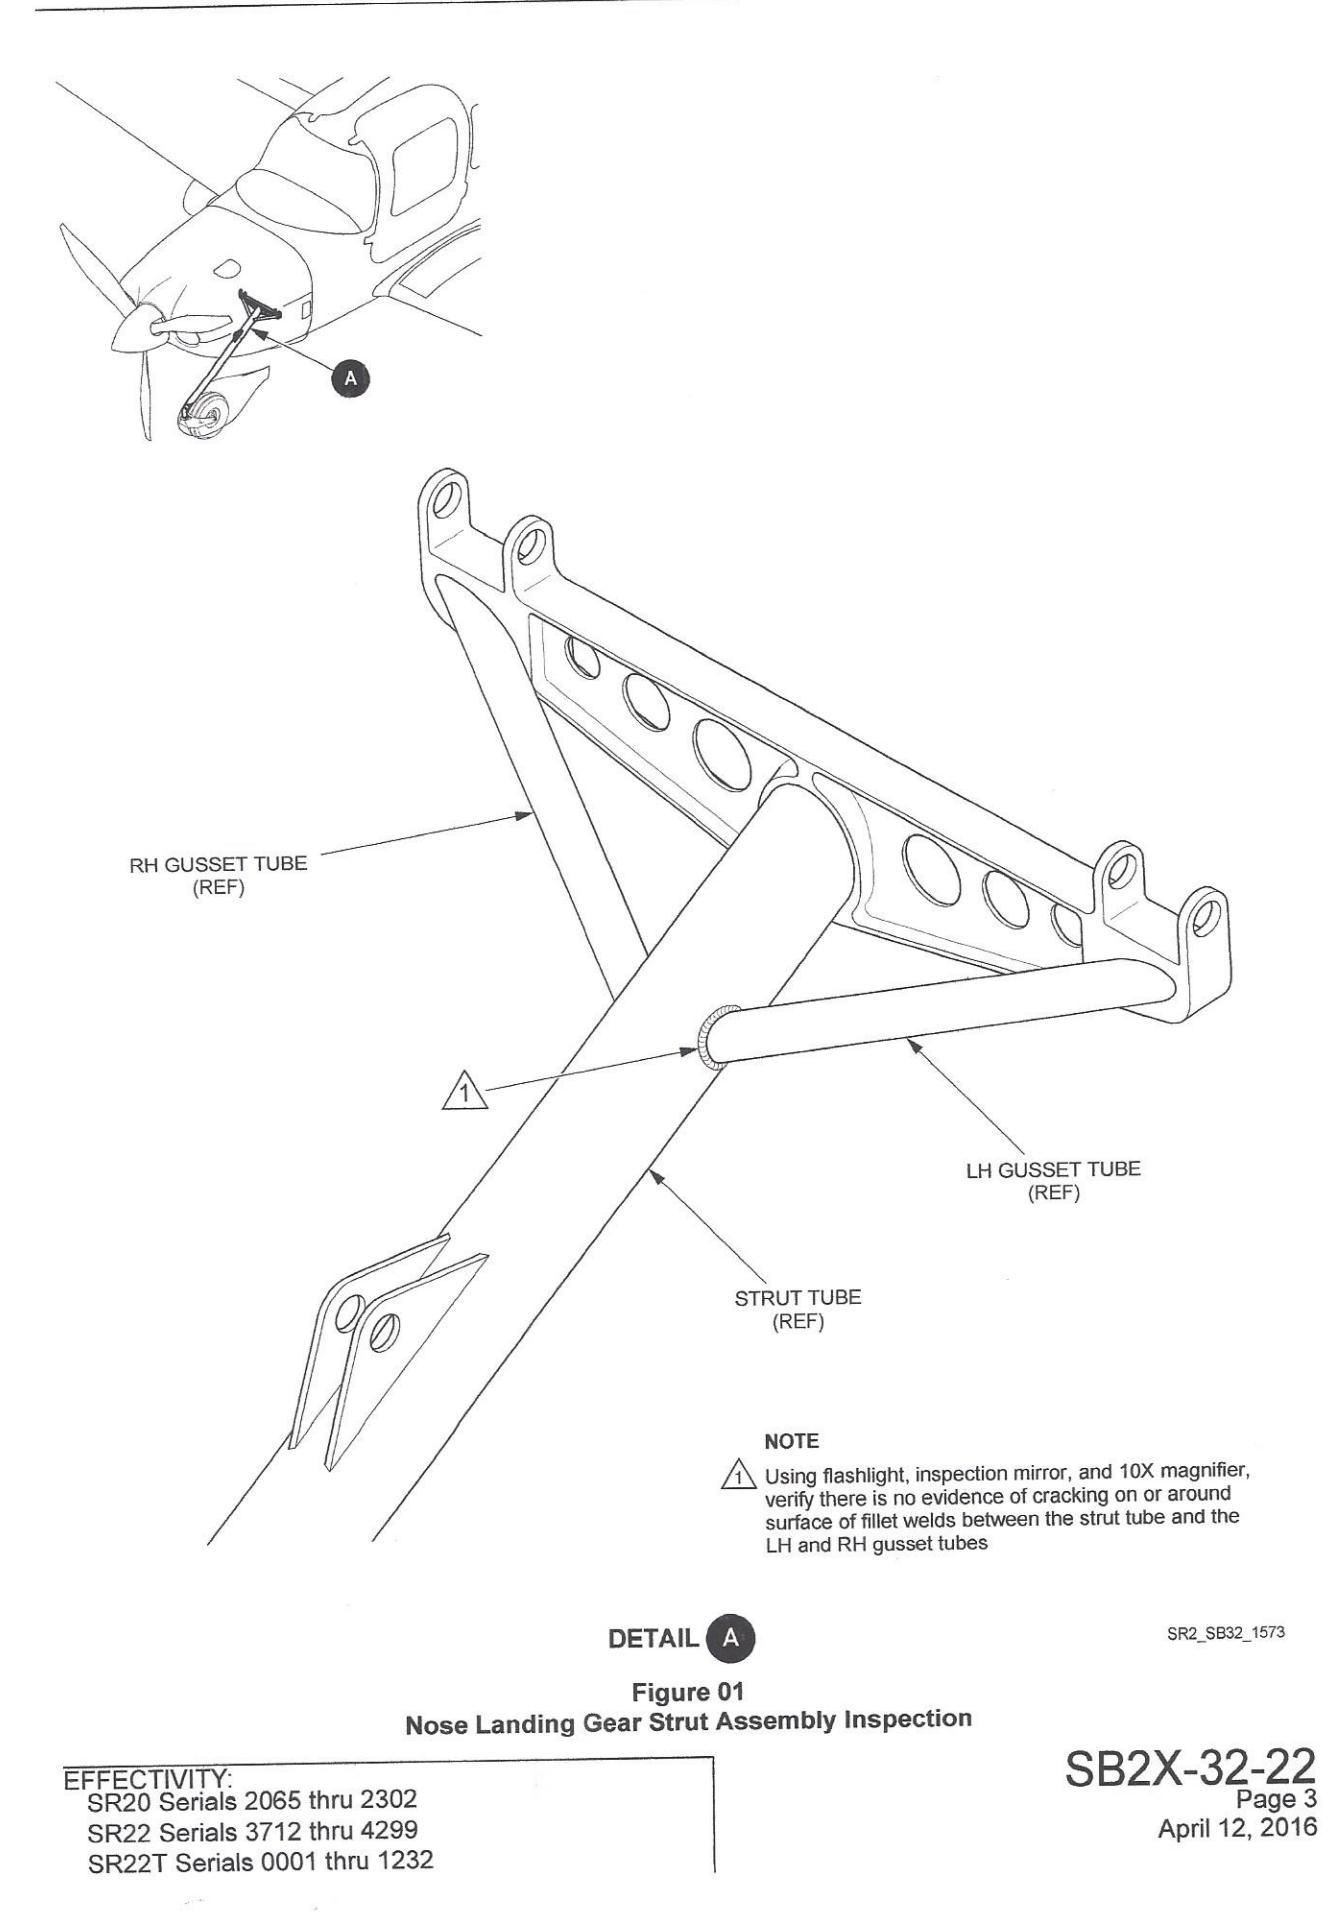
A false positive dye penetrant inspection result that is not a crack (such as a weld under-cut) will show an indication of a crack along the inner or outer edge of gusset fillet weld.

(6) Using flashlight, inspection mirror, and 10X magnifier, verify there is no evidence of cracking on or around surface of fillet welds between the strut tube and the LH and RH gusset tubes. (See Figure 01)

# WARNING: If cracking is identified in metal on or around surface of fillet welds, the aircraft is prohibited from flight until the nose landing gear strut assembly is replaced.

- (7) If cracking is identified in metal on or around surface of fillet welds, contact Cirrus for disposition.
- G. Apply LPS3 Rust Inhibitor (or equivalent) to inspection area.
- H. Remove masking tape.
- Install nose gear fairing. (Refer to AMM 32-20)
- J. Install engine cowling. (Refer to AMM 71-10)
- K. Provide inspection results to Cirrus by visiting <u>https://cirrusaircraft.formstack.com/forms/sb\_feedback</u> and completing feedback form.
- L. Complete airplane records by noting compliance with SB2X-32-22R1 in Aircraft Logbook.

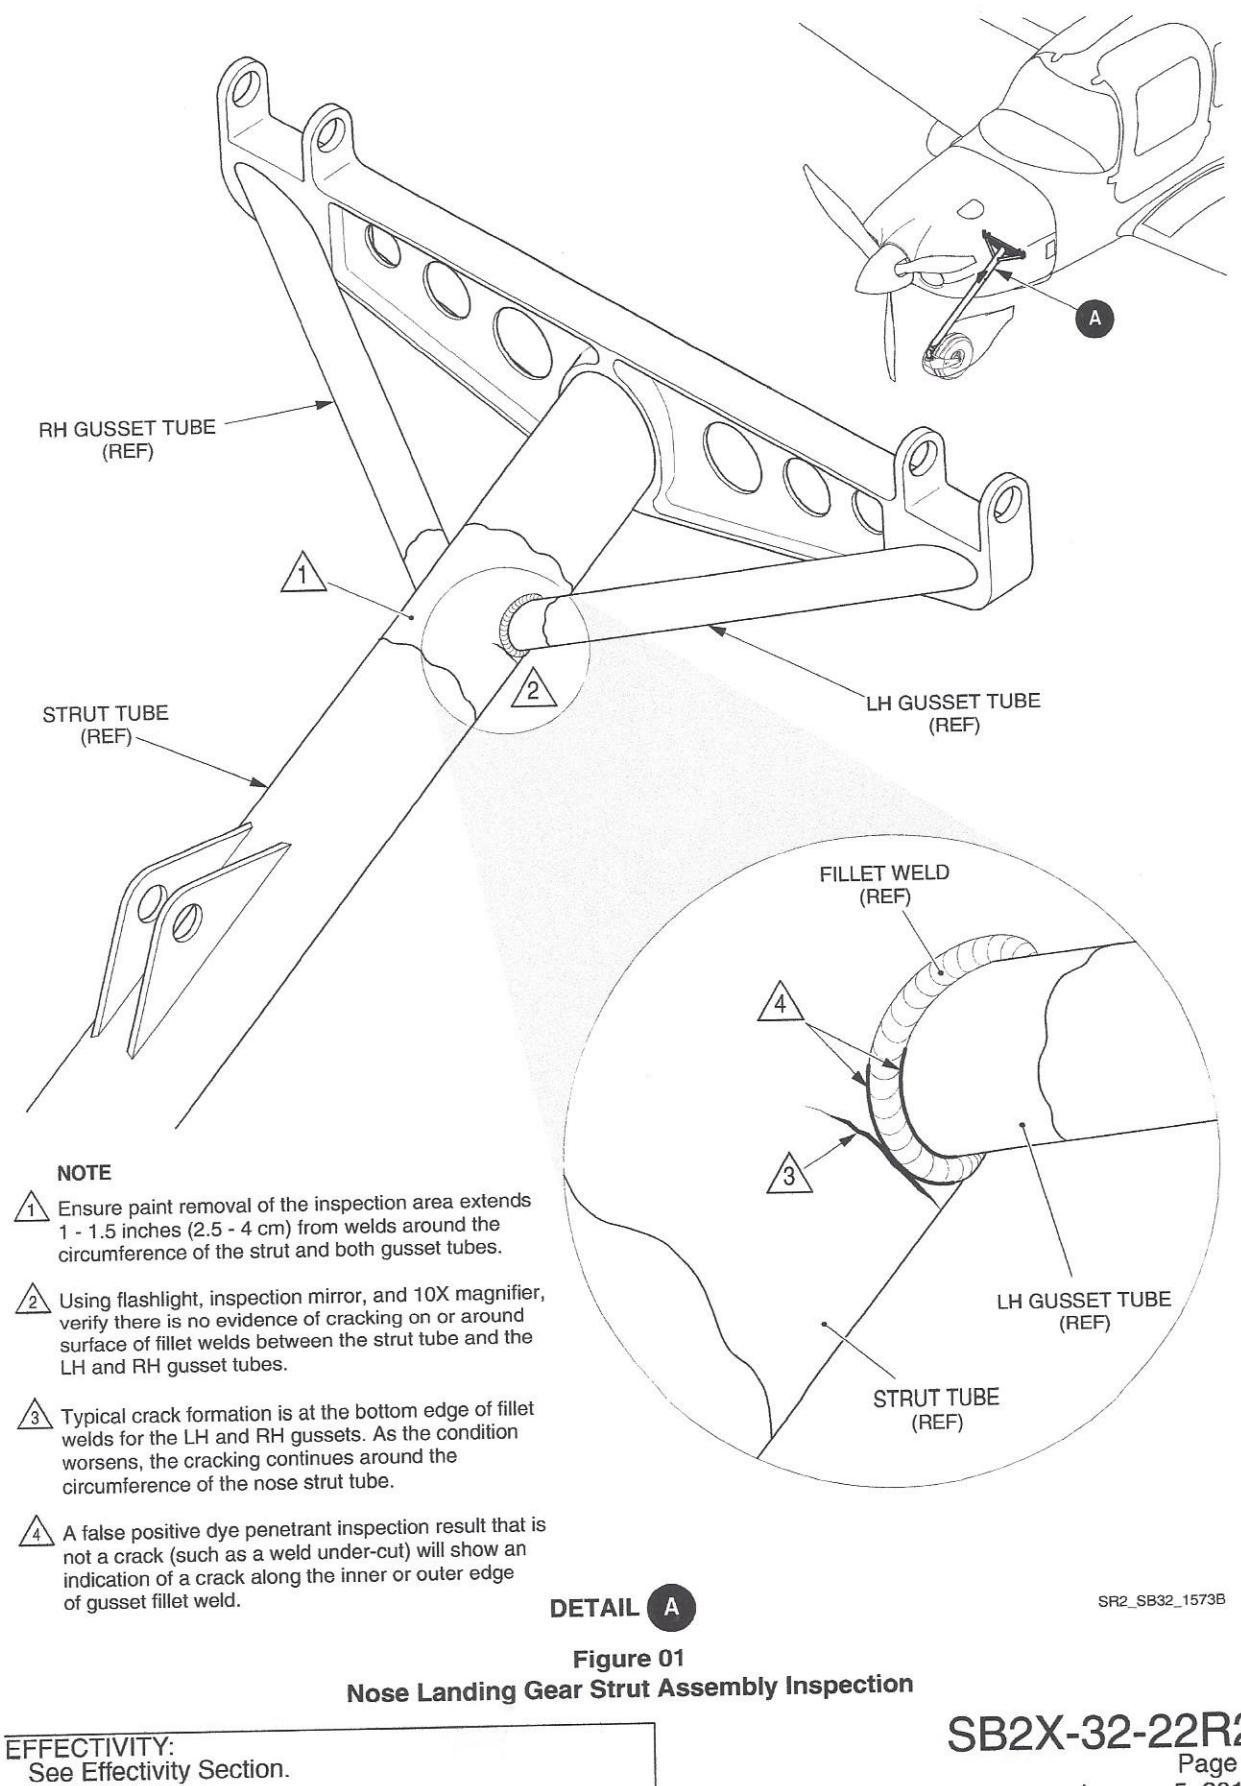
- (5) Dye penetrant inspect in accordance with FAA AC 43.13-1B, Chapter 5, Section 5.
  - Note: Typical crack formation is at the bottom edge of fillet welds for the LH and RH gussets. As the condition worsens, the cracking continues around the circumference of the nose strut tube.

A false positive dye penetrant inspection result that is not a crack (such as a weld under-cut) will show an indication of a crack along the inner or outer edge of gusset fillet weld.

(6) Using flashlight, inspection mirror, and 10X magnifier, verify there is no evidence of cracking on or around surface of fillet welds between the strut tube and the LH and RH gusset tubes. (See Figure 01)

# WARNING: If cracking is identified in metal on or around surface of fillet welds, the aircraft is prohibited from flight until the nose landing gear strut assembly is replaced.
