NATIONAL TRANSPORTATION SAFETY BOARD
Vehicle Recorder Division
Washington, D.C. 20594

Cockpit Display – Recorded Flight Data

Specialist's Factual Report
By Bill Tuccio, Ph.D.

Location: Abilene, Texas
Date: March 1, 2016
Aircraft: Vans Aircraft RV-6A
Registration: N419B
Operator: Private
NTSB Number: CEN16FA114

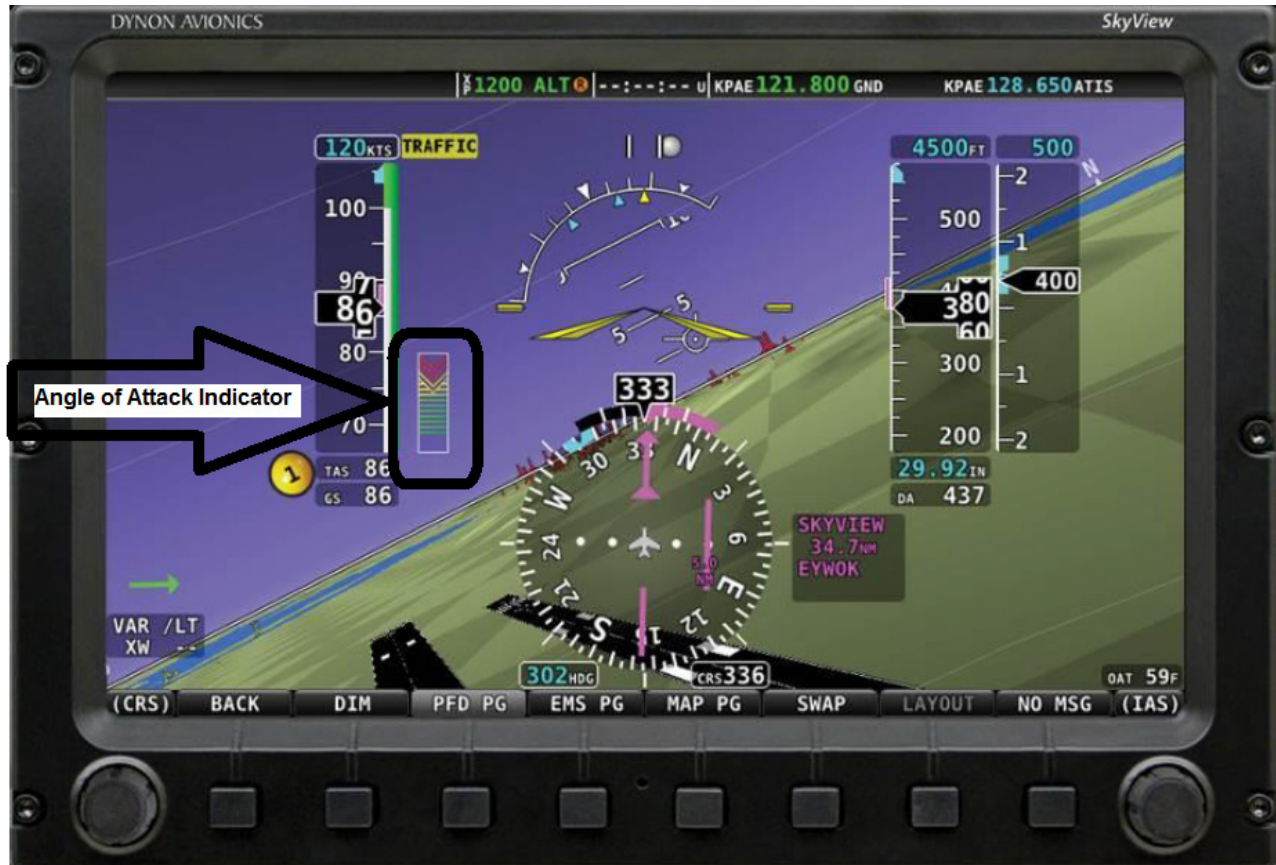
Figure 5. Angle of attack indicator in Dynon SV-D700.

The SV-D700 reports angle of attack in percent units. Angle of attack is calibrated through an inflight procedure and then electronically displayed to the pilot as shown in the exemplar display in figure 5.³ The inflight calibration procedure is intended to determine the lowest angle of attack and critical angle of attack corresponding to 0% and 100%, respectively. For this report, the validity of the angle attack calibration was not determined.⁴
