NATIONAL TRANSPORTATION SAFETY BOARD

Computed Tomography Specialist's Factual Report

WPR-15-IA-046

Operator: Hawkeye Aviation Holdings Ltd
Location: Palm Springs International Airport (PSP), Palm Springs, California
Date: November 23, 2014
Time: 1052 pacific standard time
Vehicle: Embraer EMB-505, C-GJOL

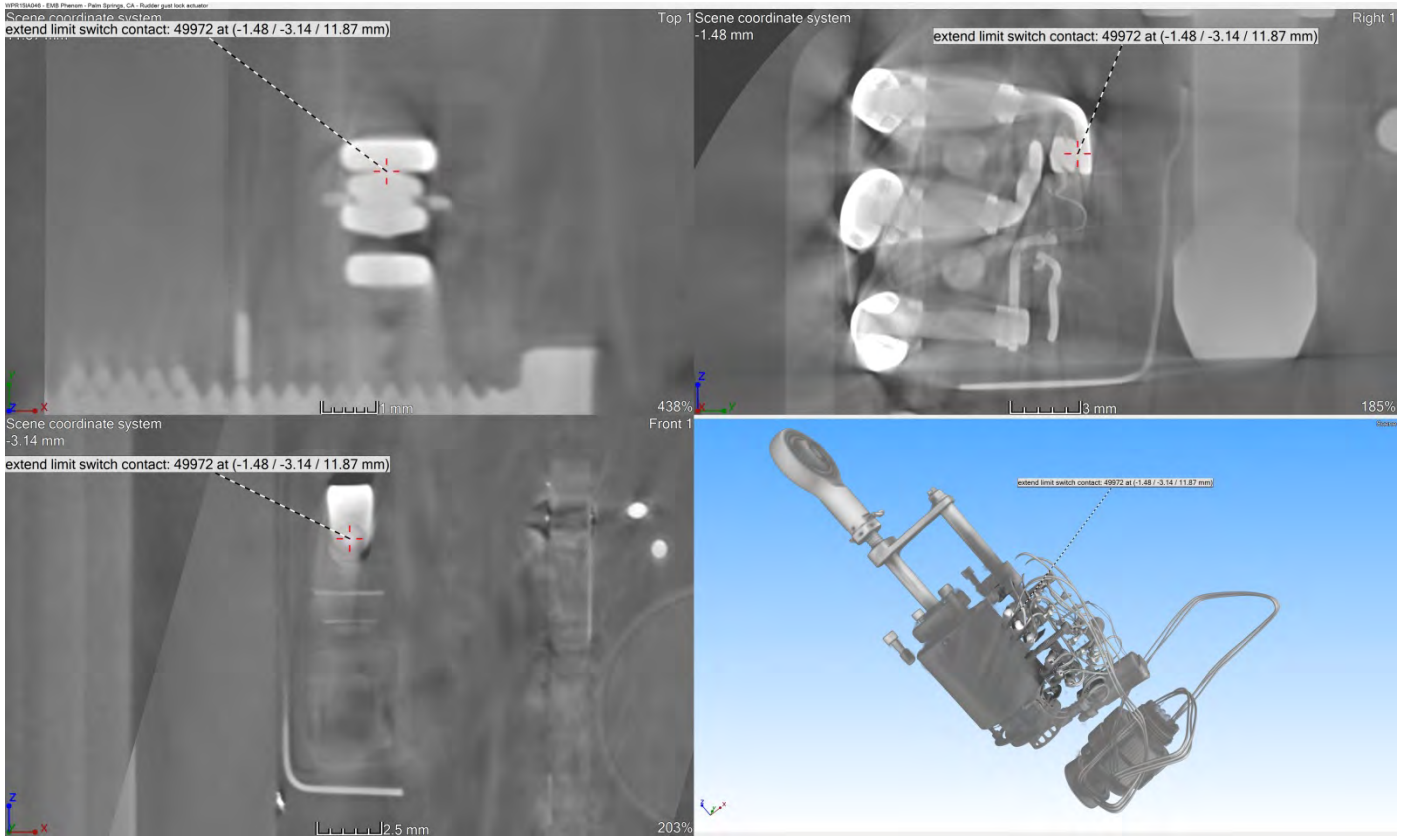
Figure 8
Rudder gust lock actuator – microfocus – extend limit switch contact point

1. The extend limit switch contacts appeared to be closed during the standard focus scans (see figure 6) and open during the microfocus scans (see figure 7). Whether this difference was due to an actual position change of the contacts or due to the resolution differences of the two scanning methods could not be determined;

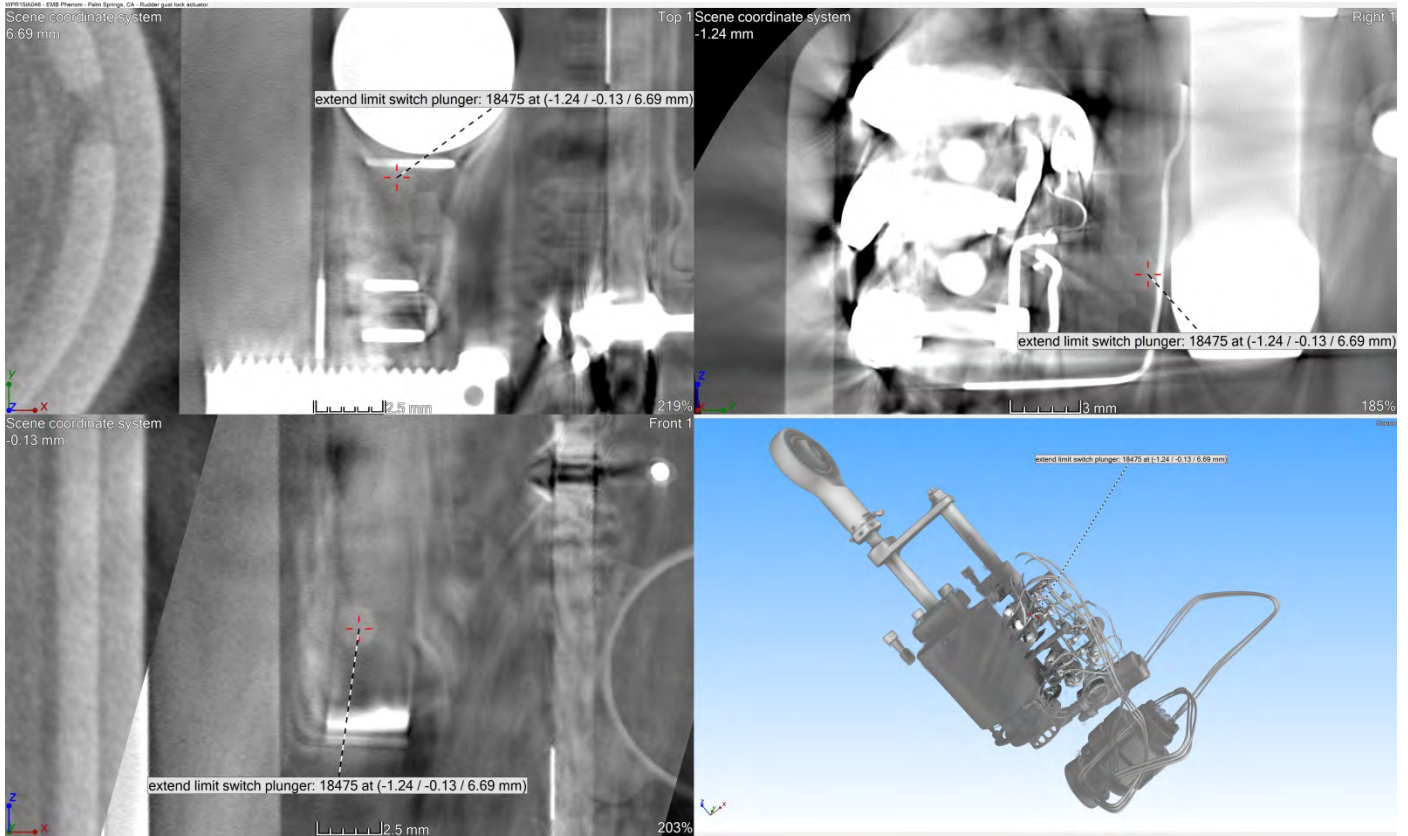
Figure 9
Rudder gust lock actuator – microfocus (re-reconstructed to enhance low density objects) – extend limit switch plunger

2. The extend and retract limit switch plungers were extended different lengths (0.87 mm and 1.26 mm respectively) (see figure 10);
3. High and medium density particles were found in various locations throughout the actuator;

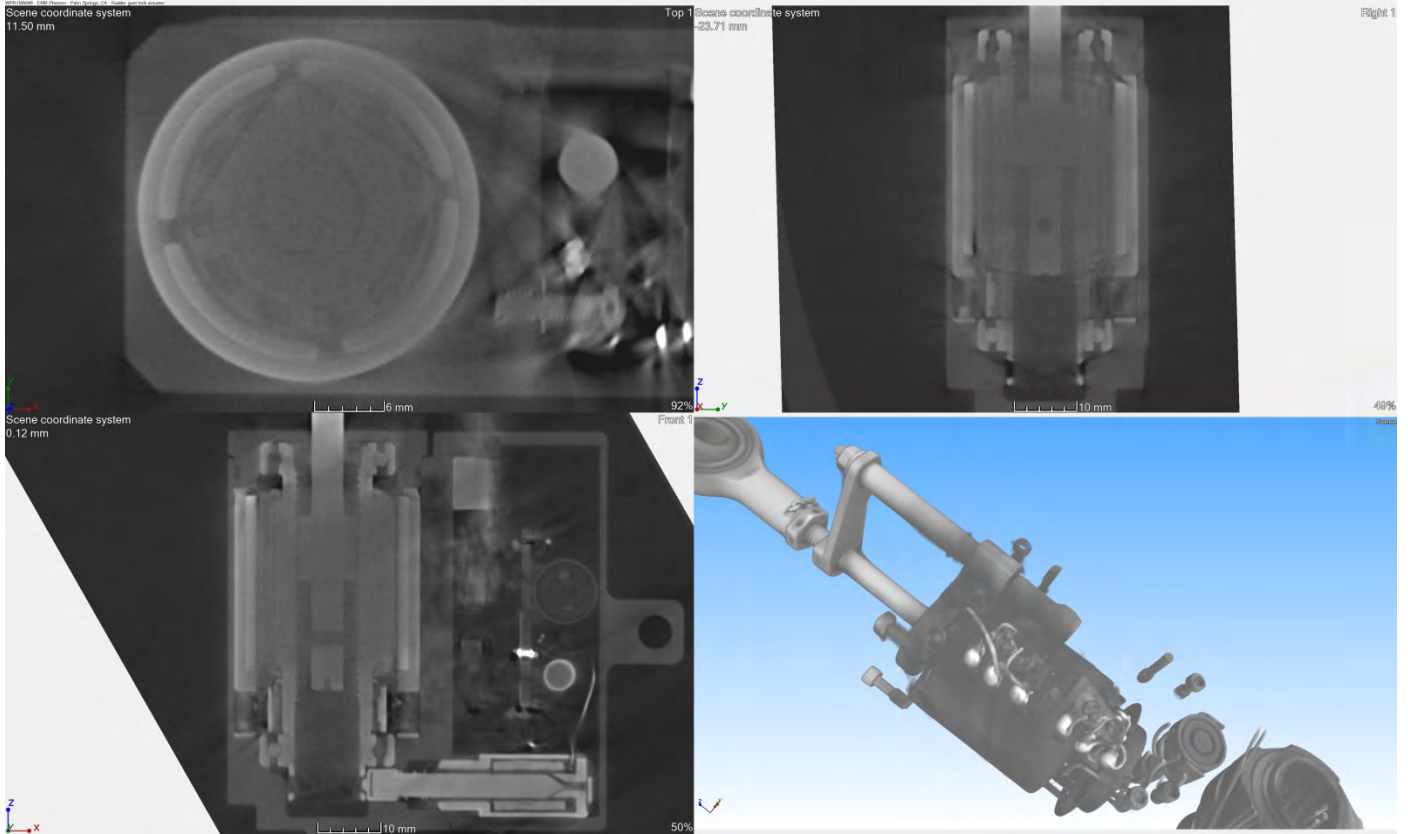
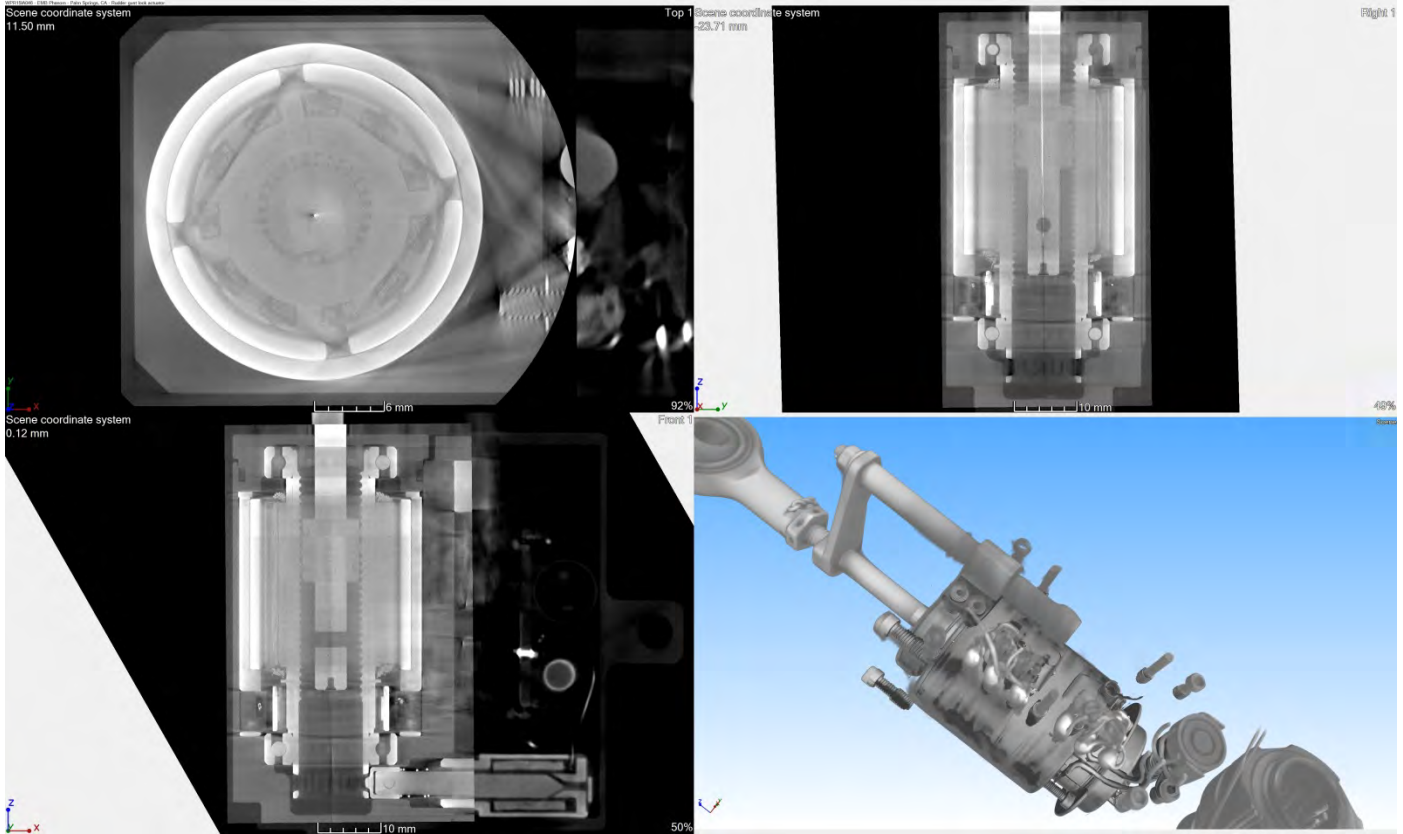
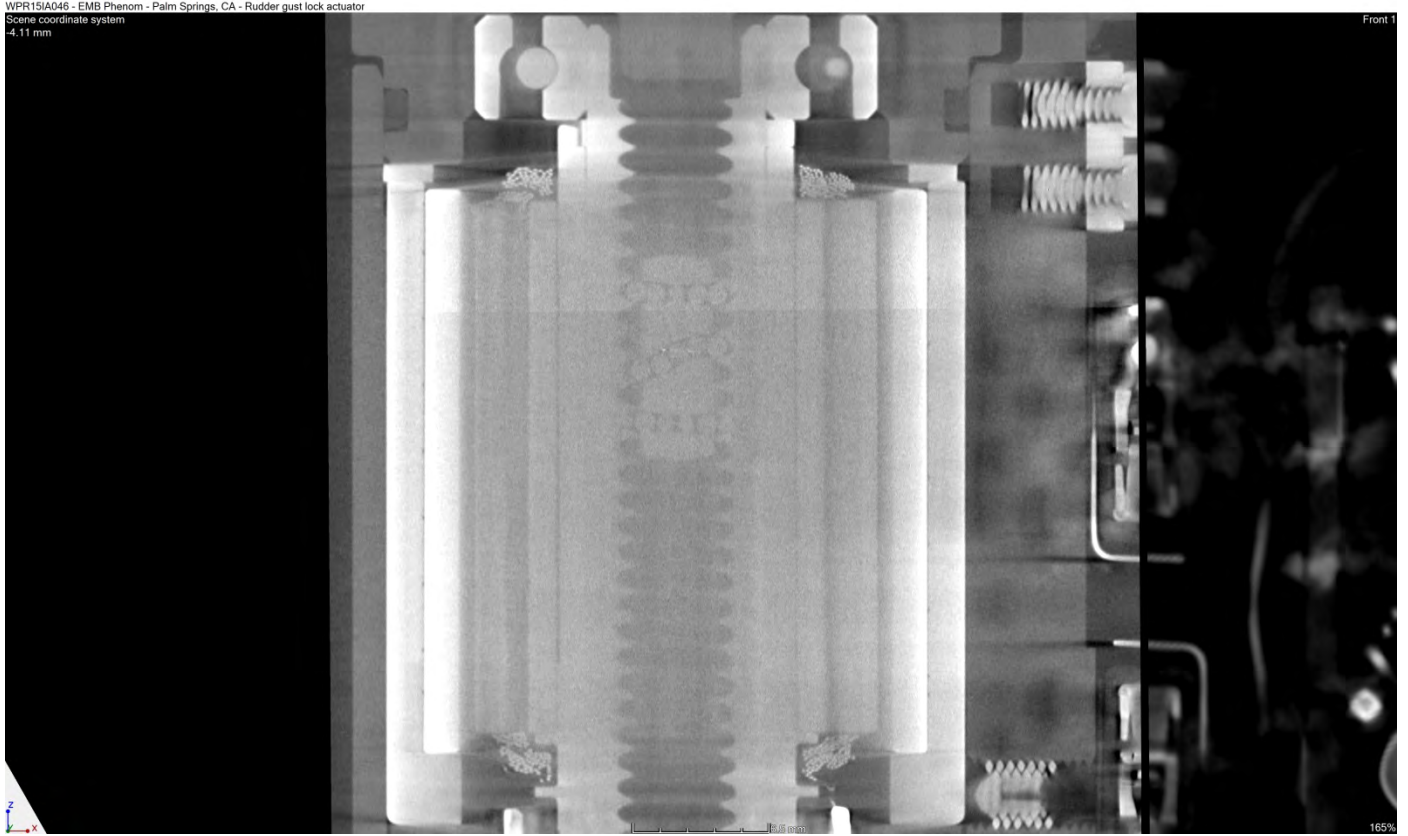
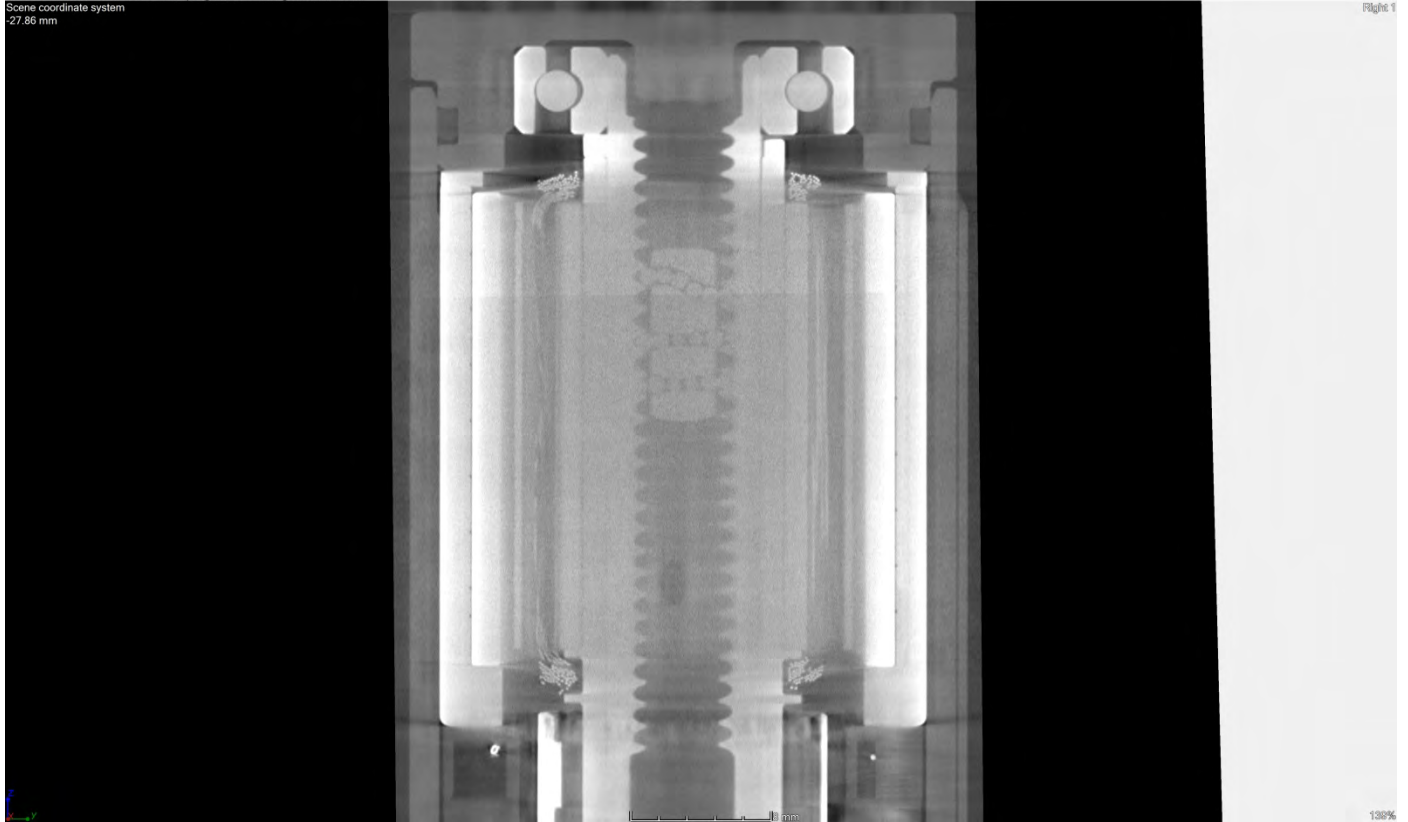
Figure 21
Rudder gust lock actuator – standard focus – overall motor and screw ball cross section

5. Indications of a crack in the ball screw that were noted in the standard focus scans were more completely resolved in the microfocus scans as the balls and groove located on the ball screw. However, there was an indication of a discontinuity within one of the balls shown on the microfocus images (see figures 19-26);

Rudder gust lock actuator – standard focus with microfocuss view overlaid – overall motor and screw ball cross section

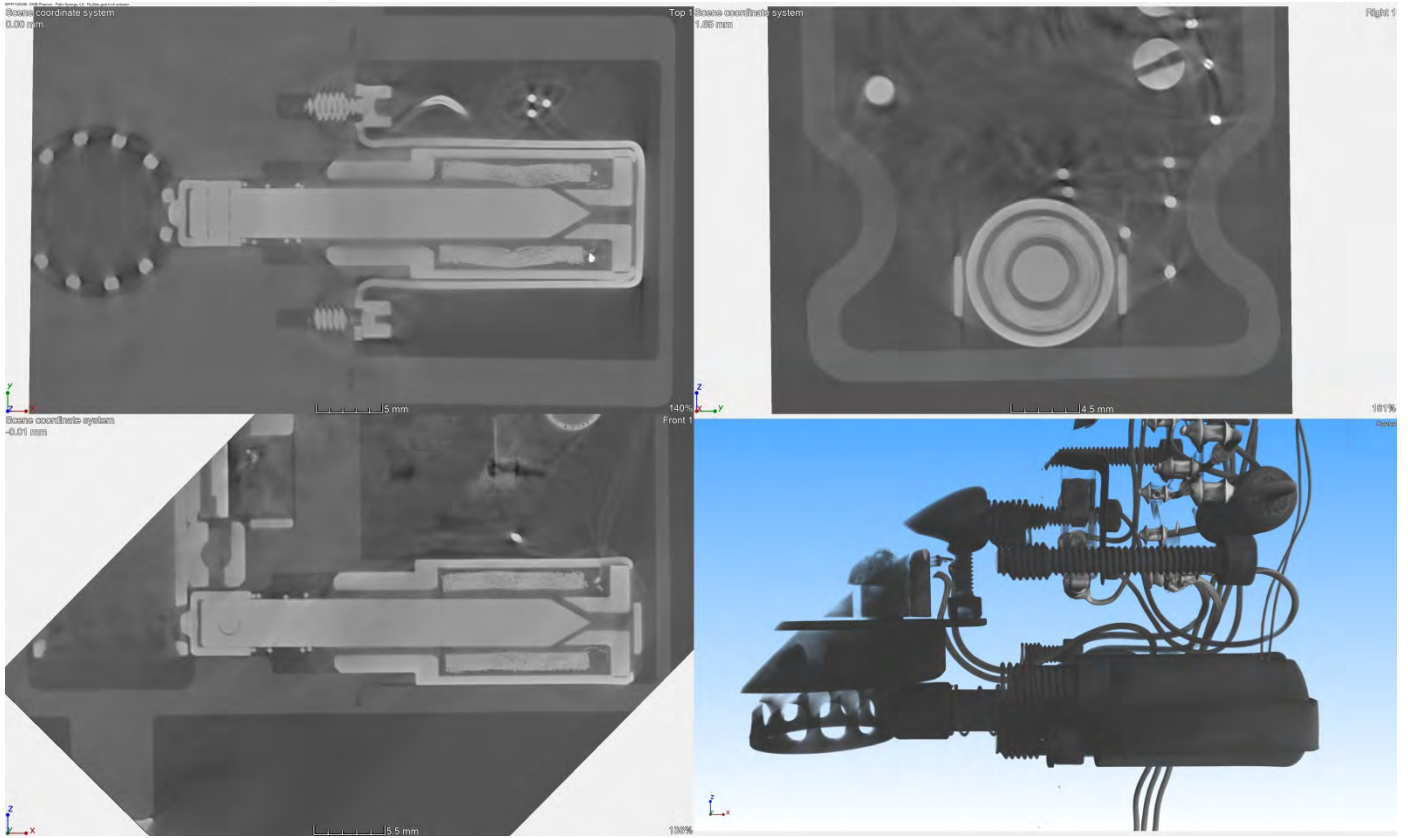
Figure 38
Rudder gust lock actuator – microfocus – solenoid overall cross section

6. There were indications of two areas with distorted windings within the solenoid. Neither of these areas appeared to contain breaks in the windings, nor did either area contact the solenoid plunger (see figures 38-42);
