NATIONAL TRANSPORTATION SAFETY BOARD
Office of Aviation Safety
Washington, D.C. 20594

Computed Tomography Specialist's Factual Report

DCA-08-MA-076

Operator: ABX Air
Location: San Francisco International Airport, California
Date: June 28, 2008
Time: Approximately 1015 pm local time
Airplane: Boeing 767-281SF, N799AX

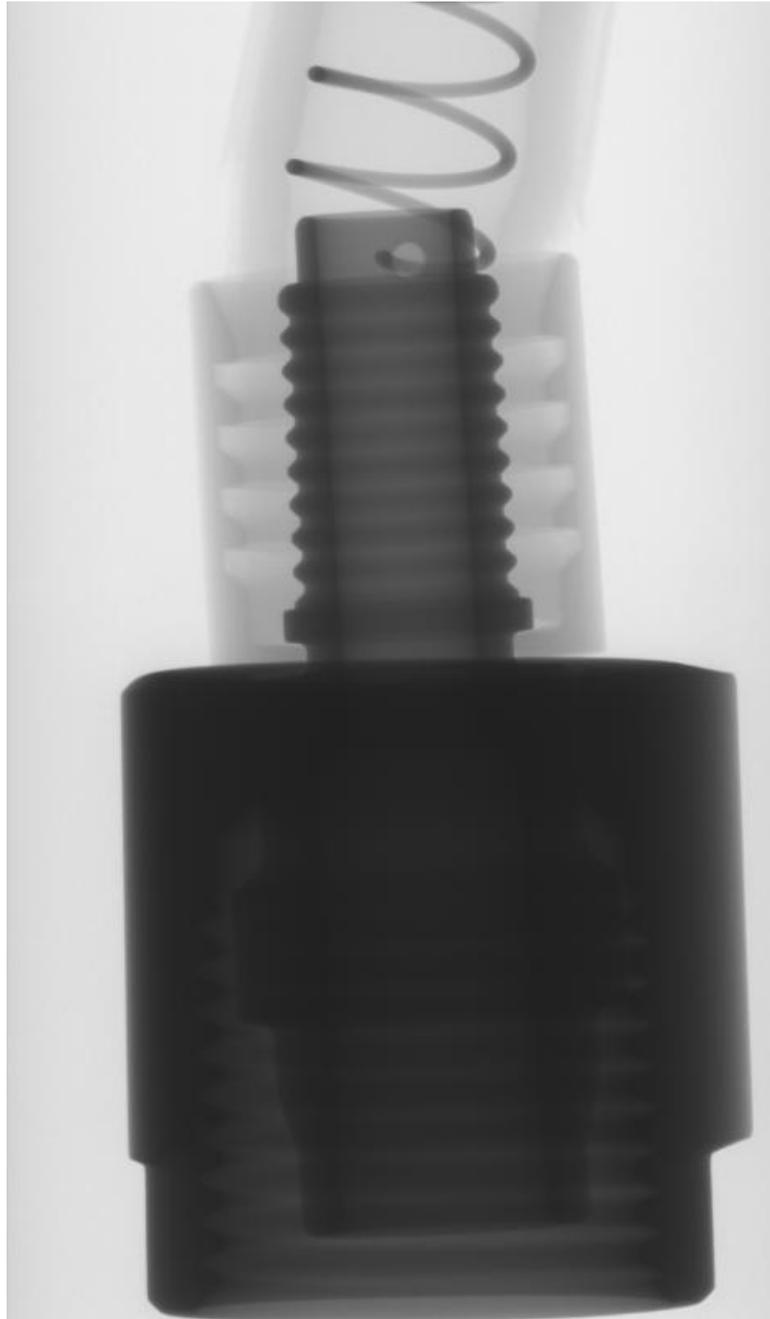
Figure 2
Hose End A – Digital Radiograph

The image data set for hose end A was composed of 281 CT slices and one DR image. The DR is presented in figure 2; a representative three dimensional images are presented in figures 3 and 4.

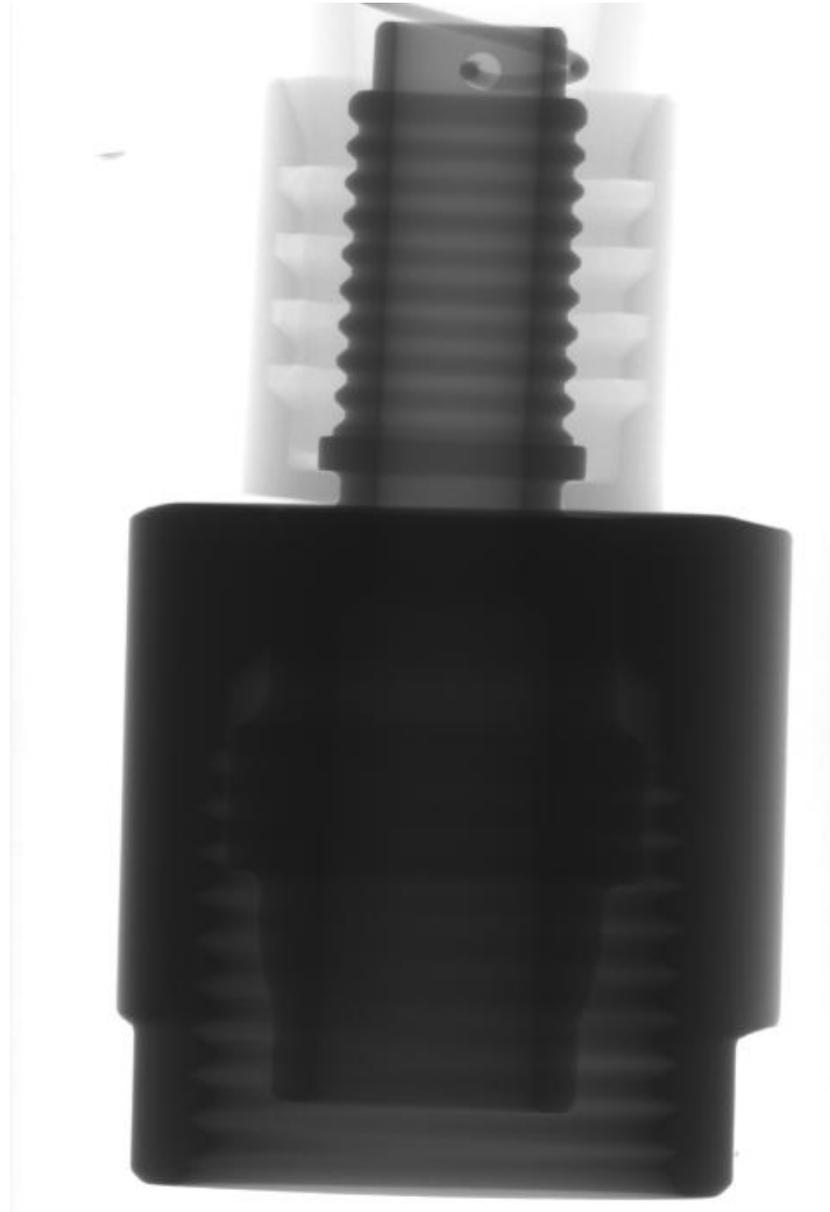
Figure 5
Hose End B – Digital Radiograph

The image data set for hose end B was composed of 281 CT slices and one DR image. The DR is presented in figure 5; a representative three dimensional image is presented in figure 6.

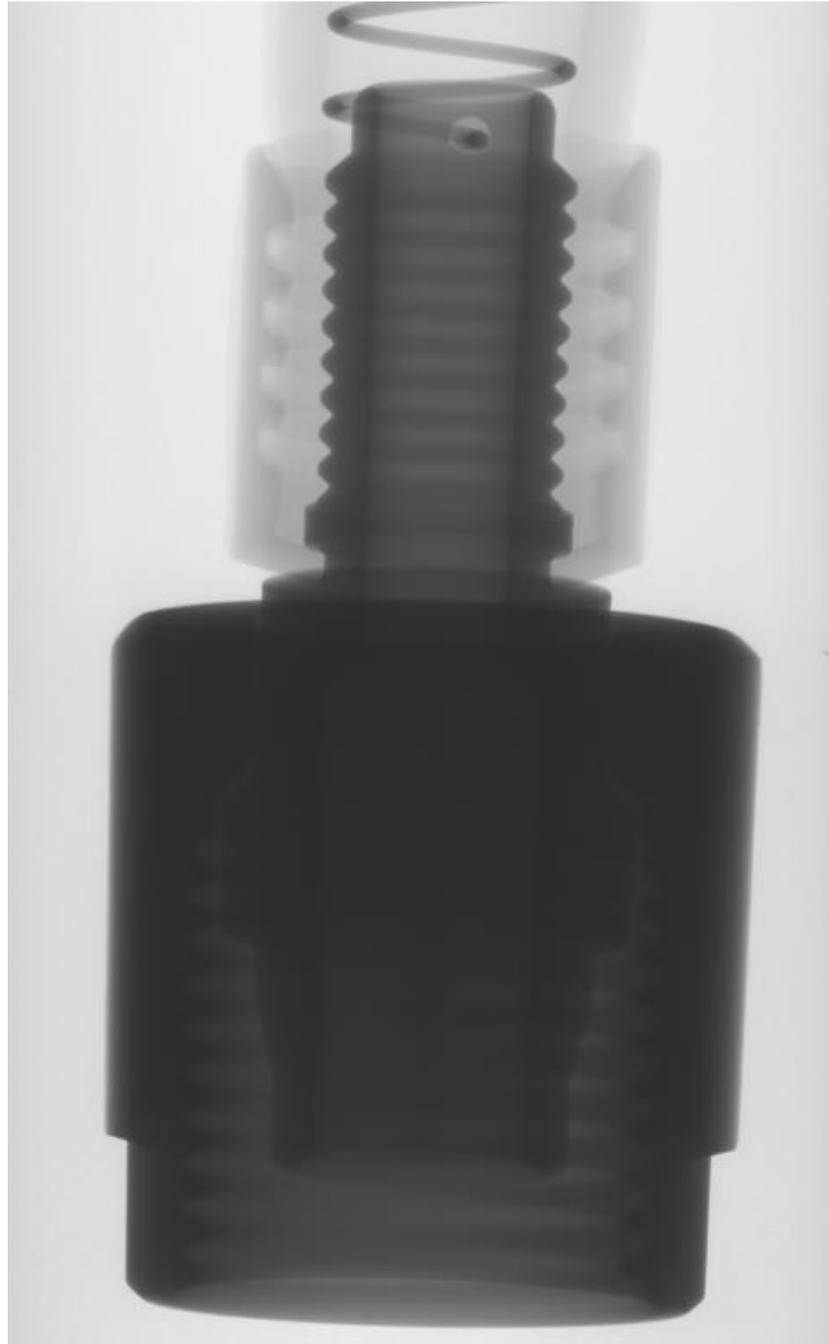
Figure 7
Hose End C – Digital Radiograph

The image data set for hose end C was composed of 301 CT slices and one DR image. The DR is presented in figure 7; a representative three dimensional image is presented in figure 8.

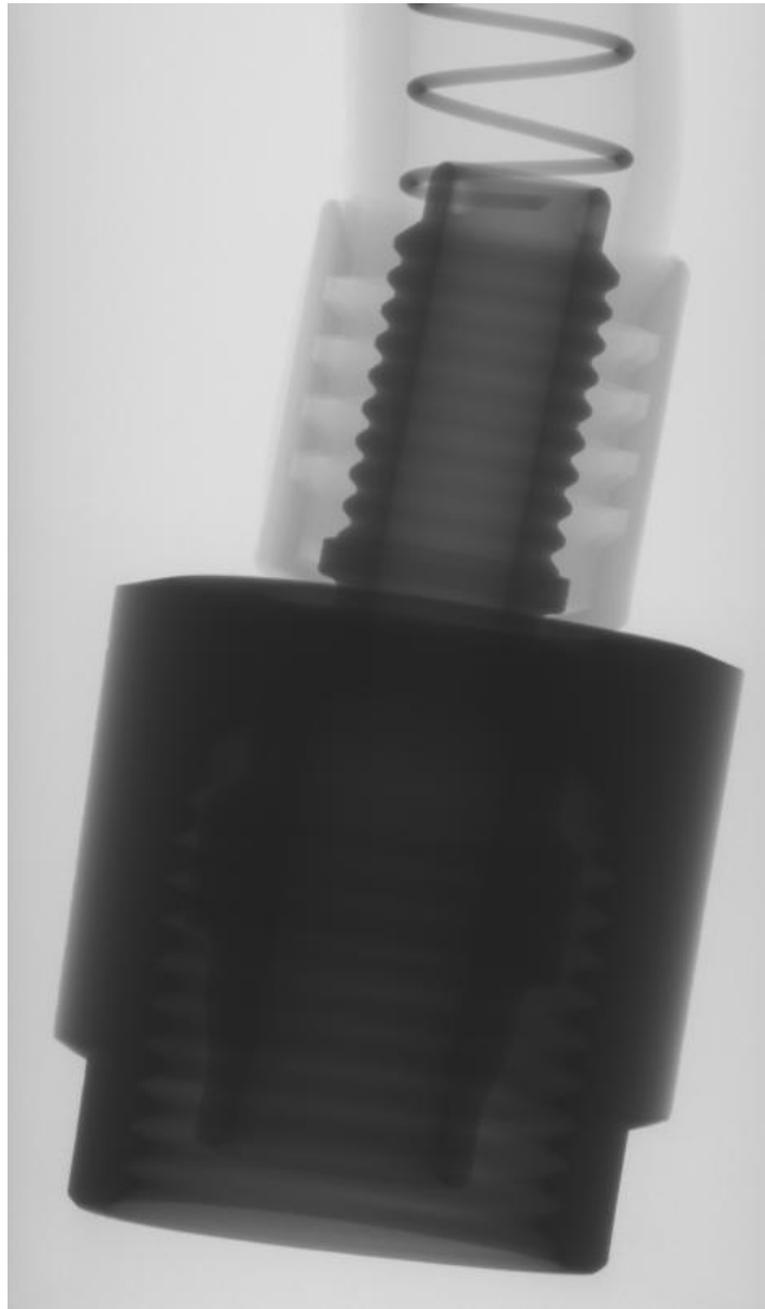
Figure 9
Hose End D – Digital Radiograph

The image data set for hose end D was composed of 291 CT slices and one DR image. The DR is presented in figure 9; a representative three dimensional image is presented in figure 10.

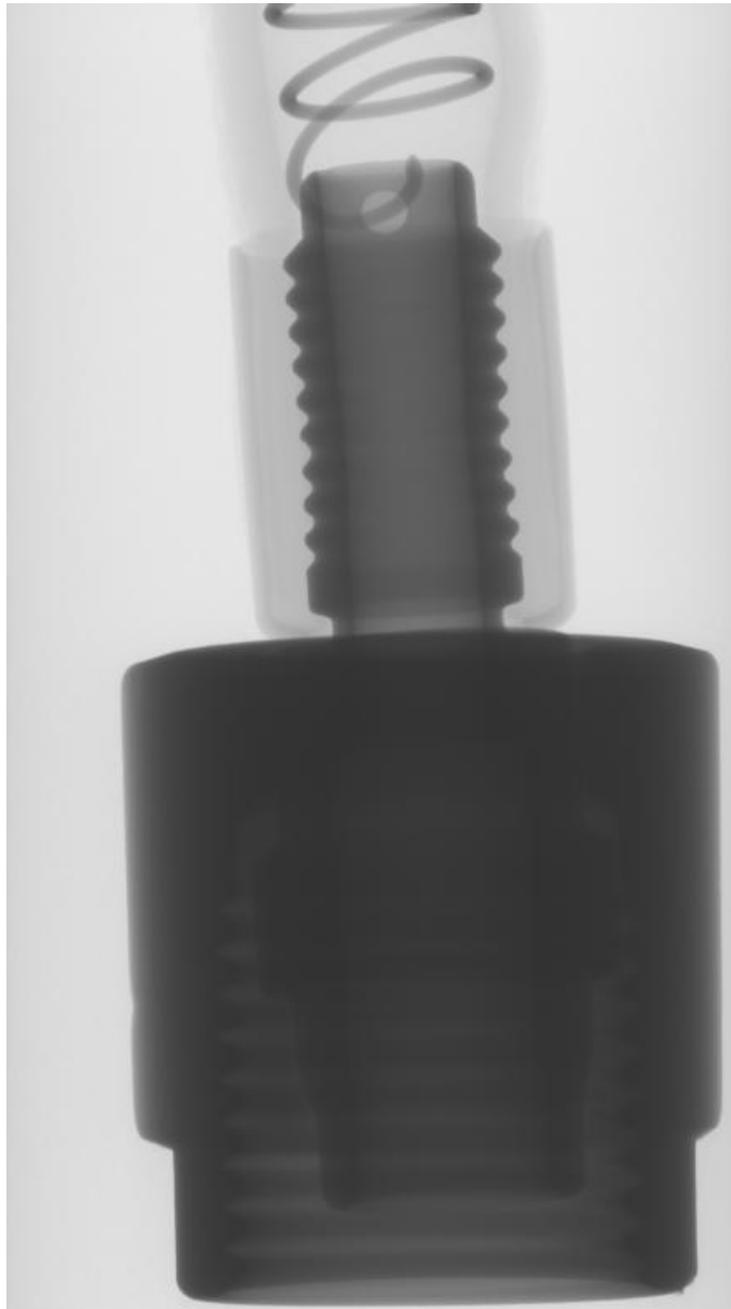
Figure 11
Hose End E – Digital Radiograph

The image data set for hose end E was composed of 301 CT slices and one DR image. The DR is presented in figure 11; a representative three dimensional image is presented in figure 12.
