NATIONAL TRANSPORTATION SAFETY BOARD

Computed Tomography and Aircraft Systems Specialist's Factual Report

CEN-14-LA-127

Operator: Mountain Aviation, Inc
Location: Abraham Lincoln Capital Airport (SPI), Springfield, Illinois
Date: January 31, 2014
Time: 1312 central standard time
Airplane: Piaggio model P180, N700FE

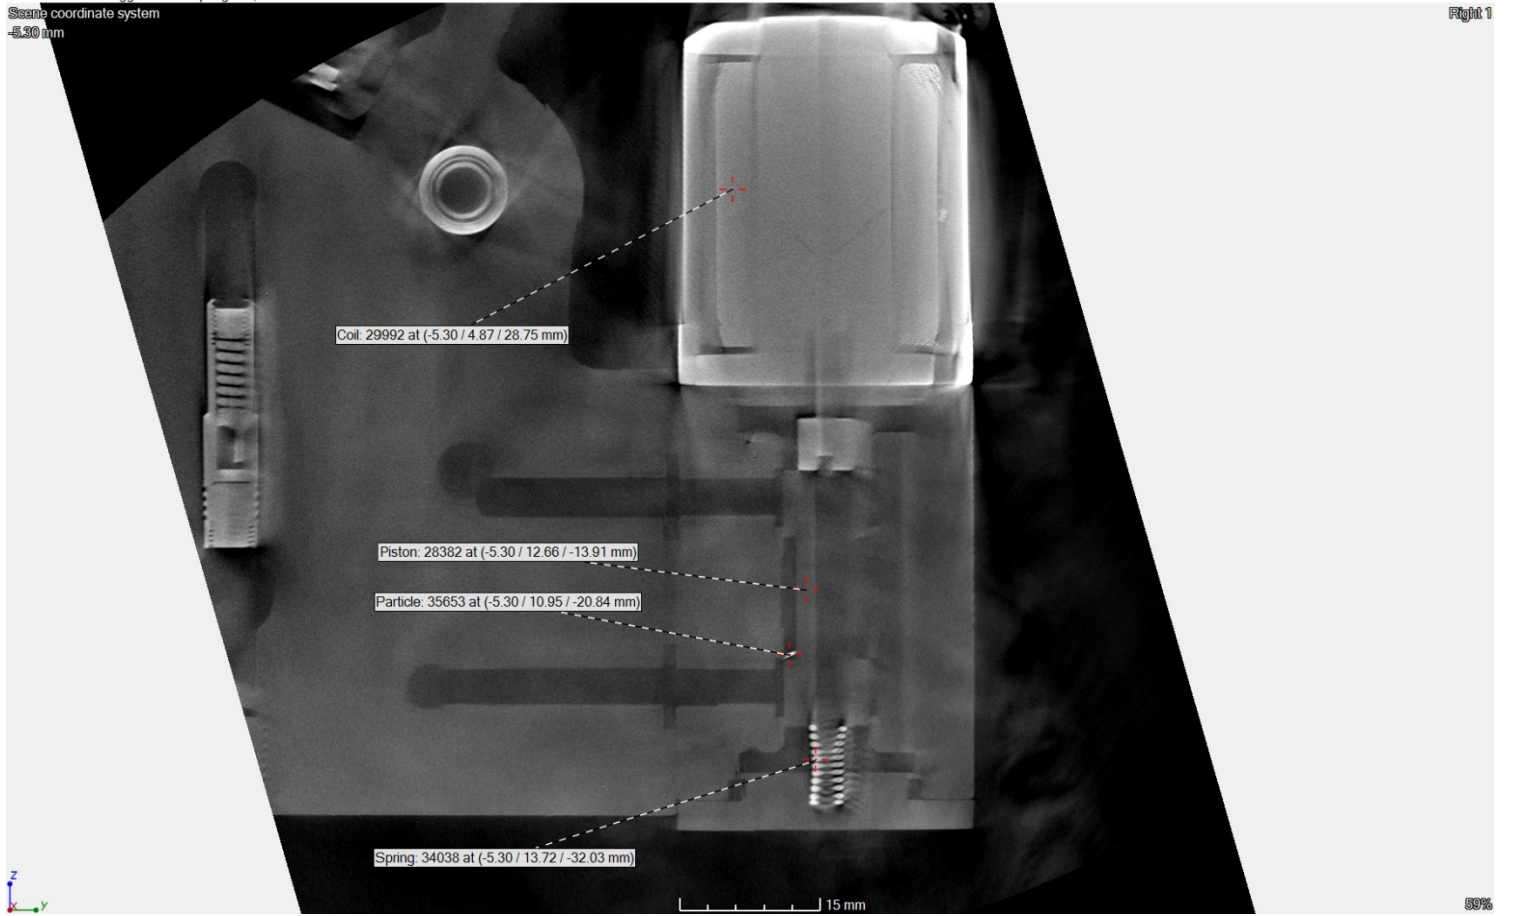
Figure 1
DCV – Overall view

The computed tomography (CT) results for the DCV are shown in figures 1 through 11. Review of the images showed that there was a particle located between one of the spool lands and the DCV housing. The particle was approximately 3 mm long.

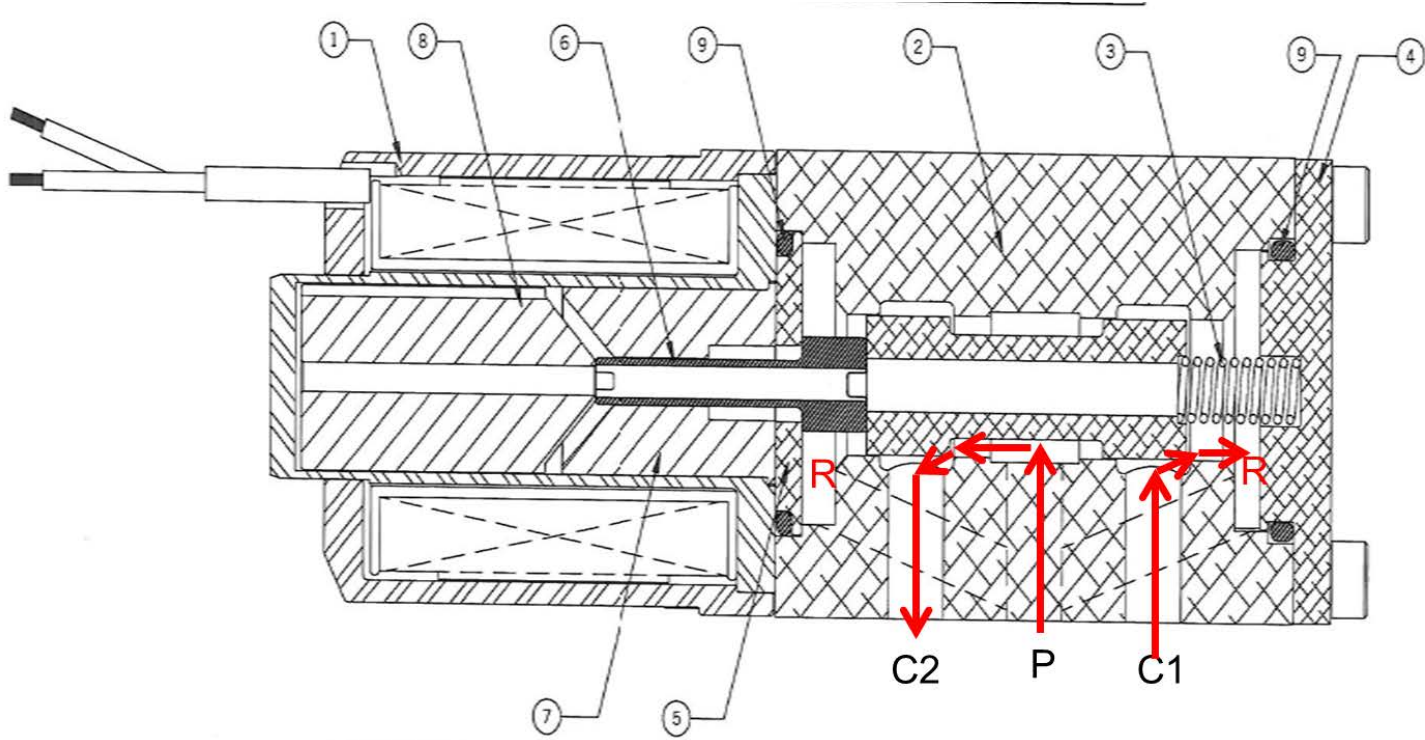
Figure 8

A review of the hydraulic system schematics was conducted, and the hydraulic ports associated with the DCV were identified. The ports are labeled in figures 8-11. The review indicated that the position of the DCV spool was consistent with a position where the pressure port would be connected to the C1 port.

Assembly drawing of the DCV showing the pressure port (P), control ports (C1, C2), and return ports (R). The arrows indicate the designed flow paths through the DCV when the solenoid is in the de-energized (gear down) position.

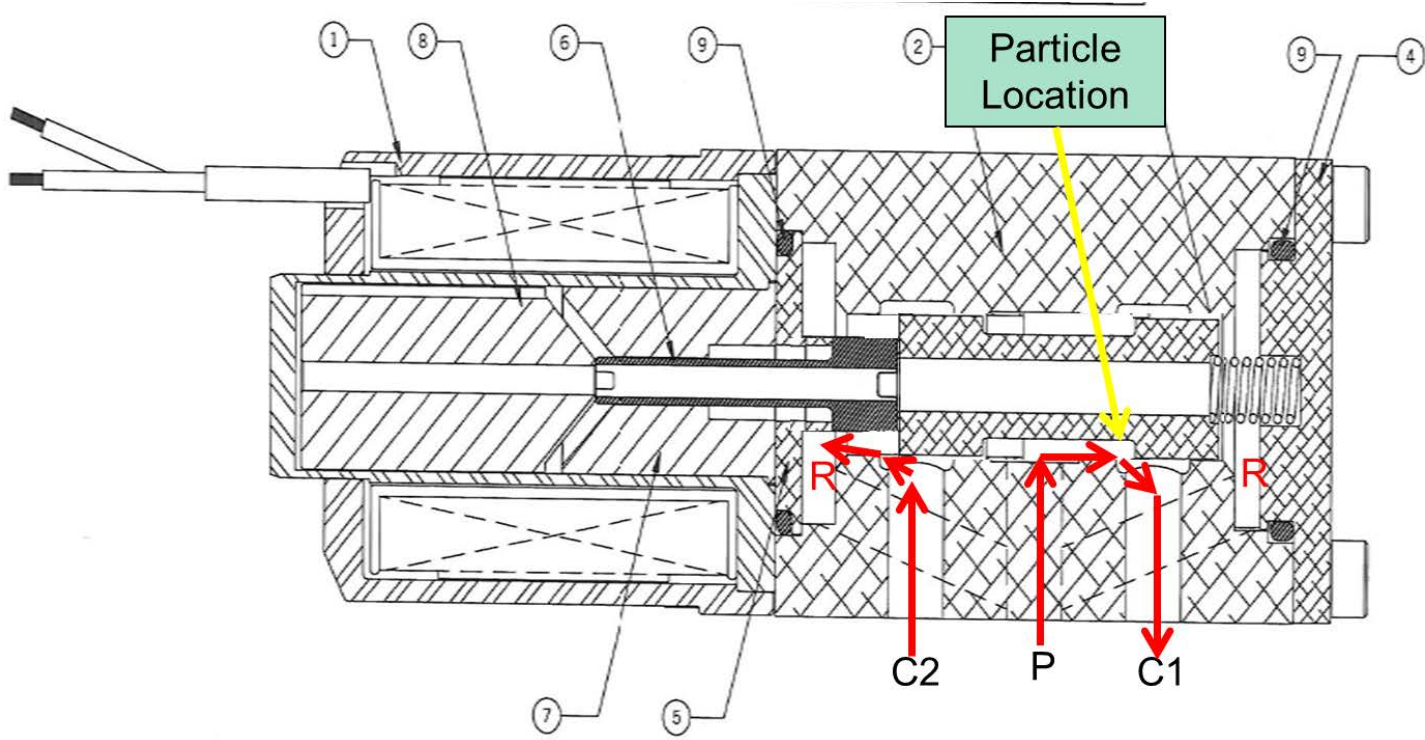
Figure 9

Assembly drawing of the DCV showing the pressure port (P), control ports (C1, C2), and return ports (R). The arrows indicate the designed flow paths through the DCV when the solenoid is in the energized (gear up) position.

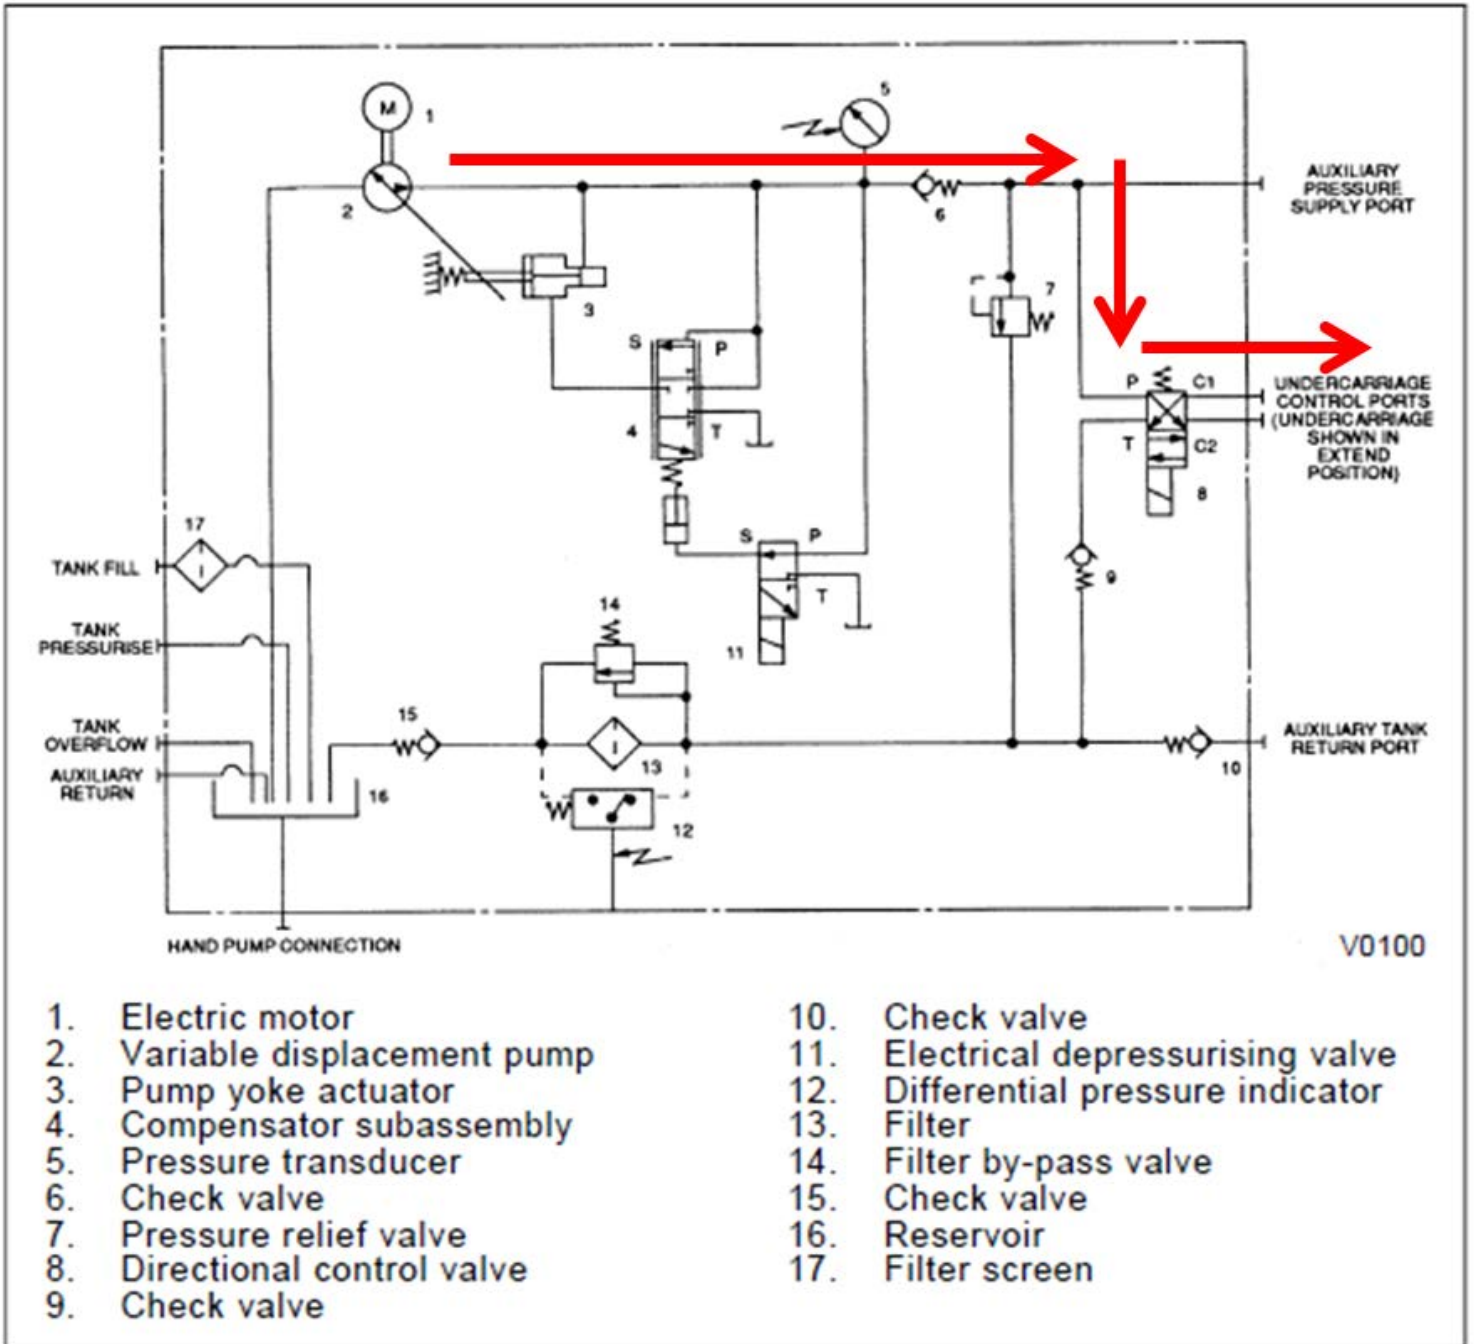
Figure 11

Hydraulic schematic of the hydraulic pump package showing the components within the unit including the DCV (8), the variable displacement pump (2), filter (13), and check valve (6). The arrows indicate the designed flow paths through the DCV when the solenoid is in the de-energized (gear down) position.

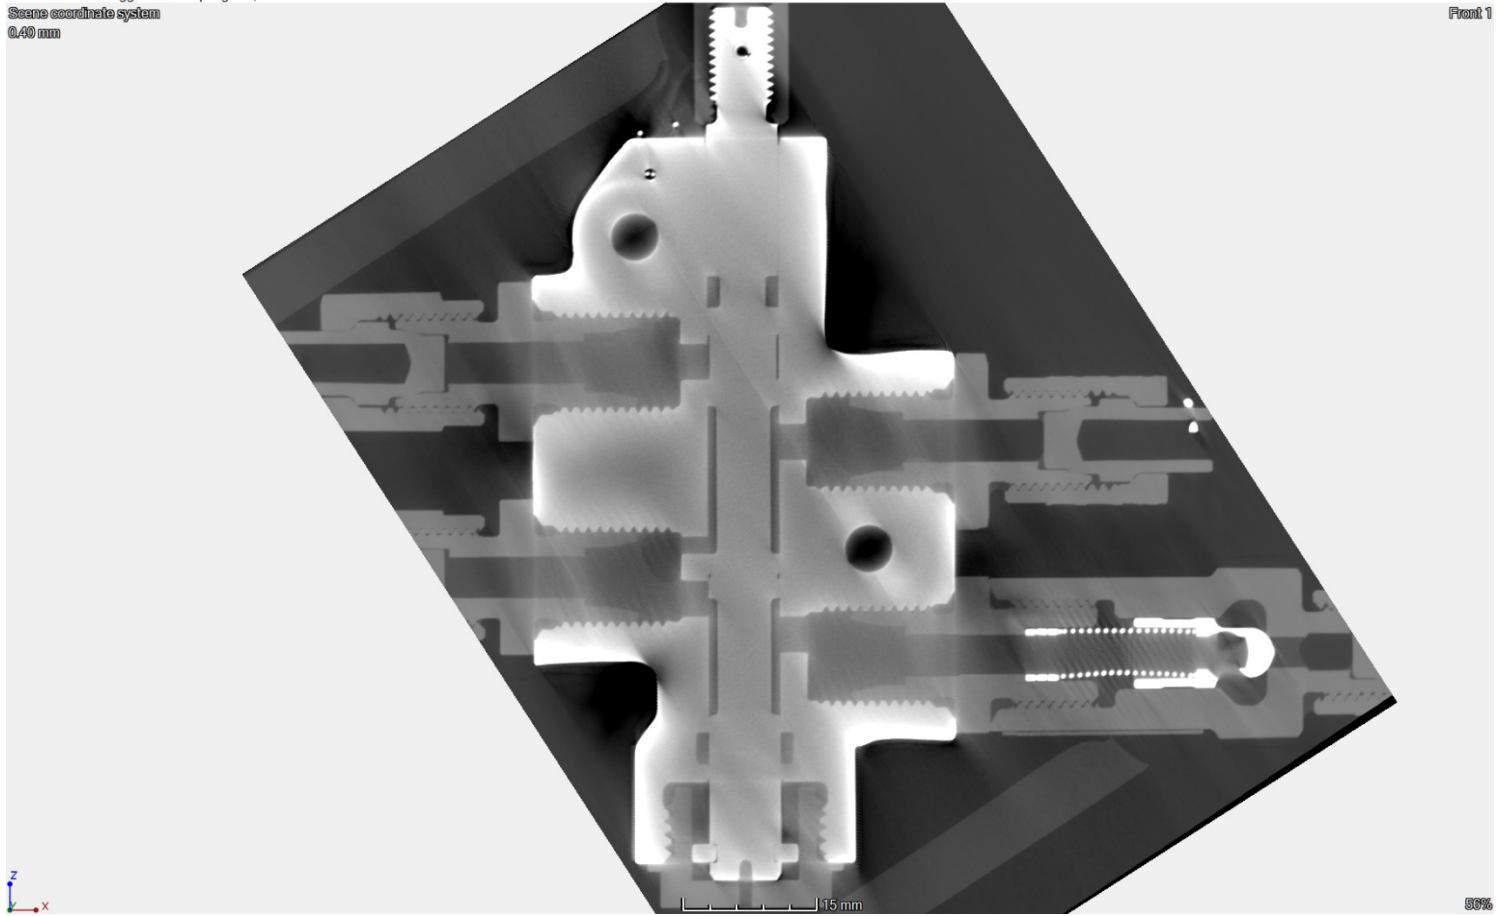
Figure 17
ELGSV – Closed Position – Close up view

The computed tomography (CT) results for the ELGSV are shown in figures 14 through 18. Both the open and closed positions were imaged. Review of the images did not show any radiographic indications of high density particles in the valve, and the path for the valve spool did not appear to have any obstructions that would prevent the spool from moving to either the open or closed positions.

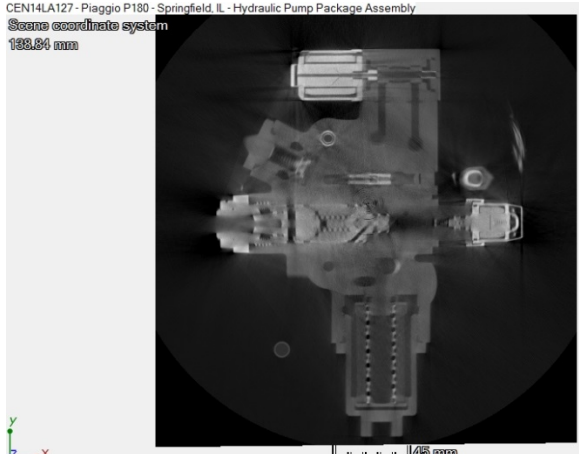
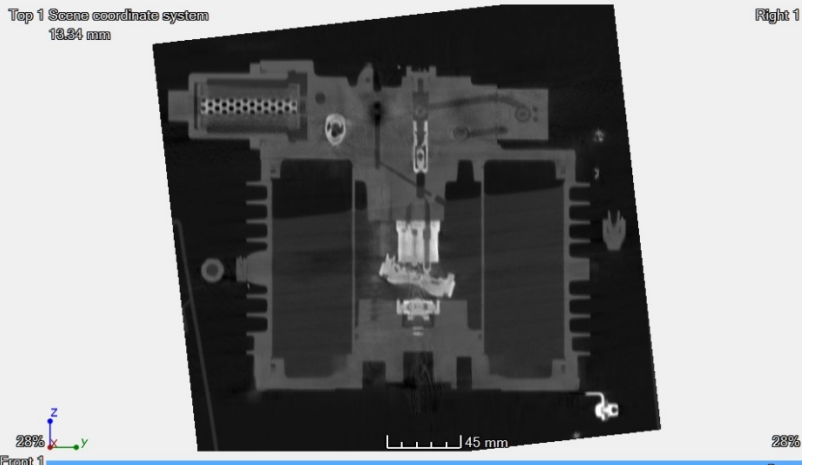
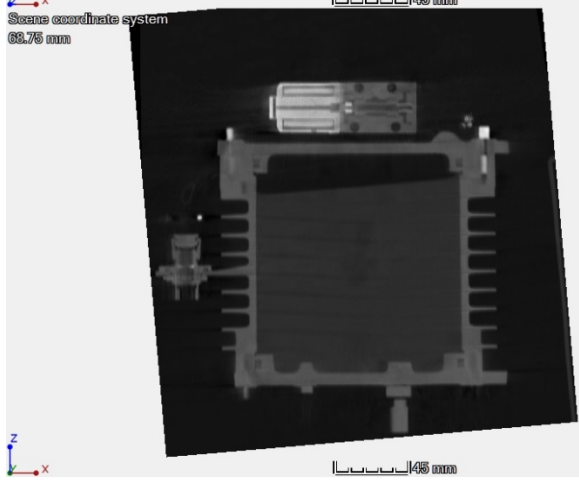
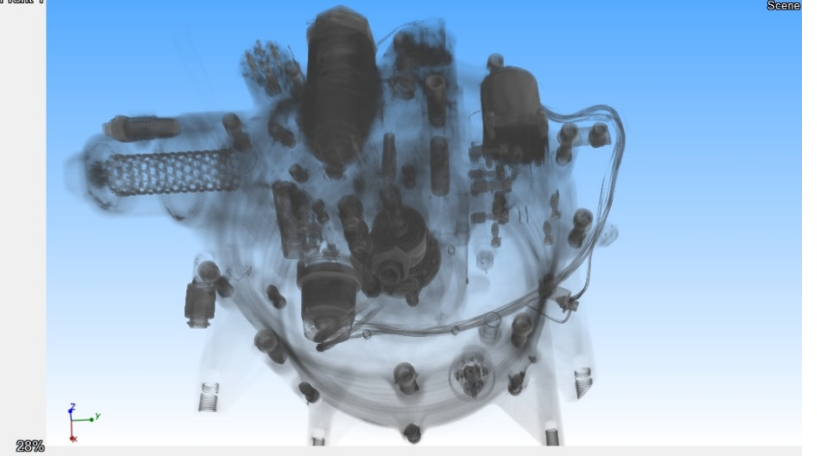
Figure 19
Hydraulic Pump Package – Overall view through DCV

The computed tomography (CT) results for the hydraulic pump package are shown in figures 19 through 27. Review of the images did not show any radiographic indications of high density particles other than the particle in the DCV. The hydraulic flow paths within the pump package were digitally marked. Pressure was colored red, return was colored yellow, C1 was colored blue, and C2 was colored green.

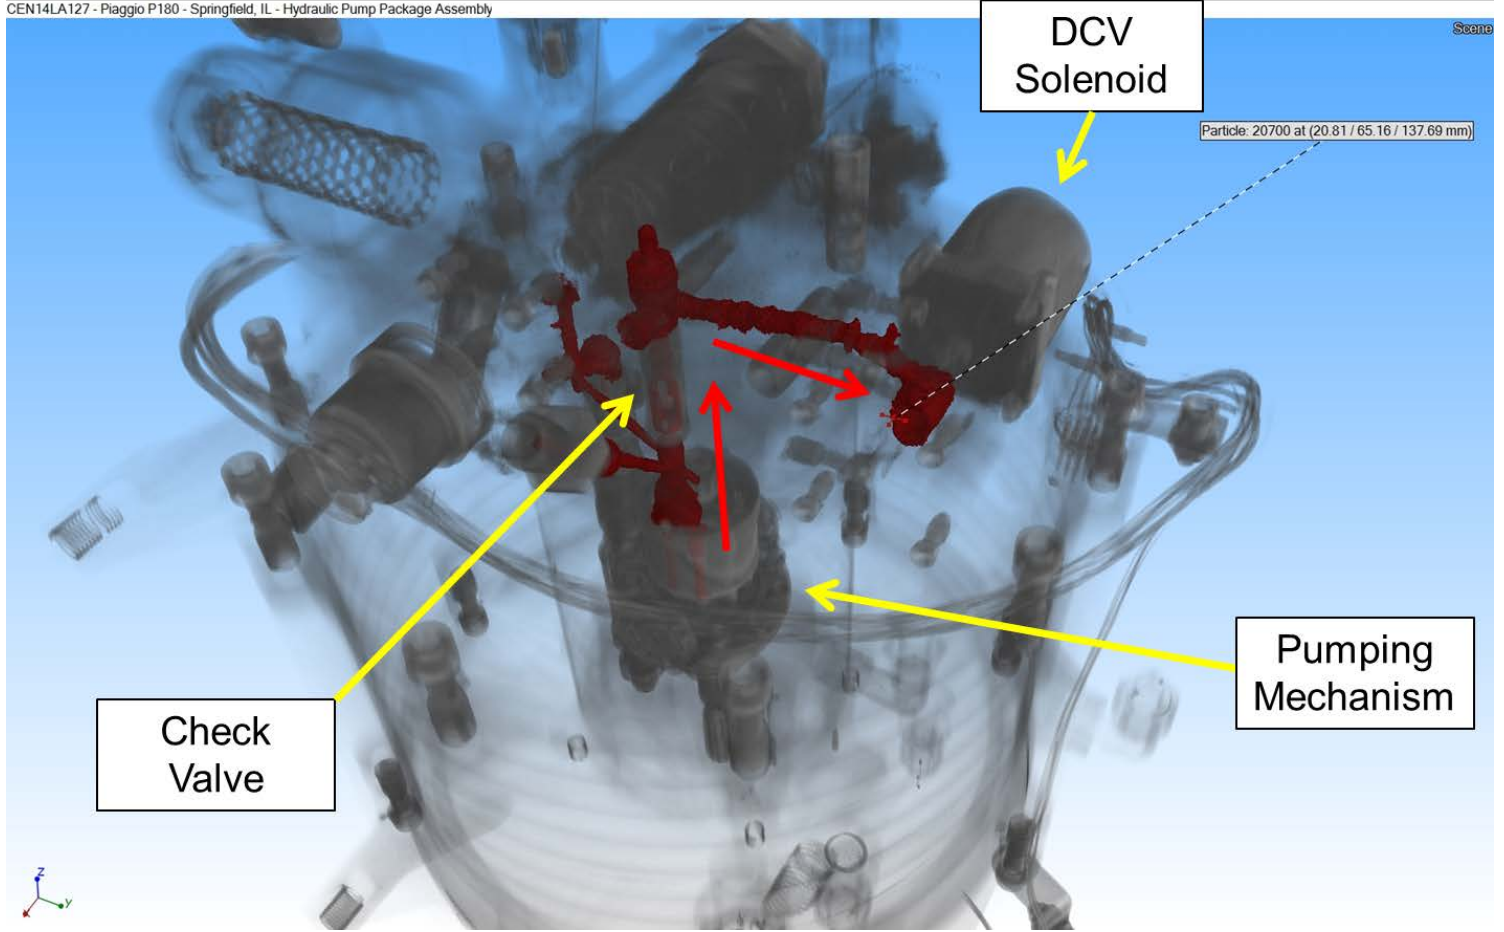
Figure 24

Hydraulic Pump Package – Three dimensional view showing isolated pressure hydraulic path. The arrows show the designed hydraulic flow path from the pumping mechanism to the DCV.

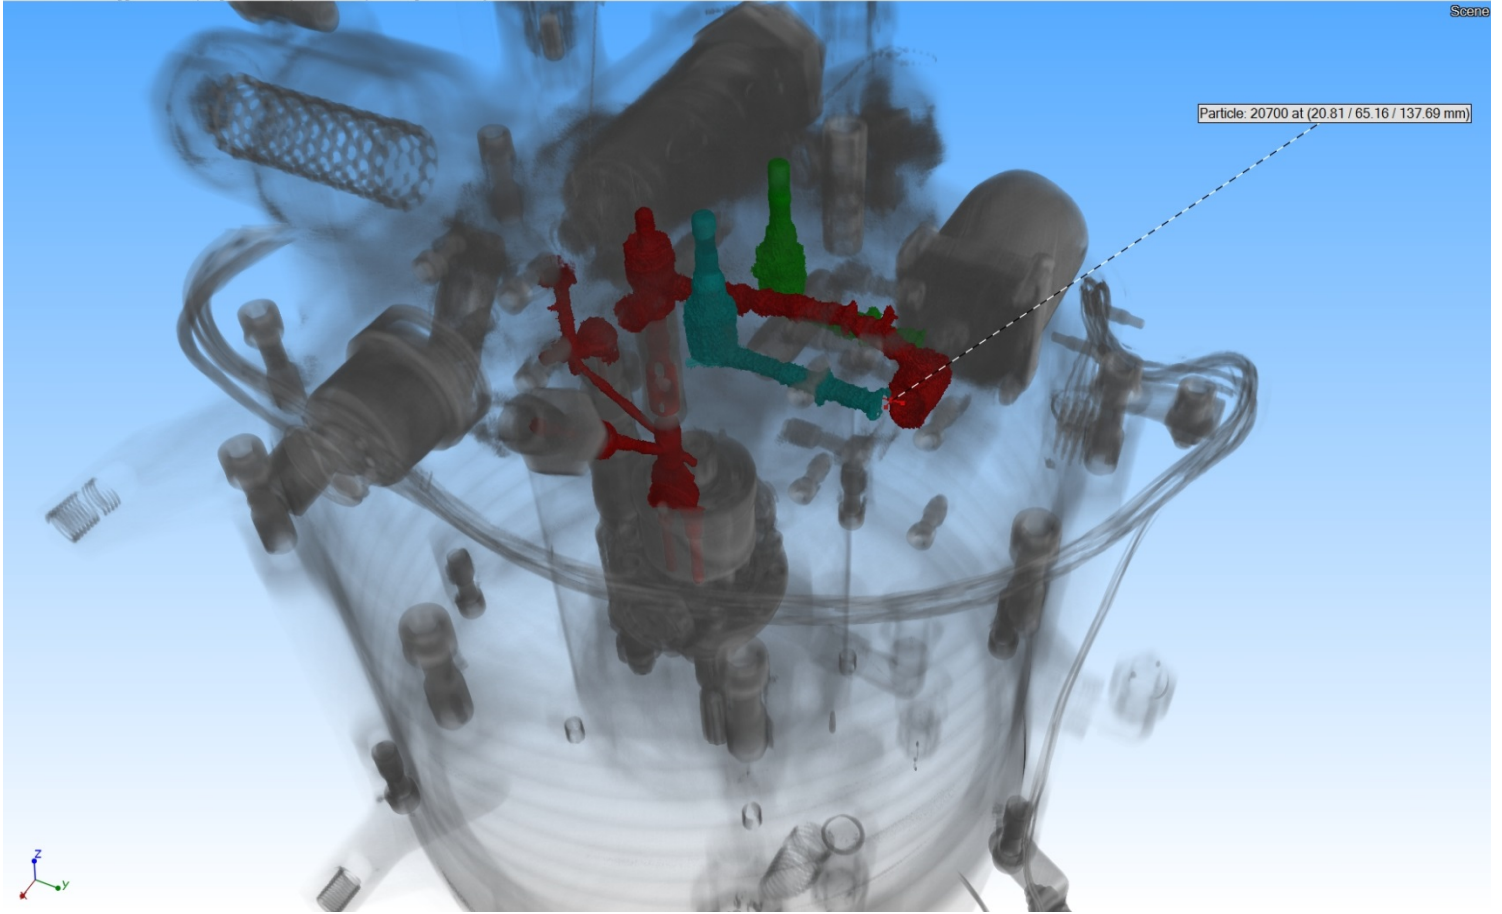
Figure 25
Hydraulic Pump Package – Three dimensional view showing pressure (red), C1 (blue), and C2 (green) hydraulic paths

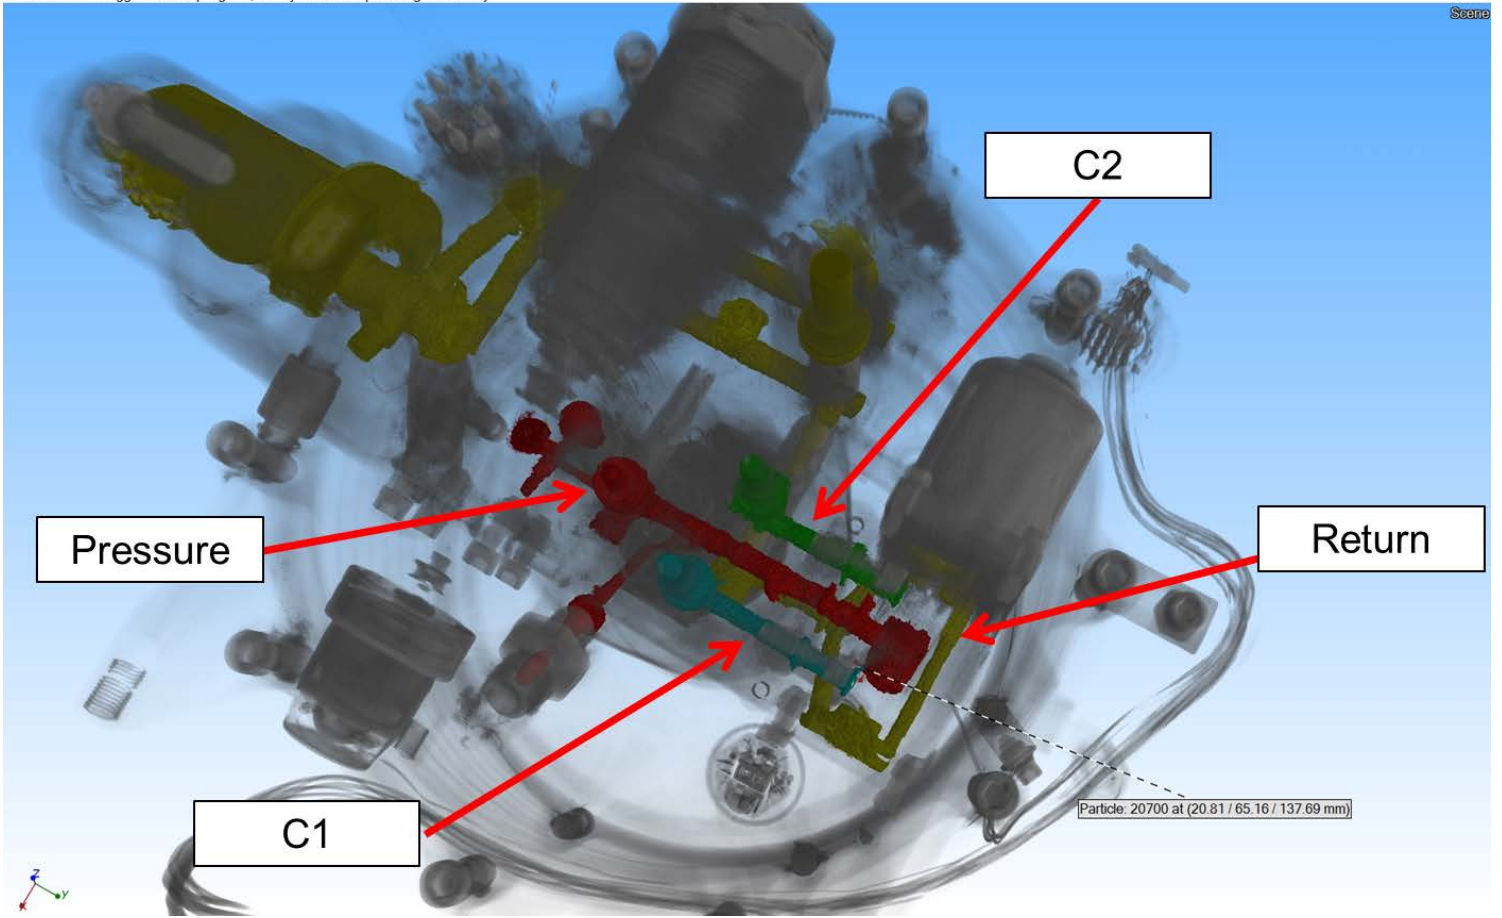
Figure 26
Hydraulic Pump Package – Three dimensional view showing pressure (red), C1 (blue), C2 (green), and return (yellow) hydraulic paths

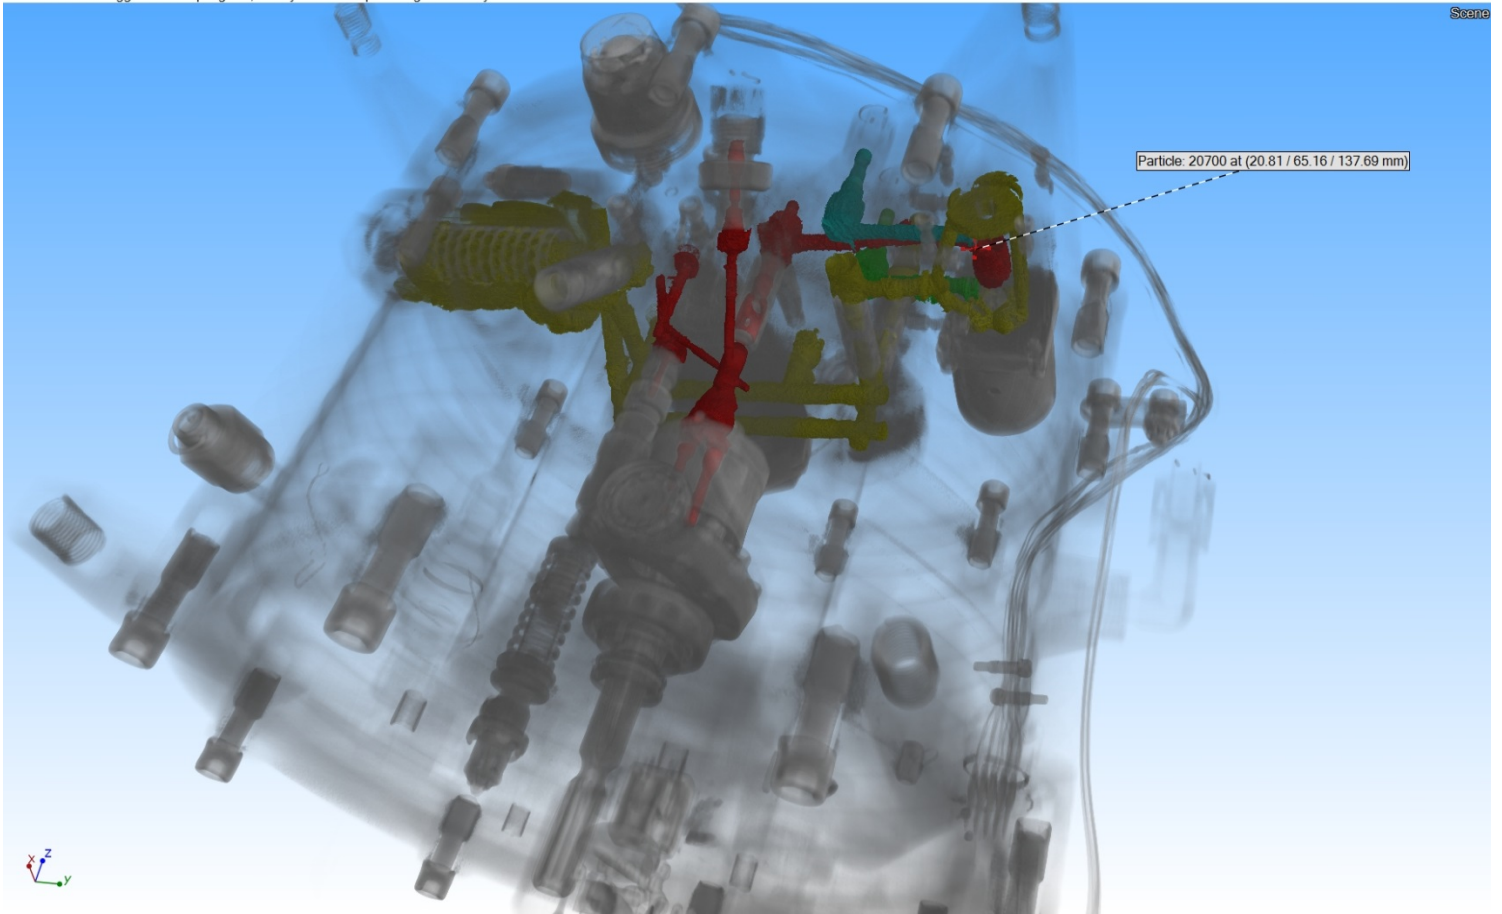
Figure 27
Hydraulic Pump Package – Three dimensional view showing pressure (red), C1 (blue), C2 (green), and return (yellow) hydraulic paths (from below)
