ENGINE FIELD INSPECTION REPORT

ENGINE MODEL	E-225
ENGINE SERIAL NUMBER	30057-D-3-4
AIRCRAFT MAKE & MODEL	Navion A
AIRCRAFT SERIAL NUMBER	NAV-4-1827
AIRCRAFT REGISTRATION	N4827K
FILE NUMBER	14-171

EXAMINATION		ACCIDENT DATA	
DATE	10/01/2014	NTSB ACCIDENT #	ANC14LA068
FACILITY	Arctic Aviation	NTSB INVESTIGATOR	Todd Gunther
ADDRESS	[REDACTED] Fairbanks, AK 99709	FAA INVESTIGATOR	Jason Major
		ACCIDENT DATE	08/24/2014
		ACCIDENT LOCATION	Coldfoot, Alaska

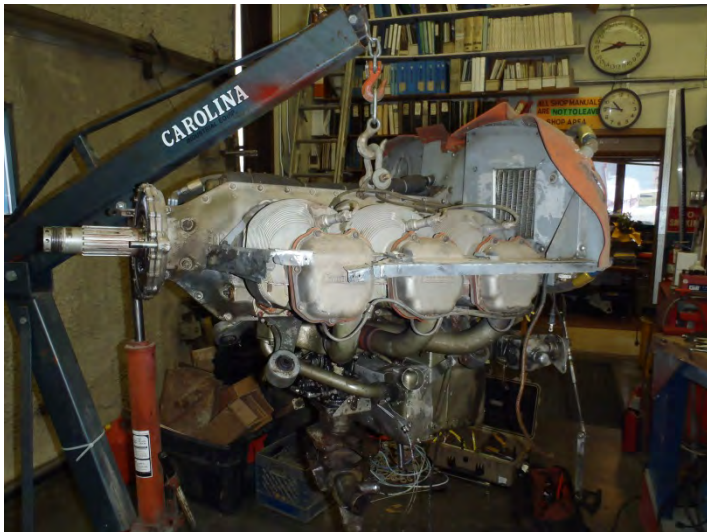
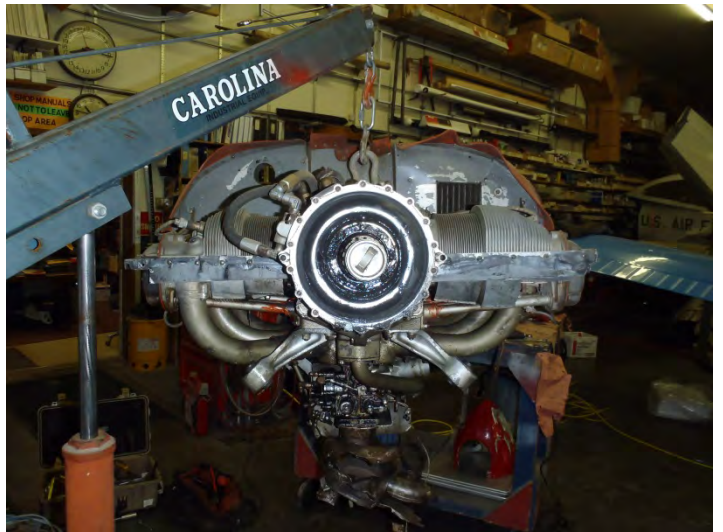
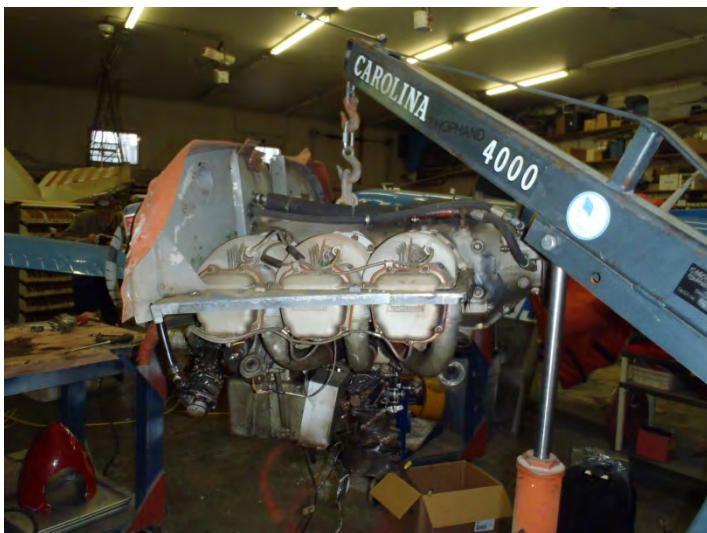
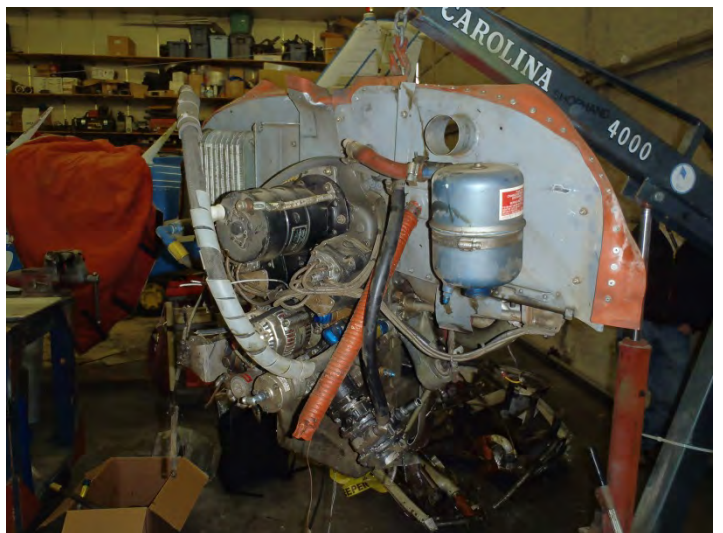
The engine had been recovered to a hanger; the engine and a portion of the airframe had been cut away from the rest of the airframe for the examination. The engine remained attached to the airframe by all three of the four engine mounts and by hoses, wires, and cables. The fourth engine mount was reported to be removed by the recovery crew. The engine was removed from the airframe for examination. The engine sustained some damage concentrated to the exhaust system and the pressure carburetor. The two blade; variable pitch propeller had been previously removed by the Hartzell representative for an examination. All six cylinders remained attached to the engine and were undamaged.

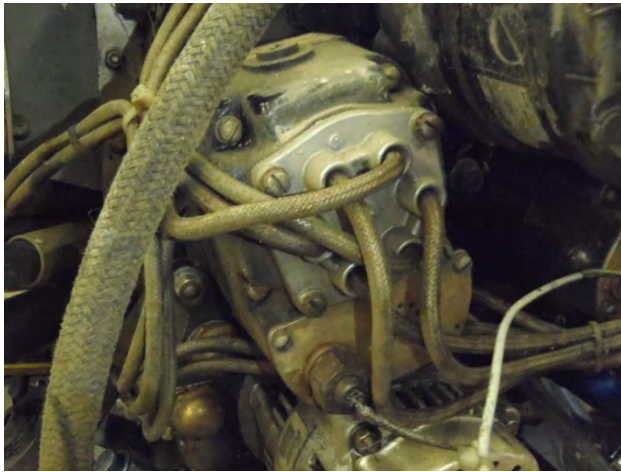
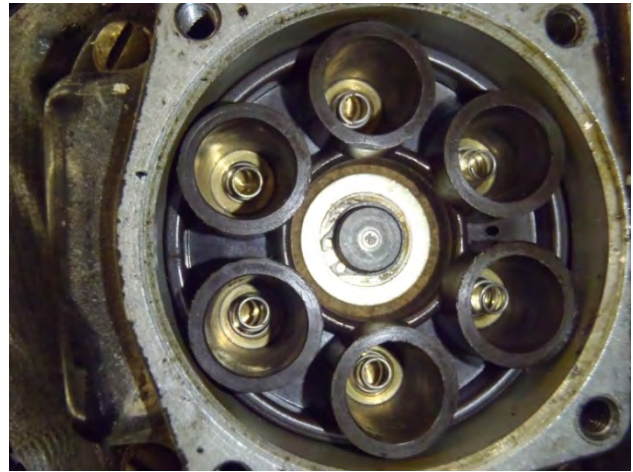
The left magneto remained attached to its respective installation point and was undamaged. The magneto drive was spun by rotating the crankshaft and it was noted that the impulse couplings engaged normally. The spark plugs were installed onto the igniton leads and it was noted that the magneto was capable of producing a spark for all six spark plugs.

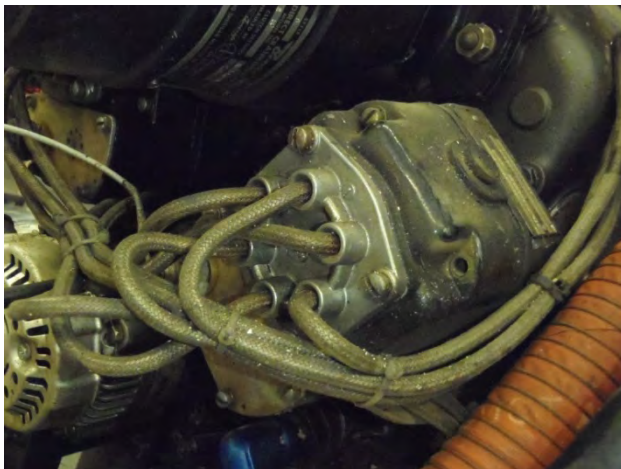
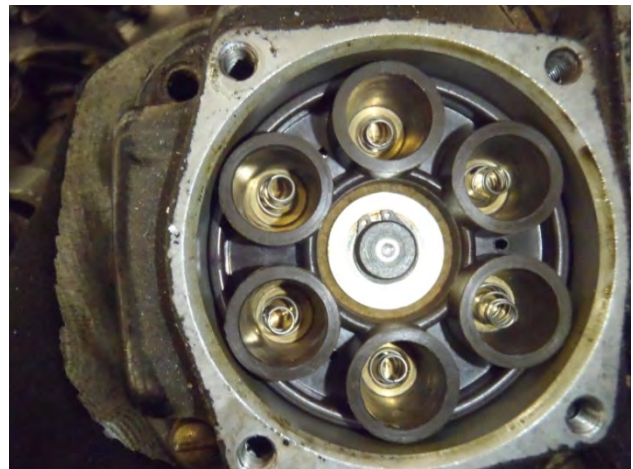
The right magneto remained attached to its respective installation point and was undamaged. It was noted that one of the magneto housing screws was missing and the magneto housing was loose. During the initial crankshaft rotation the magneto would not produce a spark; it was noted that P-Lead was cut to remove the engine which potentially caused the P-lead to ground the magneto. The magneto cover containing the P-lead was removed and the crankshaft was rotated; it was noted that the impulse couplings engaged and the magneto was capable of producing a spark for all six spark plugs.

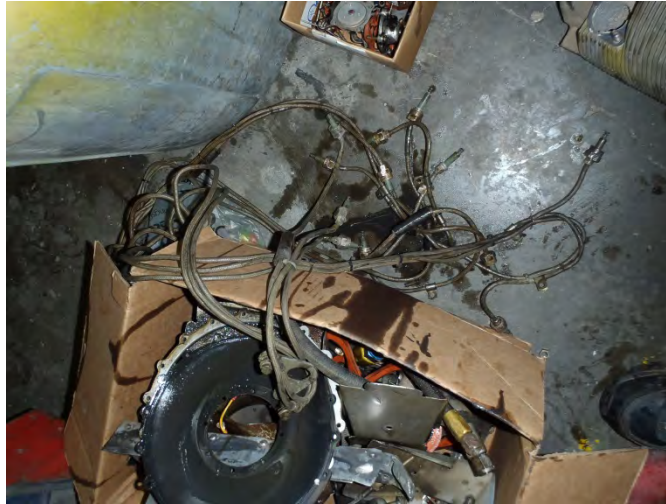
Condition:	The ignition harness remained attached to both magnetos and to each spark plug; the ignition harness was undamaged. It was noted that during the impulse coupling engagement of the magnetos that the ignition harness was capable of conducting a spark from the magnetos to each spark plug. There were no anomalies noted.
-------------------	-------------------------------------------------------------------------------------------------------------------------------------------------------------------------------------------------------------------------------------------------------------------------------------------------------------------------------

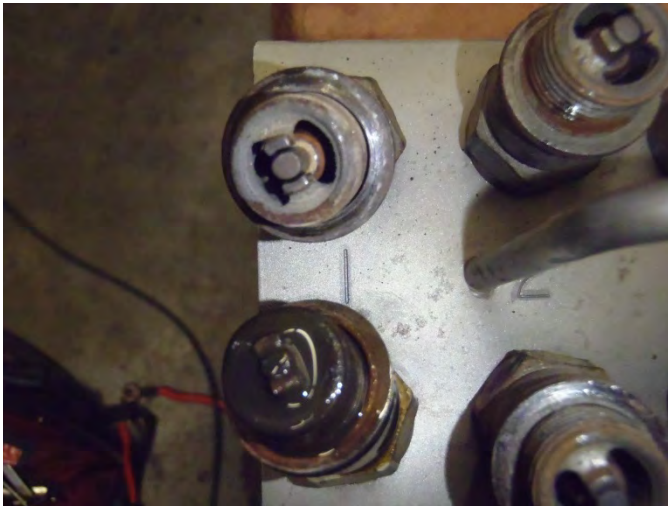
#1

Condition:	All of the spark plugs remained installed in their respective cylinders and were undamaged. All of the spark plugs were removed and visually inspected. The bottom #1, #3, and #5 spark plug electrodes were oil coated which was consistent with the engine position at rest. All of the spark plugs displayed normal operating signatures when compared to Champion Aviation Service Manual AV6-R. The #5 bottom, #2 top, and the #4 top and bottom were in a normal worn out condition when compared to Champion Aviation Service Manual AV6-R
-------------------	---------------------------------------------------------------------------------------------------------------------------------------------------------------------------------------------------------------------------------------------------------------------------------------------------------------------------------------------------------------------------------------------------------------------------------------------------------------------------------------------------------------------------------------------------

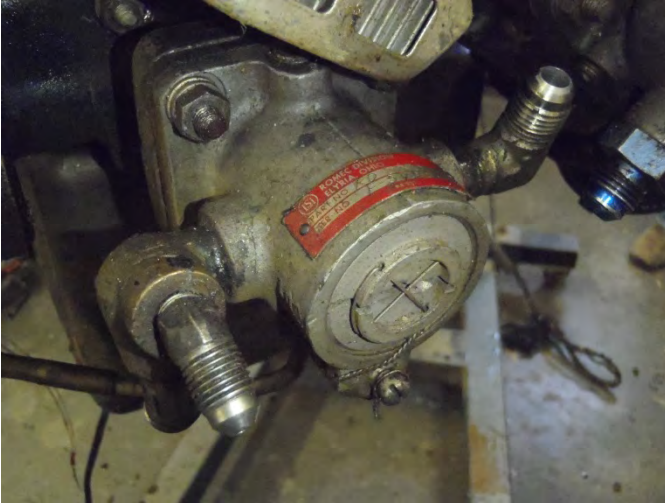
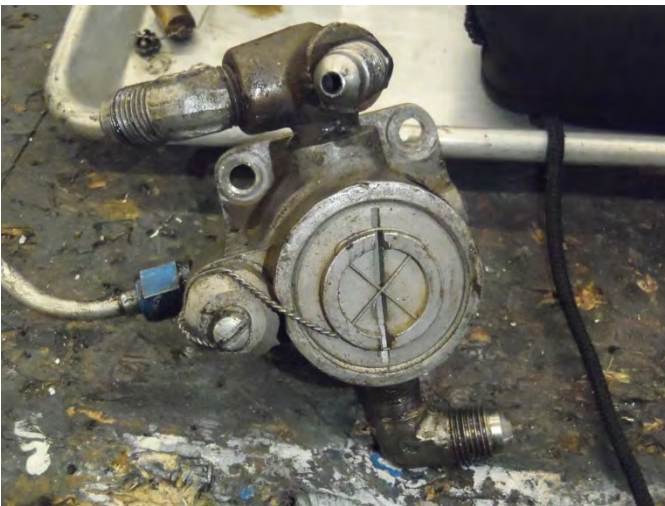
The fuel pump remained attached to its respective installation point and was undamaged. The fuel pump was removed and it was noted that the drive shaft remained intact and was capable of rotating by hand. There were no anomalies noted with the fuel pump.

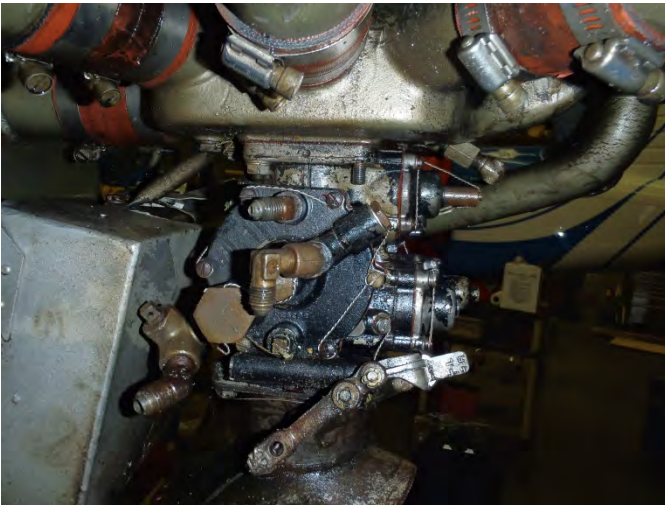
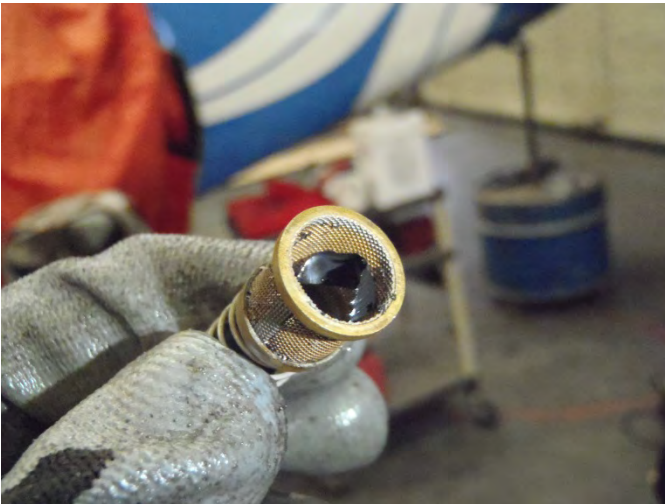
The carburetor remained attached to the engine and to the airbox. The carburetor sustained damage consistent with impact damage to the carburetor mixture control components. The carburetor was removed from the engine and disassembled for an internal examination. It was noted that the fuel inlet screen had a significant amount of material consistent with rubber and there was a significant amount of particulates noted in several of the carburetor chambers. It also noted that there was fuel present within several of the chambers of the carburetor. There were no further anomalies noted.

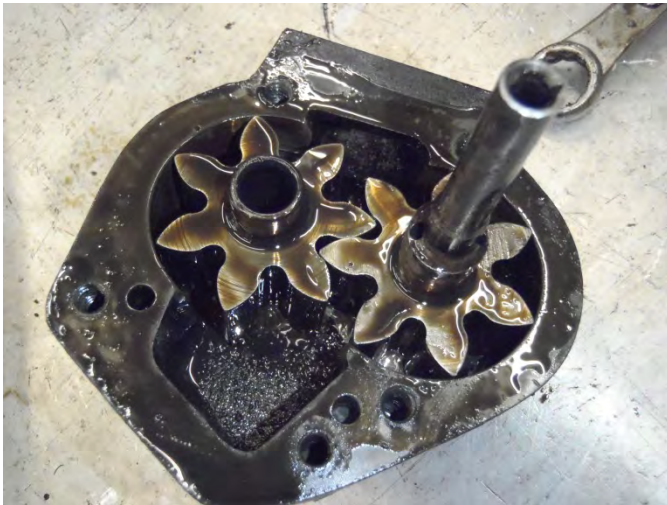
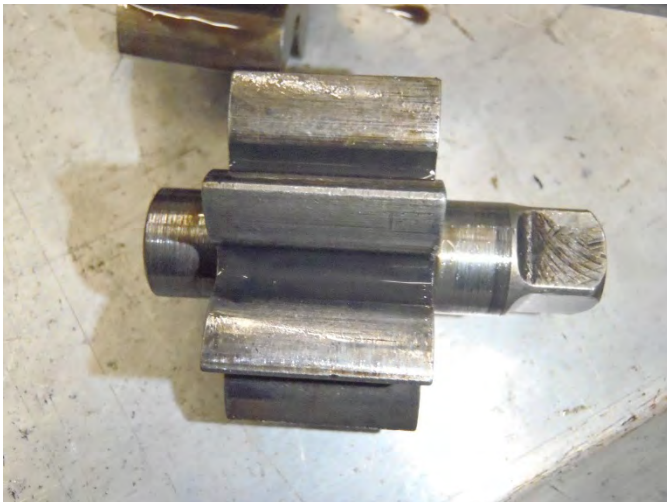
OIL SUMP	
Condition:	The oil sump remained attached to the engine and was undamaged. There were no anomalies noted with the oil sump.
OIL PICK-UP TUBE & SCREEN	
Condition:	The oil pick-up tube and screen remained installed to its respective installation point and was undamaged. The screen was clear of contaminants.
OIL PUMP	
Condition:	The oil pump remained installed in its respective installation point and was capable of normal rotation. The oil pump was disassembled and it was noted that the oil pump housing displayed scoring consistent with hard partical passage. The oil pump gears displayed small chips in several of the gear apexes consistent with hard partical passage. There were no further anomalies noted with the oil pump.

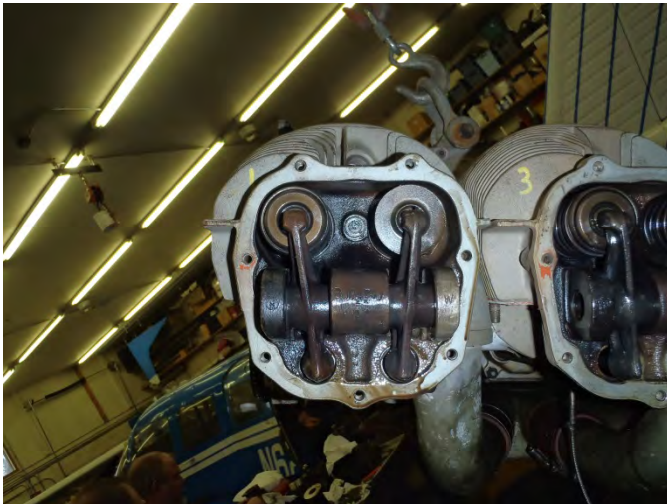
CYLINDER #1	P/N: Illegible	S/N: Illegible	
Condition:	The cylinder remained attached to the engine and there was no spot putty noted on the cylinder hold down nuts. The crankshaft was rotated and it was noted that the cylinder had good thumb compression and suction. The cylinder was removed from the engine and visually inspected. The external and internal components of the cylinder displayed normal operating signatures; there were no anomalies noted with the cylinder.

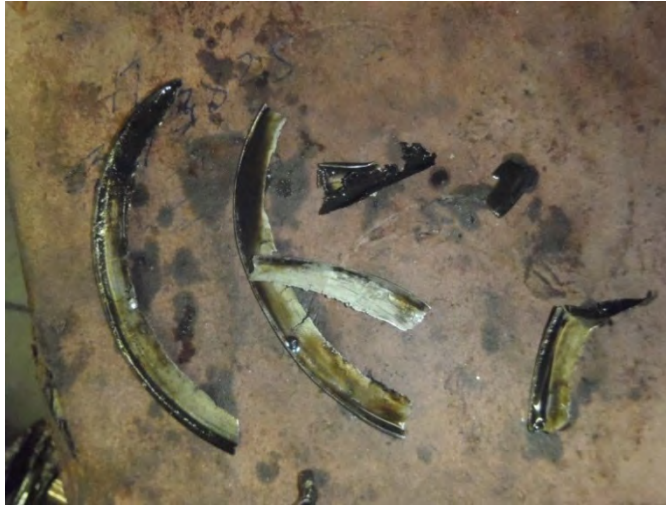
The front bearing remained installed within its respective bearing saddle and there were no signs of bearing shift. The bearing displayed damage concentrated to the rear portion of the bearing; several large, flat portions of the bearing had broken free from the bearing. Several portions of the bearing were located in the crankcase. The bearing displayed normal lubrication signatures.

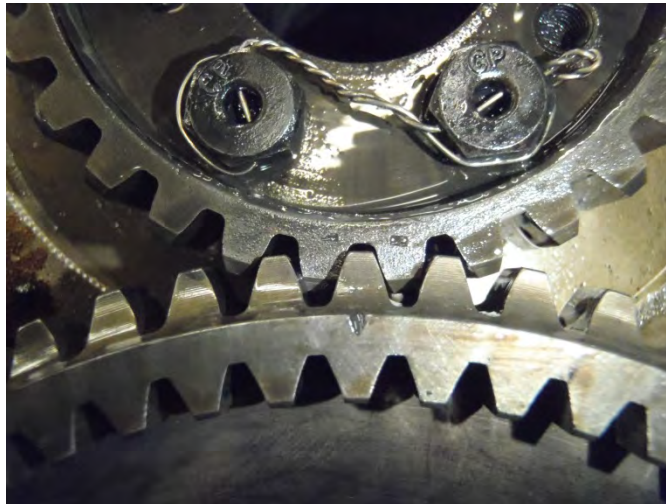
Condition: The internal timing was verified by matching the crankshaft and camshaft timing marks.

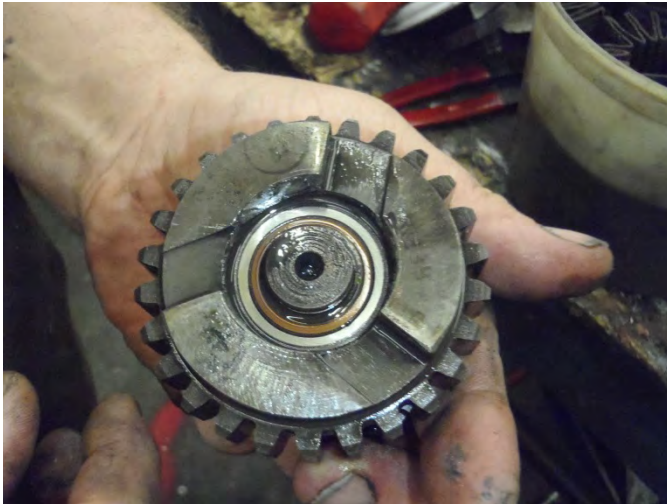
All of the accessory gears were secure and displayed normal operating signatures. It was noted that both of the magneto drive supports were secured with regular nuts; according to the E-225 parts catalog the drive supports are to be secured using a castellated nut and a cotter key.

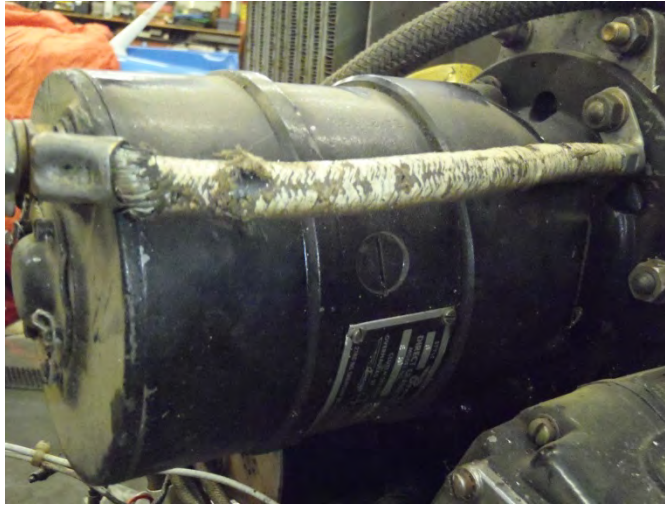
The starter remained attached to its respective installation point and was undamaged. There were no anomalies noted with the starter.

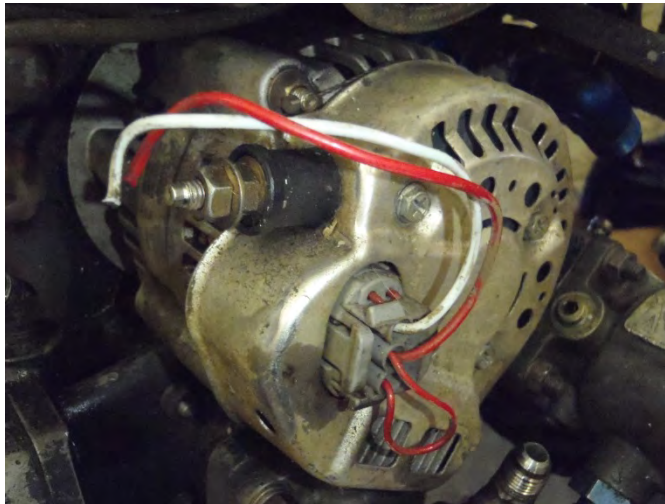
The alternator remained attached to its respective installation point and was undamaged. There were no anomalies noted with the alternator.

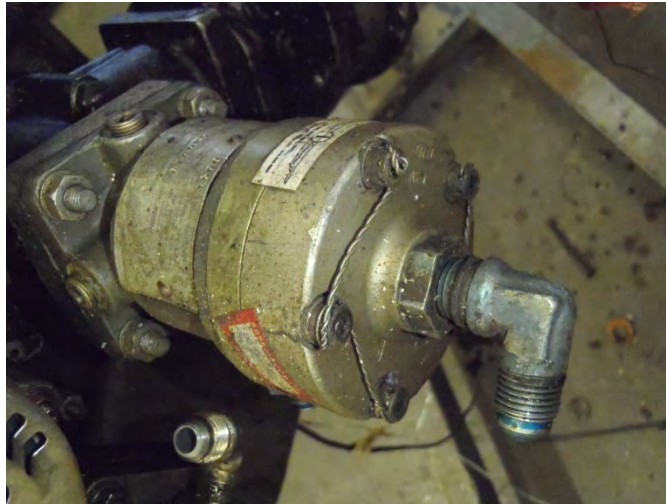
Condition: The engine driven hydraulic pump remained attached to its respective installation point and was undamaged. There were no anomalies noted with the hydraulic pump.

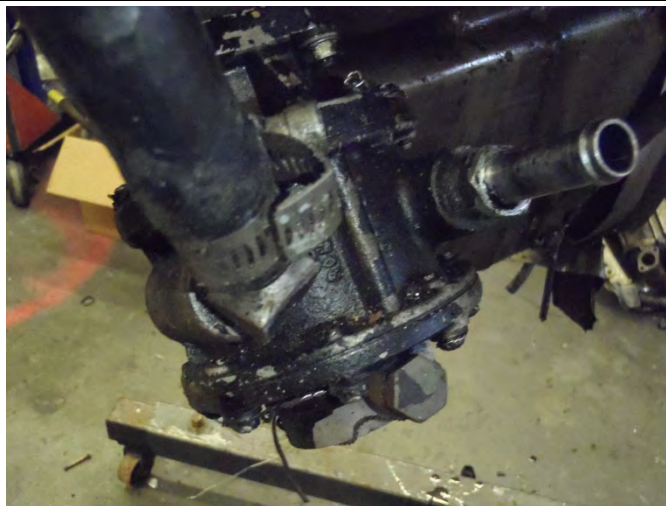
Condition: The vacuum pump remained attached to its respective installation point and was undamaged. There were no anomalies noted with the vacuum pump.

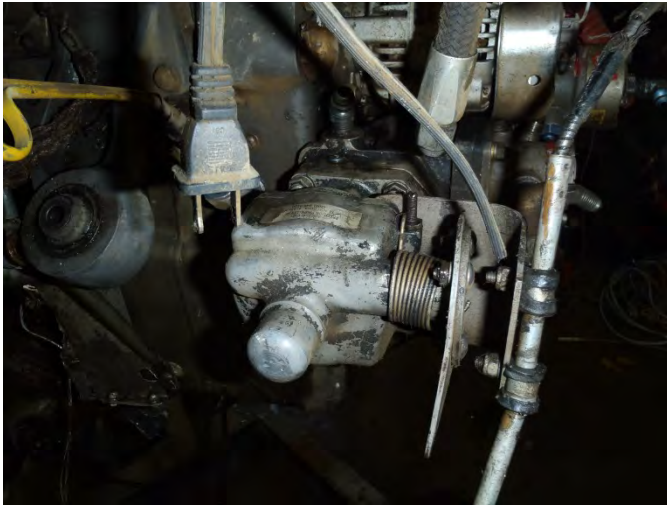
PROPELLER GOVERNOR	Manufacturer: Illegible	P/N: Illegible	S/N: Illegible
Condition:	The propeller governor remained attached to its respective installation point and was undamaged. There were no anomalies noted with the propeller governor.
