Continental Motors

ENGINE FIELD INSPECTION REPORT

ENGINE MODEL	O-470-L1
ENGINE SERIAL NUMBER	66818-6-L
AIRCRAFT MAKE & MODEL	Cessna 182
AIRCRAFT SERIAL NUMBER	33816
AIRCRAFT REGISTRATION	N5816B
FILE NUMBER	14-077

EXAMINATION		ACCIDENT DATA	
DATE	07/16/2014	NTSB ACCIDENT #	WPR14FA286
FACILITY	AvTech Services LLC	NTSB INVESTIGATOR	Tom Little
ADDRESS	[REDACTED] Kent, WA 98042	FAA INVESTIGATOR	William Shin
		ACCIDENT DATE	07/08/2014
		ACCIDENT LOCATION	Fall City, WA

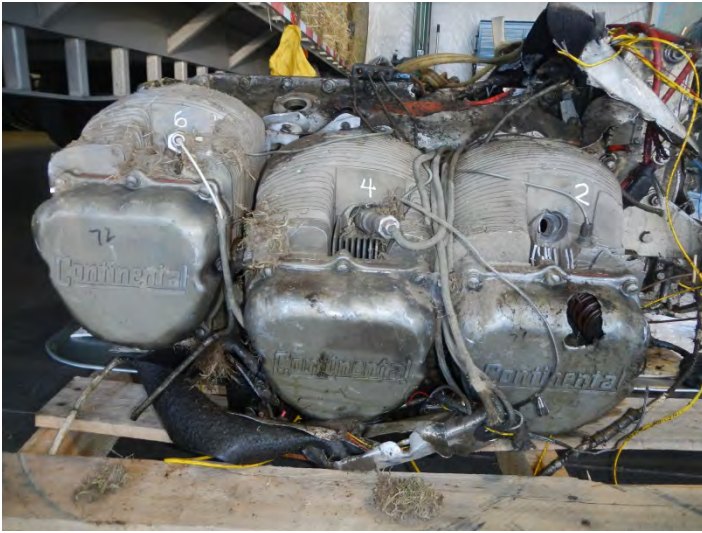
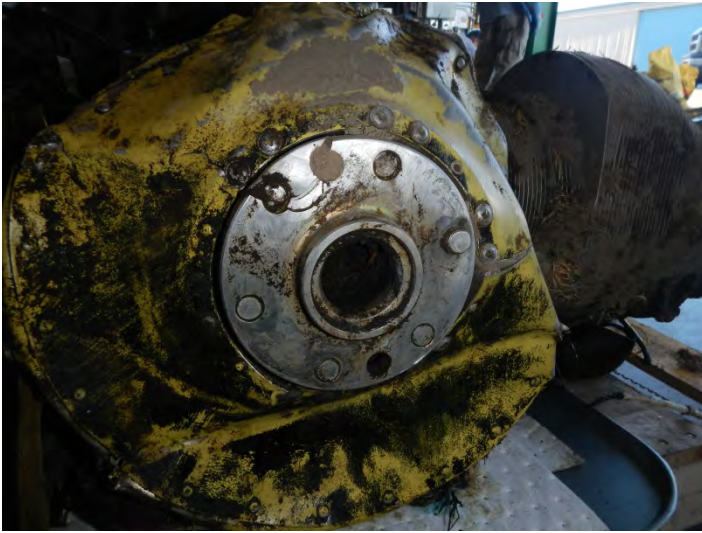
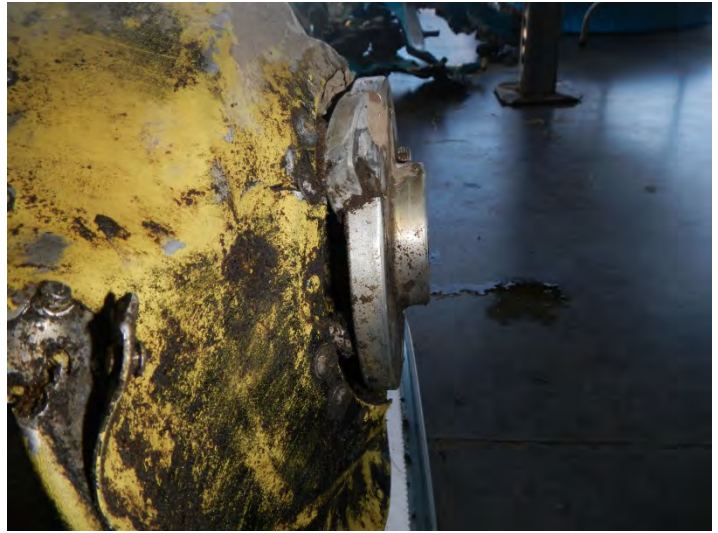
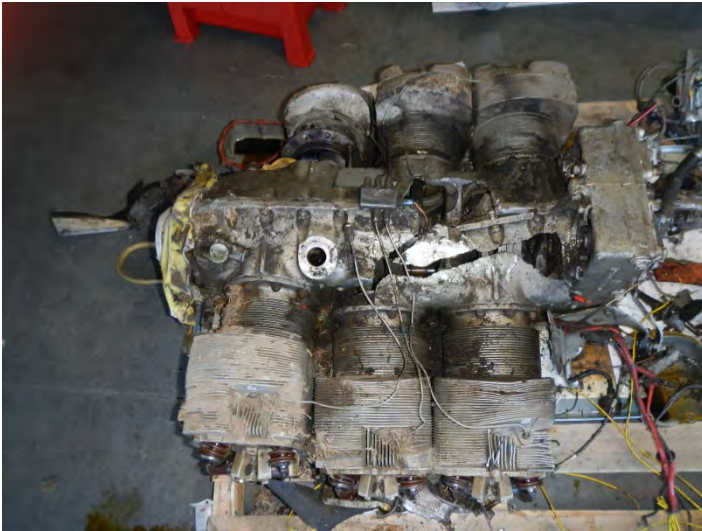
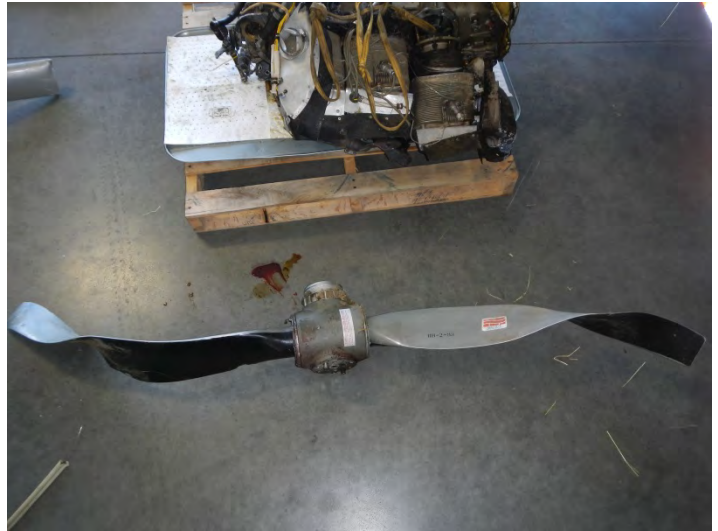
The engine was resting in an upright position on a pallet. The propeller was separated from the crankshaft's propeller flange. A portion of the propeller flange was fractured and displaced aft. All six propeller bolts remained with the propeller flange. The aft spinner bulkhead was deformed aft around the topside of the crankcase. The two-bladed propeller was lying on the floor adjacent to the engine. Both blades remained attached to the hub, both were twisted toward low pitch, and both displayed a polished erosion of the paint from the tips. One of the blades also displayed s-bending signatures. The threaded areas of the hub where the propeller bolts are normally positioned displayed distortion and elongation signatures. The propeller mounting dowels were also displaced.

The #4 and #5 cylinders were partially separated from the crankcase. The topside of the crankcase was fractured permitting a view inside the engine in the area of the four aft cylinders. Both magnetos were separated from the engine. Portions of the ignition leads remained with the engine. The carburetor was separated from the engine as was the oil cooler, starter motor, and vacuum pump. The exhaust system remained attached to the engine; however, it sustained deformation damage and flattening. The primer system and primer lines remained attached to the engine.

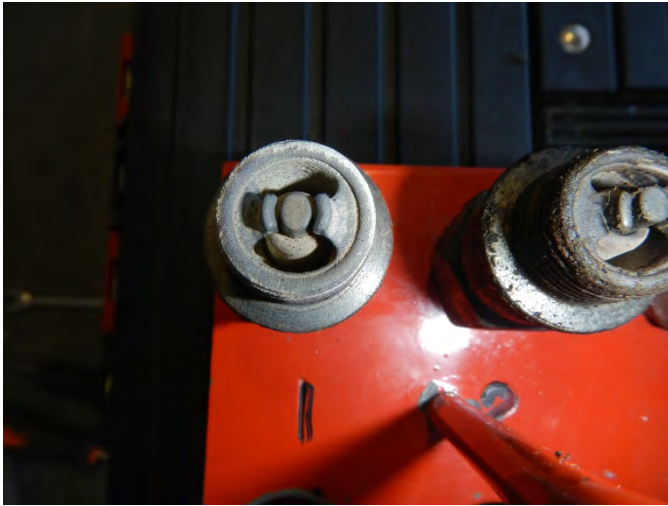
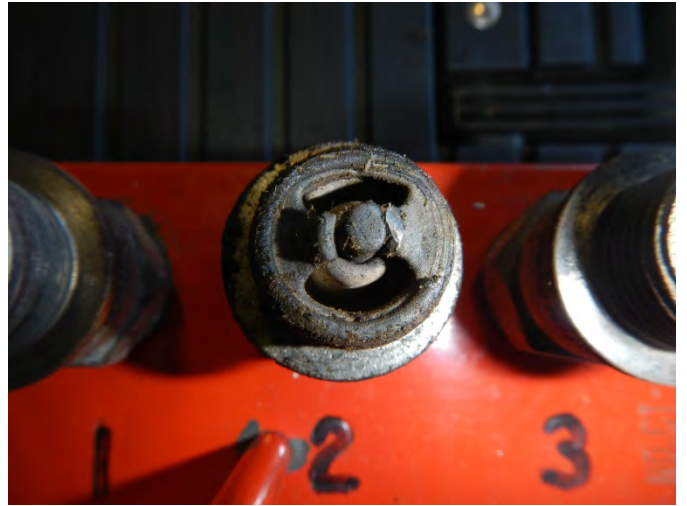
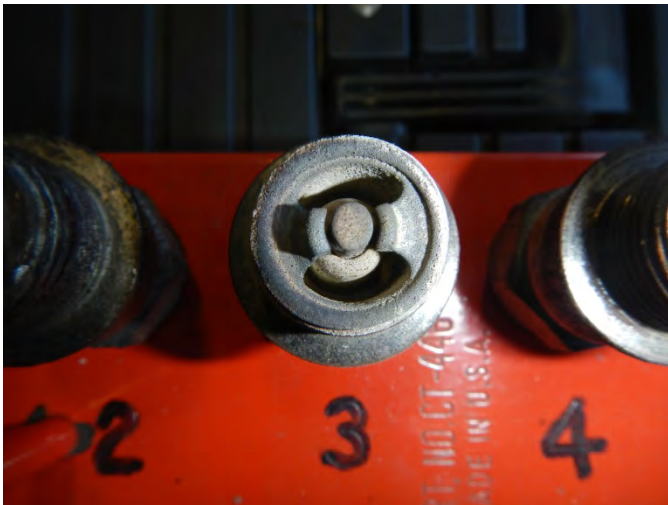
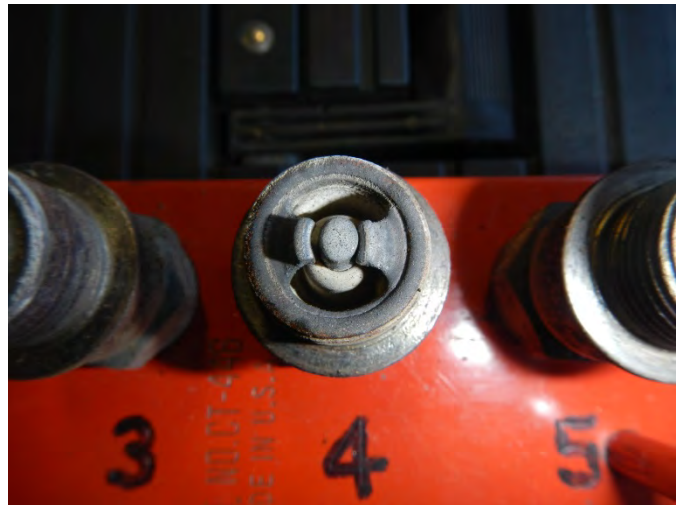
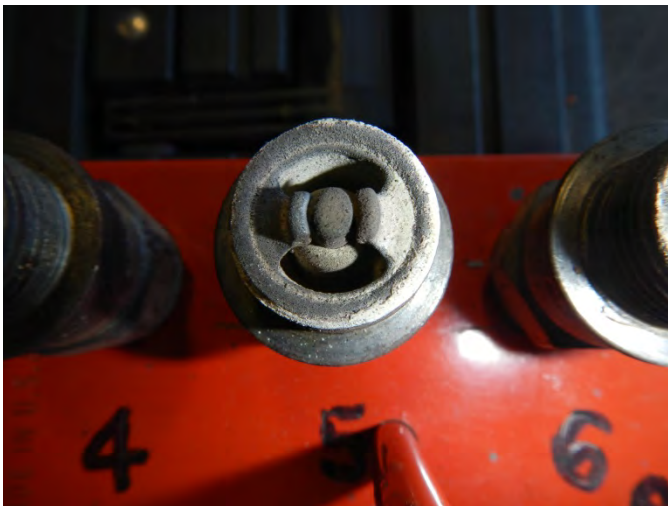
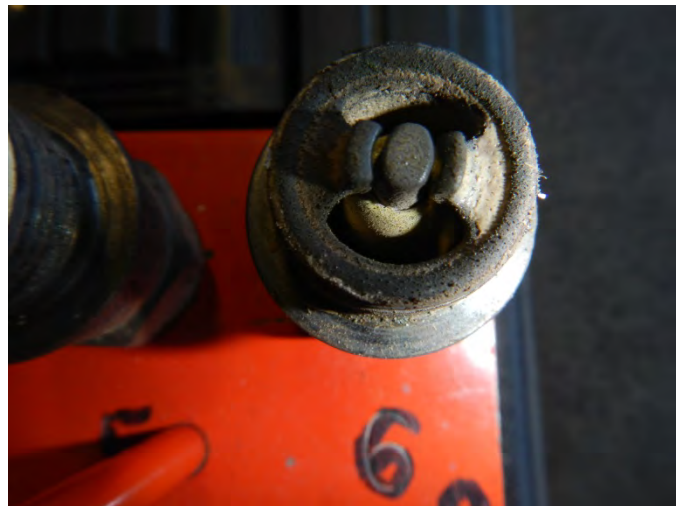
Condition: The left magneto was separated from the engine and was intact, though it sustained impact damage that separated all of the ignition leads and left mechanical deformation damage to the housing. The drive shaft could be manually rotated and the snap of the impulse coupling was audible.

Condition: The right magneto was separated from the engine and was fractured. Examination of the identified components did not reveal any pre-impact anomalies.

SPARK PLUGS	Manufacturer: Champion	P/N: REM40E
Condition:	The top sparkplugs were removed from their respective cylinders. The #2 top sparkplug sustained mechanical damage. Otherwise, they were unremarkable, showing normal wear and combustion signatures when compared to the Champion Service Manual AV6-R.

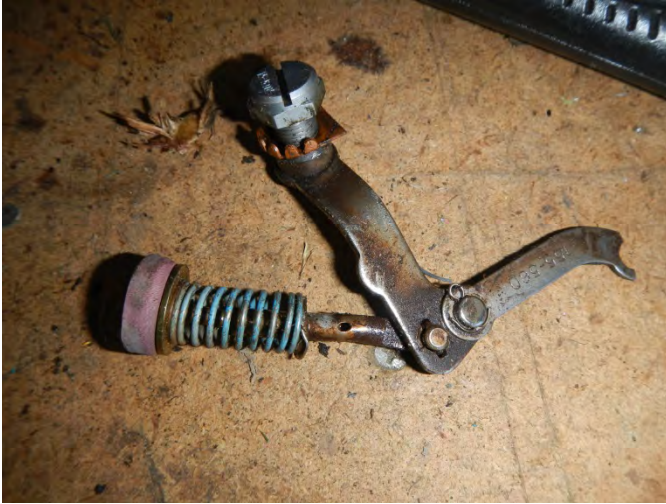
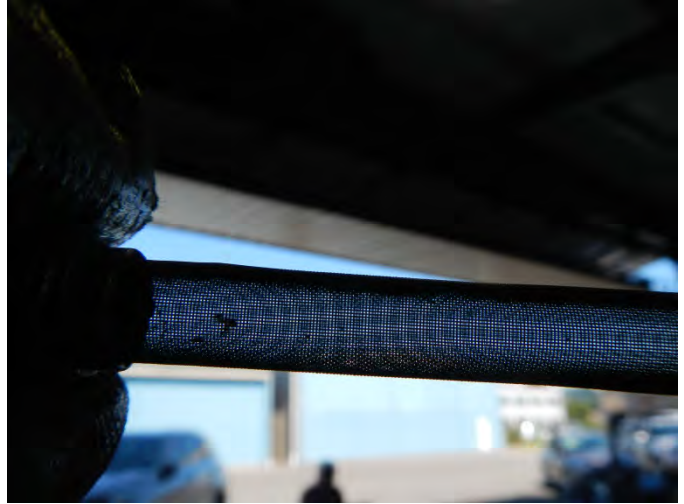
The carburetor was separated from the engine and the throttle valve was separated from the carburetor as was the accelerator pump. The mixture lever was separated from the carburetor. The throttle shaft was bent but remained attached to the throttle plate. The throttle lever remained attached to the shaft. The carburetor housing was fractured permitting a view into the carburetor bowl. Disassembly of the carburetor revealed that the inlet screen was clean, and the floats, though deformed, were intact.

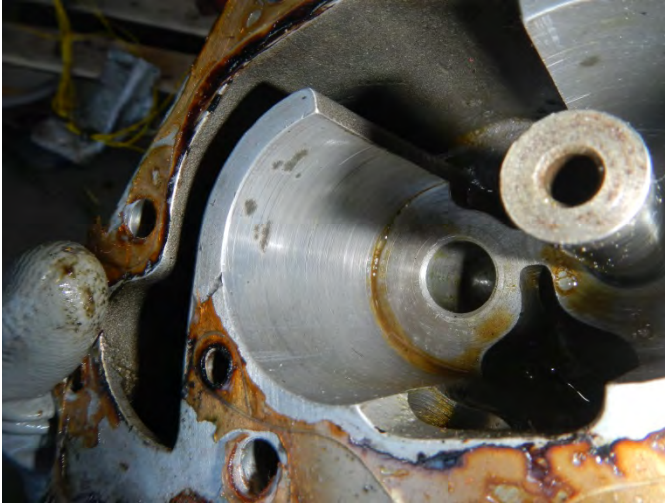
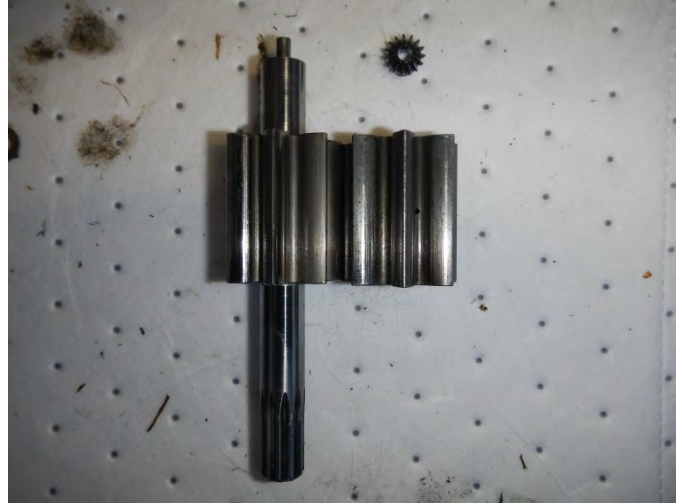
The oil pump remained secured to the backside of the engine. It was removed and disassembled. Some light scoring and corrosion was noted on the pump housing walls. There were no signs of operational distress with the oil pump housing or gears.
