Continental Motors

ENGINE FIELD INSPECTION REPORT

ENGINE MODEL	TSIO-520-B12B
ENGINE SERIAL NUMBER	176760-R
AIRCRAFT MAKE & MODEL	Cessna T310Q
AIRCRAFT SERIAL NUMBER	T310Q-0611
AIRCRAFT REGISTRATION	N310JA
FILE NUMBER	15-199

EXAMINATION		ACCIDENT DATA	
DATE	09/27 and 28/2015	NTSB ACCIDENT #	CEN15FA425
FACILITY	Accident Site	NTSB INVESTIGATOR	Courtney Leidler
ADDRESS	410 S. Wetmore Wichita, KS 67209	FAA INVESTIGATOR	Bobby Warren
		ACCIDENT DATE	09/25/2015
		ACCIDENT LOCATION	Wichita, Kansas

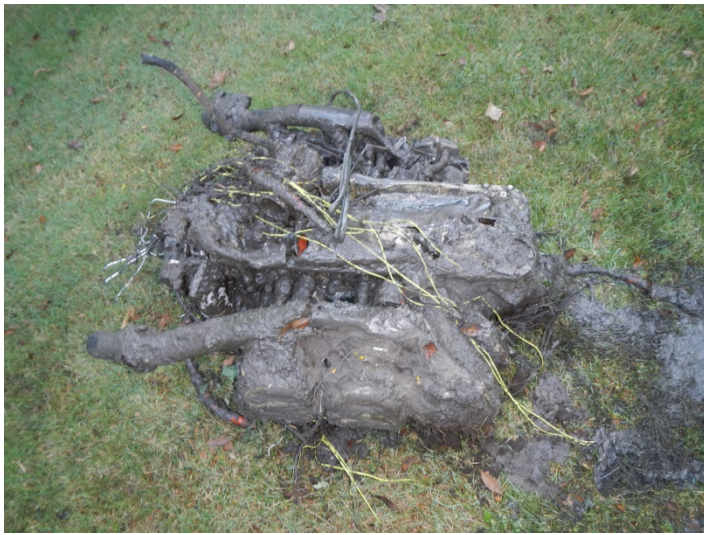
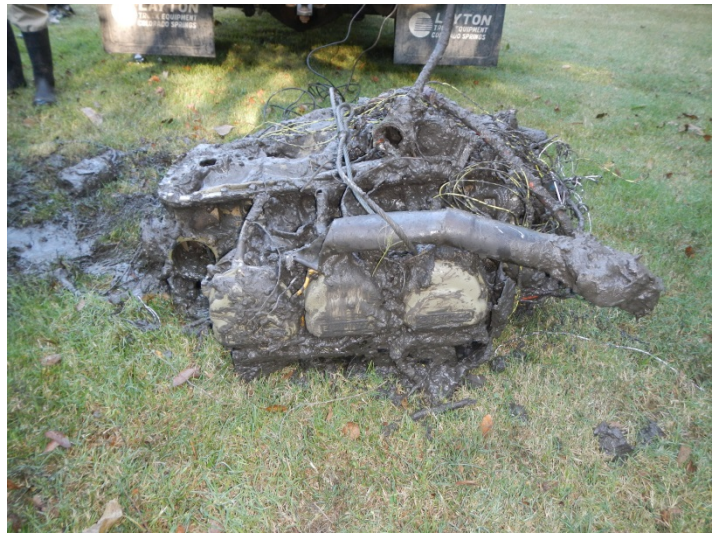
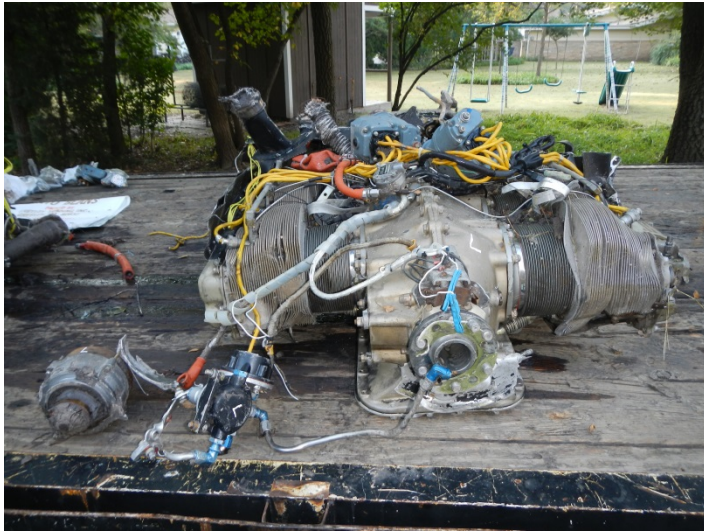
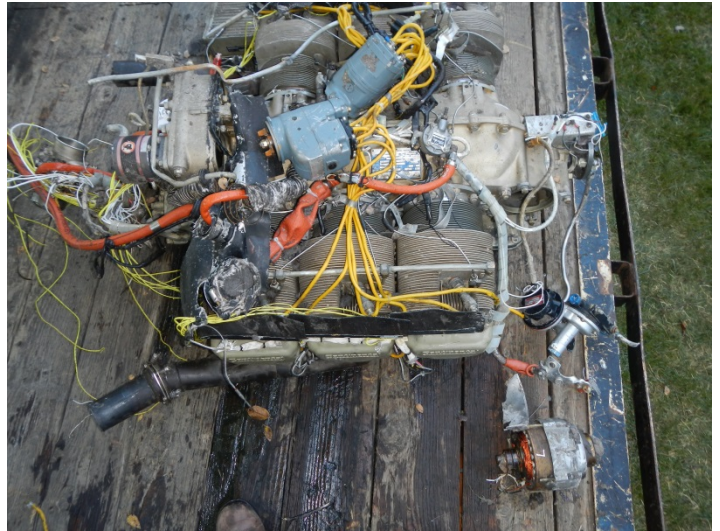
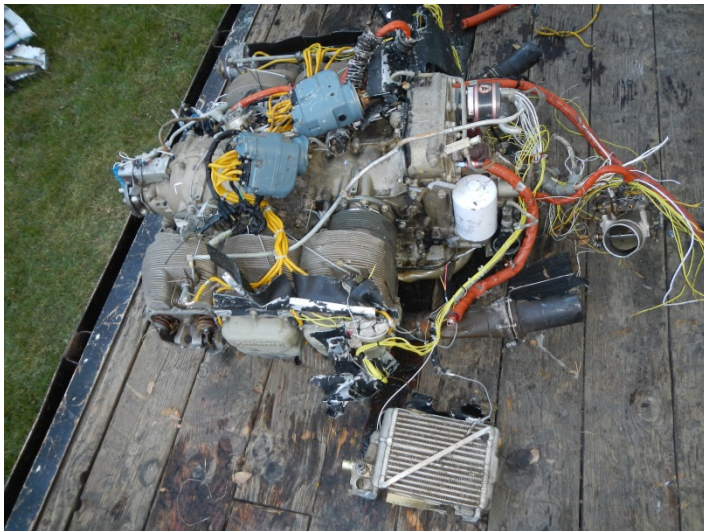
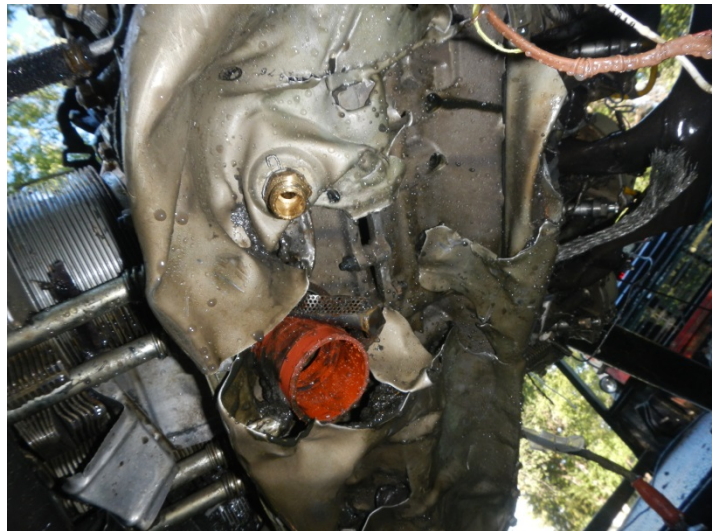
The left engine's magnetos were separated from their respective mounting pads but remained attached to the engine via the ignition harness.

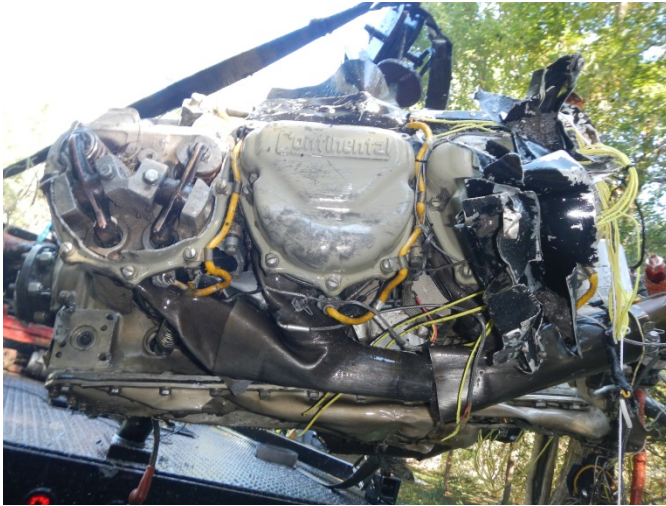
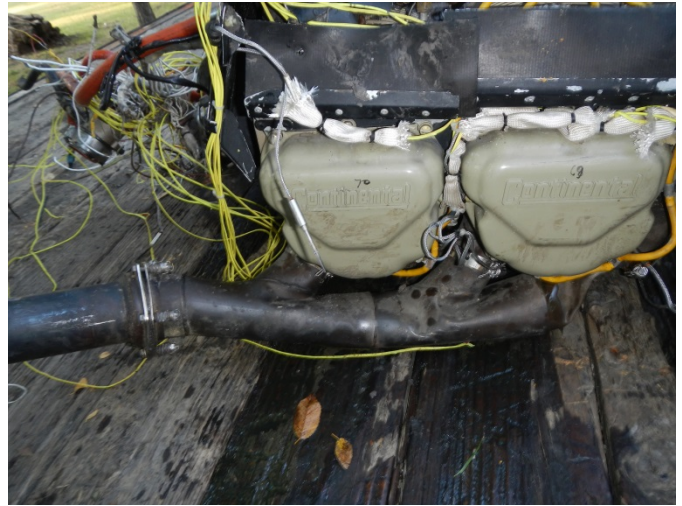
The intake risers were fractured and separated from their respective cylinders. Portions of the intake system were found in the wreckage. The throttle body remained attached to the engine via a fuel line. A majority of the induction system was not observed during the wreckage examination.

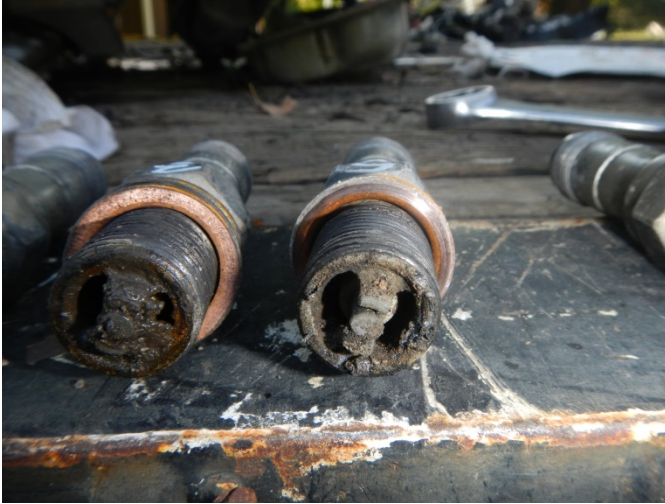
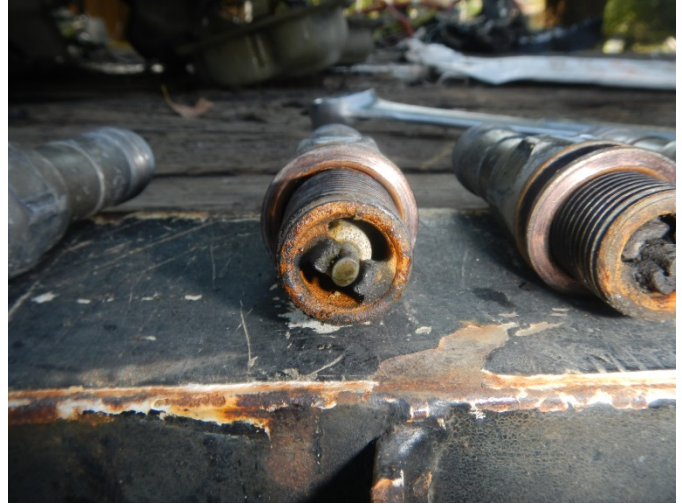
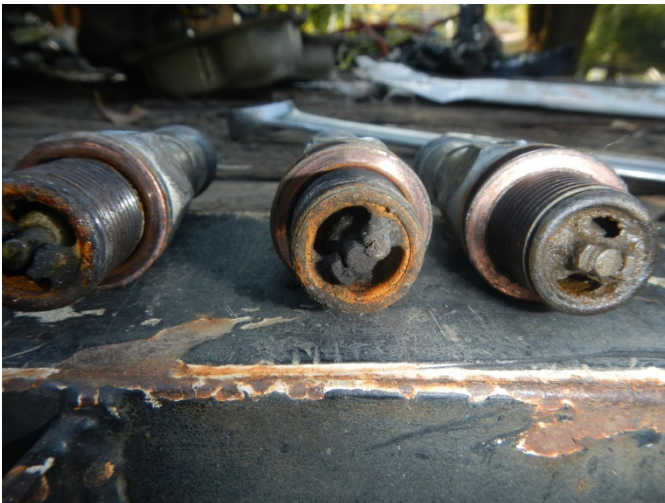
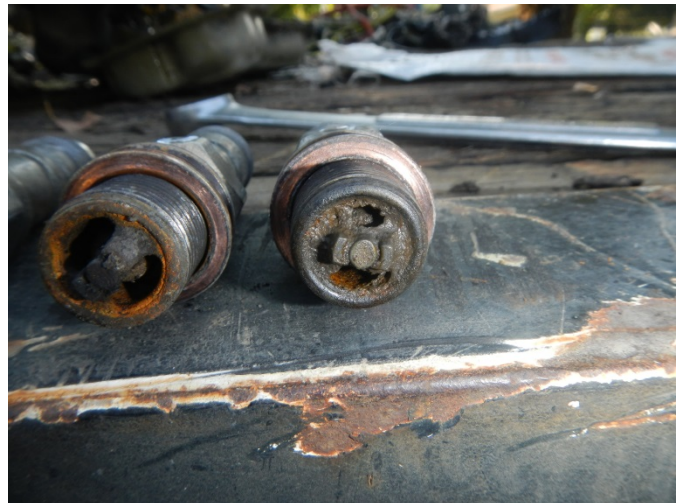
IGNITION HARNESS	Manufacturer: CMI	P/N: Unknown	S/N: Unknown
Condition:	The ignition harness remained attached to the magnetos, but a number of the leads were damaged. All of the terminal ends remained attached to their respective sparkplugs.		
SPARK PLUGS	Manufacturer: Champion	P/N: RHB32E	
Condition:	The top sparkplugs were covered with mud, water, and oil. All electrodes displayed a normal worn condition when compared to the Champion Aviation Service Manual (AV6-R).

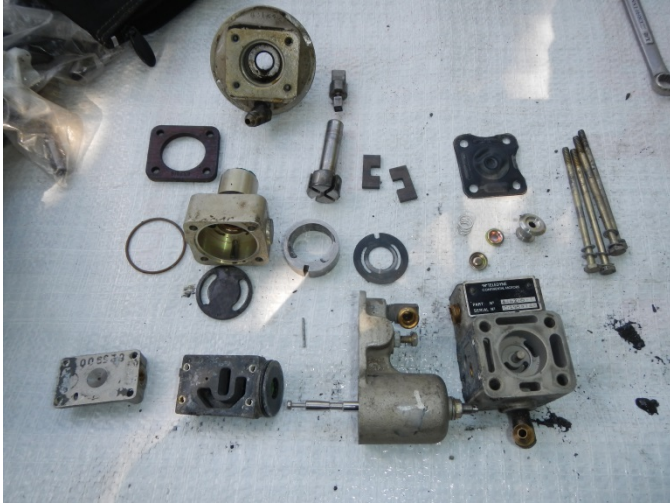
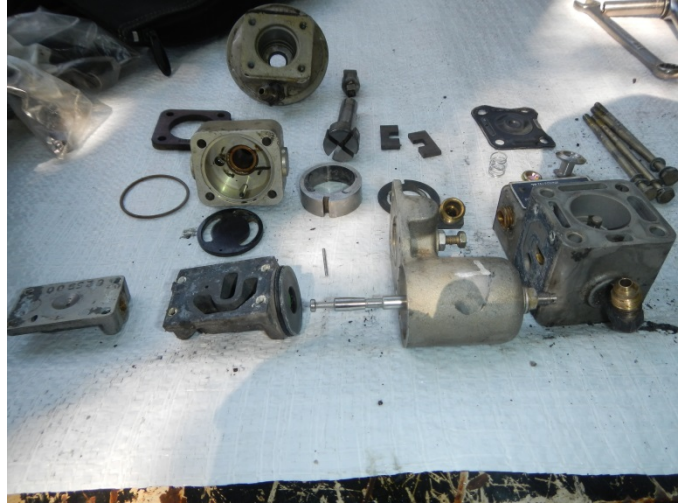
THROTTLE BODY METERING UNIT	Manufacturer: CMI	P/N: 632916-8	S/N: H129818AR
	<p>Condition: The throttle body/fuel metering unit remained attached to the engine via the fuel line between the fuel pump and the metering unit. The throttle and mixture cables remained attached to the throttle body and metering unit levers, which remained attached to their respective shafts. Rotation of the levers resulted in a coinciding rotation of the shafts with no binding noted. The metering unit fuel inlet filter was removed and no obstructions or blockage was noted, but mud and dirty water was observed. The metering unit was disassembled and besides water and dirt contamination, no pre-accident anomalies were noted with the internal components.</p>

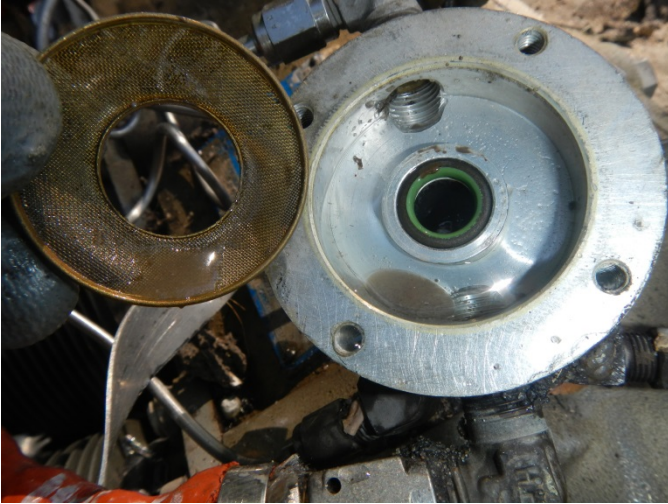
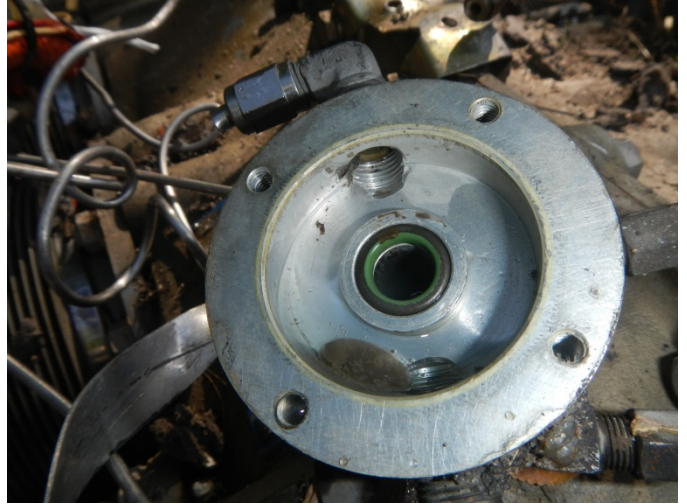
The fuel manifold valve remained attached to the topside of the engine; however, some of the fuel injection lines were fractured and it was separated from its mount. The cap was secured to the body with safety-wire. The fuel manifold valve was disassembled and aviation gasoline, mud and water were noted in the manifold. No pre-accident anomalies were noted with the diaphragm, plunger, spring, or screen.

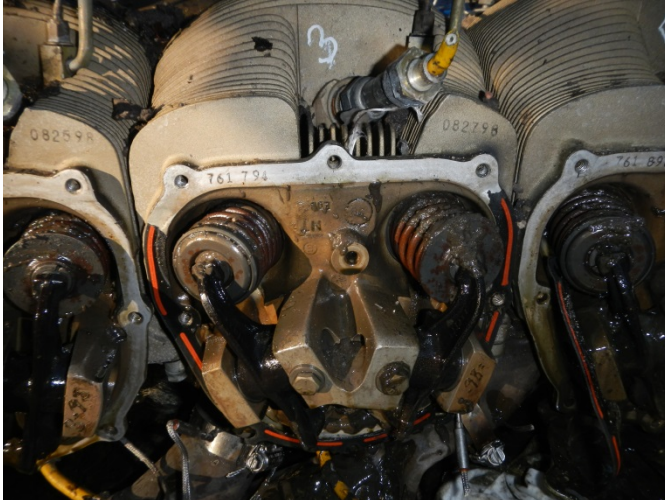
The cylinder remained attached to the engine and torque putty from the last overhaul was evident on the cylinder flange hardware. No pre-accident anomalies were noted externally. The top sparkplug was removed from the engine and the cylinder was inspected using a lighted borescope. Mud and water were observed in the cylinder. The crankshaft was rotated and the rockers, valves, and valve springs functioned properly and piston movement was observed. No pre-accident anomalies were noted with the cylinder components.

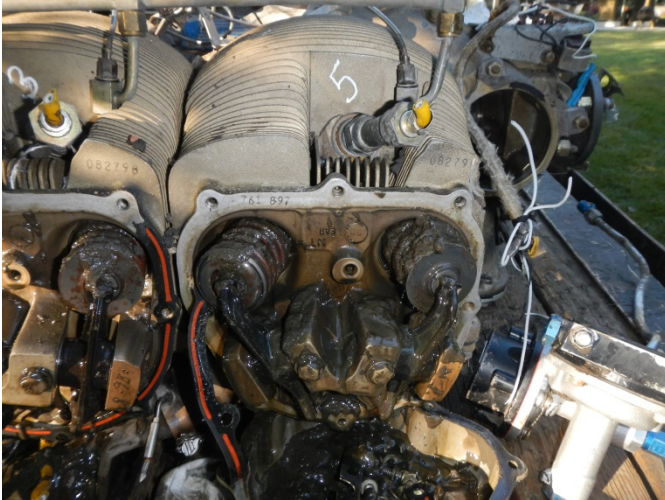
The cylinder remained attached to the engine and torque putty from the last overhaul was evident on the cylinder flange hardware. No pre-accident anomalies were noted externally. The top sparkplug was removed from the engine and the cylinder was inspected using a lighted borescope. Mud and water were observed in the cylinder. The crankshaft was rotated and the rockers, valves, and valve springs functioned properly and piston movement was observed. No pre-accident anomalies were noted with the cylinder components.

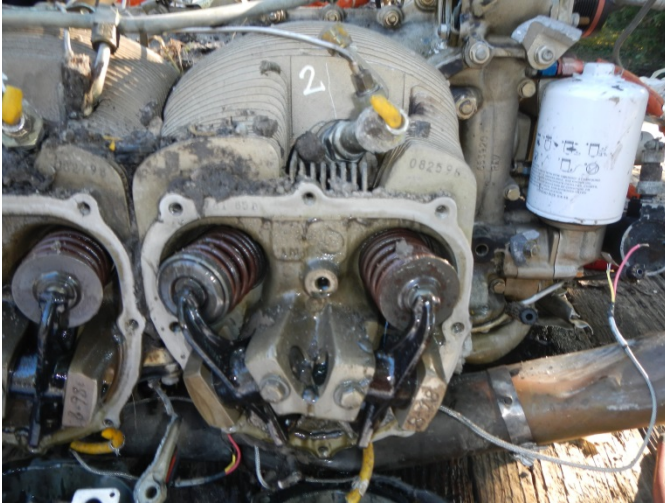
The cylinder remained attached to the engine and torque putty from the last overhaul was evident on the cylinder flange hardware. No pre-accident anomalies were noted externally. The top sparkplug was removed from the engine and the cylinder was inspected using a lighted borescope. Mud and water were observed in the cylinder. The crankshaft was rotated and the rockers, valves, and valve springs functioned properly and piston movement was observed. No pre-accident anomalies were noted with the cylinder components.

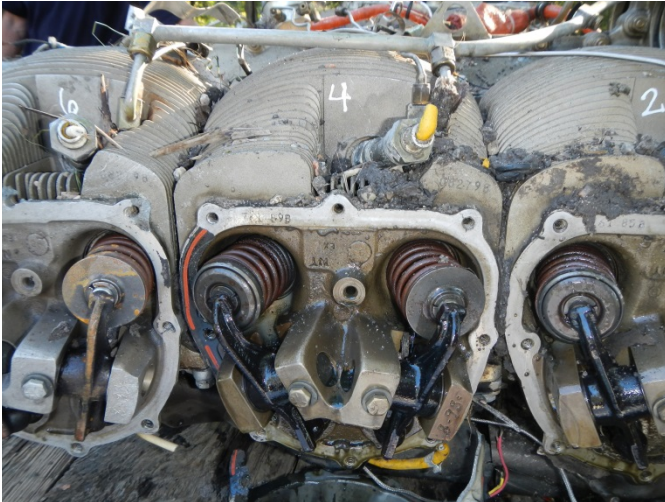
The cylinder remained attached to the engine and torque putty from the last overhaul was evident on the cylinder flange hardware. No pre-accident anomalies were noted externally. The top sparkplug was removed from the engine and the cylinder was inspected using a lighted borescope. Mud and water were observed in the cylinder. The crankshaft was rotated and the rockers, valves, and valve springs functioned properly and piston movement was observed. No pre-accident anomalies were noted with the cylinder components.

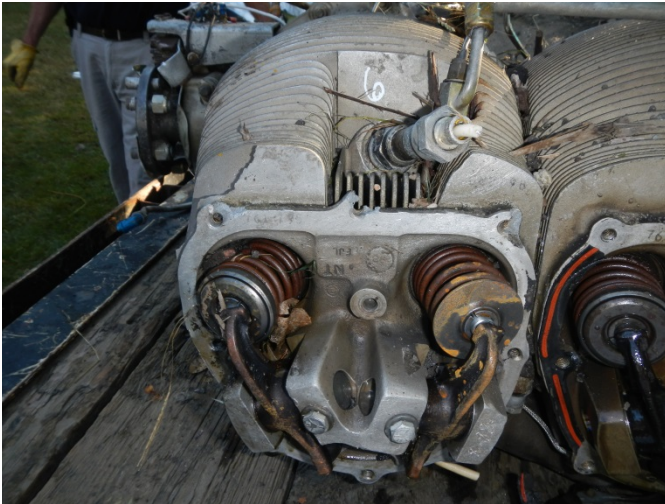
The rocker cover was fractured and the majority was missing. The cylinder remained attached to the engine and torque putty from the last overhaul was evident on the cylinder flange hardware. No pre-accident anomalies were noted externally. The top sparkplug was removed from the engine and the cylinder was inspected using a lighted borescope. Mud and water were observed in the cylinder. The crankshaft was rotated and the rockers, valves, and valve springs functioned properly and piston movement was observed. No pre-accident anomalies were noted with the cylinder components.

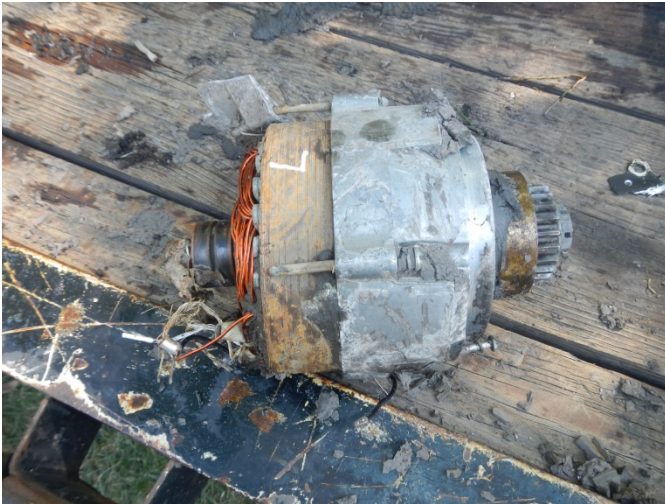
ALT/GEN #1	Manufacturer: Unknown	P/N: Unknown	S/N: Unknown
Condition:	The alternator was separated from the front right side of the engine. No pre-accident anomalies were noted with the alternator drive gear.

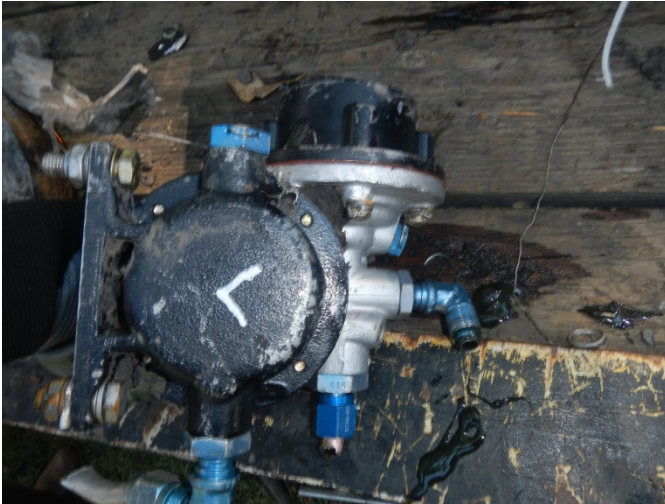
The controller was separated from the aircraft and engine. The controller was intact with no external signs of operational distress. Residual oil poured from the controller during the examination.
