ENGINE FIELD INSPECTION REPORT

ENGINE MODEL	TSIO-520-B11B
ENGINE SERIAL NUMBER	176759-R
AIRCRAFT MAKE & MODEL	Cessna T310Q
AIRCRAFT SERIAL NUMBER	T310Q-0611
AIRCRAFT REGISTRATION	N310JA
FILE NUMBER	15-199

EXAMINATION		ACCIDENT DATA	
DATE	09/27 and 28/2015	NTSB ACCIDENT #	CEN15FA425
FACILITY	Accident Site	NTSB INVESTIGATOR	Courtney Leidler
ADDRESS	410 S. Wetmore Wichita, KS 67209	FAA INVESTIGATOR	Bobby Warren
		ACCIDENT DATE	09/25/2015
		ACCIDENT LOCATION	Wichita, Kansas

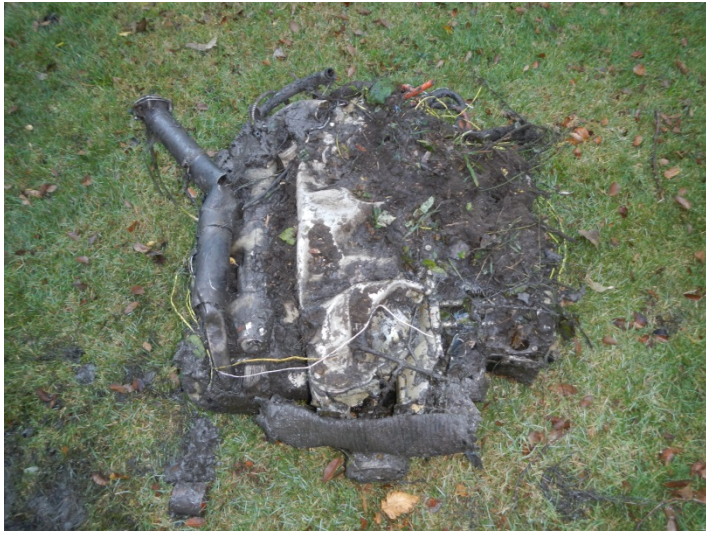
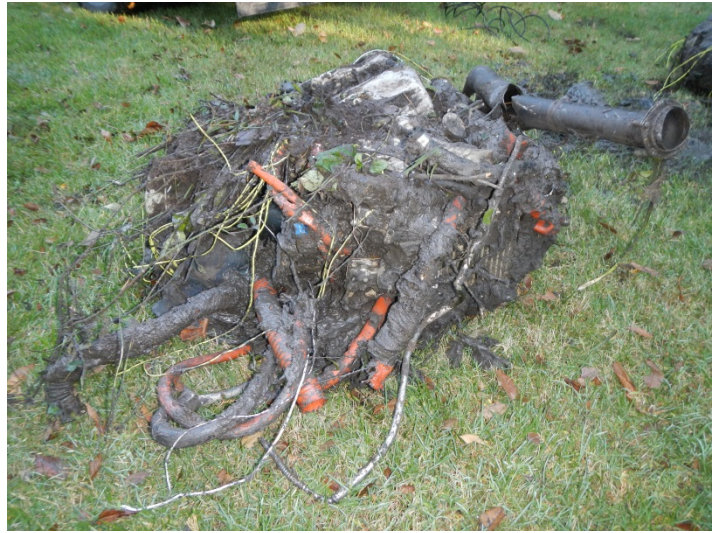
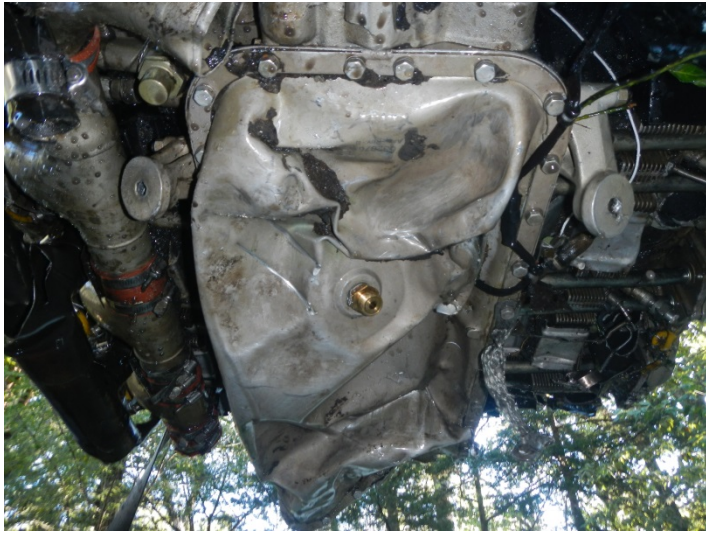
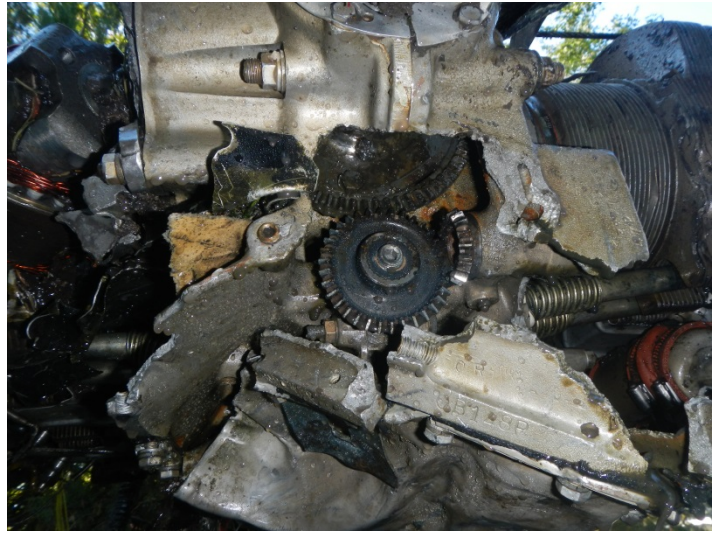
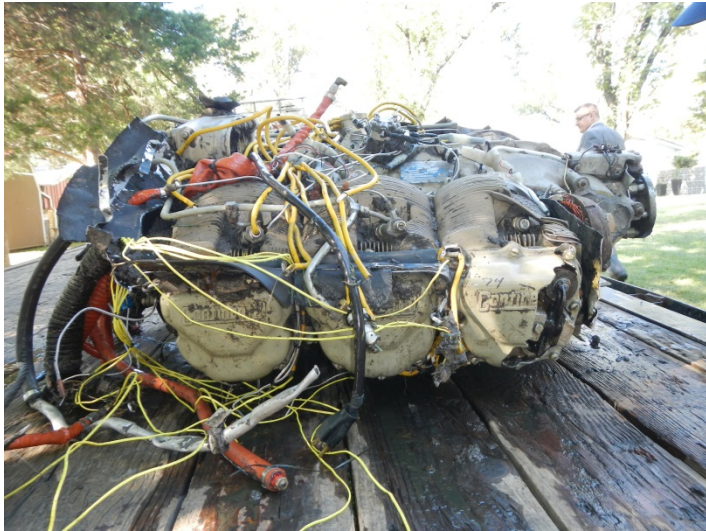
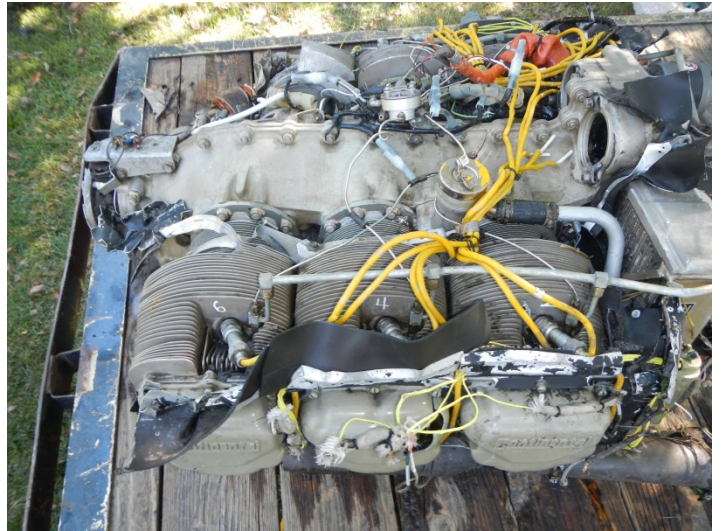
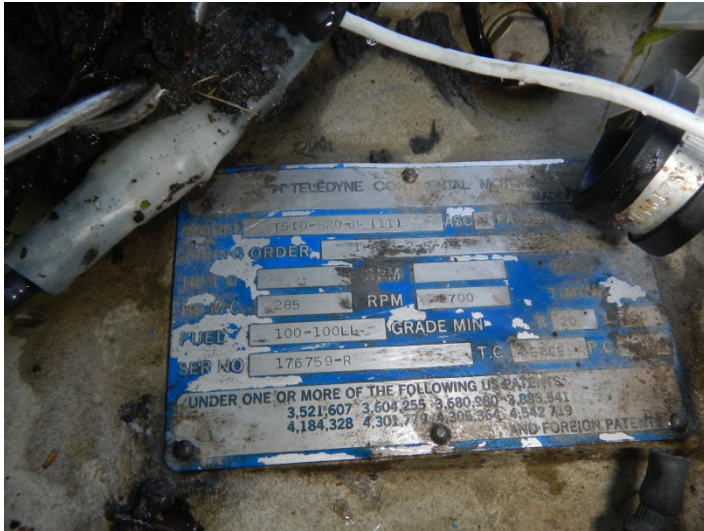
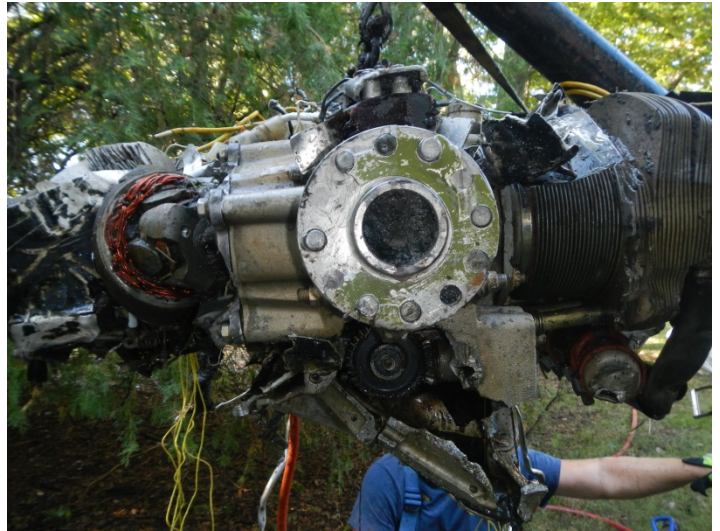
The engine was recovered from a pond in a residential area prior to this investigator's arrival. The engine was covered in mud and organic debris. The engine was cleaned using fresh water. The propeller was separated from the engine. The alternator remained attached to the front right side of the engine, but it was distorted and displaced aft into the #5 cylinder. The #5 cylinder sustained damage that separated the cooling fins on the top front side of the cylinder. The #5 and #4 rocker covers were fractured. The front crankcase sustained damage that fractured the case, permitting a view of the alternator face gear, the camshaft bevel gear, and the propeller governor drive gear. The propeller governor was separated from the engine. Both magnetos were separated from the engine and only one was recovered.

There were no external signs of pre-accident operational distress with any of the engine components or systems.

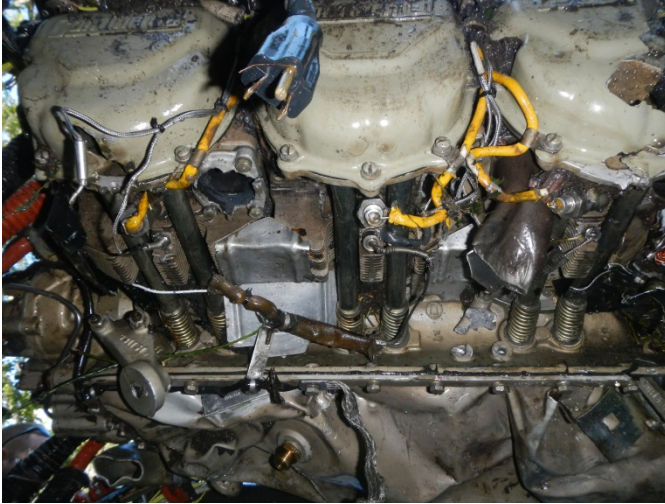
The left side intake risers and manifold remained in place and attached to the engine. The right side intake risers and manifold was separated and not observed. The throttle body was attached to turbocharger section of the engine nacelle.

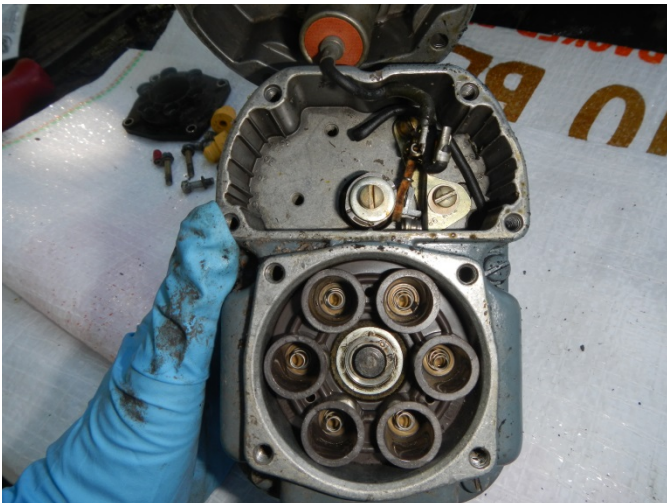
LEFT MAGNETO	Manufacturer: Unknown	P/N: Unknown	S/N: Unknown
Condition:	The magneto was separated from the engine and was not located during the examination.		
RIGHT MAGNETO	Manufacturer: CMI S6RSC-205	P/N: 10-600656-1	S/N: H299806ER
Condition:	The magneto was separated from the engine. The mounting flange of the right magneto was fractured in an area that coincided with the attach washers. The ignition harness cap was removed from the right magneto. The drive shaft was rotated with some binding noted. The magneto was disassembled and when the housing was removed the drive shaft rotated with some binding noted at the drive end. The distributor gear rotated freely. The points were intact and opened/closed with driveshaft rotation. No internal, pre-accident anomalies, besides water emersion and mud contamination, were observed with the magneto.

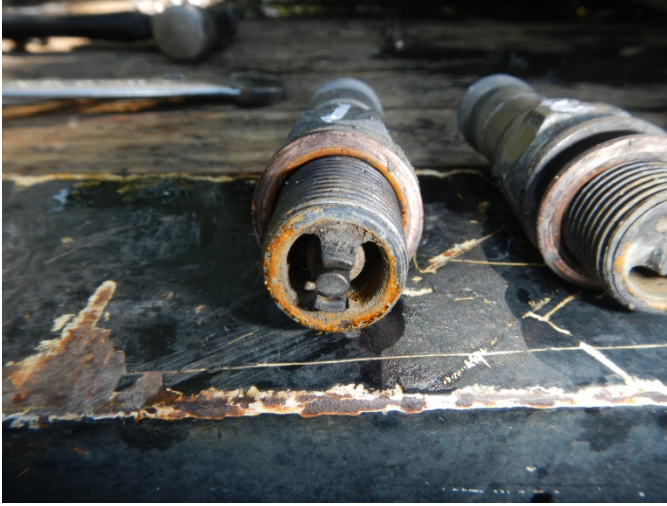
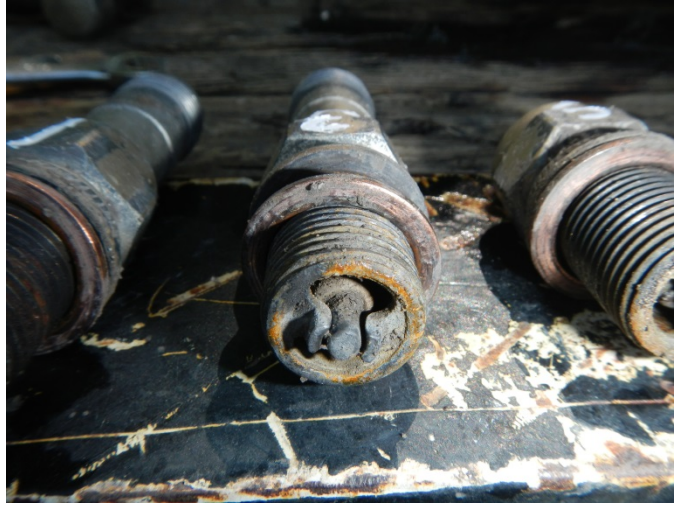
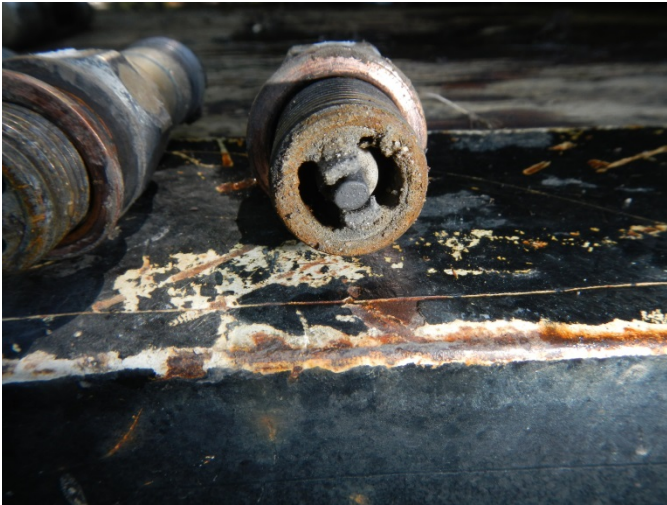
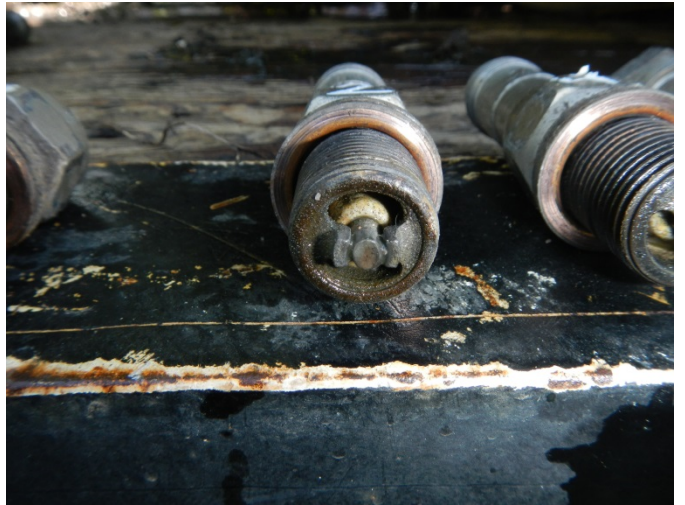
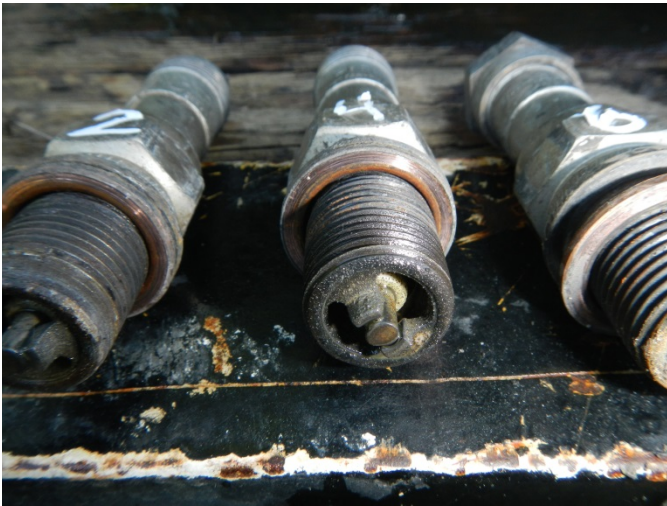
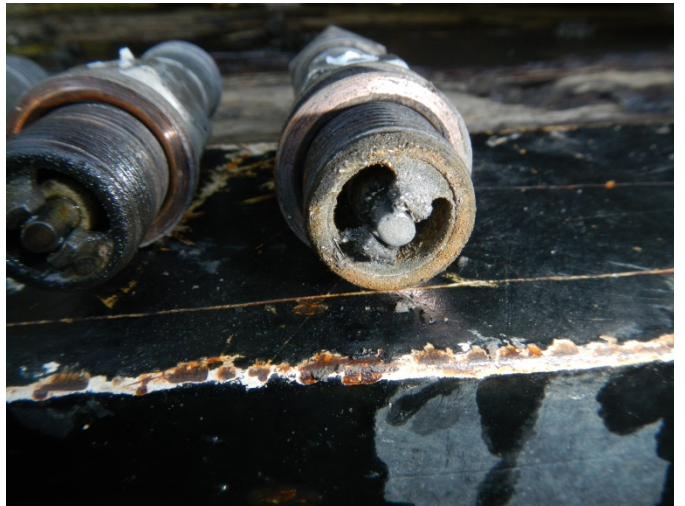
Condition: All of the sparkplugs remained secured to their respective cylinders. Removal of the top sparkplugs revealed that they were covered with mud, water, and oil. All electrodes displayed a normal worn condition when compared to the Champion Aviation Service Manual (AV6-R).

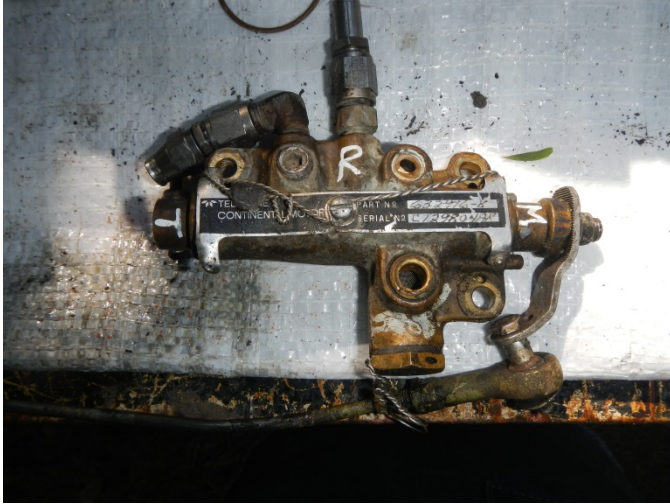
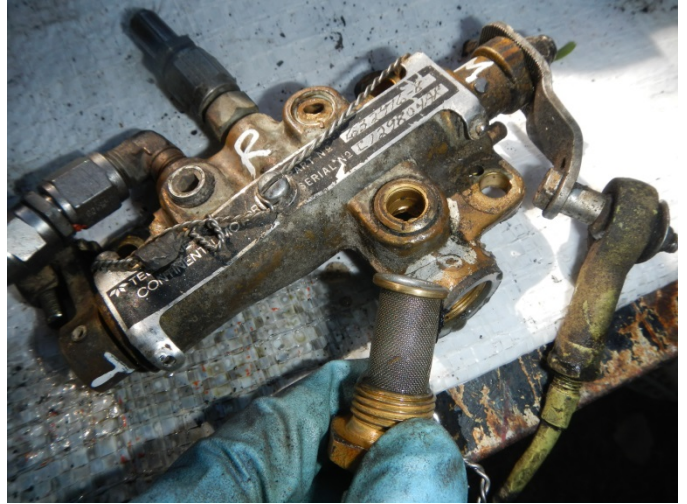
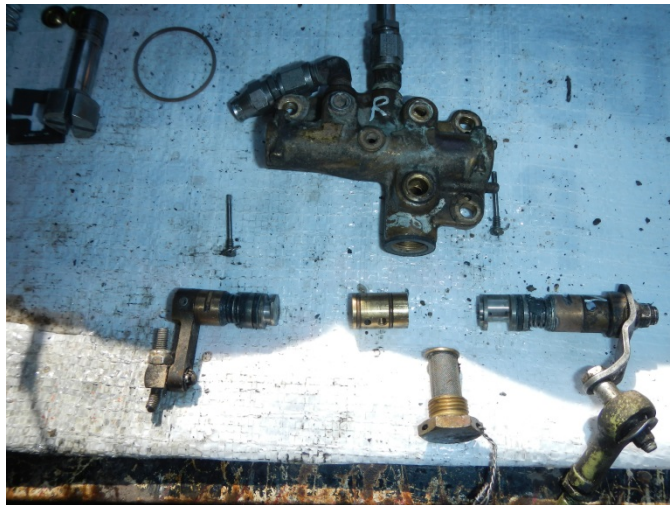
THROTTLE BODY METERING UNIT	Manufacturer: CMI	P/N: 632916-8	S/N: C129804AR
Condition:	<p>The throttle body/fuel metering unit remained attached to the engine nacelle. The throttle and mixture cables remained attached to the throttle body and metering unit levers, which remained attached to their respective shafts. The linkage between the throttle valve shaft and the metering unit's throttle cam shaft was fractured and bending deformation was noted at the fracture. Rotation of the levers resulted in a coinciding rotation of the shafts with no binding noted. The metering unit fuel inlet filter was removed and no obstructions or blockage was noted, but mud and dirty water was observed. The metering unit was disassembled and besides water and dirt contamination, no pre-accident anomalies were noted with the internal components.</p>

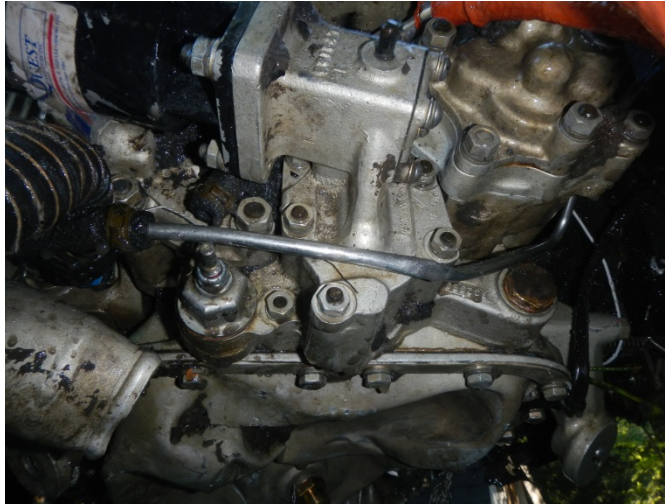
The oil pump remained attached to the backside of the engine. No external pre-accident anomalies were noted. The oil pump was not disassembled, but all of the visible components of the engine appeared to be well lubricated with no signs of thermal distress noted.

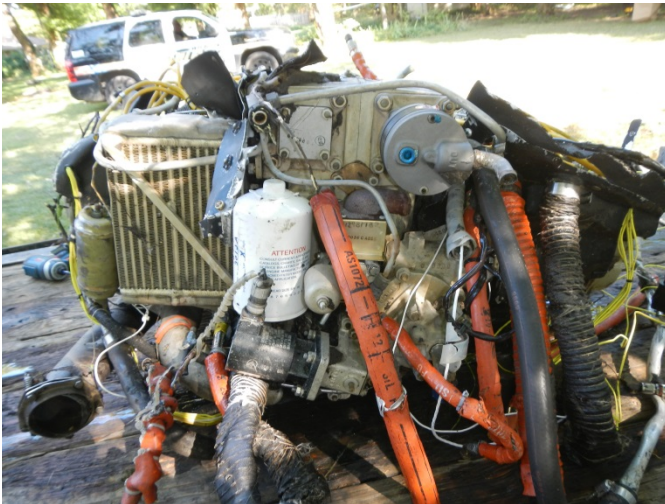
The oil filter remained secured with safety-wire to the engine. There were no signs of pre-accident anomalies with the oil filter. The date of 4/29/15 was written on the oil filter with a tachometer time listed as 187.7. The filter indicated that it was utilized on the right engine.

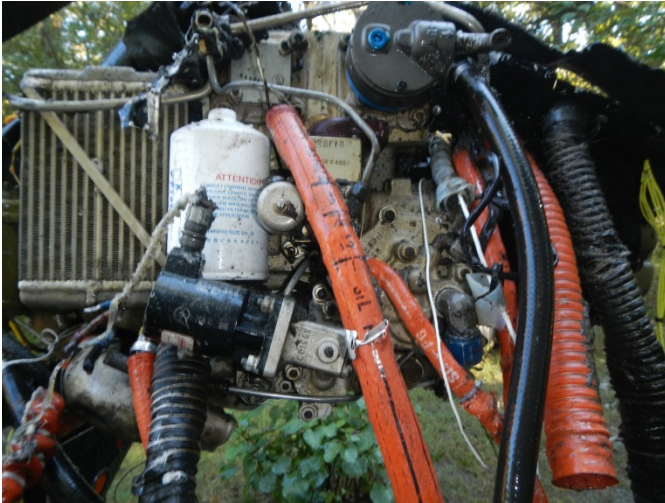
The oil cooler remained attached to the engine and no pre-accident anomalies were noted.

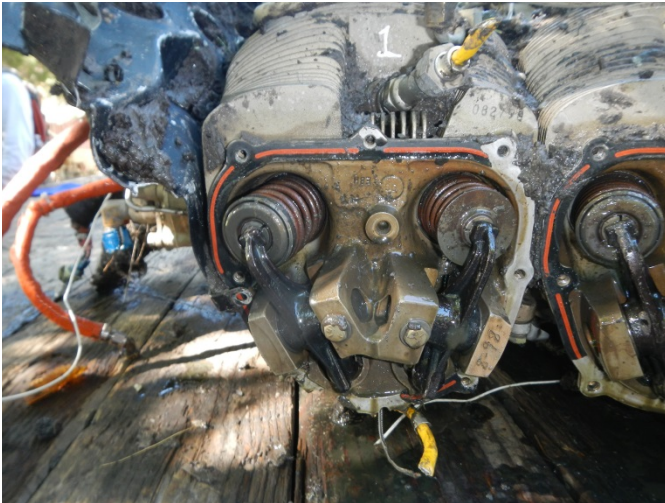
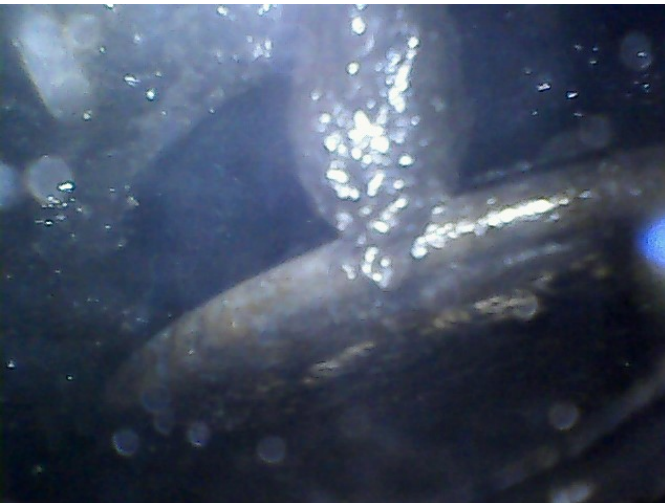
CYLINDER #1	P/N: 658552A1	S/N: Unknown	Head Date: 8-98
Condition:	The cylinder remained attached to the engine and torque putty from the last overhaul was evident on the cylinder flange hardware. No pre-accident anomalies were noted externally. The top sparkplug was removed from the engine and the cylinder was inspected using a lighted borescope. Mud and water were observed in the cylinder. The crankshaft was rotated and the rockers, valves, and valve springs functioned properly and piston movement was observed. No pre-accident anomalies were noted with the cylinder components.

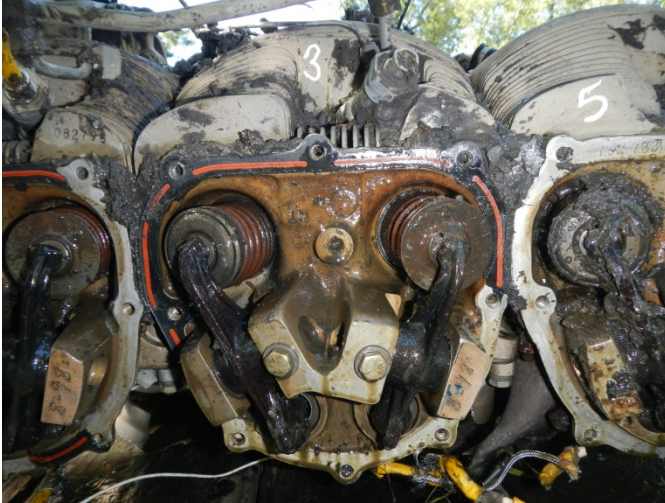
The cylinder remained attached to the engine and torque putty from the last overhaul was evident on the cylinder flange hardware. No pre-accident anomalies were noted externally. The top sparkplug was removed from the engine and the cylinder was inspected using a lighted borescope. Mud and water were observed in the cylinder. The crankshaft was rotated and the rockers, valves, and valve springs functioned properly and piston movement was observed. No pre-accident anomalies were noted with the cylinder components.

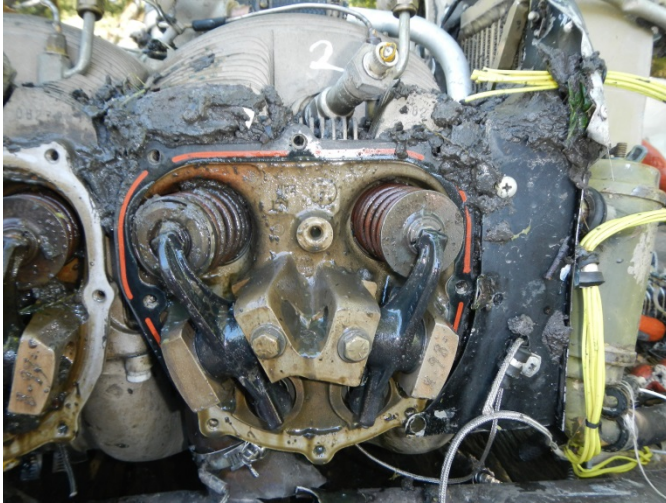
The cylinder remained attached to the engine and torque putty from the last overhaul was evident on the cylinder flange hardware. No pre-accident anomalies were noted externally. The top sparkplug was removed from the engine and the cylinder was inspected using a lighted borescope. Mud and water were observed in the cylinder. The crankshaft was rotated and the rockers, valves, and valve springs functioned properly and piston movement was observed. No pre-accident anomalies were noted with the cylinder components.

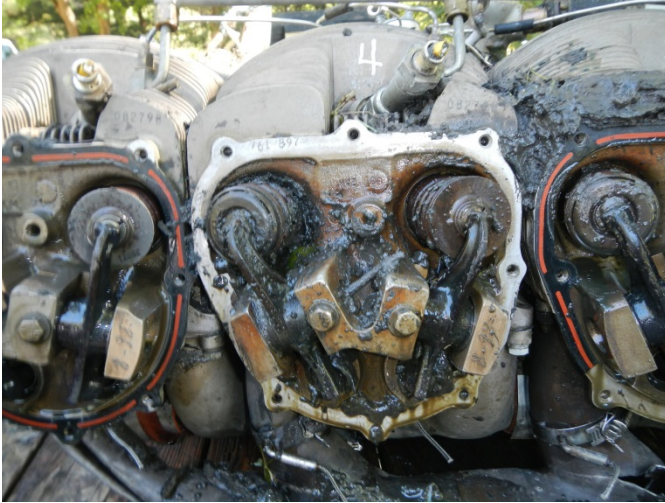
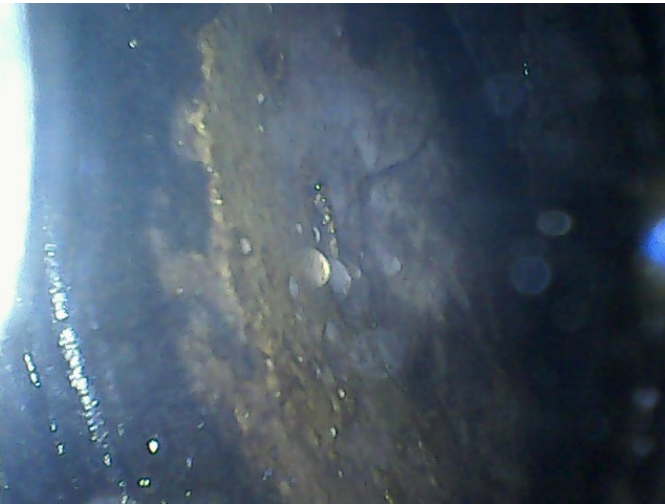
The cylinder remained attached to the engine and torque putty from the last overhaul was evident on the cylinder flange hardware. No pre-accident anomalies were noted externally. The top sparkplug was removed from the engine and the cylinder was inspected using a lighted borescope. Mud and water were observed in the cylinder. The crankshaft was rotated and the rockers, valves, and valve springs functioned properly and piston movement was observed. No pre-accident anomalies were noted with the cylinder components.

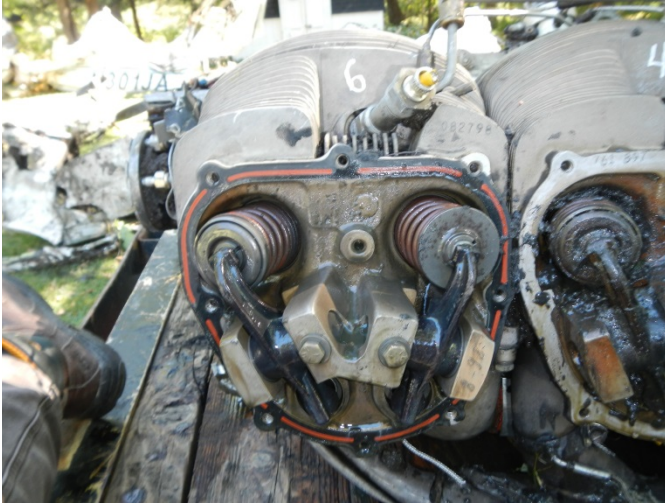
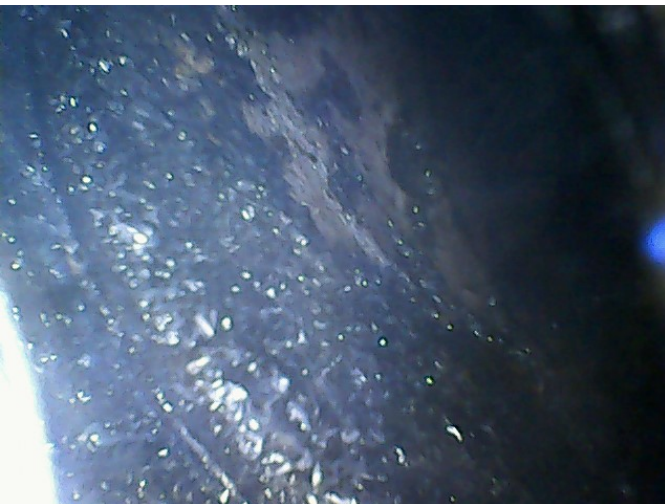
The cylinder remained attached to the engine and torque putty from the last overhaul was evident on the cylinder flange hardware. No pre-accident anomalies were noted externally. The top sparkplug was removed from the engine and the cylinder was inspected using a lighted borescope. Mud and water were observed in the cylinder. The crankshaft was rotated and the rockers, valves, and valve springs functioned properly and piston movement was observed. No pre-accident anomalies were noted with the cylinder components.

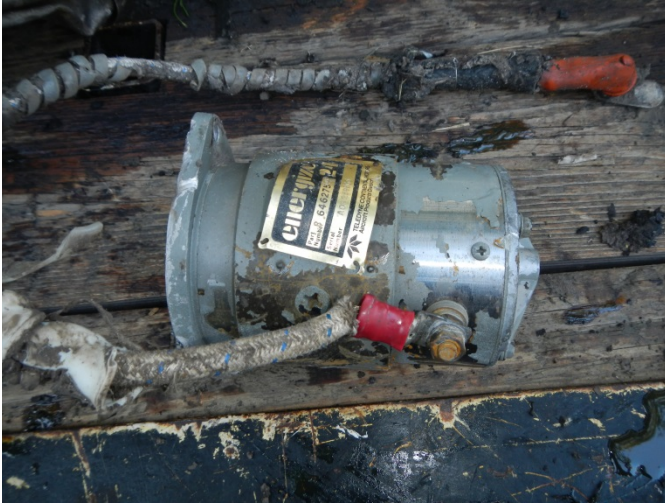
STARTER	Manufacturer: Unknown	P/N: Unknown	S/N: Unknown
Condition:	The starter motor was separated from its mounting pad. Only one starter motor (Energizer 24 PN: 646275 SN: A08269806) was recovered from the pond. No pre-accident anomalies were noted with the recovered motor.

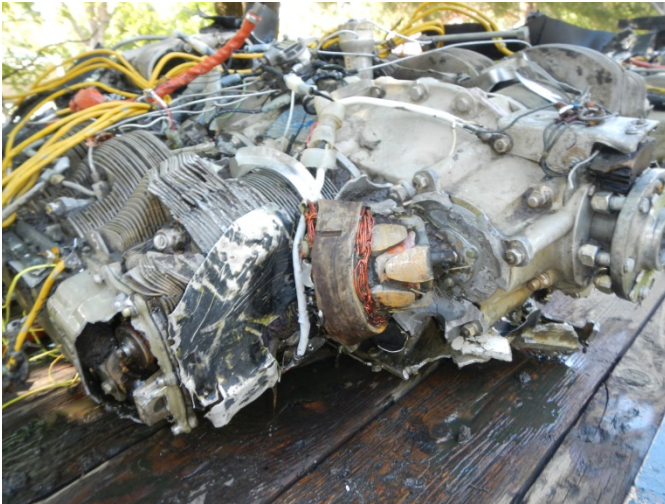
ALT/GEN #1	Manufacturer: Unknown	P/N: Unknown	S/N: Unknown
Condition:	The alternator remained attached to the engine, but its housing was destroyed and the remaining portions were displaced aft into the #5 cylinder barrel.

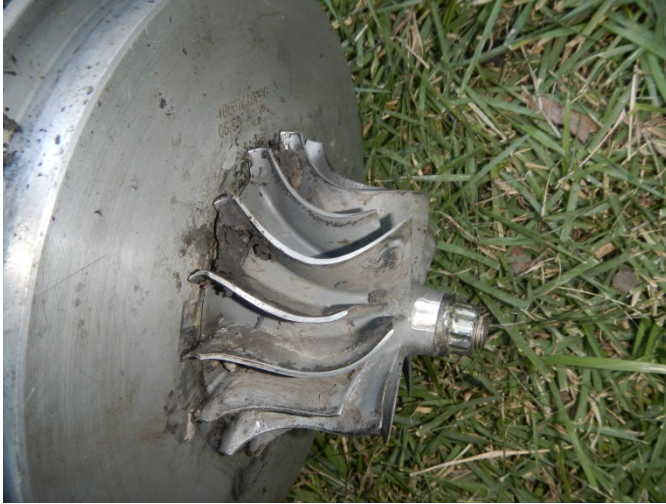
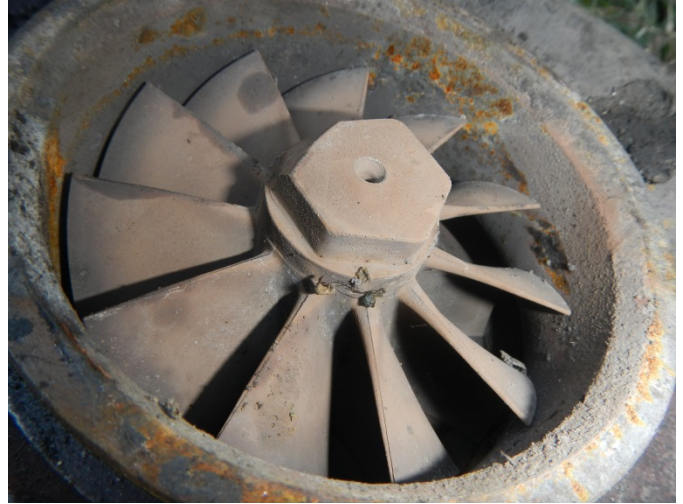
The turbocharger, wastegate, overboost valve and controller remained with the engine nacelle. Dirt and mud were observed in both the impeller and turbine sections of the turbocharger. Removal of the turbocharger impeller shroud revealed that the impeller was intact and the shaft to the turbine was intact; however, the turbine was binding on the turbine shroud and would only permit partial rotation. A small area of rotational scoring was noted on the impeller shroud.

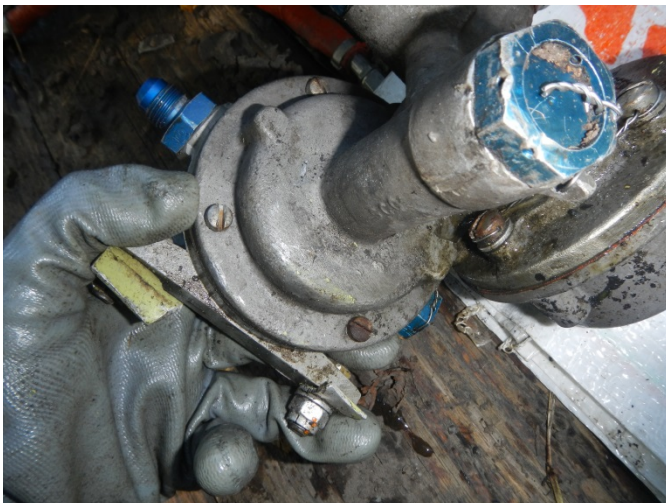
The controller remained with the turbocharger components in the engine nacelle piece. The controller was intact with no external signs of operational distress. Residual oil poured from the controller during the examination.

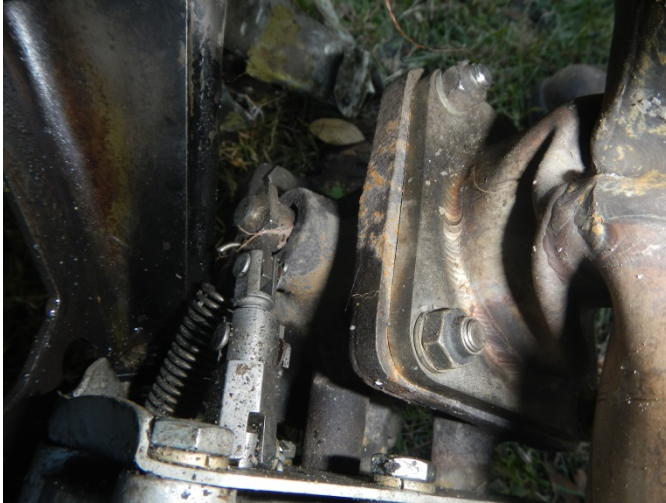
Condition: The wastegate actuator remained attached to the wastegate linkage and no pre-accident anomalies or disconnects were noted.
