Continental Motors, Inc. Fuel System Component Test and Analysis Report

Date Received:		06/05/2013 and 07/09/2013		Analytical Date:		07/16/2013	
Warranty Claim #:		N/A		RGA #:		N/A	
Engine Model:		IO-550-B39		Engine Serial #:		684677	
Component P/N:		Metering Unit 649468-2		Component S/N:		A00HA381	
Component P/N:		Fuel Pump 646212-18		Component S/N:		B00HA286	
Component P/N:		Fuel Nozzles		Component S/N:		N/A	
Component P/N:		Fuel Flow Transducer		Component S/N:		Unknown	
Engine:	Component:	<input checked="" type="checkbox"/> New:	<input type="checkbox"/> Rebuilt:	<input type="checkbox"/> Overhaul:	Date:	Unknown	
Aircraft Make/Model:		Raytheon Aircraft Co. A36		Aircraft S/N:		E3380	Reg. #: N999PK
Engine Position:		Single:	<input checked="" type="checkbox"/> Left:	<input type="checkbox"/> Right:	Front:	<input type="checkbox"/> Rear:	
Engine Build Date:		11/22/2000		Date in Service:		03/06/2001	
Date of Occurrence:		05/28/2013		Engine/Component Hours:		Approx. 960 hours

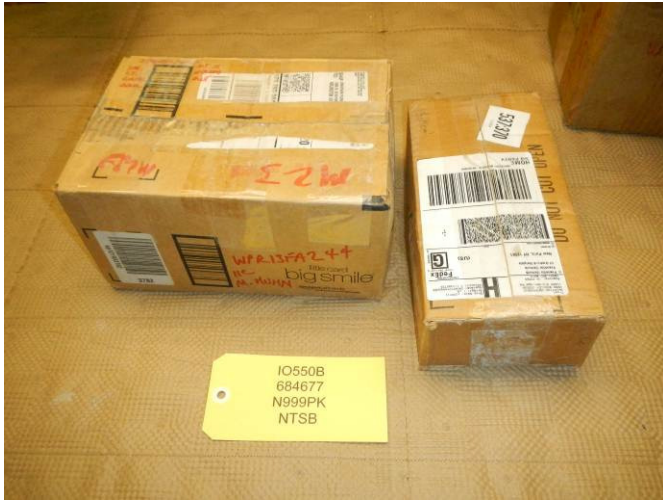
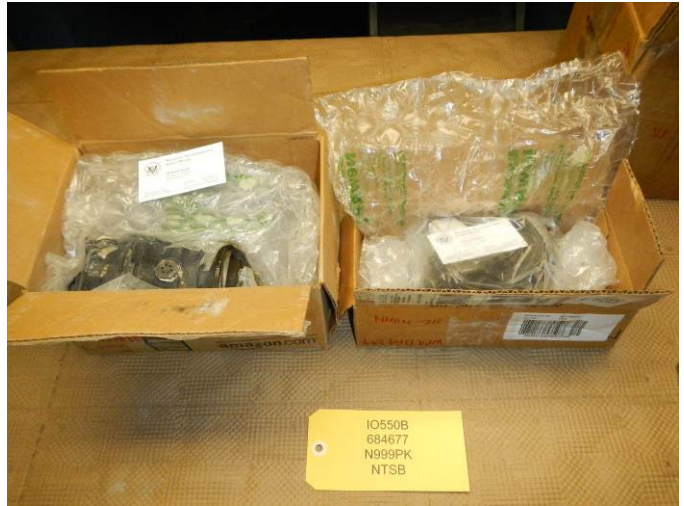
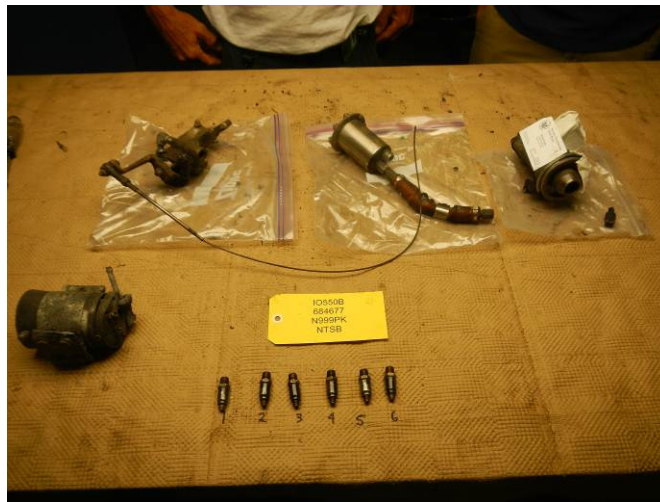
Fuel Pump

The fuel pump remained intact with its safety-wire in place, though the lead seal was thermally damaged. White tape was placed over the inlet and vapor return ports. Disassembly of the pump revealed that all of the pump's internal components were intact and in place, though many of the components sustained thermal damage. Significant amounts of brown, gummy material were found to be obstructing the vapor return ejector and coating the pump's swirl chamber. The NTSB Materials Laboratory will evaluate the material.
