Continental Motors, Inc. Ignition System Analytical Report

Date Received:	06/05/2013	Analytical Date:	07/16/2013		
Warranty Claim #:	N/A	RGA #:	N/A		
Engine Model:	IO-550-B39	Engine Serial #:	684677		
Aircraft Make/Model:	Raytheon Aircraft Co. A36	Aircraft S/N:	E3380	Reg. #:	N999PK
Engine Position:	Single: <input checked="" type="checkbox"/> Left: <input type="checkbox"/> Right: <input type="checkbox"/>	Front:	<input type="checkbox"/>	Rear:	<input type="checkbox"/>
Engine Build Date:	11/22/2000	Date in Service:	03/06/2001	Date Removed:	N/A
Date of Occurrence:	05/28/2013	Magneto Hours:	Approx. 960 hours		
Components Returned:	Left and Right Magneto and Sparkplugs				
Returned By:	Mike Huhn – NTSB investigator-in-charge (IIC)				
Magneto Model/P/N:	Left: Slick 6310	Magneto S/N:	00091583		
Magneto Model/P/N:	Right: Slick 6310	Magneto S/N:	00091606		
Ignition Harnesses:	N/A (destroyed)				
Sparkplug Type:	Champion RHB32S				
Party to the Inspection:	Phillip Grice – CMI

Party to the Inspection:	Nicole Charnon – CMI				
Party to the Inspection:	Mike Huhn – NTSB				
Party to the Inspection:	Kris Wetherell – Beechcraft				
Reason for Return:	NTSB Accident Investigation – WPR13FA244				
I

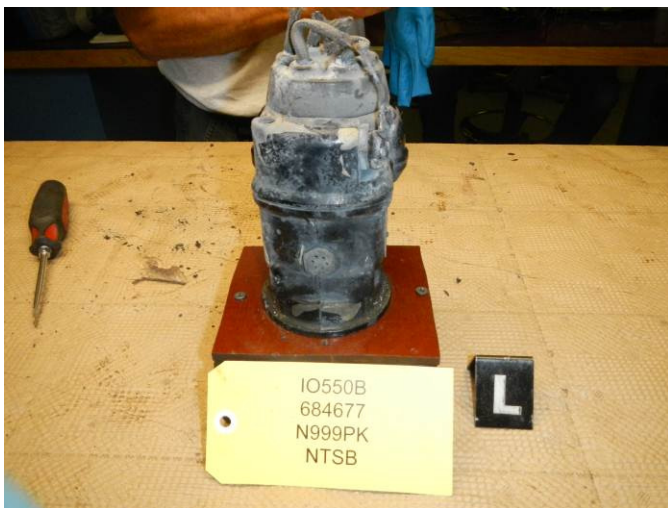
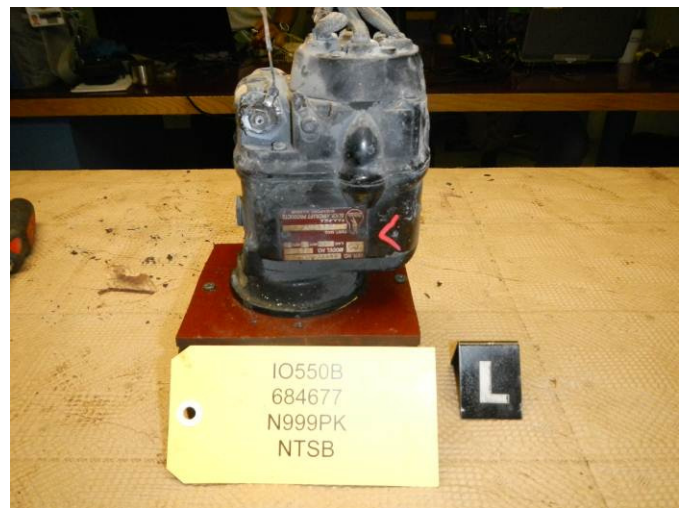
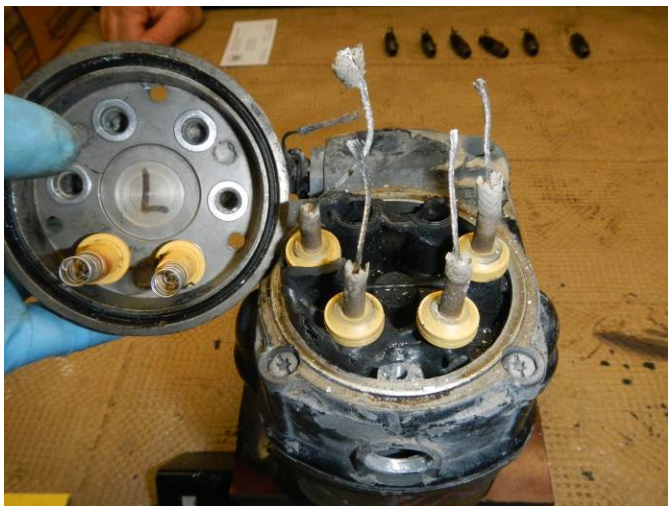
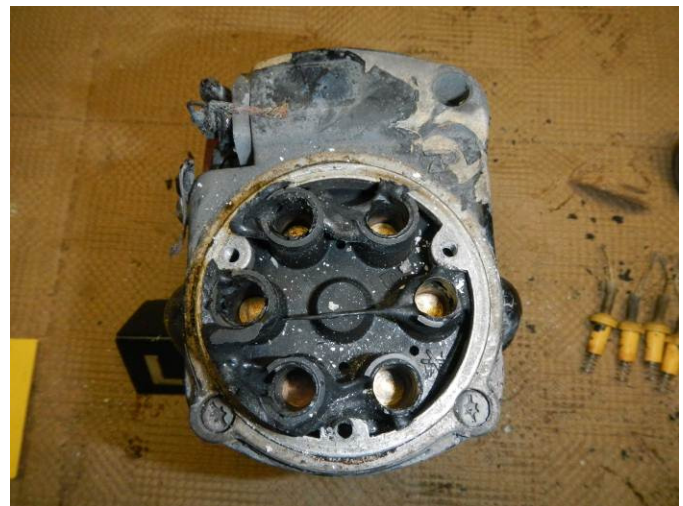
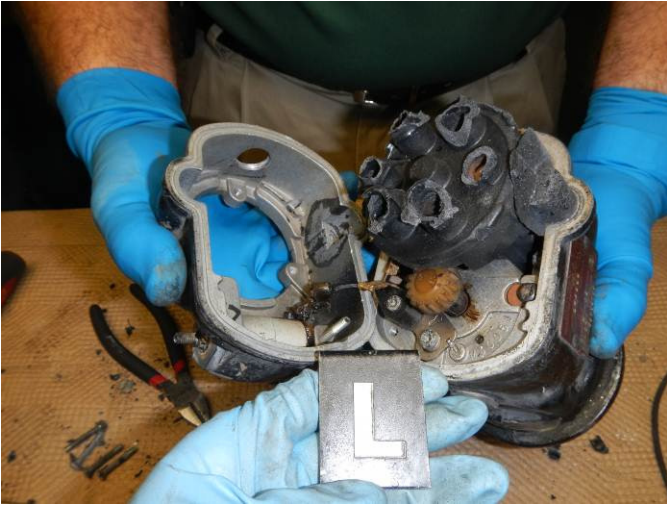
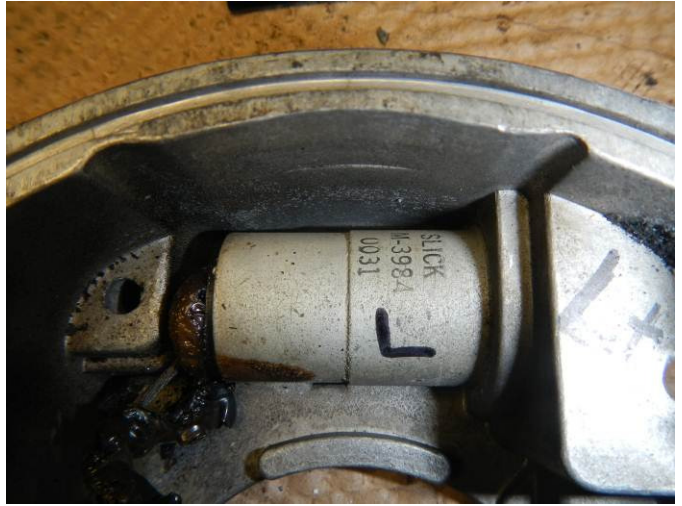
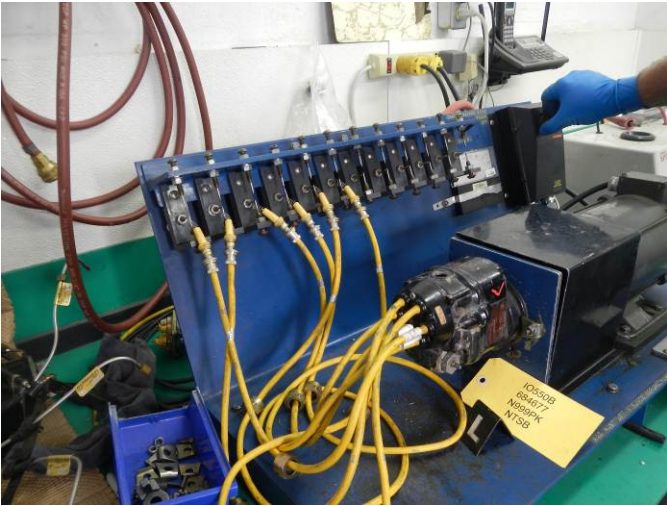
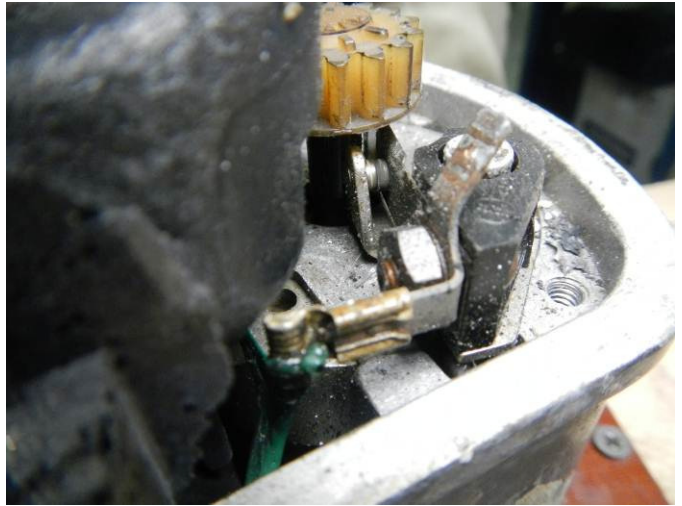
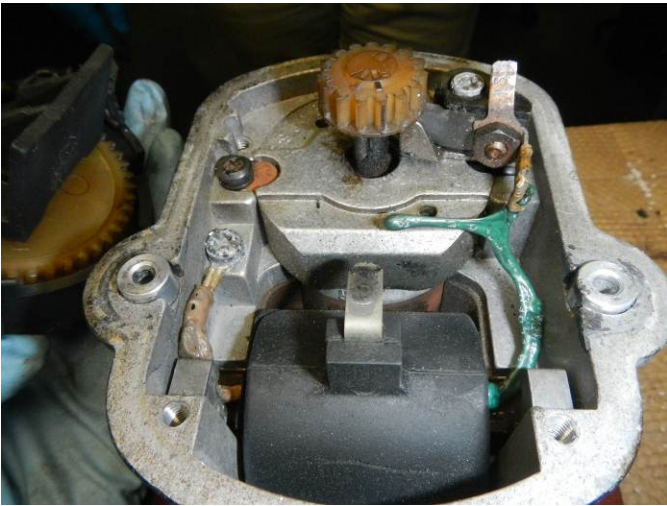
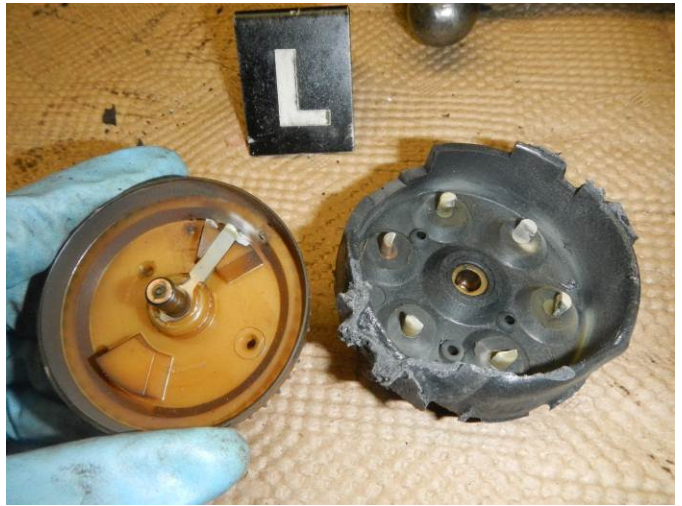
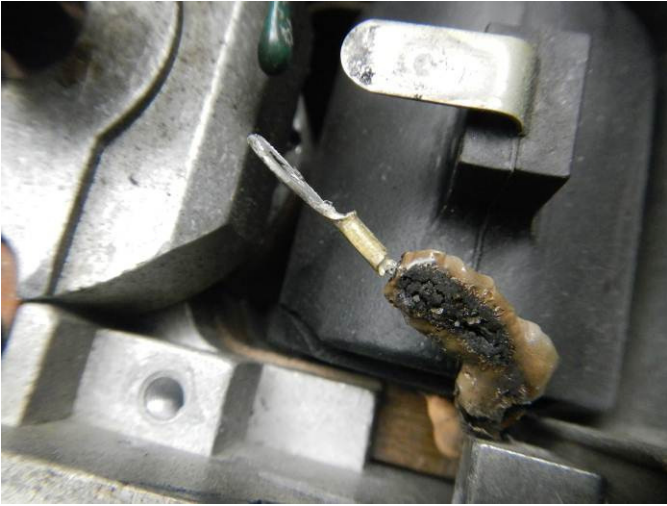
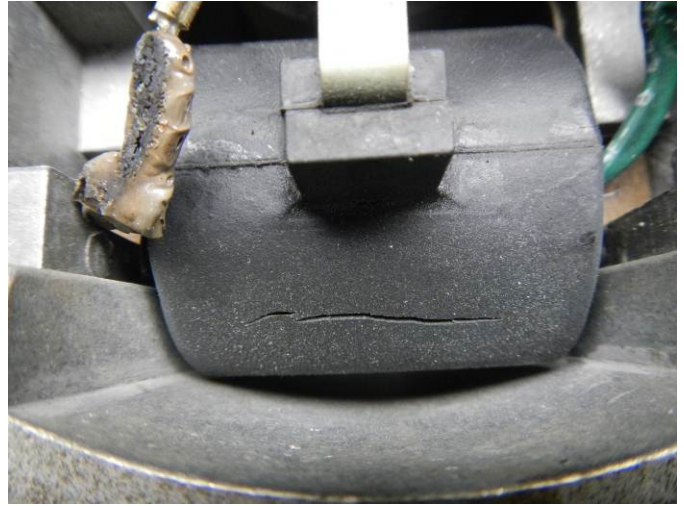
Left Magneto

Analytical Report: The magnetos were removed from the shipping package and were photographed. Both magnetos sustained thermal damage. The ignition harnesses sustained significant thermal damage and the ignition leads were cut. Manual rotation of the magneto drive shafts revealed they would turn freely with impulse coupling engagement. Placement of the magnetos on the test bench with a substitute ignition harness revealed that neither magneto would produce a spark across a 7 mm gap. The magnetos were partially disassembled and the capacitor for each magneto was found to be thermally damaged. A replacement capacitor was placed in each magneto and the magnetos were returned to the test bench. With the replacement capacitor, the right magneto produced a blue spark across a 7mm gap. The left magneto was only capable of producing a blue spark across a 7 mm gap irregularly and intermittently. The magnetos were again partially disassembled and examined. Both of the magnetos sustained thermal damage to the distributor block, capacitor, internal wires, and the coil, with the left magneto sustaining more thermal damage than the right. It is likely that the thermal damage to the left magneto's internal components provided an internal electrical short, which only permitted irregular and intermittent current to the distributor block. With the exception of the thermal damage sustained by both magnetos, no other anomalies were noted. Testing of the Champion RHB32S fine-wire sparkplugs in a SPCT-100 Spark Plug Cleaner Tester revealed that all of the sparkplugs were capable of producing a spark, with the exception of the #6 top spark plug. The #6 top spark plug had a fractured ceramic insulator in the barrel.
