Lakehead Pipe Line Company, Inc.

In-line inspection detects early cracking on Canadian crude-oil line

FAILURE SITE MP 1009.90 MARCH 4, 1991 - GRAND RAPIDS, MINNESOTA.

LINE 3 - 34-inch, 0.281-inch wall, API 5LX-52, U.S. STEEL
MARCH 3, 1991, FAILURE GRAND RAPIDS, MINNESOTA.

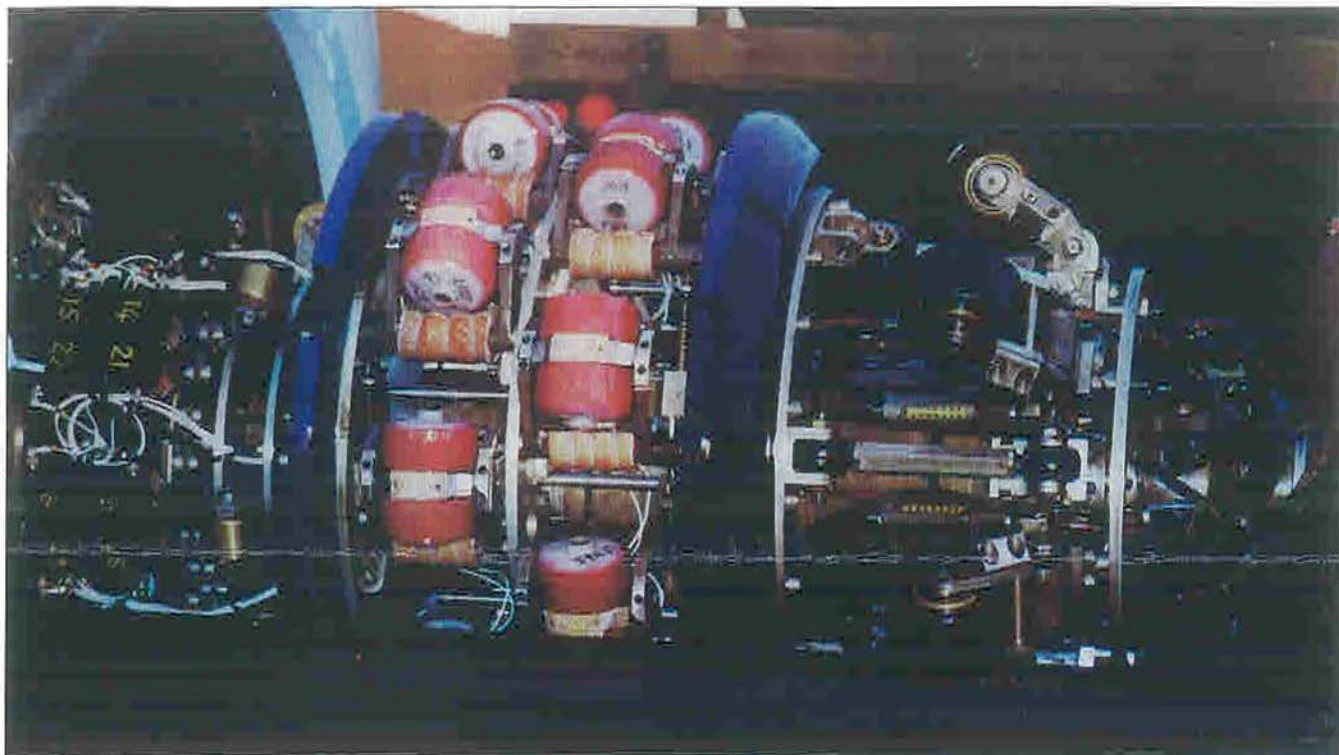
BG Technology developed the EW crack-detection vehicle (Fig. 2), which is owned and operated by Pipeline Integrity International Ltd., Cramlington, U.K. BG Technology, a unit of BG plc, Reading, U.K., conducts research and development in all parts of the gas supply chain, from exploration to burner design.

The EW vehicle detects cracks by transmitting circumferential elastic shear waves at ultrasonic frequencies into the pipe wall. These are generated by transducers in liquid-filled wheels, coupled to the inside pipe surface through soft tires. Spring loading maintains good contact with the pipe wall, which allows the system to be used without slugs in gas pipelines as well as in liquids.

An elastic wave in-line inspection (ILI) tool has arrived at a pig-receipt station after a run to detect cracks along Inter-provincial Pipe Line's Line 3 (Fig. 2).

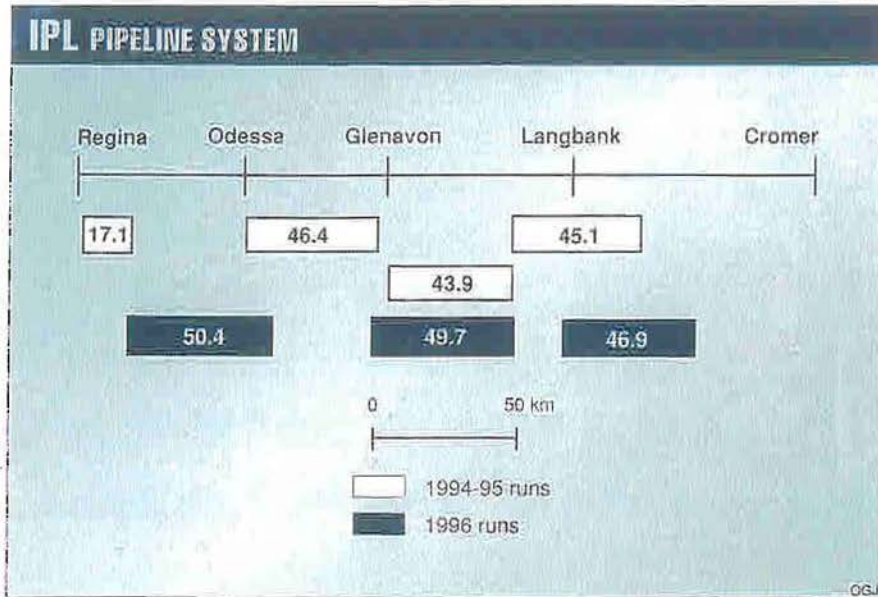
Fig. 4 shows a schematic of the 1994-95 inspections, together with the crack-detection runs made in 1996. In summary, the 1994-95 program had collected data from 153 km, including some short overlaps between runs.

Data from 176 km, when combined with previous years' inspections, give coverage of 213.5 km out of the 253 km between Regina and Cromer. Fig. 4 shows the coverage from the runs.

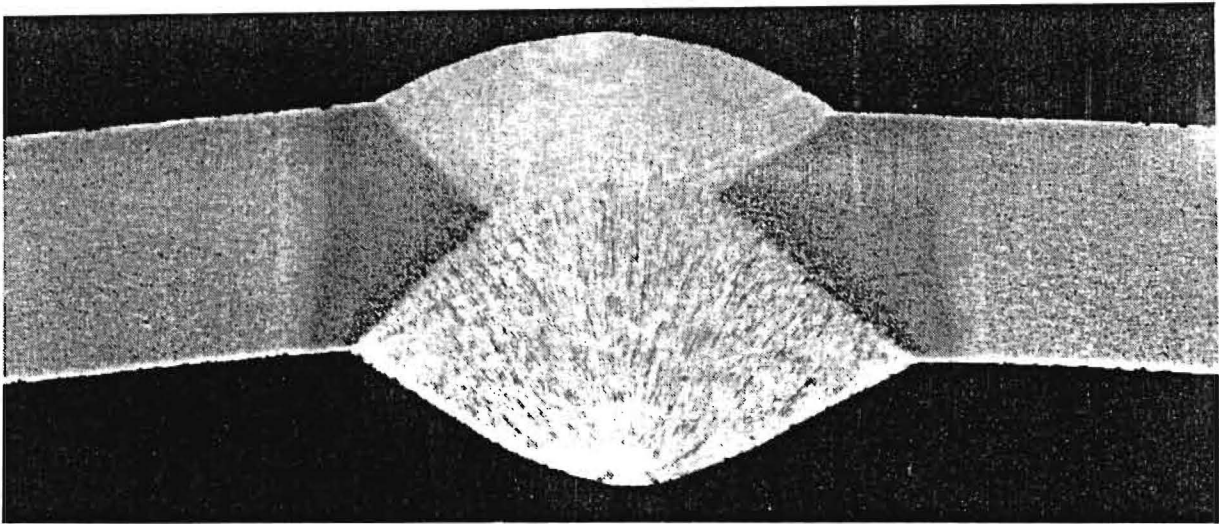
(a) Section indicating plate edge offset
