Enbridge Incorporated
Hazardous Liquid Pipeline Rupture and Release
Marshall, Michigan
July 25, 2010

NTSB/PAR-12/01
PB2012-916501
Notation 8423
Adopted July 10, 2012

Pipeline Accident Report

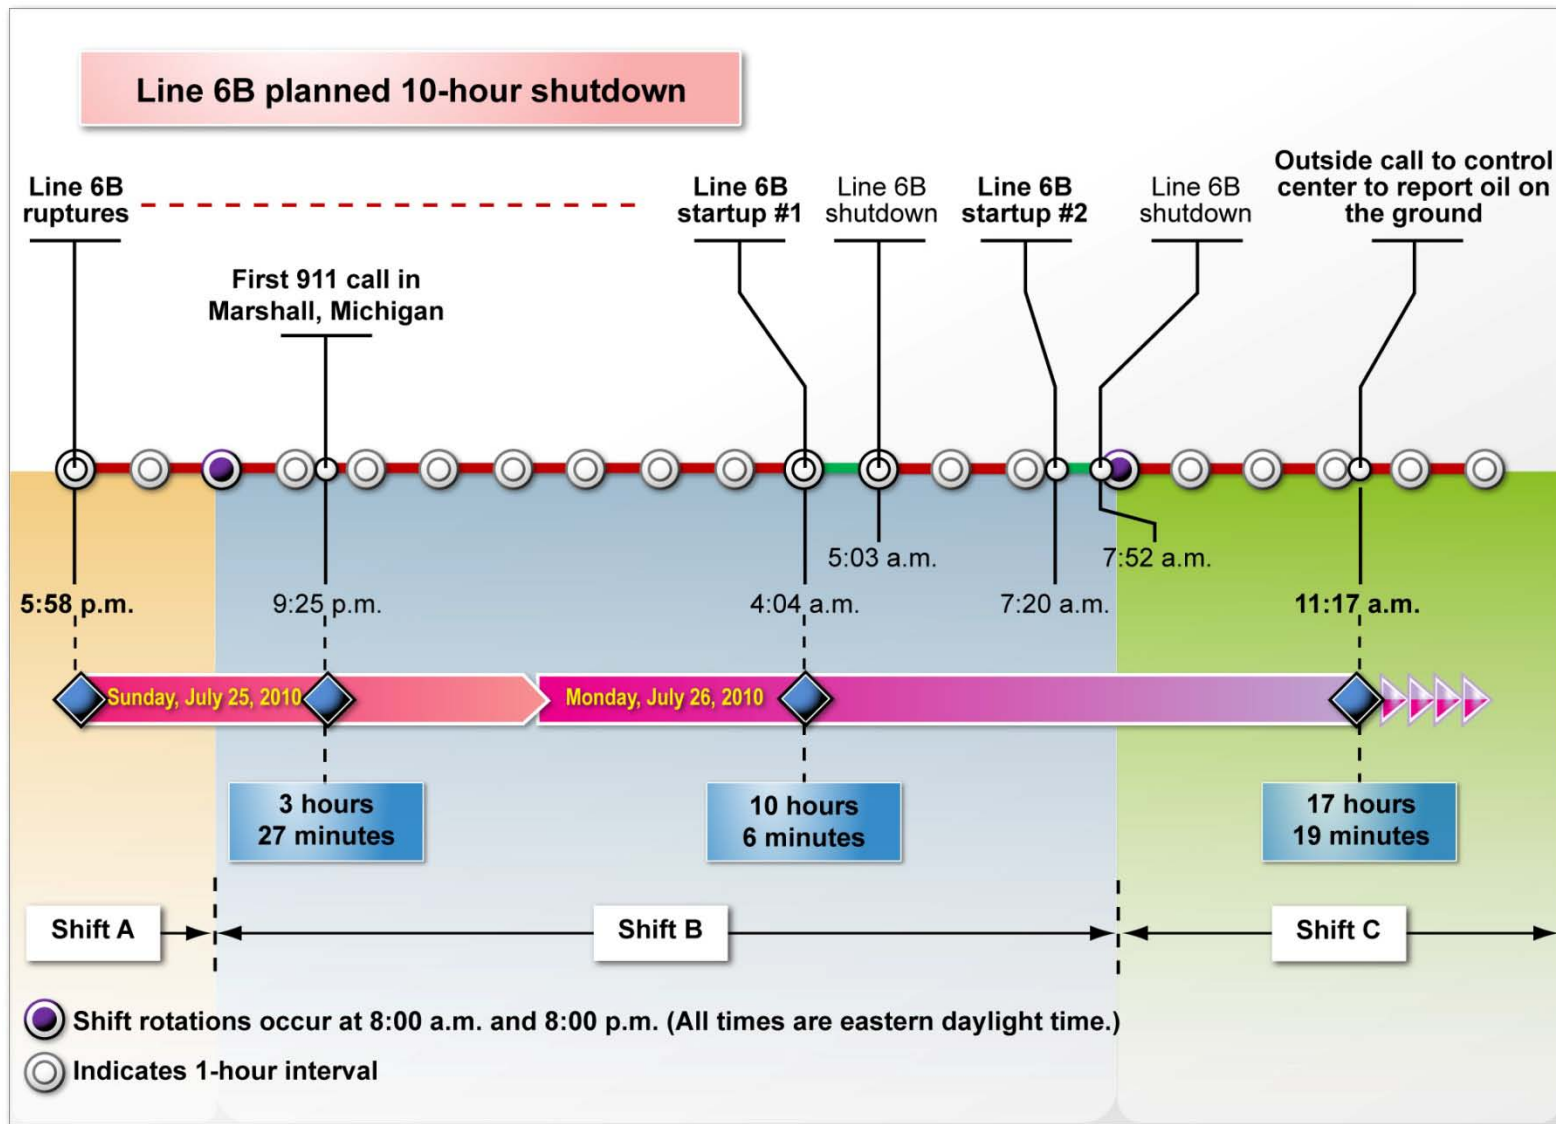
Figure 5 shows a timeline highlighting the accident events that spanned over 17 hours from the time of the rupture until the Enbridge control center was made aware of it. Figure 6 shows the key Enbridge staff involved.

Figure 5. Key events timeline of the Line 6B rupture in Marshall, Michigan, showing the events from the time of rupture on July 25, 2010, to the time of discovery on July 26, 2010.
