Exhibit 17.

Post-Recovery Technical Examination – SCRRRA Passenger Coach Equipment¹⁵⁴1. Notes of **California PUC** (typewritten, of the Party Representative)SCAX 617

3. Notes of **Bombardier** (handwritten - scanned, of the Party Representative)

UNIT #617 9/15/08
POST RECOVERY INSPECTION
Side View Cab Car

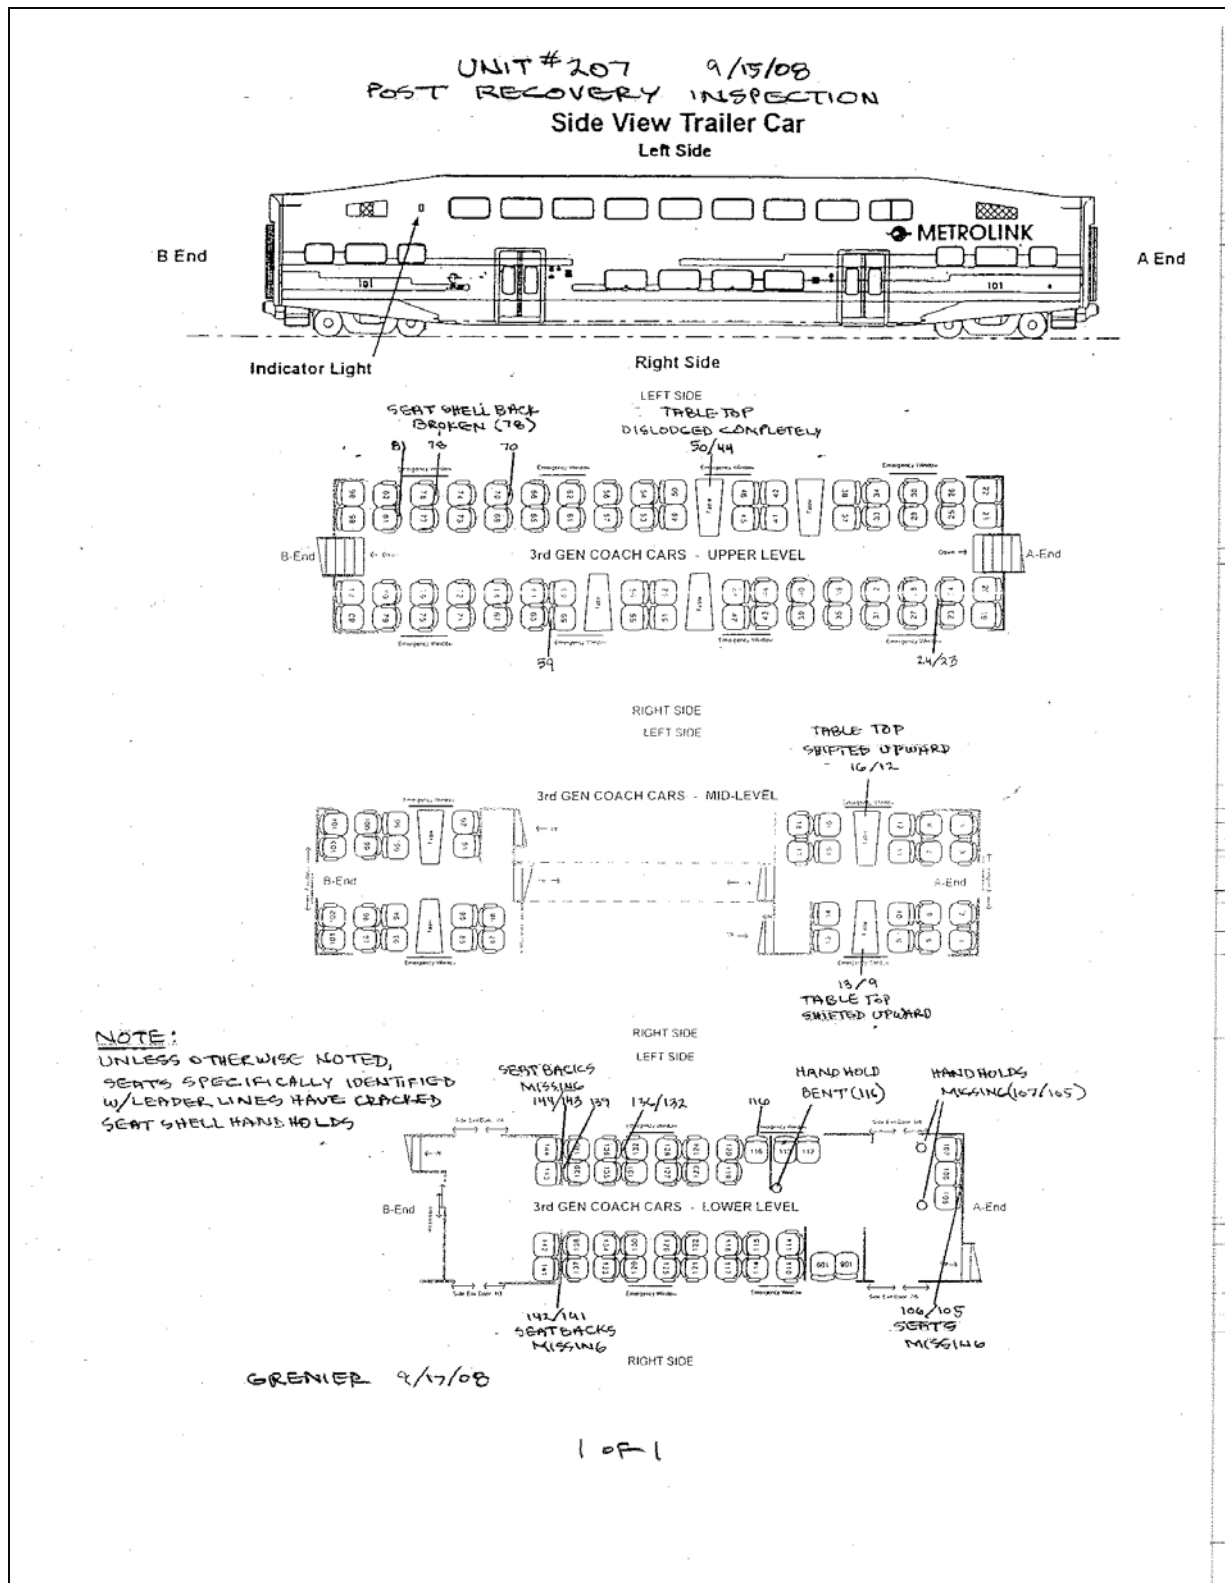
NOTE:
UNLESS OTHERWISE NOTED,
SEATS SPECIFICALLY IDENTIFIED
W/LEADER LINES HAVE
CRACKED SEAT SHELL
HANDHOLDS
