DEUTSCHE BABCOCK
WERKE
AKTIENGESELLSCHAFT

SS NORWAY

Repair to the Steam and Lateral Drum of Boiler 21 in the
 SS Norway from 7.11. - 21.11.1987

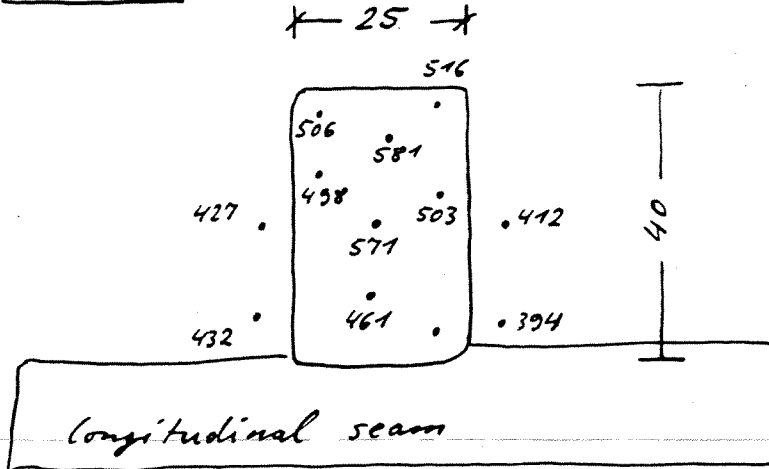
"Hole" 1:

<i>L₀ gem.</i>	<i>Correction</i>	<i>L₀ dist</i>	<i>HV</i>
394	6	388	133
412	5	407	148
427	5	422	159
432	5	427	164
449	5	444	178
461	5	456	189
498	5	493	223
503	5	498	228
506	5	501	231
516	5	511	241
571	4	567	301
581	4	577	312

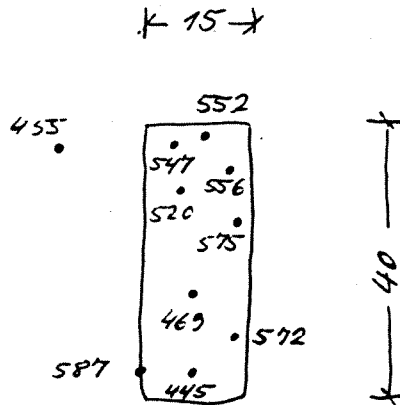
"Hole" 2:

Lateral drum boiler 21

Logem	Correction	Dist	HV
445	5	440	175
455	5	450	183
469	5	464	196
520	5	515	245
547	5	542	273
552	4	548	280
556	4	552	284
572	4	568	302
575	4	571	305
587	4	583	319

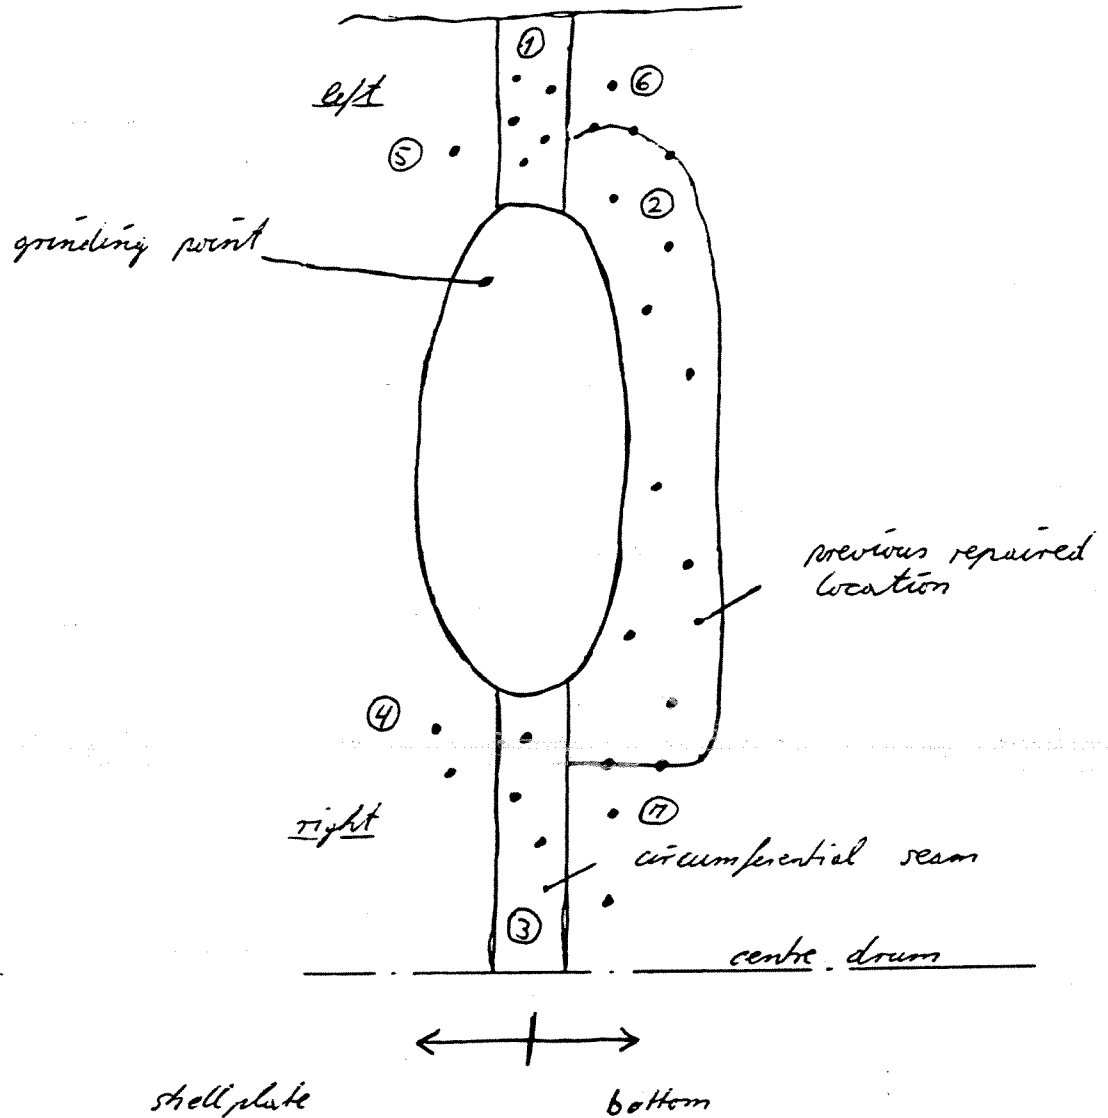
Defective position 1:

Position of the measuring points prior to welding

Hardness test of the defective location 1 prior to welding:

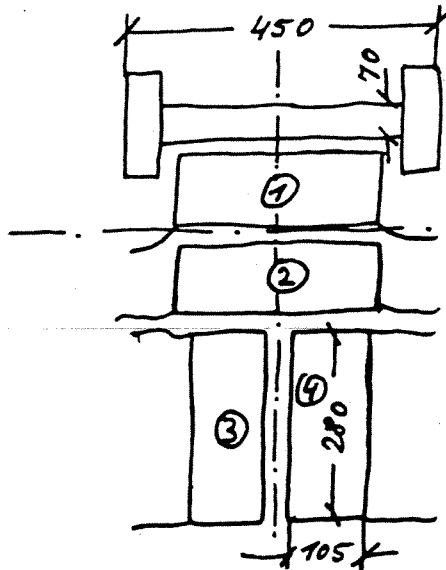
Position of the Pre-Heater Elements:

*○ No of the annealing pad
 Centre of the drum*

*Pads 1+2 and 3+4 arranged in series.
 Pads fixed and insulated on the drum from outside.
 The temperature was measured from inside.*

The point of application and a surrounding area of at least drum wall thickness is to be pre-heated to about 150°C. Resistive heating is employed for the pre-heating. Thermocouples measure the temperature from the inner side of the drum. For the filler material, the electrode SH Schwarz 3 MK is to be used and string beads are to be welded. On the required wall thickness being reached, additional annealing layers are to be welded which are then re-worked. The completed welding area is finally subjected to a surface crack inspection.

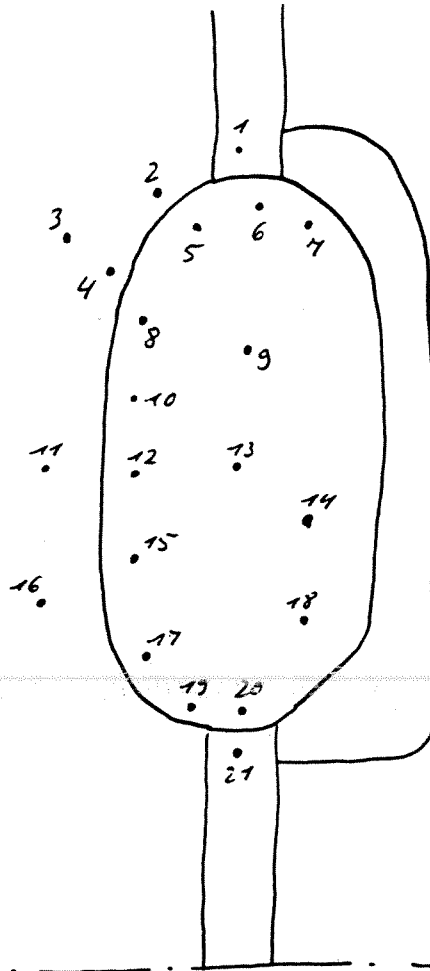
Defective location 1:

Position of the measuring points, completed repair point

Hardness test of the completed repair point 1:

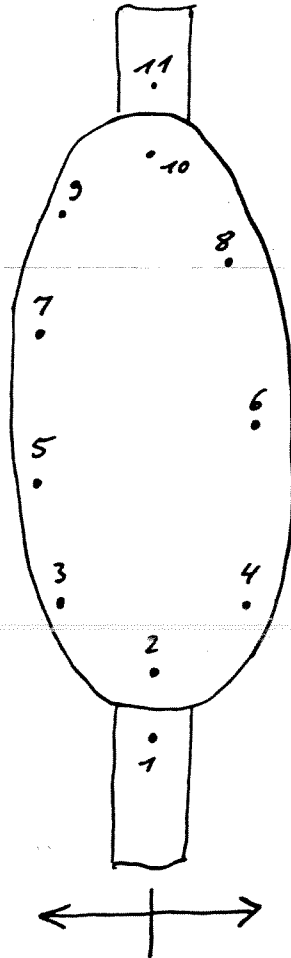
Defective location 2:

Position of the measuring points, completed repair point

Hardness test of the completed repair point 2:
