# NATIONAL TRANSPORTATION SAFETY BOARD

## FIELD NOTES

NTSB ID No.: CEN17FA183 (CEN17MA183)

Location: Teterboro, New Jersey  
Date: May 15, 2017  
Time: 1529 eastern daylight time  
Aircraft: Gates Learjet 35A, N452DA, Trans-Pacific Jets

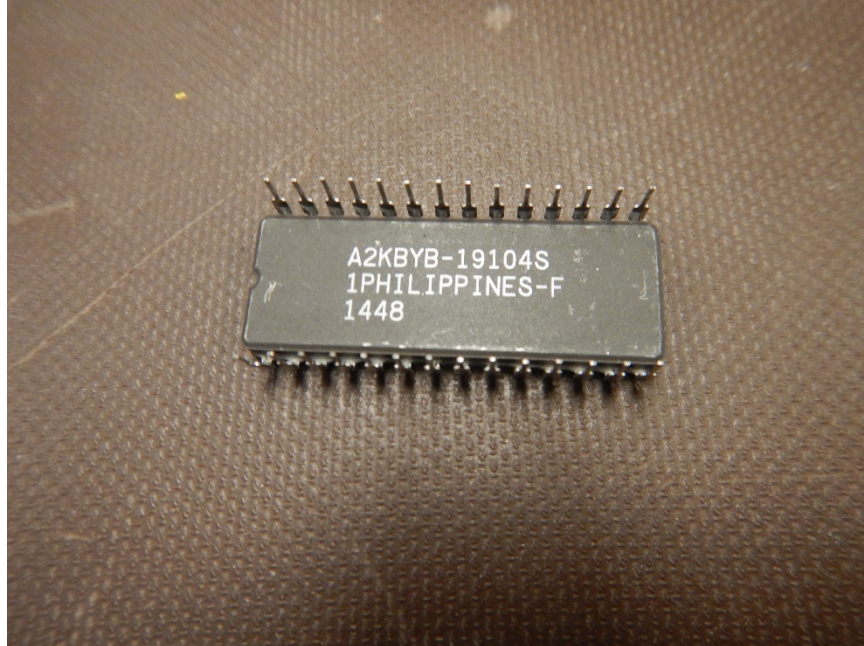
Photo No. 15: Markings on underside of exemplar memory chip. (Honeywell)

Markings that were noted on the underside of the chip and compared to an exemplar memory chip indicated the chip had been manufactured by Atmel. (Photos Nos. 14, 15, and 16) According to Honeywell, Atmel, which is based in San Jose, California, was the designated vendor for the memory chips in the DEECs that were installed on the accident engines.
