GLENDALE, CALIFORNIA
Dynamic Science, Inc. No. 013
Volpe, John Hopkins/FRA

Injury Causation Study Field Notes

Crash Date: January 26th, 2005
Crash Time: 0602 Hours (6:02 a.m.)
Crash Type: Metrolink Train No. 100 Southbound impacts Jeep Cherokee
Parked perpendicular on tracks and derails impacting northbound
Metrolink Train No. 901. The lead car of Train No. 100
subsequently impacts stationary Union Pacific locomotive

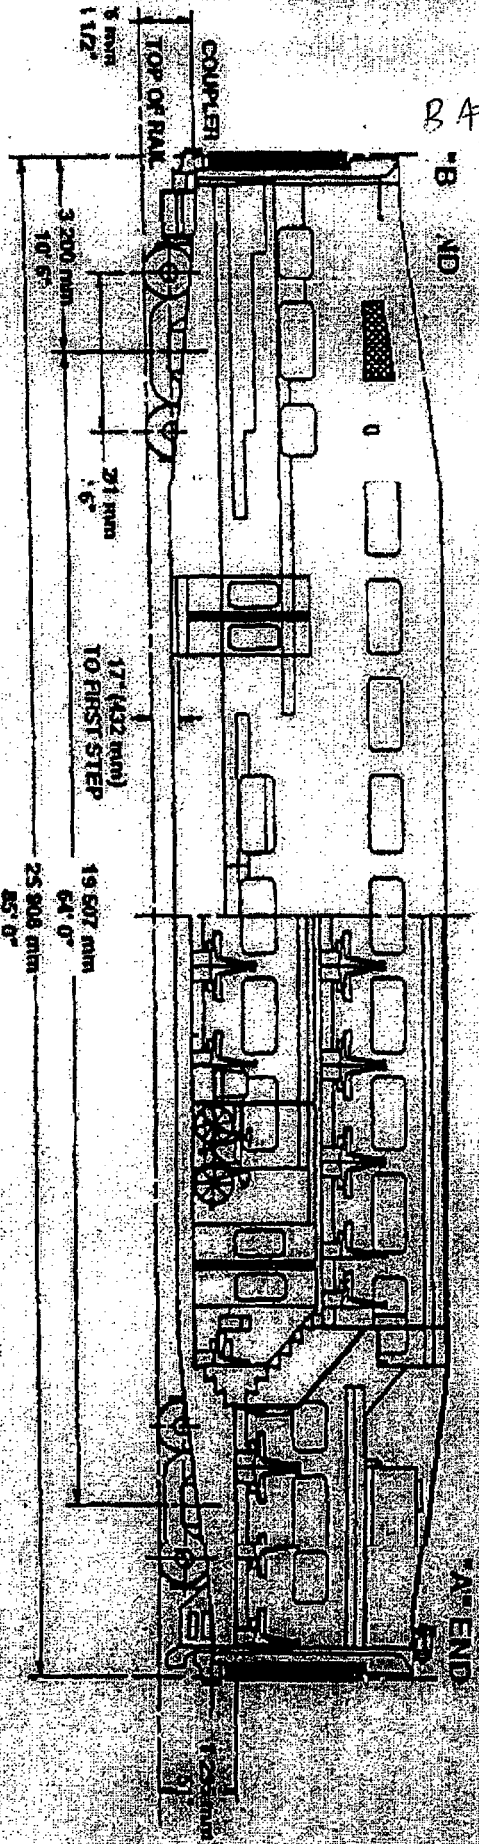
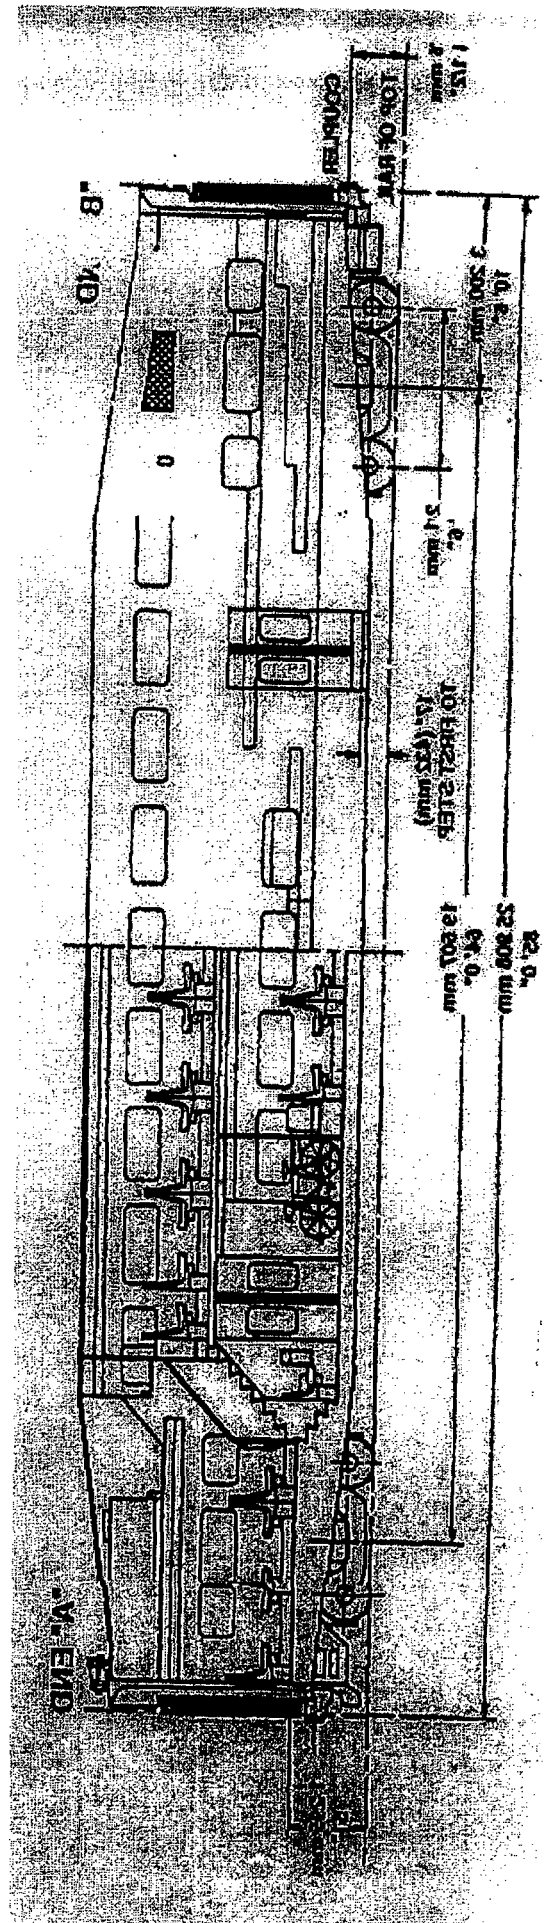
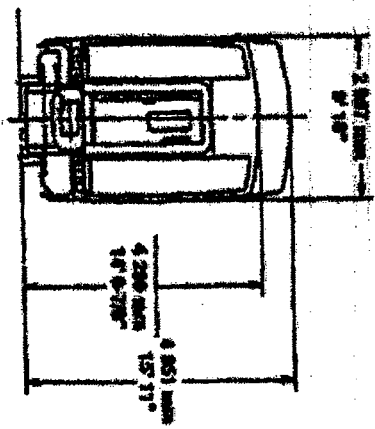
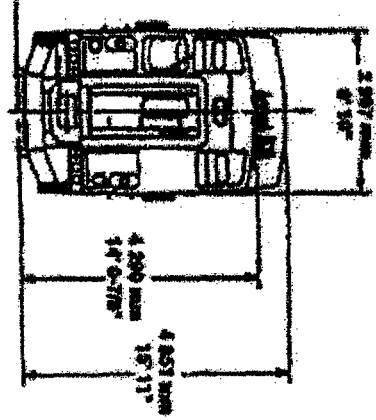
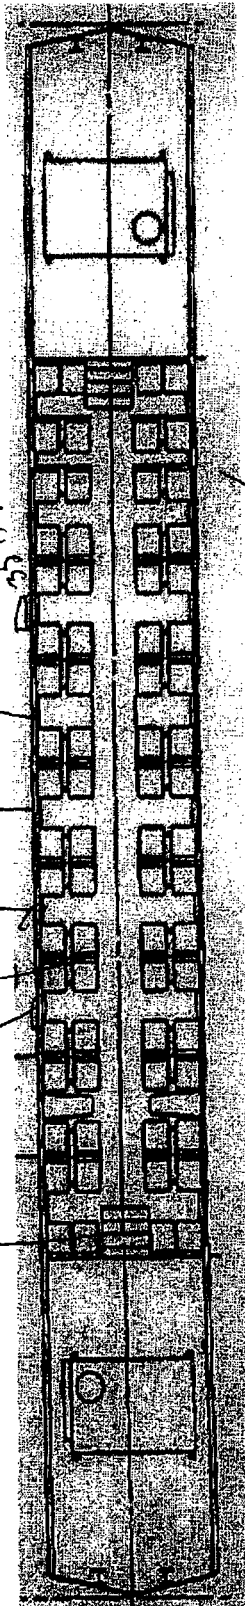
CAB
CAR

35769
GUESTS OUT
GUESTS OUT
GUESTS OUT
6/70 SEAT BRAC
OUTLINE GUESTS DISINTEGRATED
HORIZONTAL CRACKS
GROUP ON WALL OF STRIPS

ALL SEAT CUSHIONS OF TYPE A
(ALL WINDOWS OF TYPE B)

SEATS SINCE TRACK
- DINING SEATS DISLOADED

105/101
BOARD FROM SEAT BOTTOM
CRACKED

INTRUSION INTO SWIRLWELL
DOOR OPENED BY IMPACT 92"

INTRUSION @ FRAME LEVEL = 28" 25"

4 SIDE WINDOW OUT
INTERIOR SIDE STRUCTURE OPENING
ALL SEATS

INTRUSION 40" TO C/L

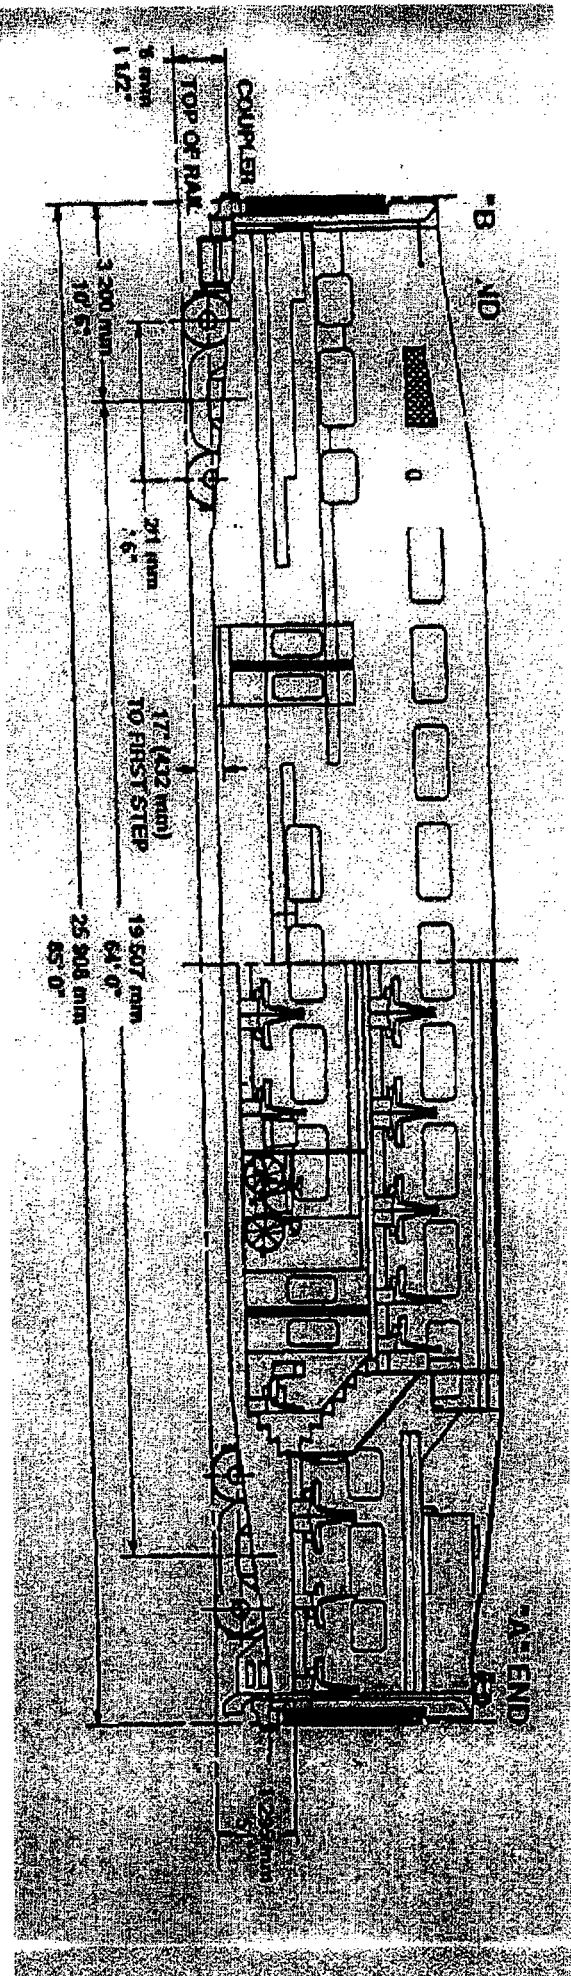
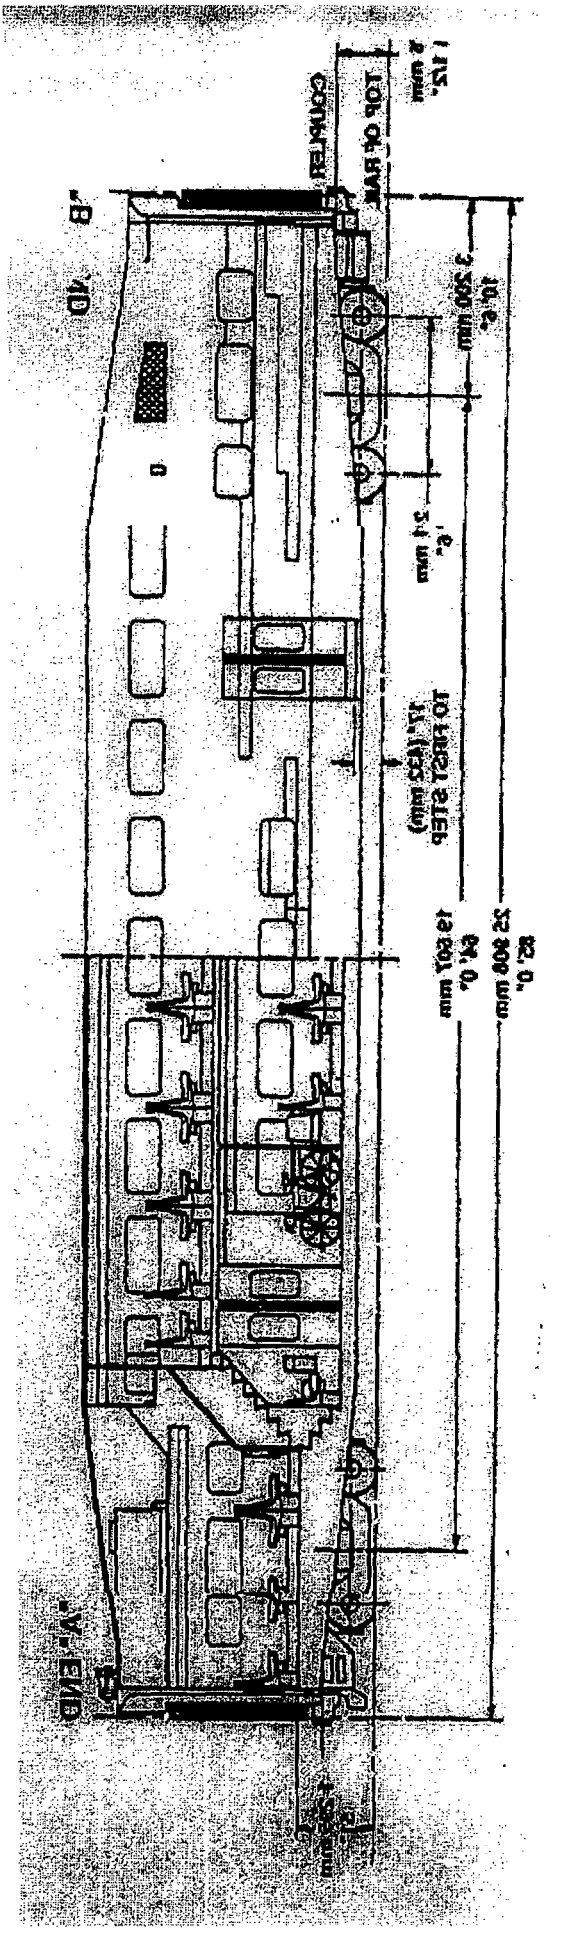
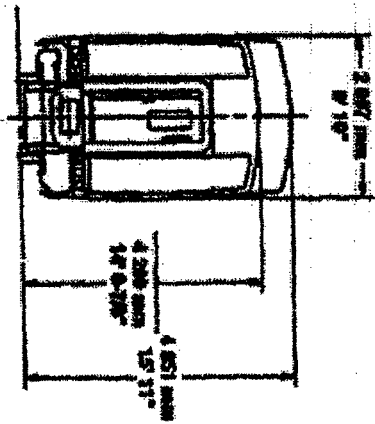
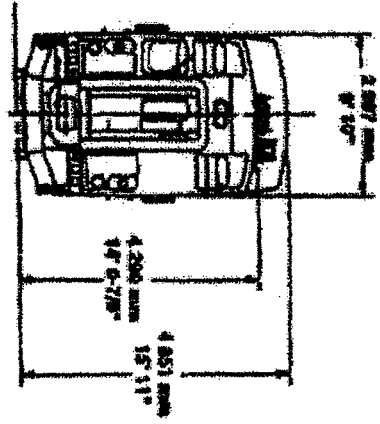
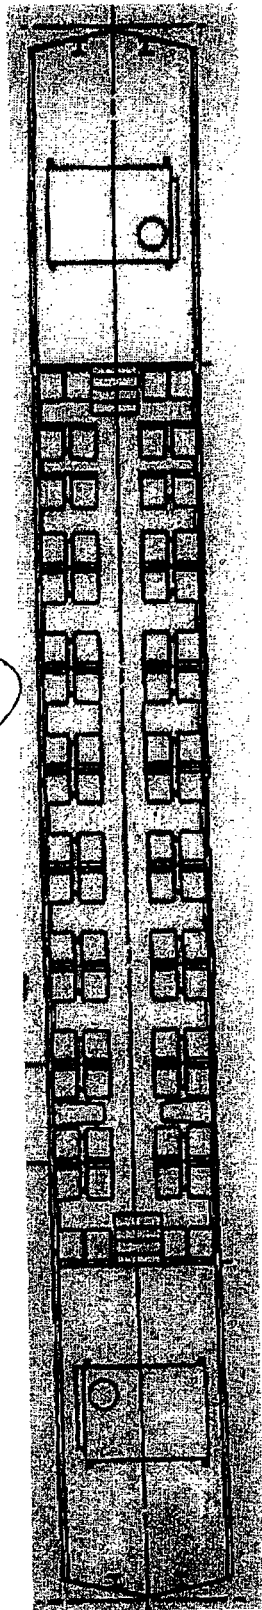
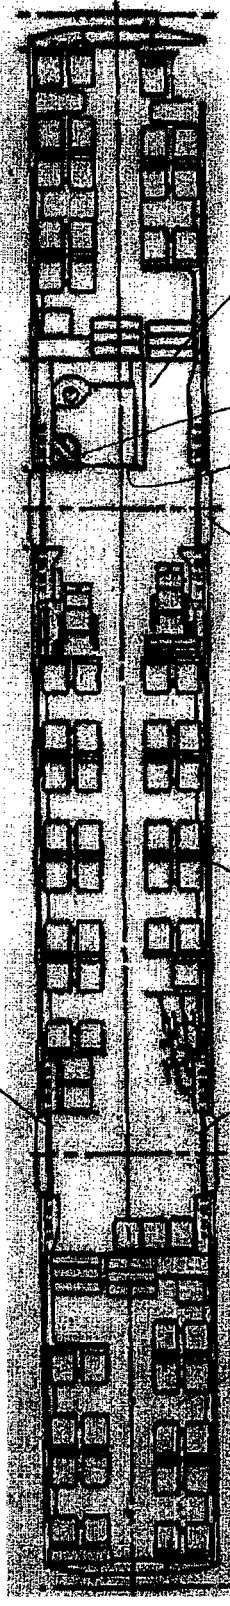
TRAILER
CAR

HAMMER/SAW
ARTE CUT OUT

BELOW IN SINK
HEAD IMPACT
BLOOD STAIN

The DSI investigators accessed the upper level via the forward stairwell. The upper level of Coach car No. 177 revealed no areas of occupant contacts. Or indications of sustained trauma. The upper level of this car was void of any intruding components or integrity loss.

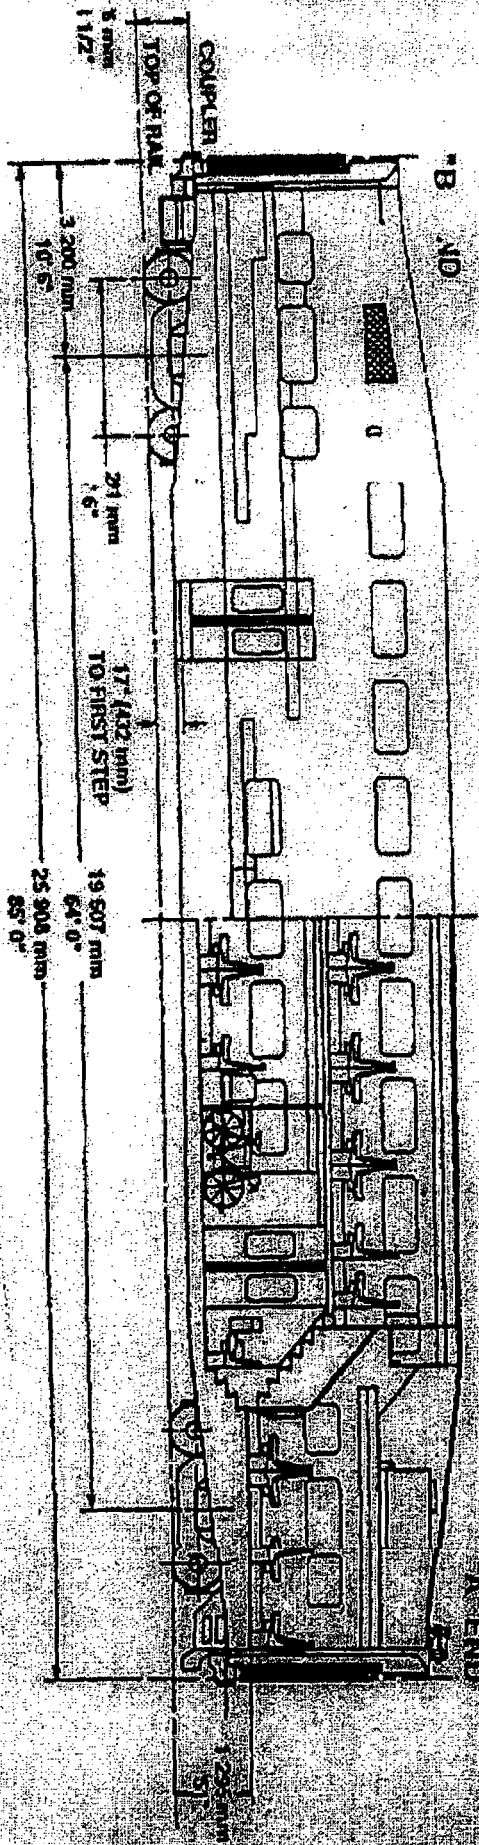
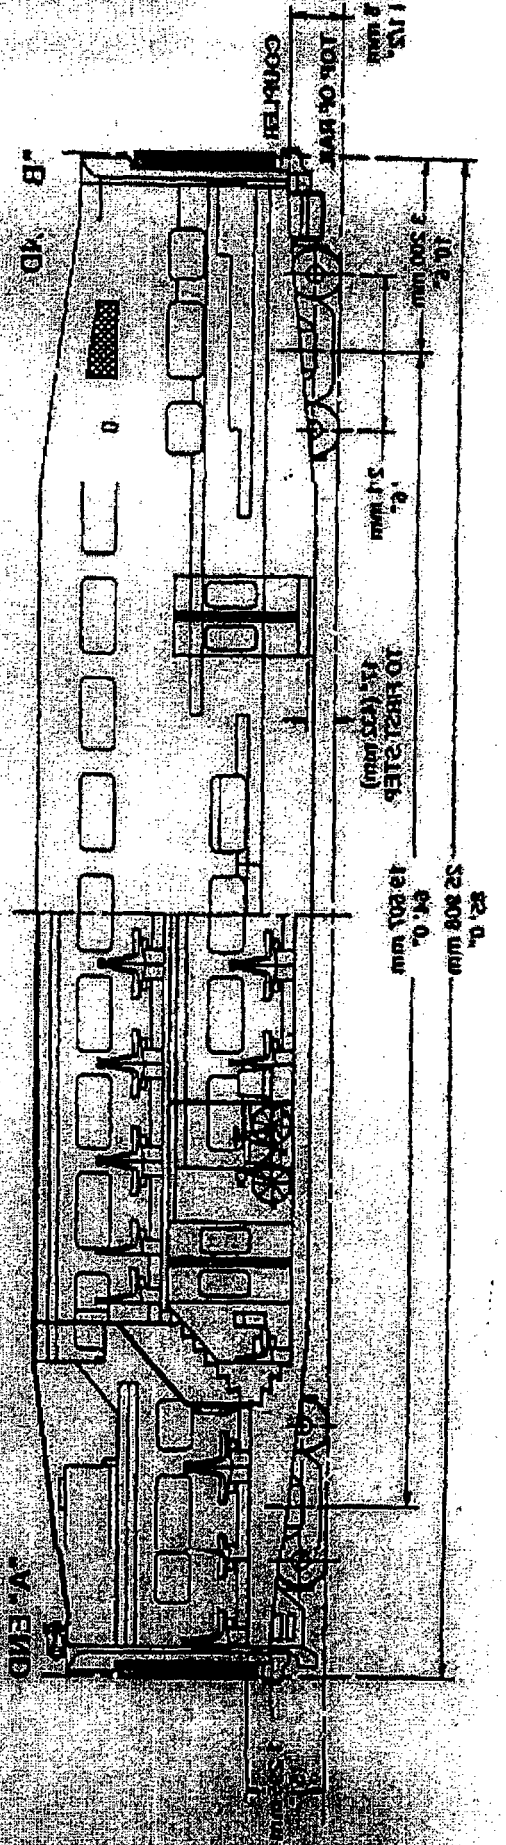
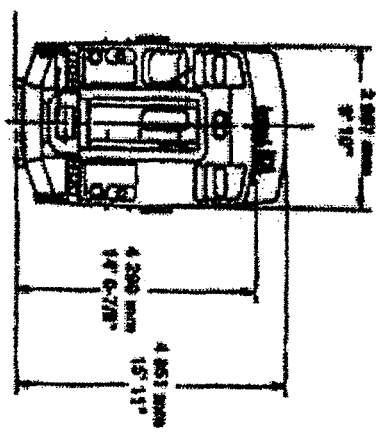
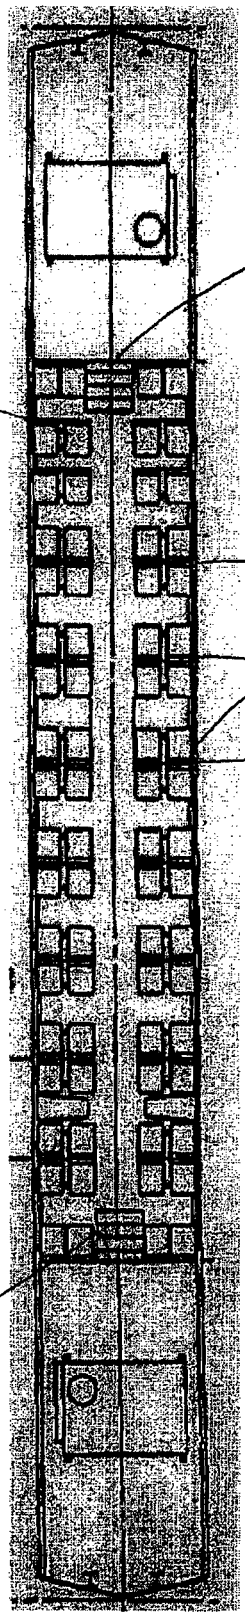
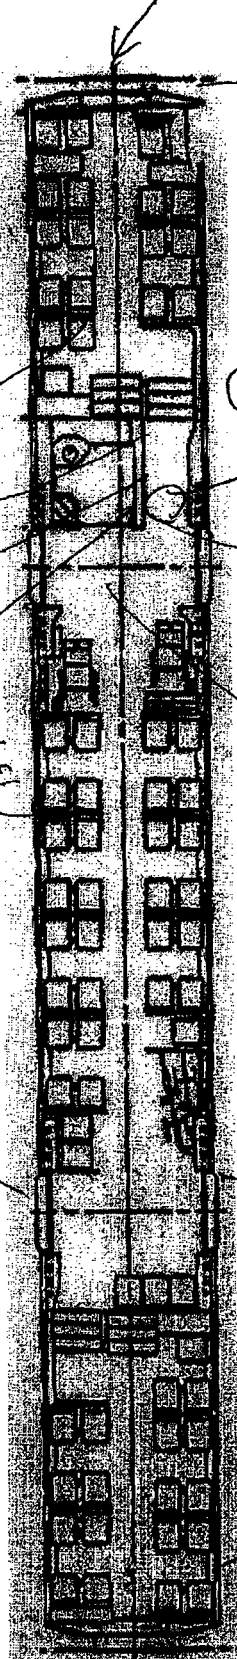
197
~~198A~~
TRAILER
CAR

DAMAGE FROM FEW GAD

CRASHED
MIDWAY

Coach Car No. 197/ Southbound Train No. 100 (3rd car in Consist): The Inspection of this car was initiated by accessing the lower front right entrance/exit door. The inspection initiated at the “B” end of the car, commencing forward.

Blood deposits were noted on seat No. 88 on the right side of the car. The blood was spattered on the seat cushion and immediate floor region of this seating area. There was a blood smear noted to the handrail which accesses the upper level. This likely was the result of passenger egression, post-derailment. Numerous seat cushions were noted to be displaced, but their actual final rest is unknown.

Moving down the stairwell towards the front of the car, it was noted that the panels which cover the sledge hammer/saw and fire extinguisher were opened/broken. Immediately forward of the narrow hallway, a large blood pooling and spatters were documented on the floor surface,

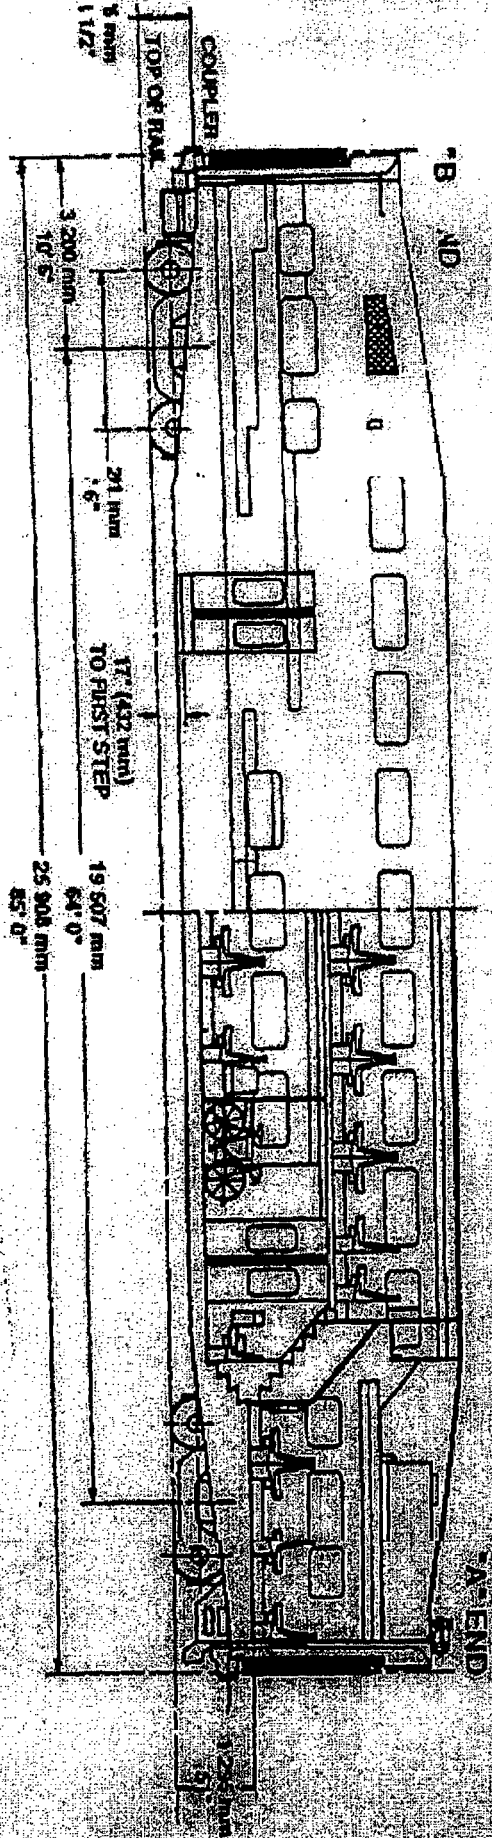
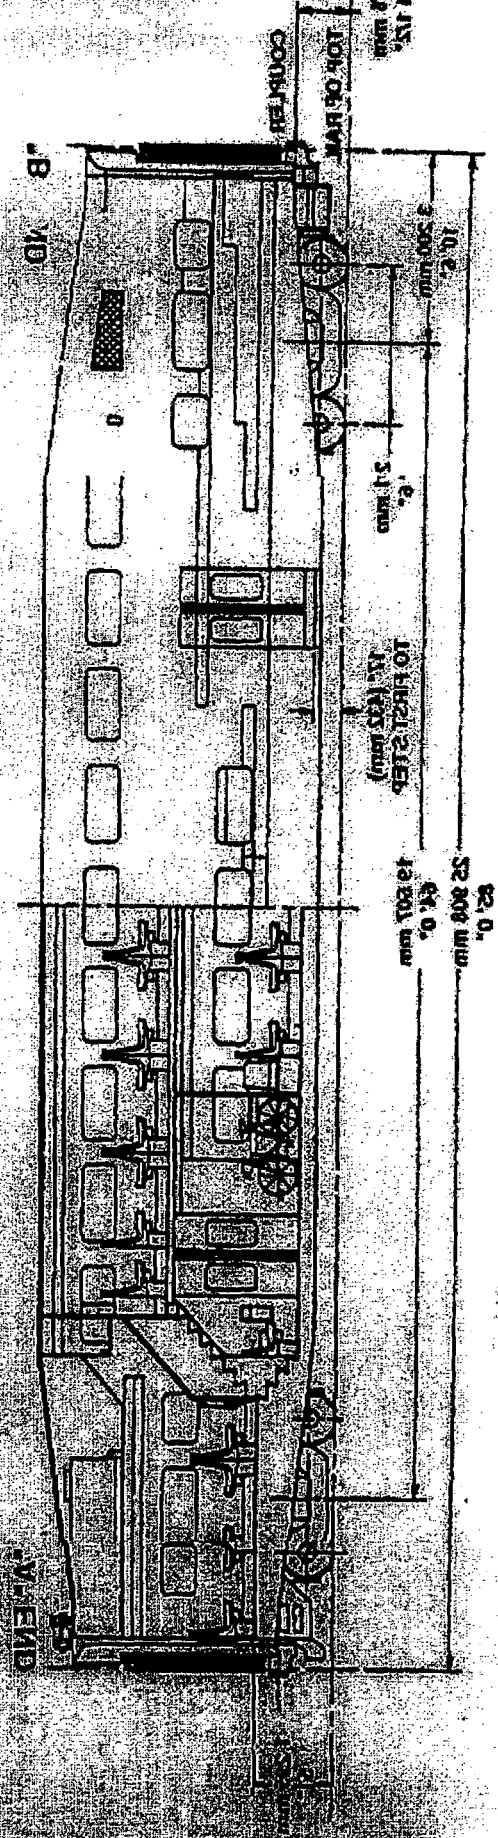
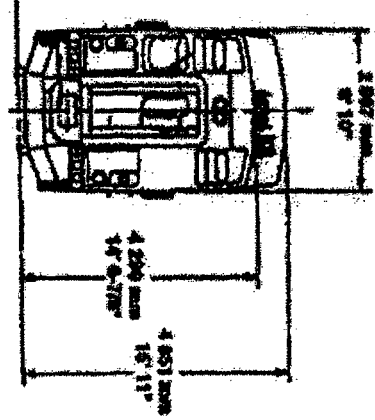
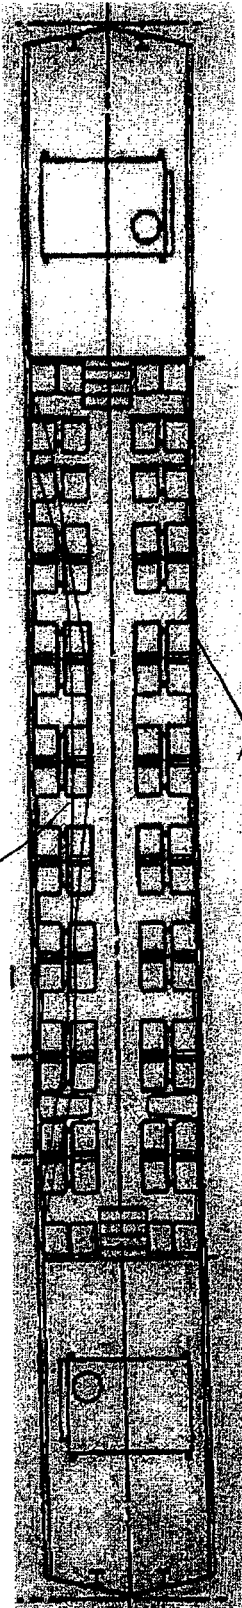
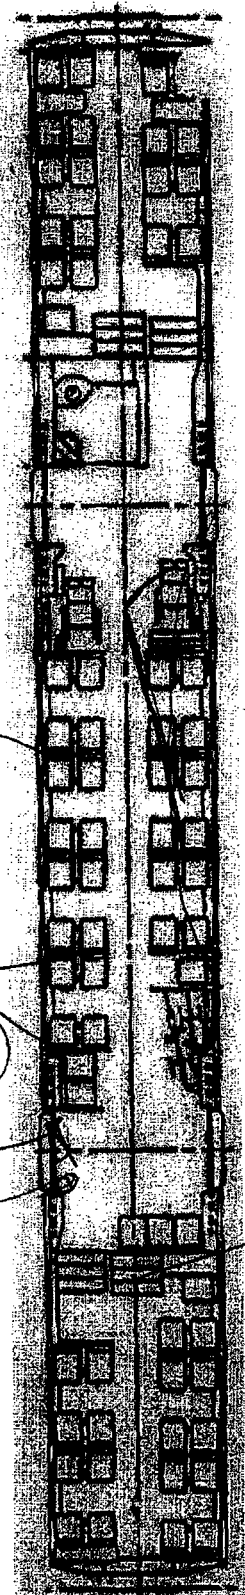
TRAILER
CAR

Jump
down
to
DECK
02 x C6

DOWN
TO
DECK
02 x C6
LIGHT/VENT
KIDSS
52"

The upper level was accessed via the forward staircase and the left lighting vent ridge was observed to have intruded approximately 52 in. The right side lighting/ ventilation ridge was deformed vertically downward approximately 29 in. due to buckling.

A large tear or hole in the roof panel along the right side of the car was observed. The hole measured 59 in. x 30 in. in width. This hole was due to direct contact with the collapsed signal mast tower.

A row of seats behind seat No's 64 & 68 are missing and another row of seats further back are separated and completely missing. There is a hole in the left side window which is 17 in. x 11.5 in. This holed left side window designates the actual initiating point of direct contact along the left side plane.

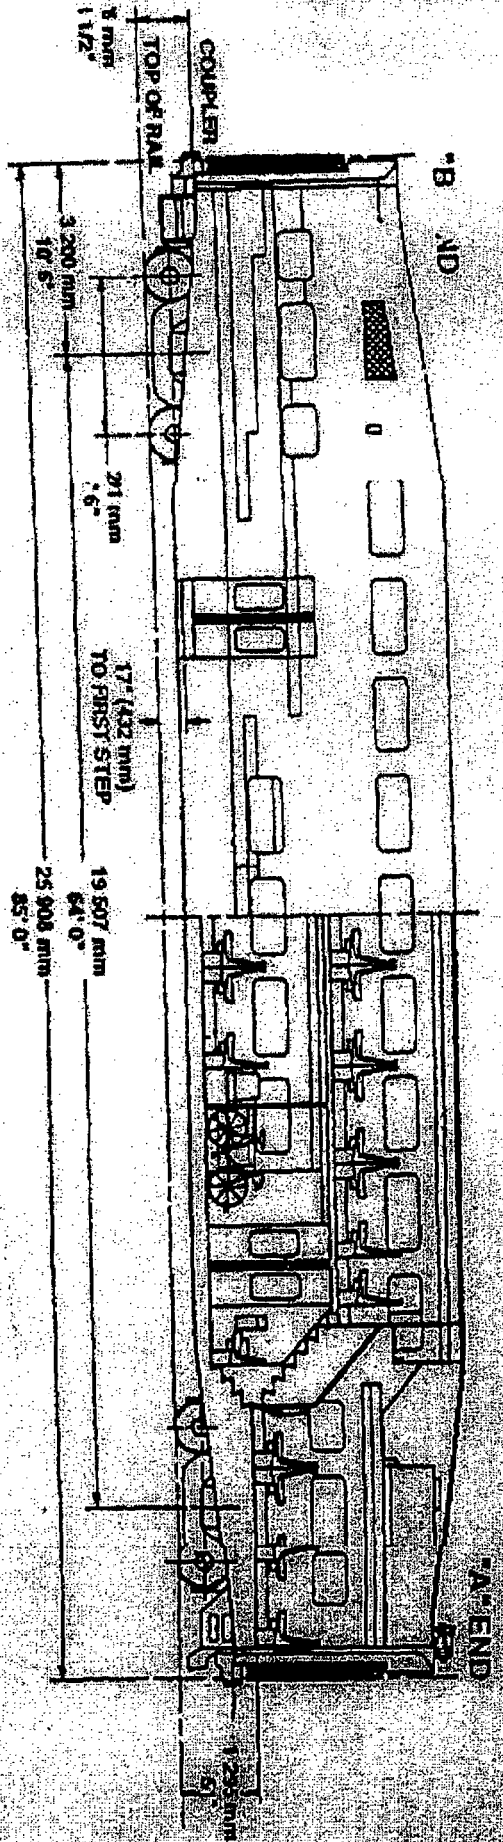
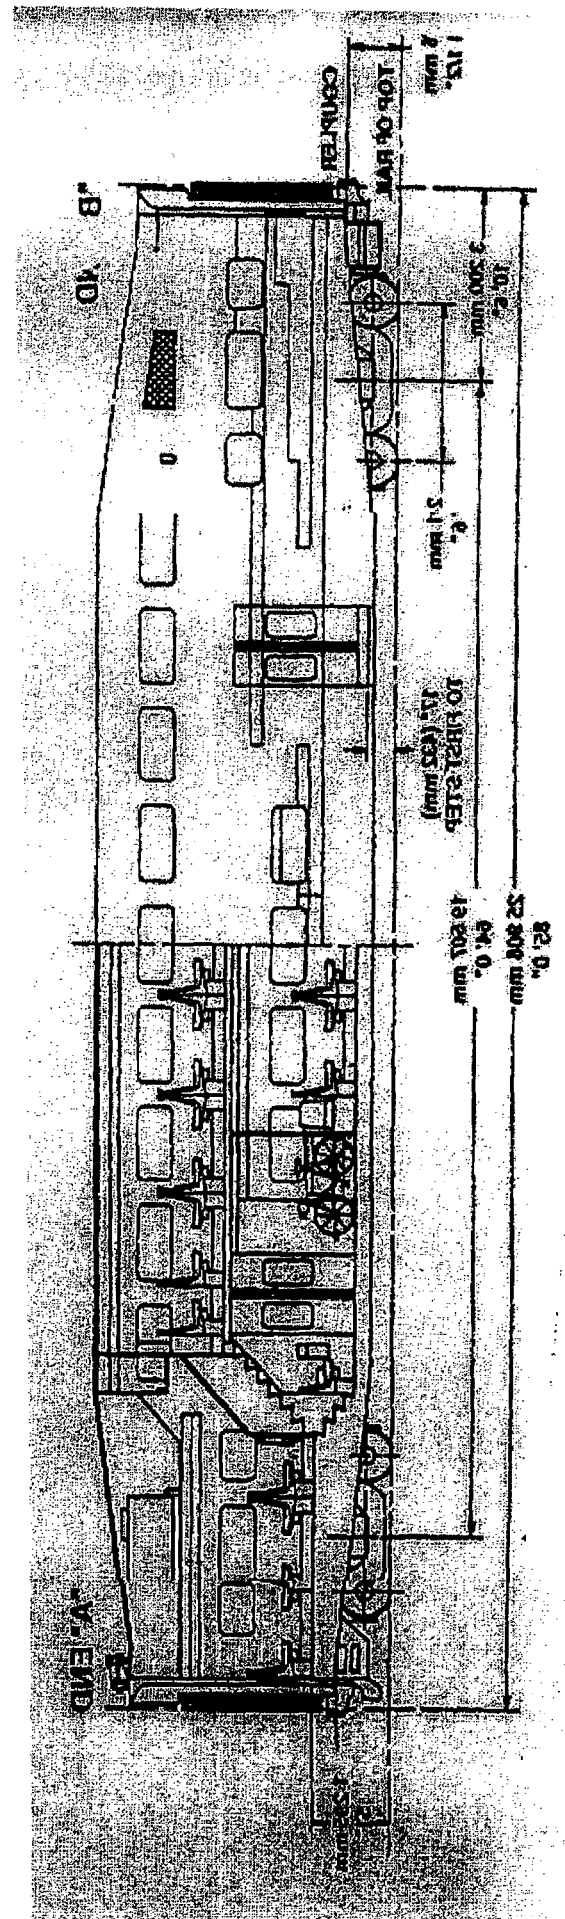
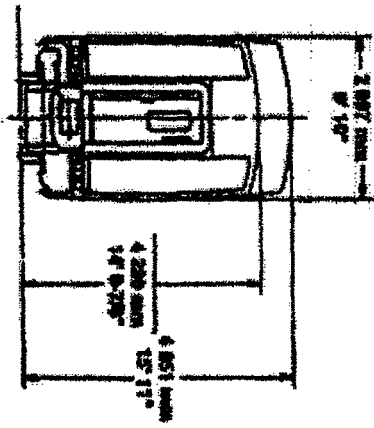
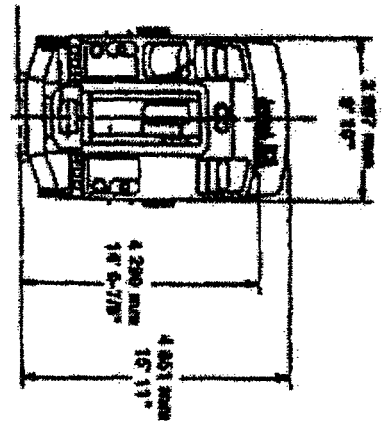
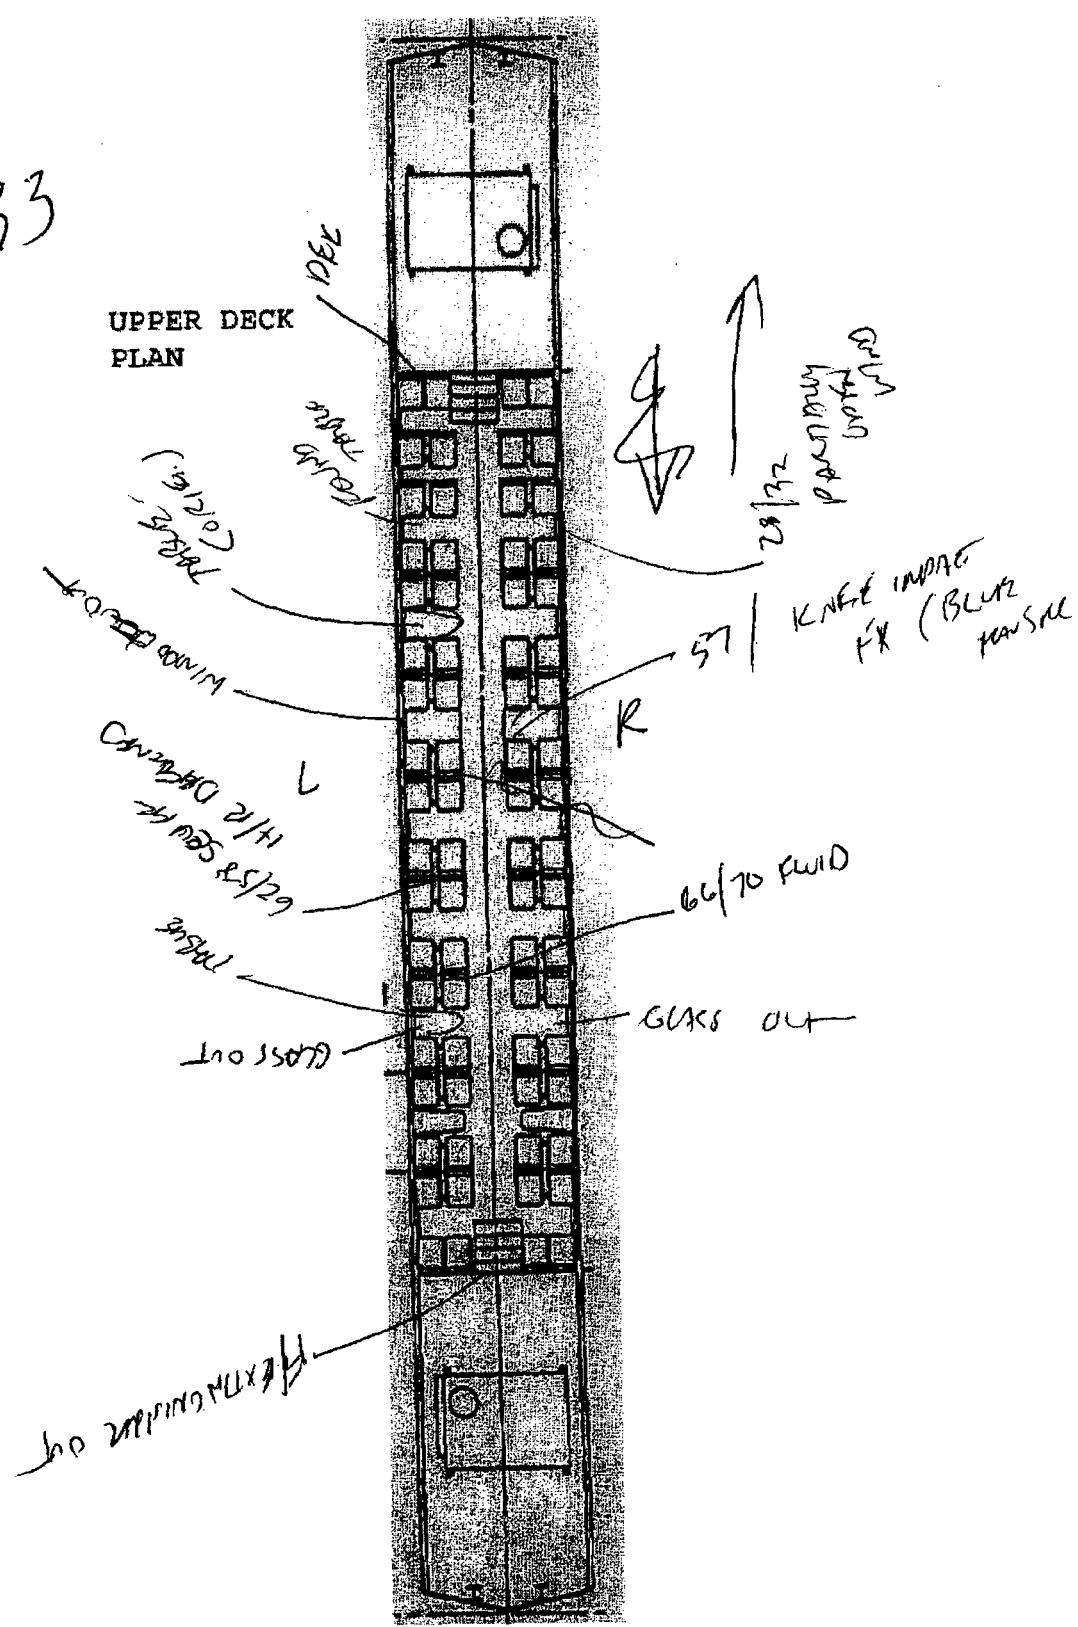
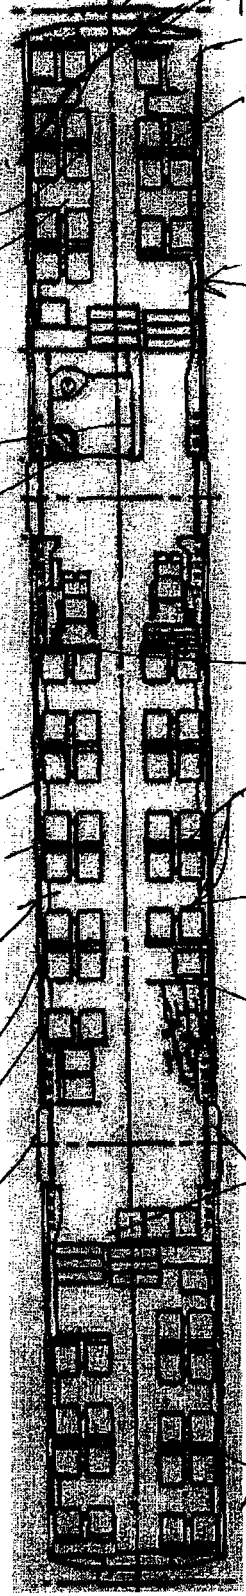
133
TRAILER
CAR

1/2 CRACKED
WINDOW CRACKS (MARKET MARK)

NO WINDOW
123/120 CRACK

PARTIAL
CRACK

FRAMING SAW CRACK/
FURNITURE CRACK

CRACK 2 1/2

Emergency exit windows along the right side, above seats 76/80 were pulled and the glazing was cracked. On the opposite side and adjacent to window seats 83/79, the window fell onto the center table resulting in glazing damage. The fire extinguisher above the stairwell, immediately rearward of the air conditioning return duct vent grate was removed.
