NATIONAL TRANSPORTATION SAFETY BOARD
Office of Aviation Safety
Western Pacific Region

March 24, 2016

ELT EXAMINATION

Location: Biggs, CA
Date: December 15, 2015
Aircraft: Airbus AS350B3

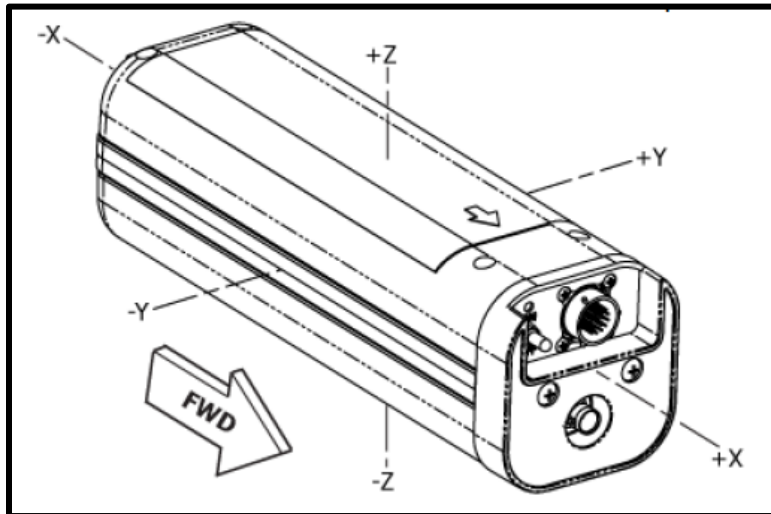
Picture #02: Six Orthogonal Axes

The Artex C406-N HM ELT is a single output ELT that incorporates latitude/longitude information from the helicopter's GNS 530W navigation system and transmits on all three emergency frequencies (121.5/243.0 and 406 MHz). The ELT was developed for helicopter installations and features an additional 5-axis G-Switch module, which allows the ELT to be activated in any of the six orthogonal axes. Activation can occur by the following three circumstances: automatically by the g-switches (either the 2.3-g primary g-switch or the 12.5-g 5-way g-switch); manual activation on unit; manual activation on cockpit panel.
