Egyptian Delegation Presentation

Flight MS 990 Accident

April 28, 2000

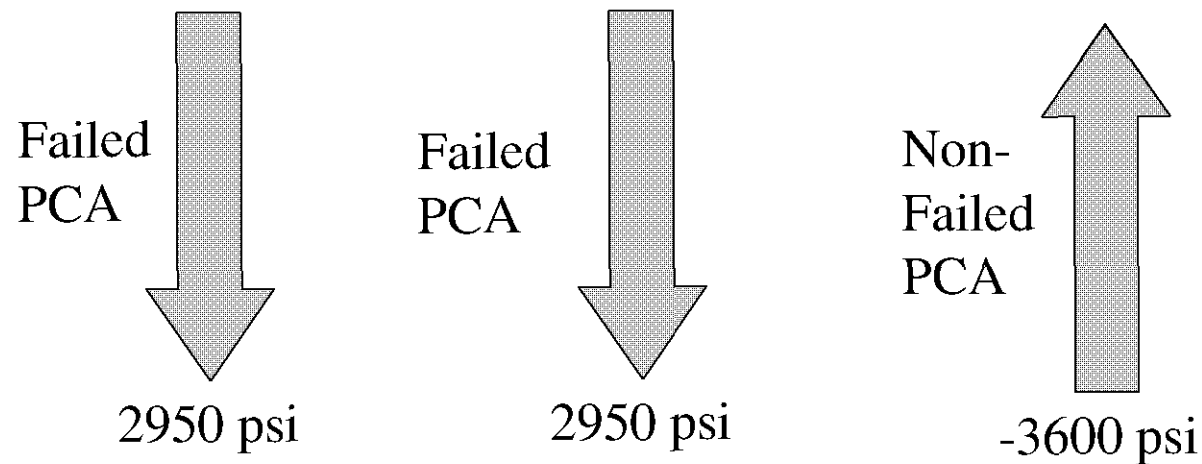
Dual PCA Failure on one side

In all cases of dual PCA failure on one side (either jamming, disconnect or combined jam and disconnect), the two failed PCA's will be fighting against the non failed PCA

Normal system press is 3000 psi, system return press 50 psi, non failed PCA relief press is 3600 psi

The effective force acting on the elevator is
 $(2950 \text{ psi} + 2950 \text{ psi} - 3600 \text{ psi}) * \text{PCA area}$
 $= 2300 \text{ psi} * \text{area} = 0.77 \text{ PCA}$

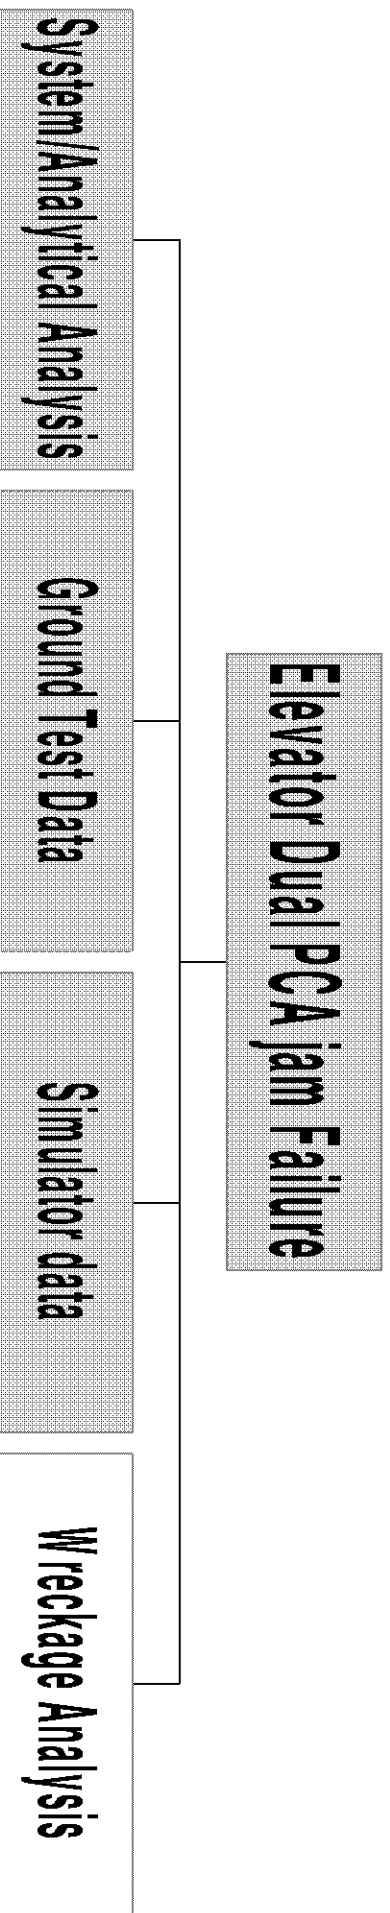
Wreckage analysis:

Recovered elevator PCA's were examined at the Boeing facility, following is the preliminary findings:

- The internal slide spring cap was found separated from the slide in the servo valve for the right elevator outboard PCA through the rolled rivet. This was the only servo valve in which this cap was found separated.
- The right elevator outboard and center PCA bell crank linkage were sheared as if the bell crank arms were moving to a lower relative angle, while the other three bell cranks (the inboard of the right elevator and two of the left elevator) were sheared as if the bell crank arms were moving to a higher relative angle.

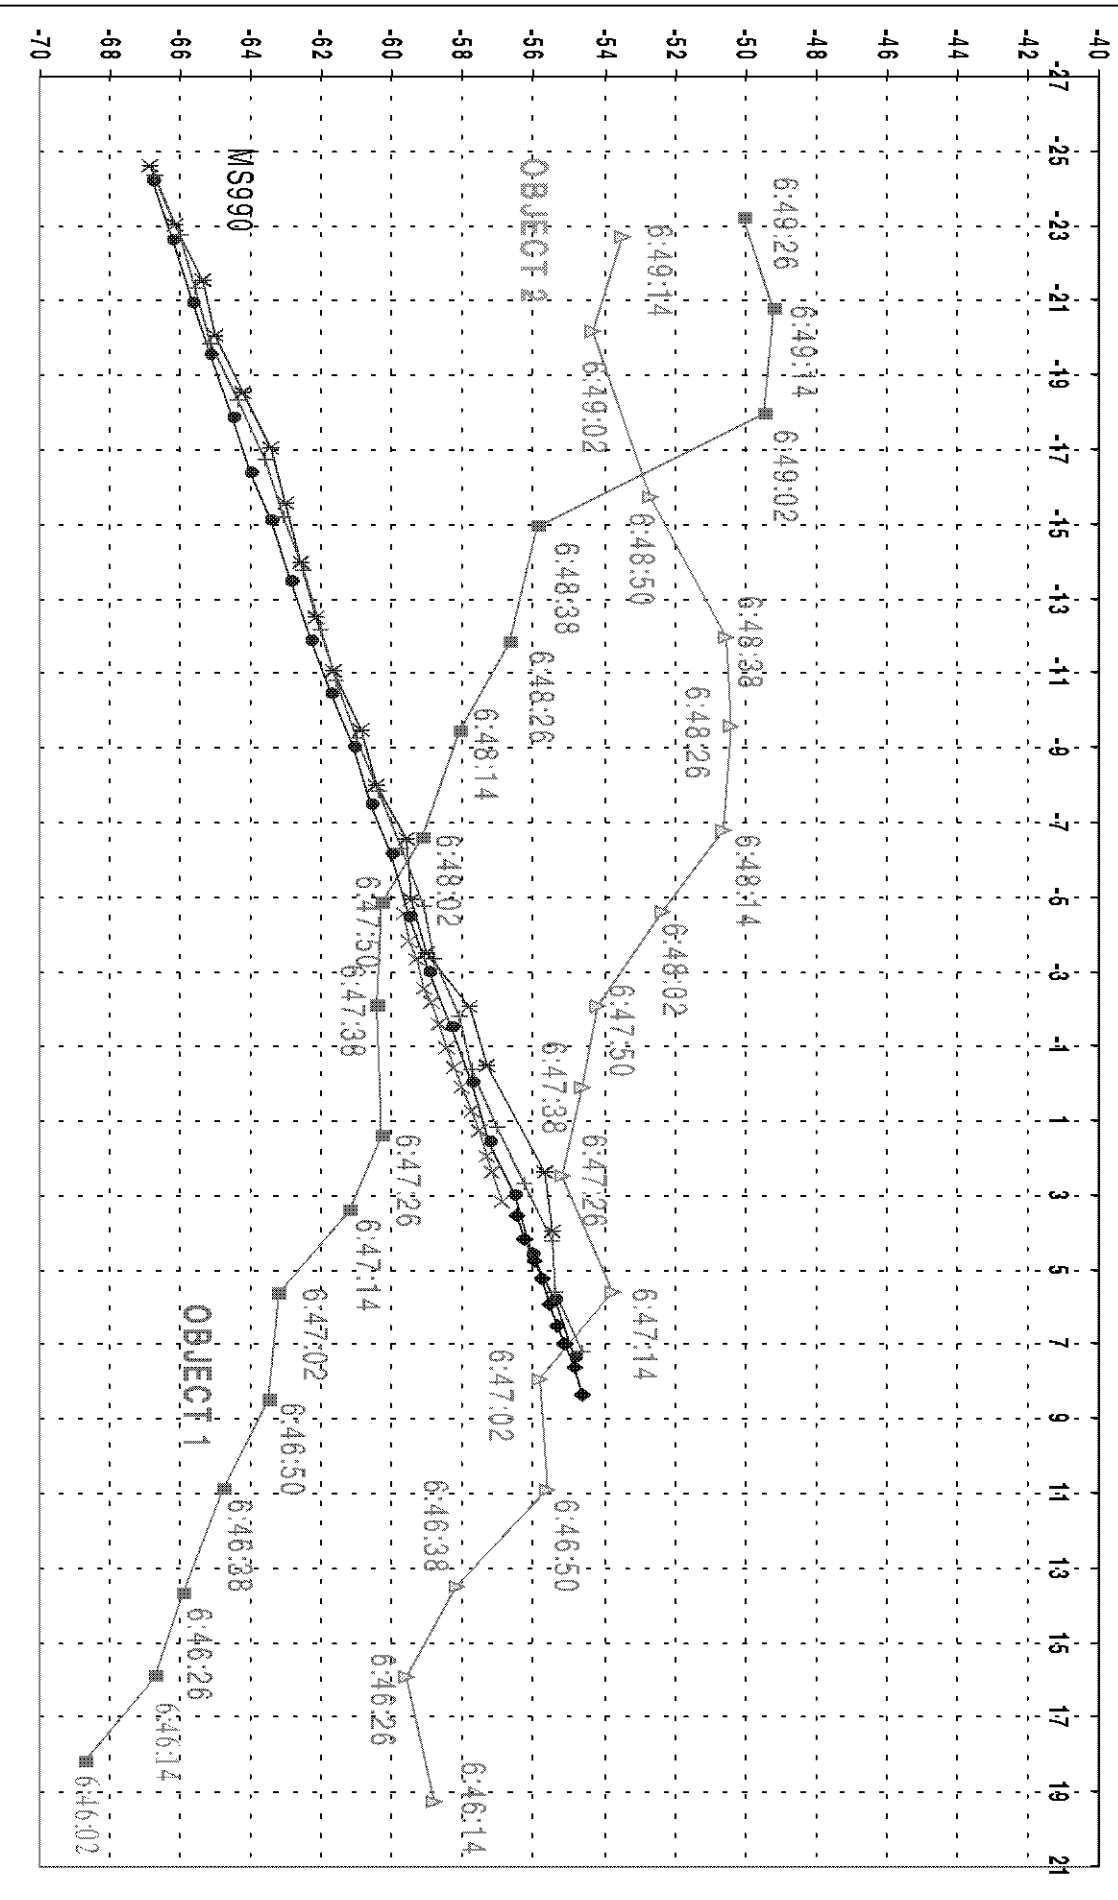
Radar Returns

- Returns data have been obtained from four radar's stations:
 - ARSR-4 AT Riverhead, NY (RIV)
 - ARSR-4 at Gigsboro, NJ (GIB)
 - ARSR-4 AT North Truro,MA (NOR)
 - ASR9 at Nantucket, MA (ACK)
- Radar data provides two types of returns:
 - Beacon (supported by airplane transponder)
 - Primary (not supported by airplane transponder)

(Data is classified as reinforced data when both beacon and primary returns data coincide for the same target)

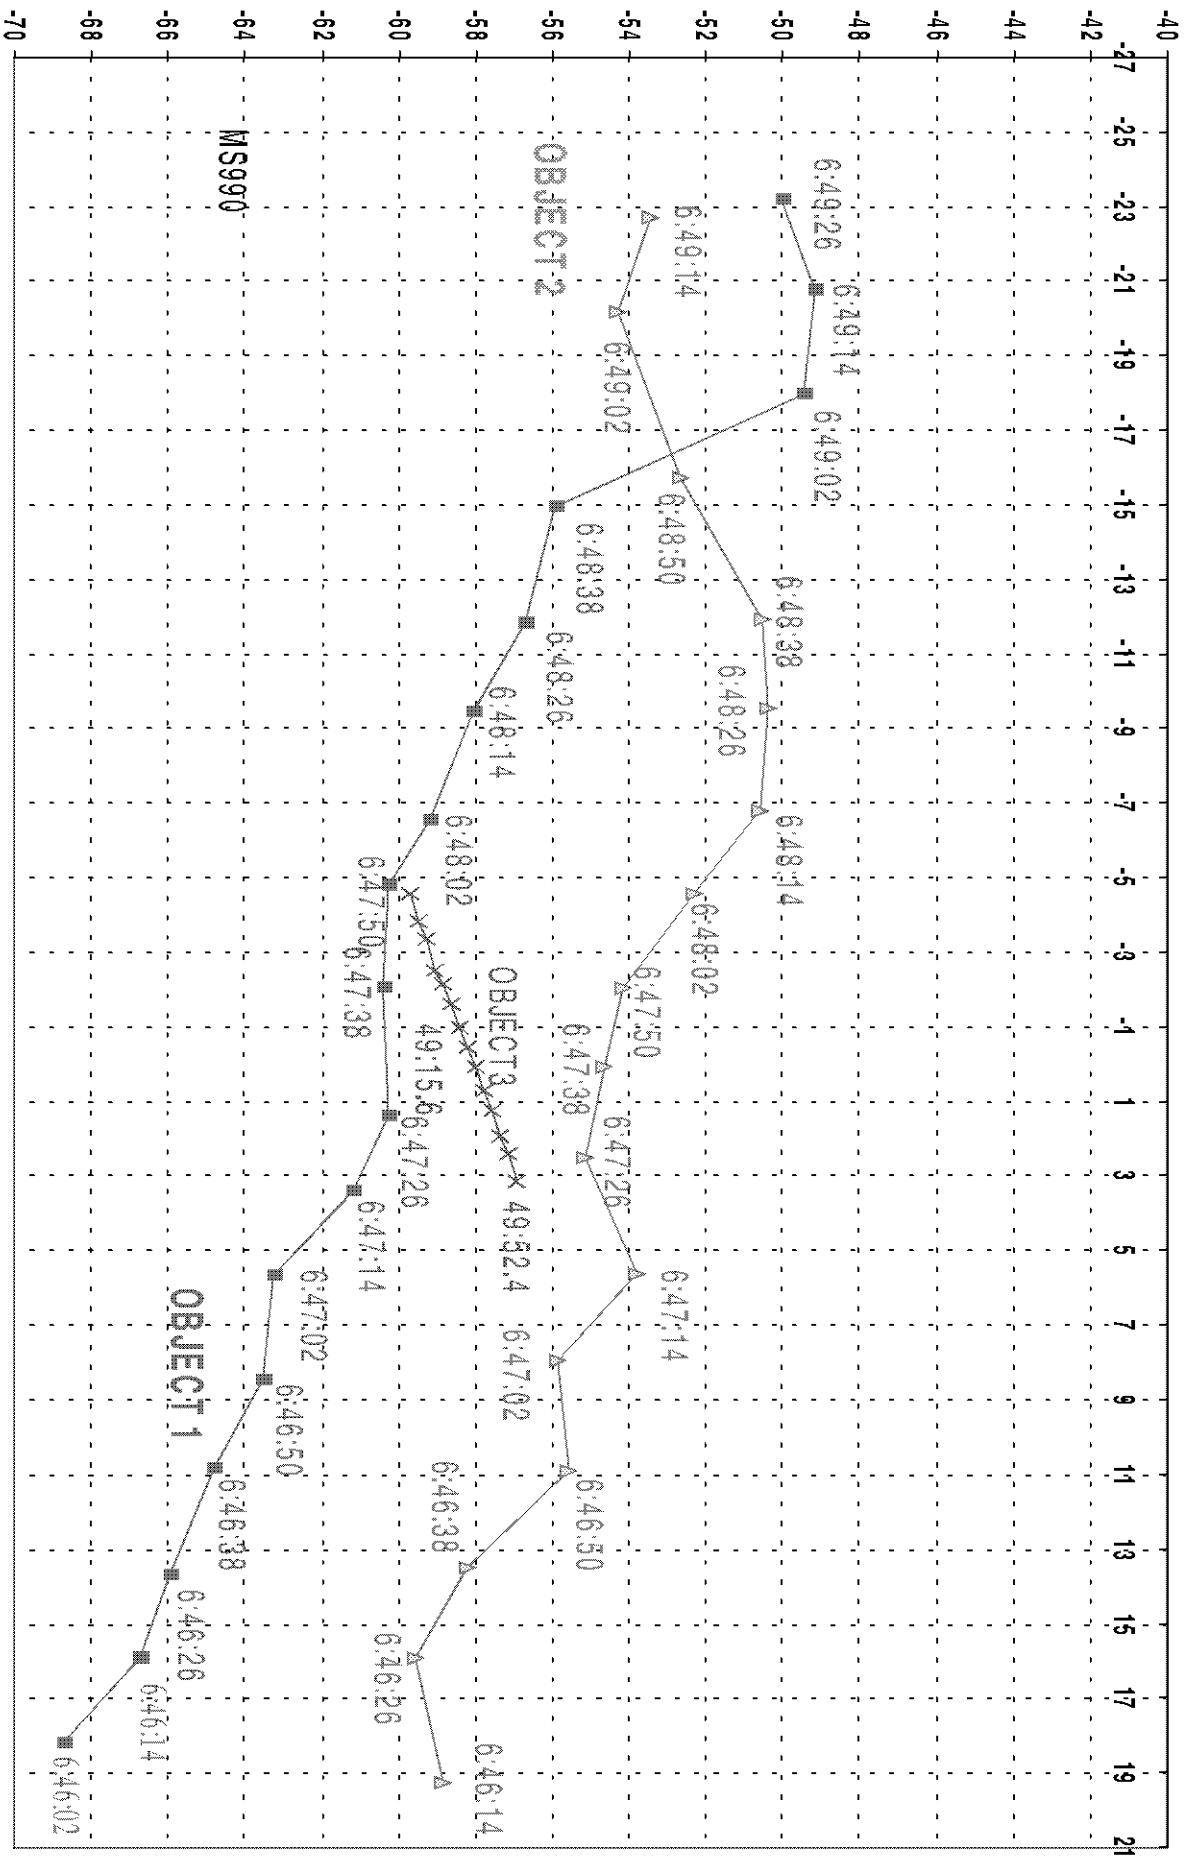
Radar Returns

- Many of the unidentified returns formed continuous flight paths. These targets were travelling generally from East to West at a high ground speed.
- The altitude of the targets is not identified
- The continuous flight paths of the unidentified returns crossed the path of MS990 several times
- At this time, the only explanation for these returns are :
 - 1- They are caused by an unknown phenomenon that is unique to that location over the ocean

- 2- They were caused by real airborne objects
- Further information is requested from NTSB to continue the analysis.
