NATIONAL TRANSPORTATION SAFETY BOARD

**Specialist's Factual Report
by Christopher Babcock**

Location: Lake Berryessa, California
Date: May 8, 2017
Aircraft: Icon A5
Registration: N184BA
Operator: Icon Aircraft Inc.
NTSB Number: WPR17FA101

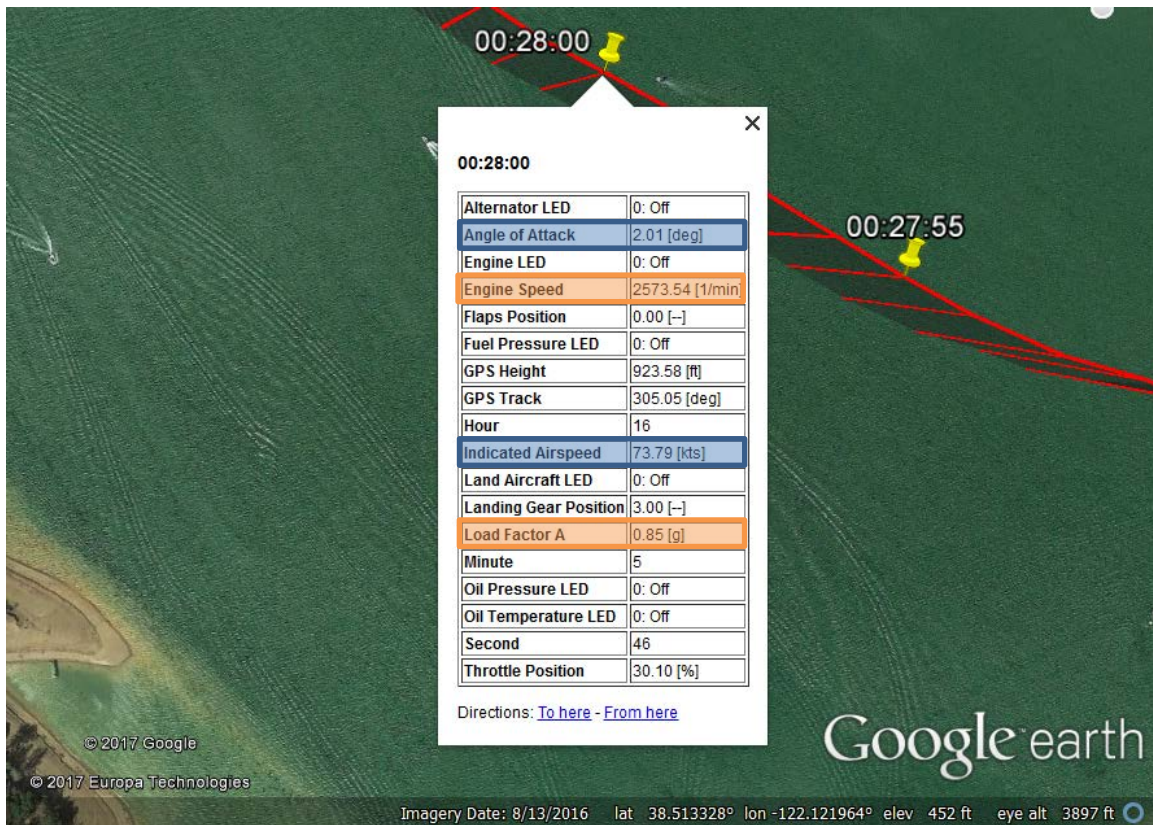
The conversion software produced a Keyhole Markup Language (kml) file and a comma separated value (csv) text file containing the recorded data sampled at 10 Hz. Examination of the kml file and the text file revealed that the kml file contained additional precision in the latitude and longitude values. Additionally, the placemarks included in the kml file contained snapshots of the parametric data. These snapshots contained data from two adjacent samples (see example in Figure 2).
