NATIONAL TRANSPORTATION SAFETY BOARD

Electronic Devices

Specialist's Factual Report
by Bill Tuccio, Ph.D.

Location: Lolo Pass, Idaho
Date: July 28, 2014
Aircraft: Meyer-Lancair, Legacy
Registration: N29MM
Operator: Private
NTSB Number: WPR14FA316

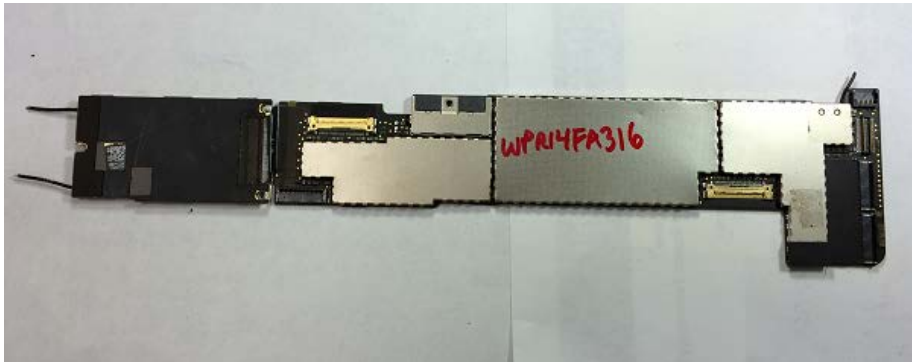
Figure 9. Apple iPad 2 internal board.

disassembled and the internal processor board removed, as shown in figure 9. The internal board was placed in an NTSB surrogate device and powered on normally. Contents were downloaded using forensic software and select screens were photo documented.

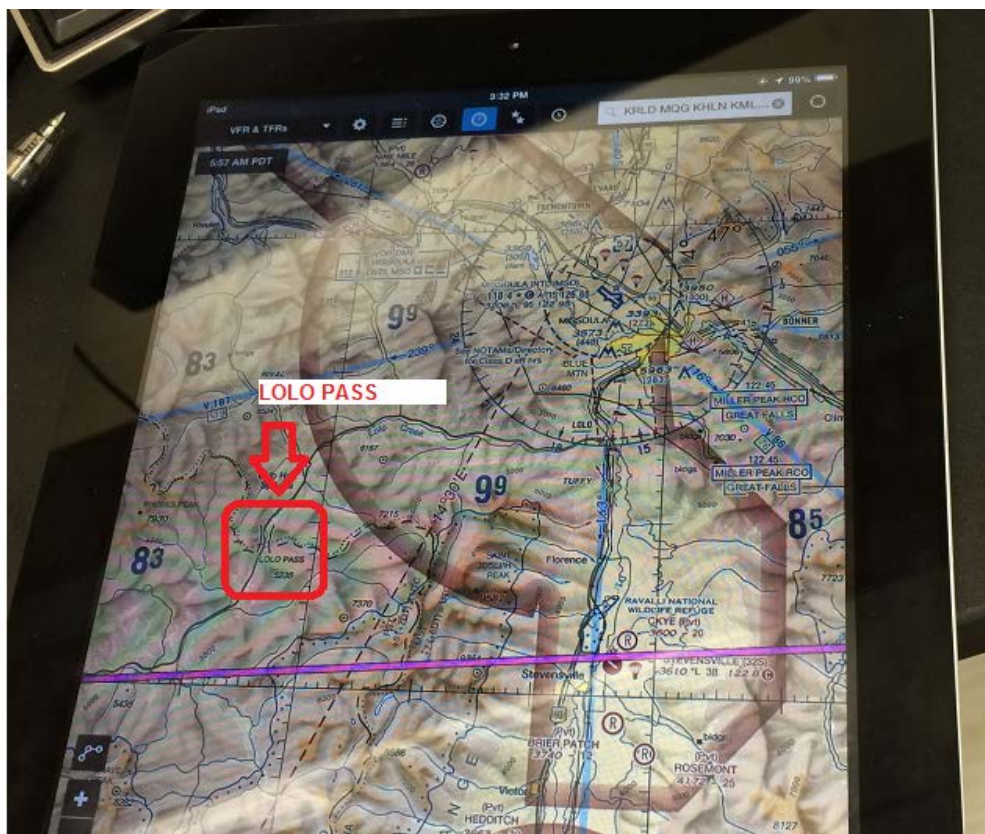
Figure 10. ForeFlight opening map page.

The ForeFlight application contained an active route from RLD to BHK. When started, the ForeFlight “Maps” page displayed the image shown in figure 10 (the location of “Lolo Pass” is annotated for reference).

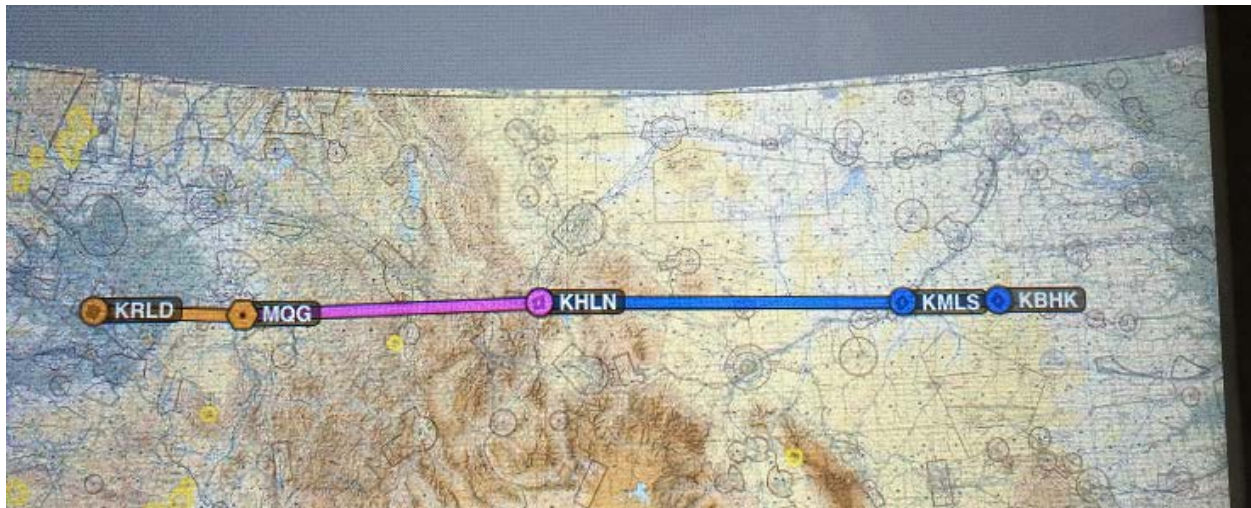
Figure 12. ForeFlight full route.

Figure 12 shows the entire route from RLD to BHK by way of MQG KHLN and KMLS.
