**NATIONAL TRANSPORTATION SAFETY BOARD
Office of Research and Engineering
Vehicle Recorder Division
Washington, DC 20594**

**GROUP CHAIRMAN'S FACTUAL REPORT OF INVESTIGATION
Electronic Recording Devices and Flight Data Factual Report
DCA15MA019**

Location: Koehn Dry Lake, California
Date: October 31, 2014
Vehicle: Model 339 SpaceShipTwo
Registration: N339SS
Operator: Scaled Composites
NTSB Number: DCA15MA019

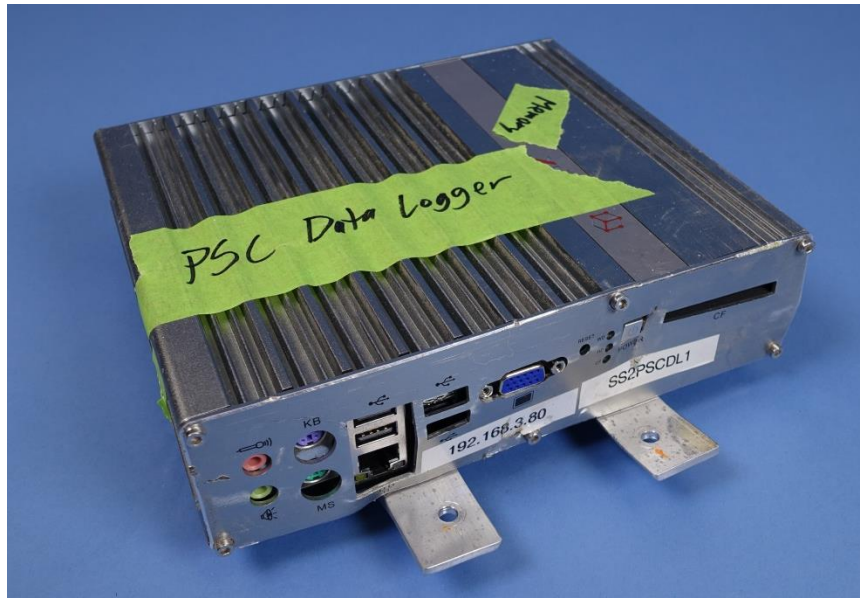
Figure 2 shows a picture of the PSC data logger, a component of the PSC system, which was recovered from the wreckage.

Figure 2. The pressurization system controller data logger.

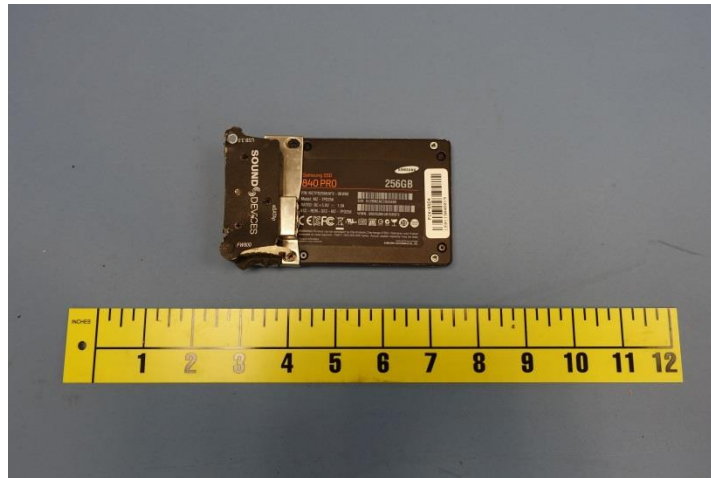
Figure 6. The “SS Boom Cam” Hard Drive and the Associated PIX Chassis Connector.

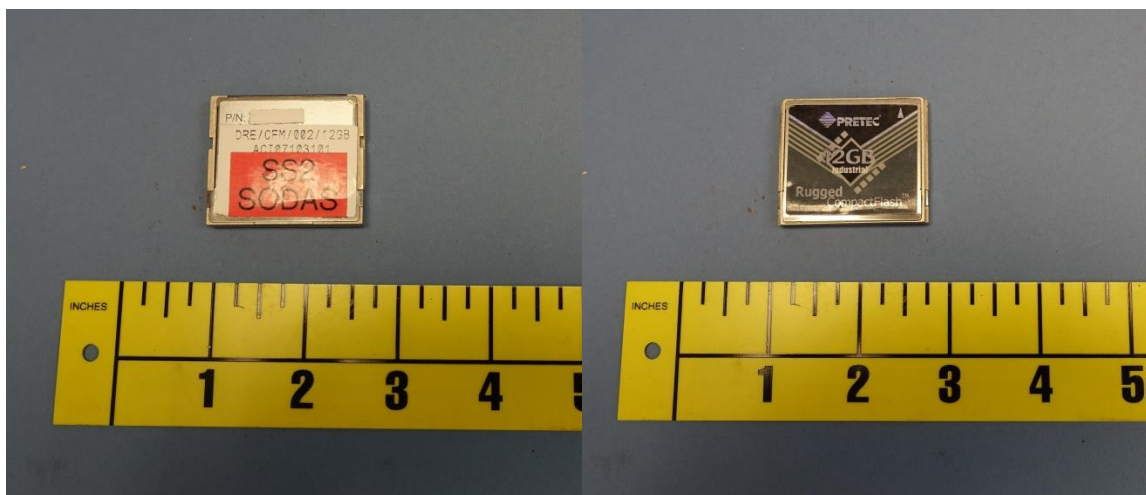
Figure 7. The front and back of the SODAS CF Card.

The SODAS Compact flash card contained a complete, onboard, electronic file record of the flight data that was streamed to the ground by the SODAS instrumentation system. The CF card was noted to have slight displacement damage in its external packaging (Figure 7). Upon arrival at the NTSB vehicle recorder laboratory, it was X-rayed using the lab's GE Phoenix Nanomex X-ray inspection device. An internal inspection using the X-ray device revealed unlikelihood of internal damage to the compact flash card's contents, and the device was read out normally using a compact flash card forensic write blocker. A 12 GB image file of the device's internal memory was retained using PC software.

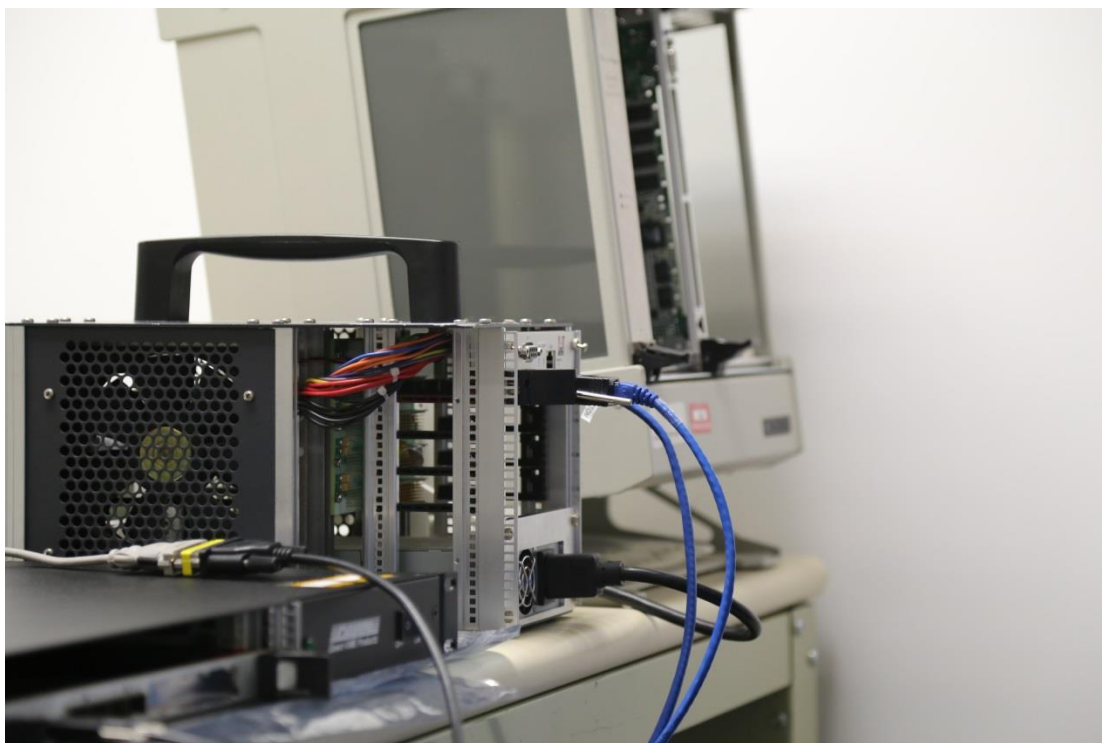
On December 18, 2014, the card was brought by an NTSB specialist to Aitech Defense Systems in Chatsworth, California for further inspection and read out. Upon arrival at Aitech Defense Systems, the card was inspected for damage by a production specialist. It was confirmed that the board contained damaged pins in the JP3 and JP4 region of the card and the subsequent displaced resistor was identified. A rework order was created and the damage was repaired by an Aitech laboratory specialist. The card was then put through an impedance test to verify that the card could safely be powered on a test board. The card passed the impedance test with only slight deficiencies noted and it was determined to be a low risk of data loss to apply power to the card in a test board. Power was applied to the card on a test board (Figure 11) and the card was unable to boot. It could not be ascertained why the card would not function properly in the test board.

Figure 11. Power applied to the test card with the accident board installed.

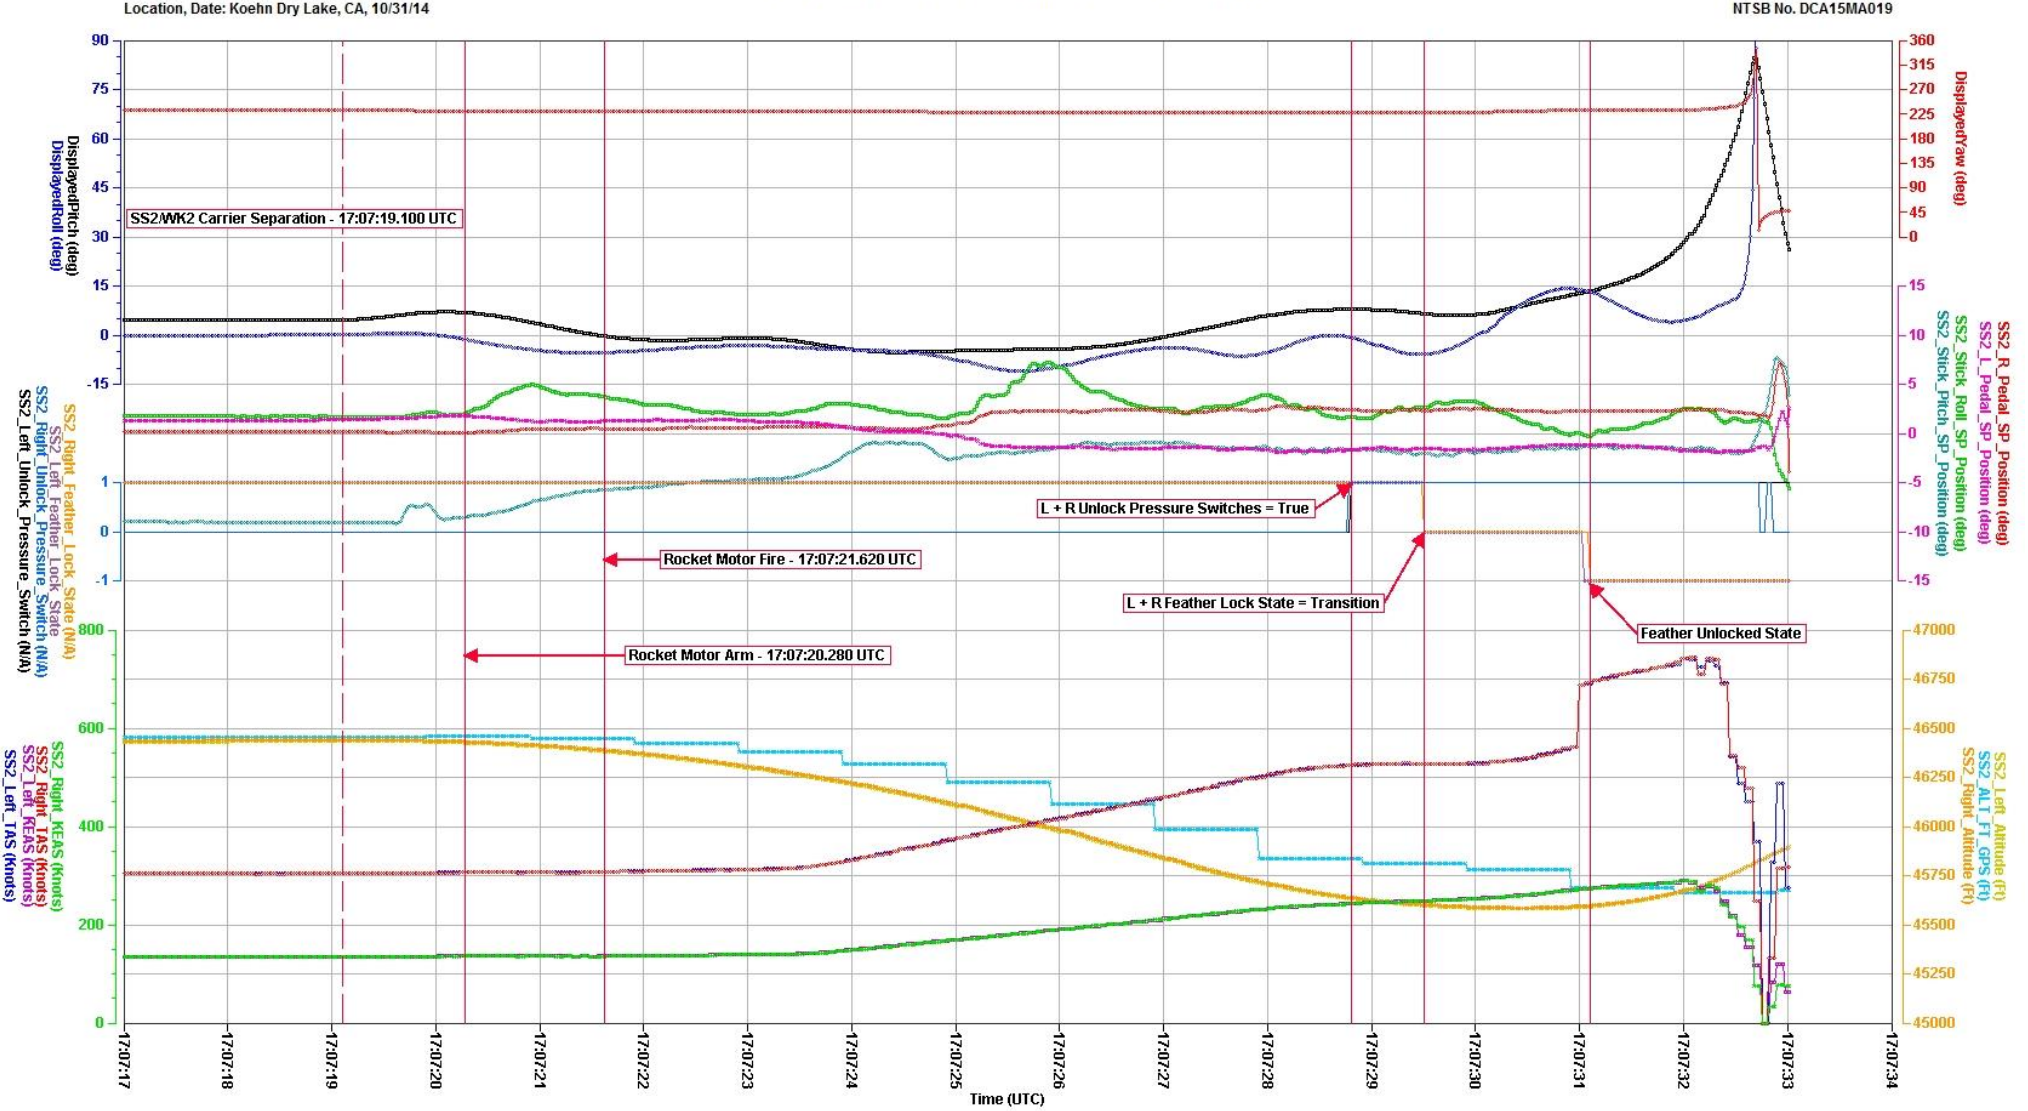
Figure 16 is an expanded resolution plot of the same parameters displayed in Figure 15. The plot covers a total of 17 seconds between 17:07:17 and 17:07:34 UTC, the time interval around carrier separation (WK2 release) and loss of signal. The plot shows carrier separation occurring at 17:07:19.100 UTC and the vehicle’s parameters continuing in a dynamic, yet nominal state. The times for the rocket motor armed discrete (17:07:20.280 UTC) and rocket motor fired (17:07:21.620 UTC) are demarcated as vertical lines at their associated times. Airspeed is shown increasing after rocket motor ignition along with a reverse in trend of the recorded altitude data as the pitch is shown increasing at a point described later in the accident flight.

Figure 16. Flight Controls and Select Vehicle Performance Parameters - Carrier Separation through Loss of Signal
 Scaled Composites SpaceShipTwo, PF04, N339SS

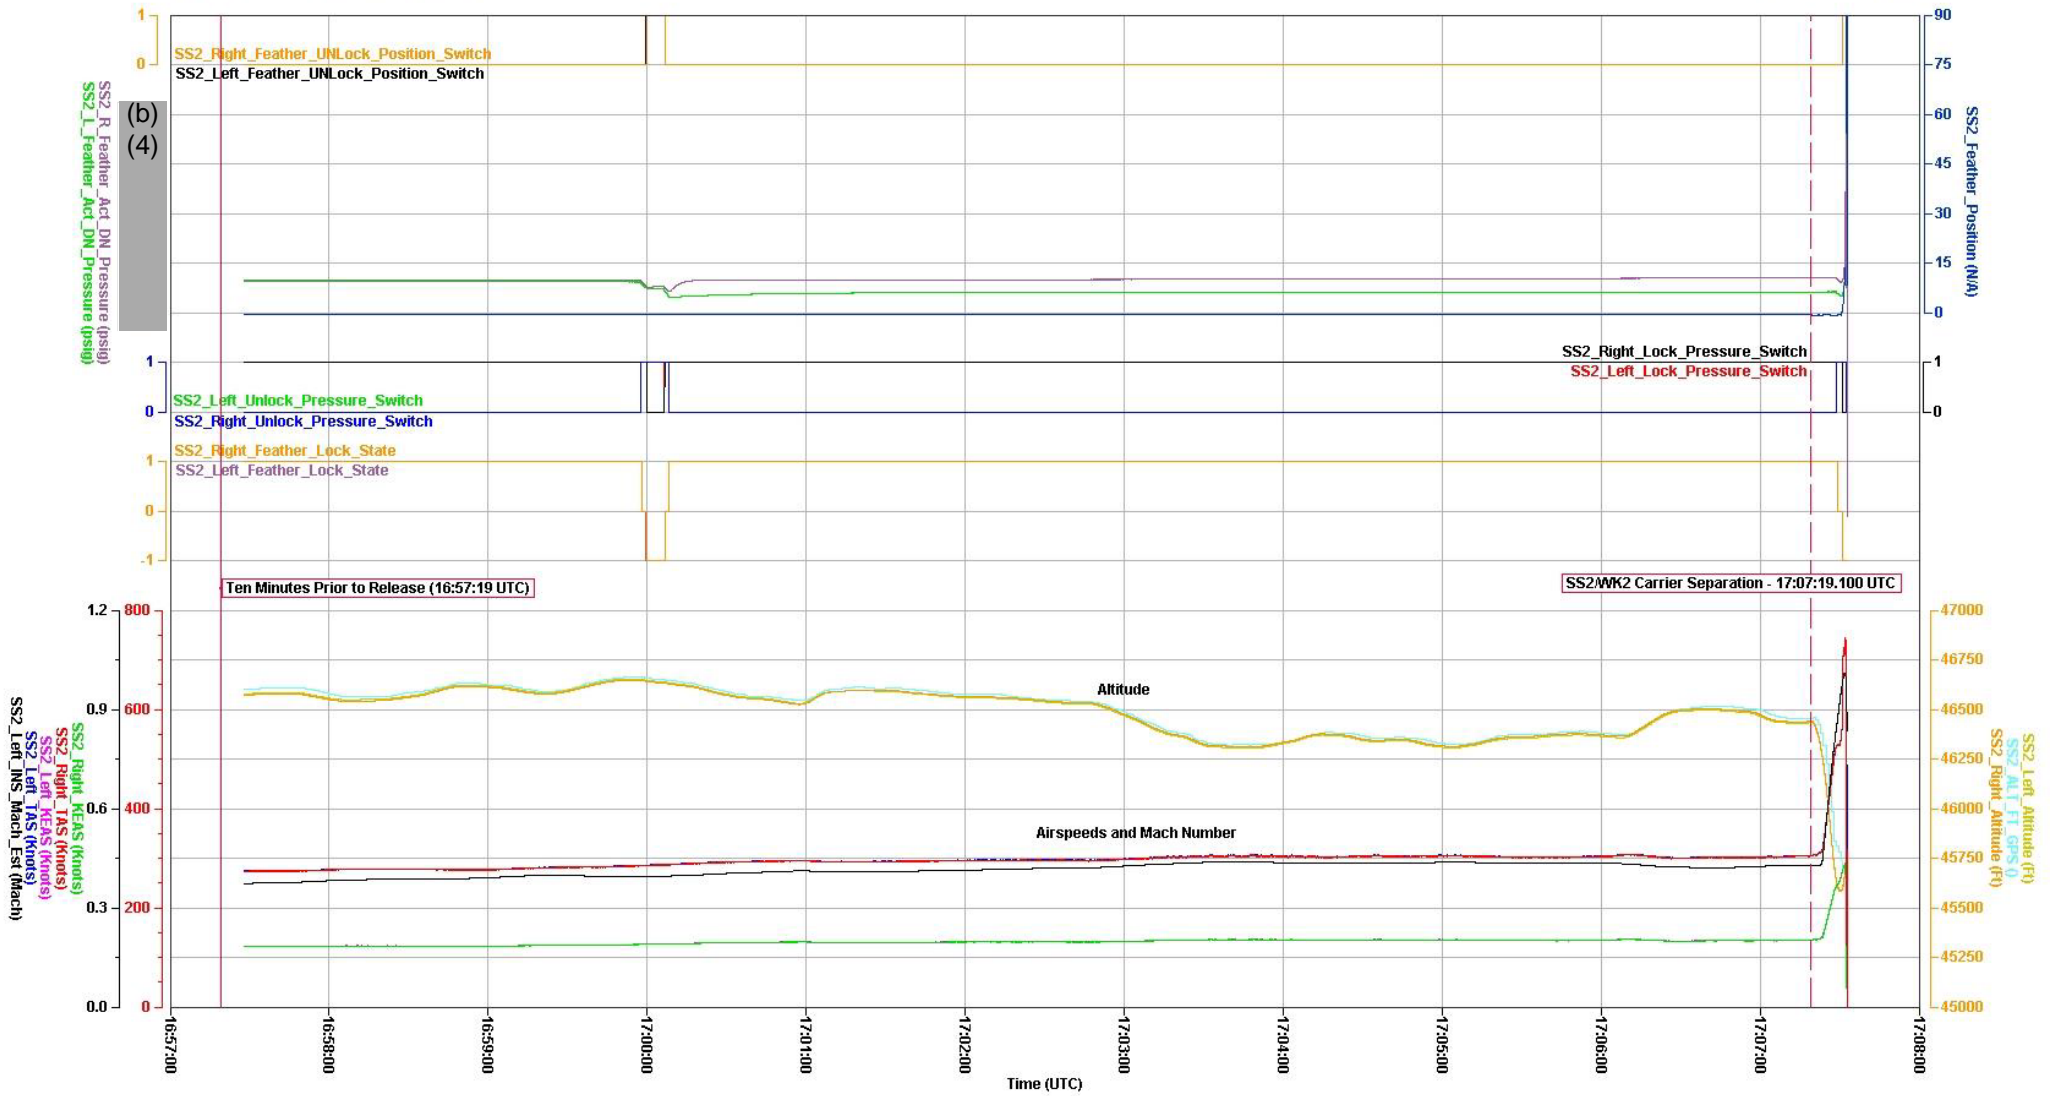
Figure 17 displays relevant feather-related parameters in relation to basic vehicle performance data. Data shows values for various feather-related parameters changing as expected during a time period consistent with the “L minus 10” checks. Near the end of the recording, data shows airspeed and Mach number increasing rapidly until the left and right Feather Lock States indicates a transition occurring to an unlocked state at 17:07:31.100 UTC. Loss of signal occurs shortly thereafter.

Figure 17. Feather System and Selected Vehicle Performance Parameters – L – 10 through Loss of Signal
 Scaled Composites SpaceShipTwo, PF04, N339SS

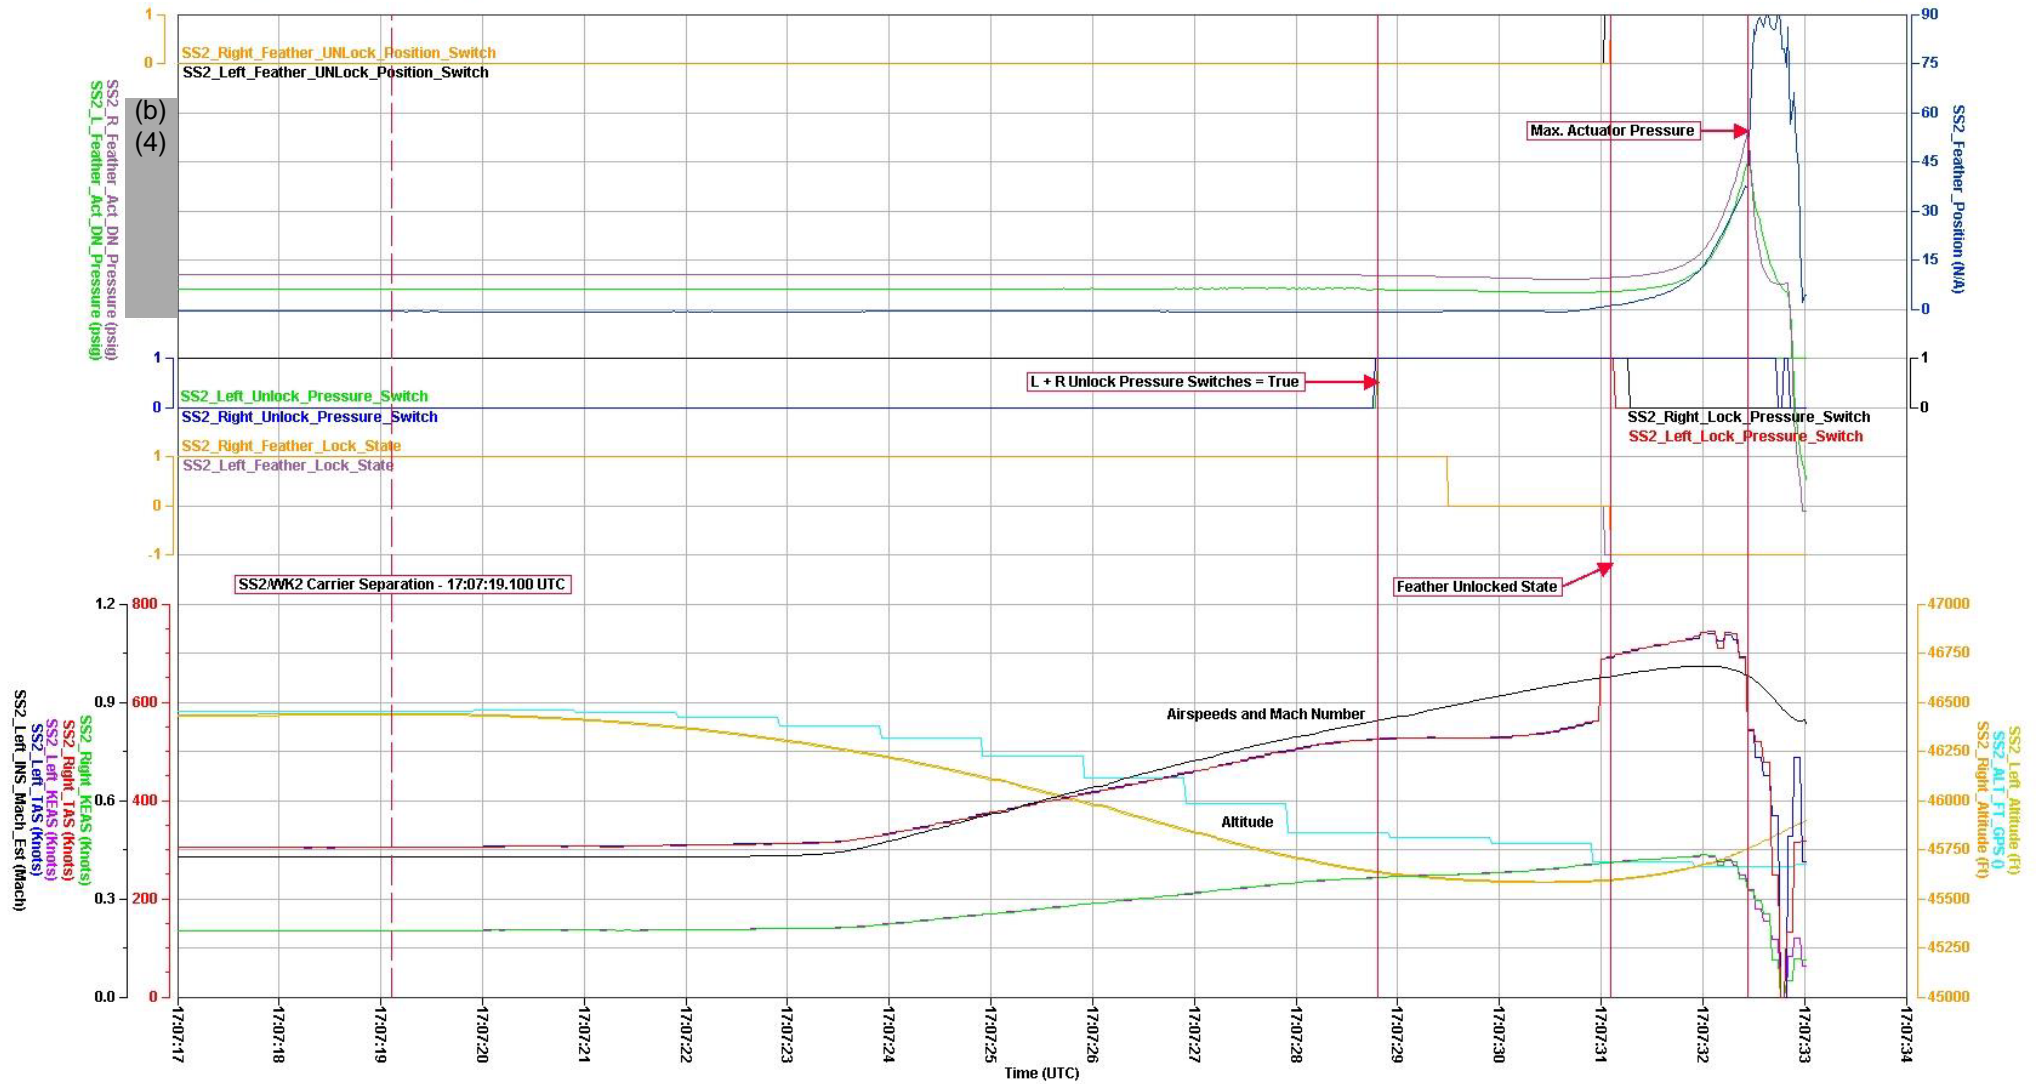
Figure 18 is an expanded resolution plot of the same parameters displayed in Figure 17. The plot covers a total of 17 seconds between 17:07:17 and 17:07:34 UTC, the time interval bounded by carrier separation and loss of signal. Data shows airspeed and Mach number climbing rapidly as the vehicle slowly reverses an altitude loss trend after carrier separation. Left and Right Feather Unlock Pressure switches are shown as true at 17:07:28.800 UTC, and Feather Lock State shows Unlocked by 17:07:31.100 UTC. Shortly afterward, Left and Right Feather Actuator Down Pressures climb until Right Feather Actuator Down Pressure reaches a maximum value at 17:07:32.440 UTC. In

Figure 18. Feather System and Selected Vehicle Performance Parameters – Carrier Separation through Loss of Signal
 Scaled Composites SpaceShipTwo, PF04, N339SS

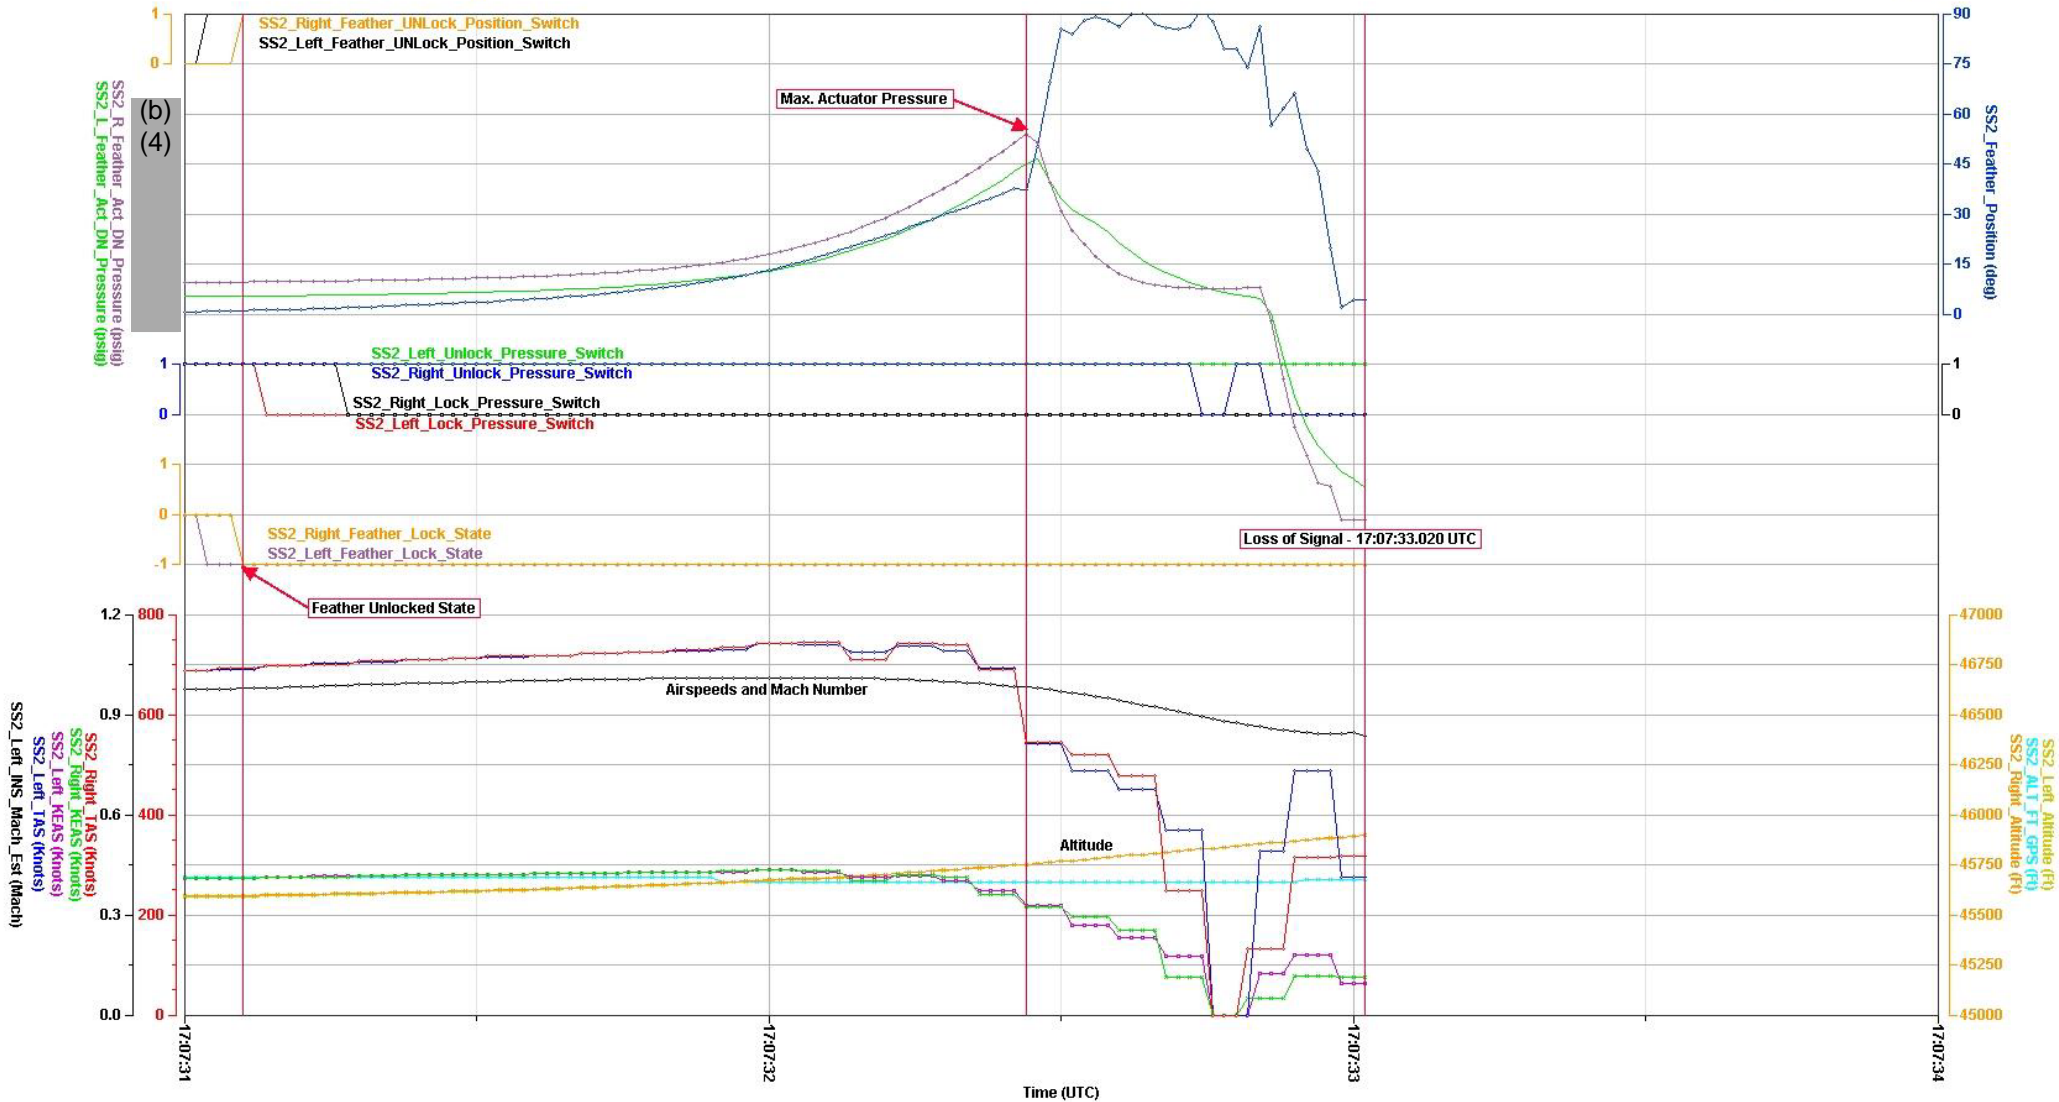
Figure 19 is an expanded resolution plot of the same parameters displayed in Figures 17 and 18. The time interval is just over 2 seconds total, from 17:07:31 UTC until loss of signal at 17:07: 33.020 UTC.

Figure 19. Feather System and Selected Vehicle Performance Parameters – Final Portion of Signal
 Scaled Composites SpaceShipTwo, PF04, N339SS

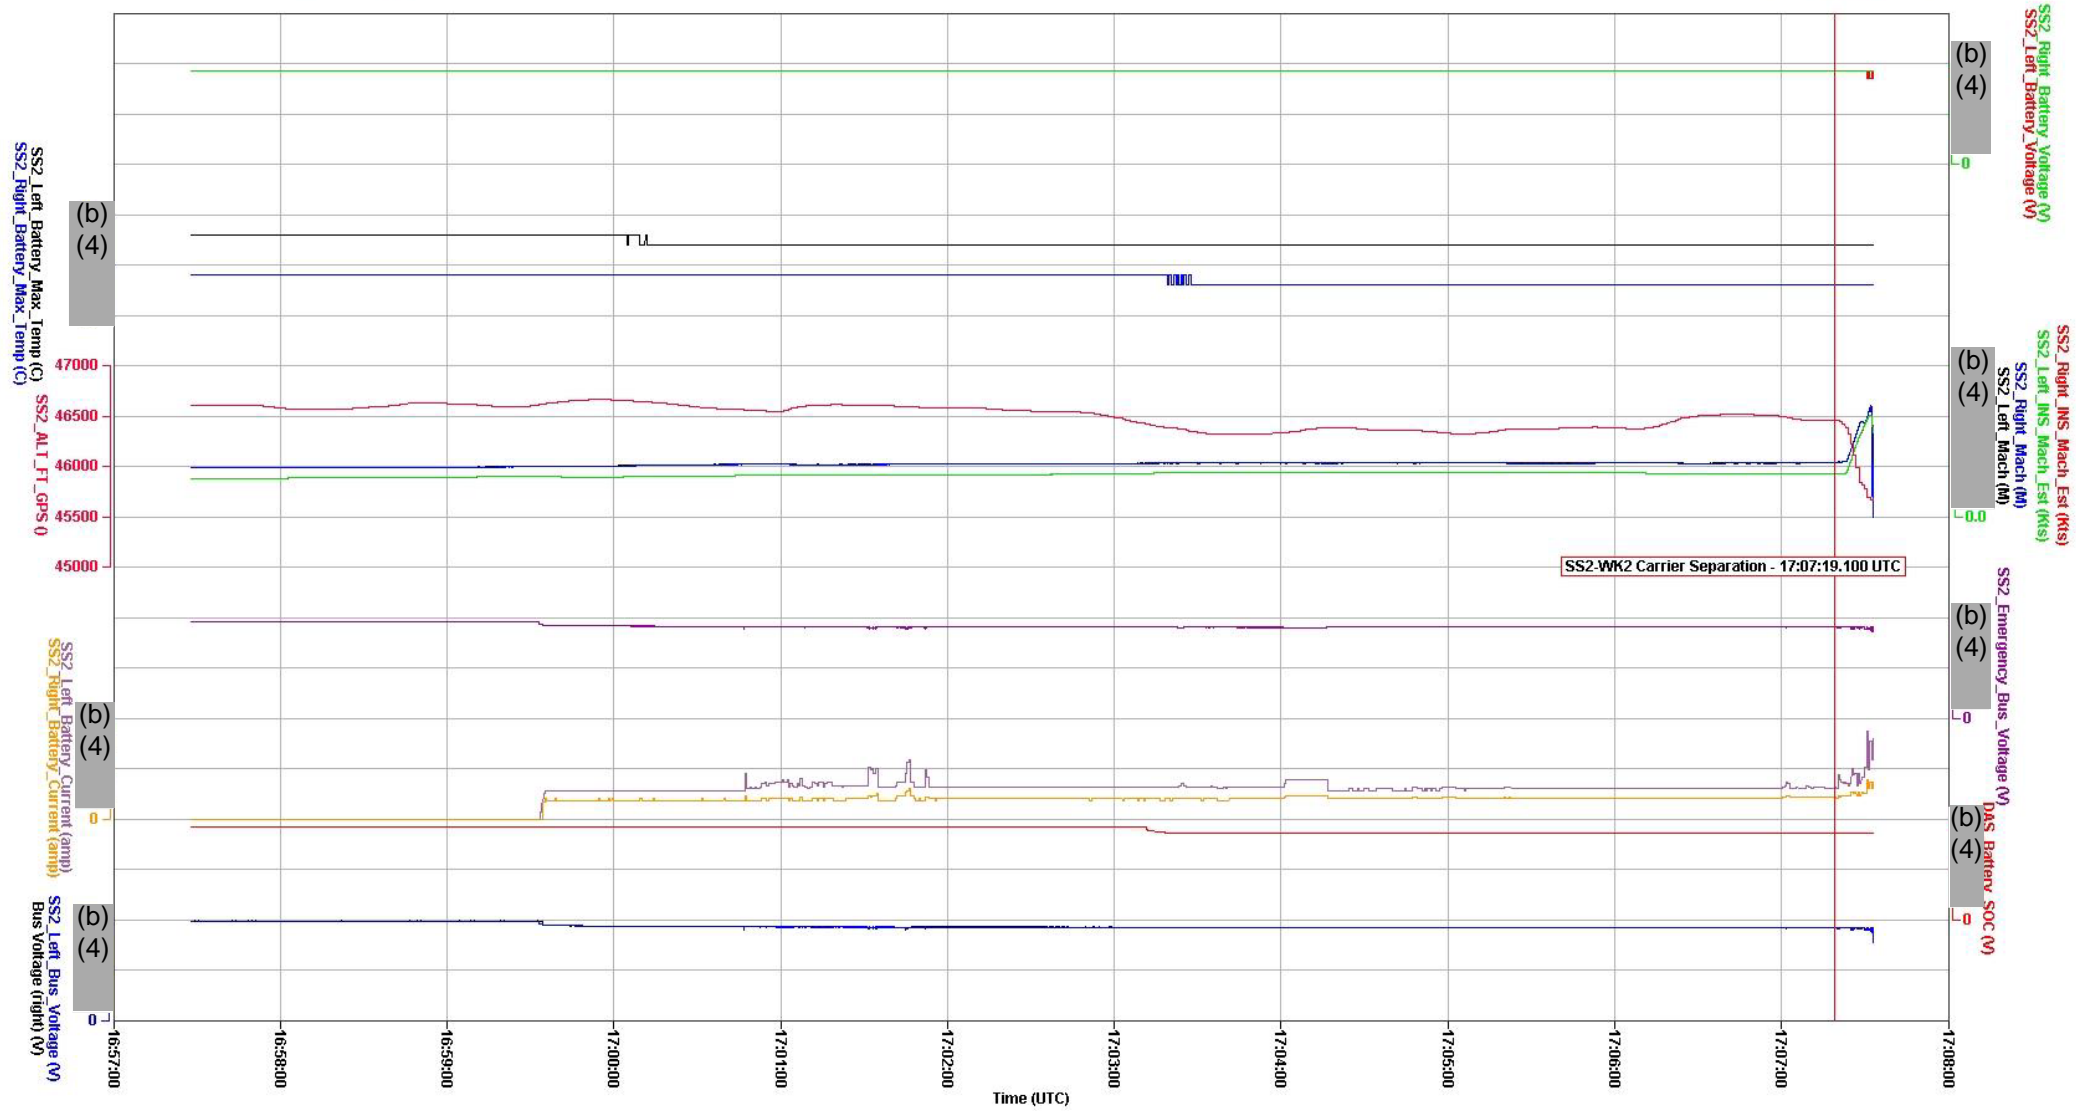
Figure 20 displays various SpaceShipTwo electrical system related parameters. The plotted time interval begins at 16:57:00 UTC and covers the “L minus 10” checks through carrier separation and loss of signal. Mach number, and altitude are also plotted for reference. The plotted parameters show the electrical system functioning nominally throughout the recording.

Figure 20. Electrical System – L – 10 through Loss of Signal
 Scaled Composites SpaceShipTwo, PF04, N339SS

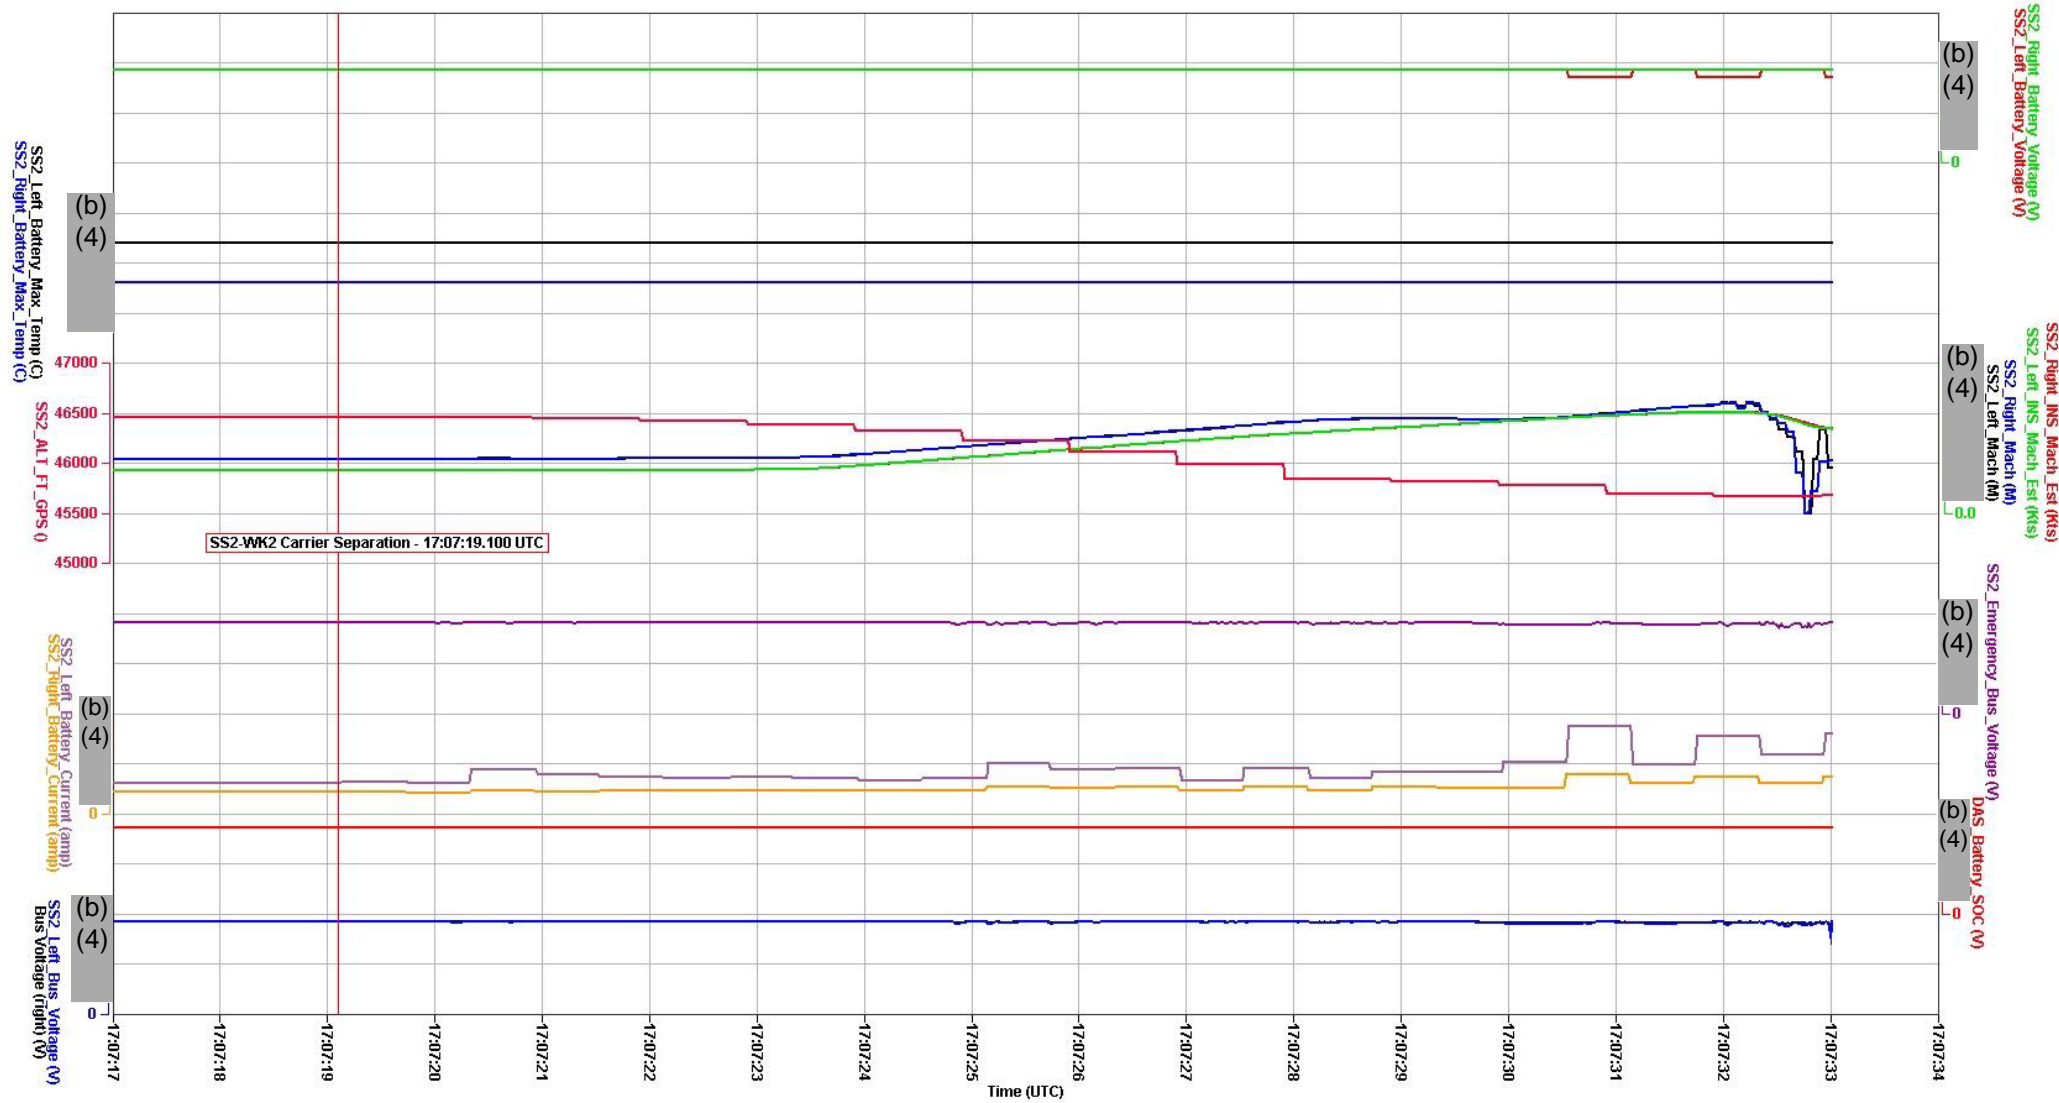
Figure 21 is an expanded resolution plot of the same parameters displayed in Figure 20. The plot covers a total of 17 seconds between 17:07:17 and 17:07:34 UTC, the time interval around carrier separation and loss of signal. Data shows the electrical system functioning nominally throughout the plotted time interval.

Figure 21. Electrical System – Carrier Separation through Loss of Signal
 Scaled Composites SpaceShipTwo, PF04, N339SS

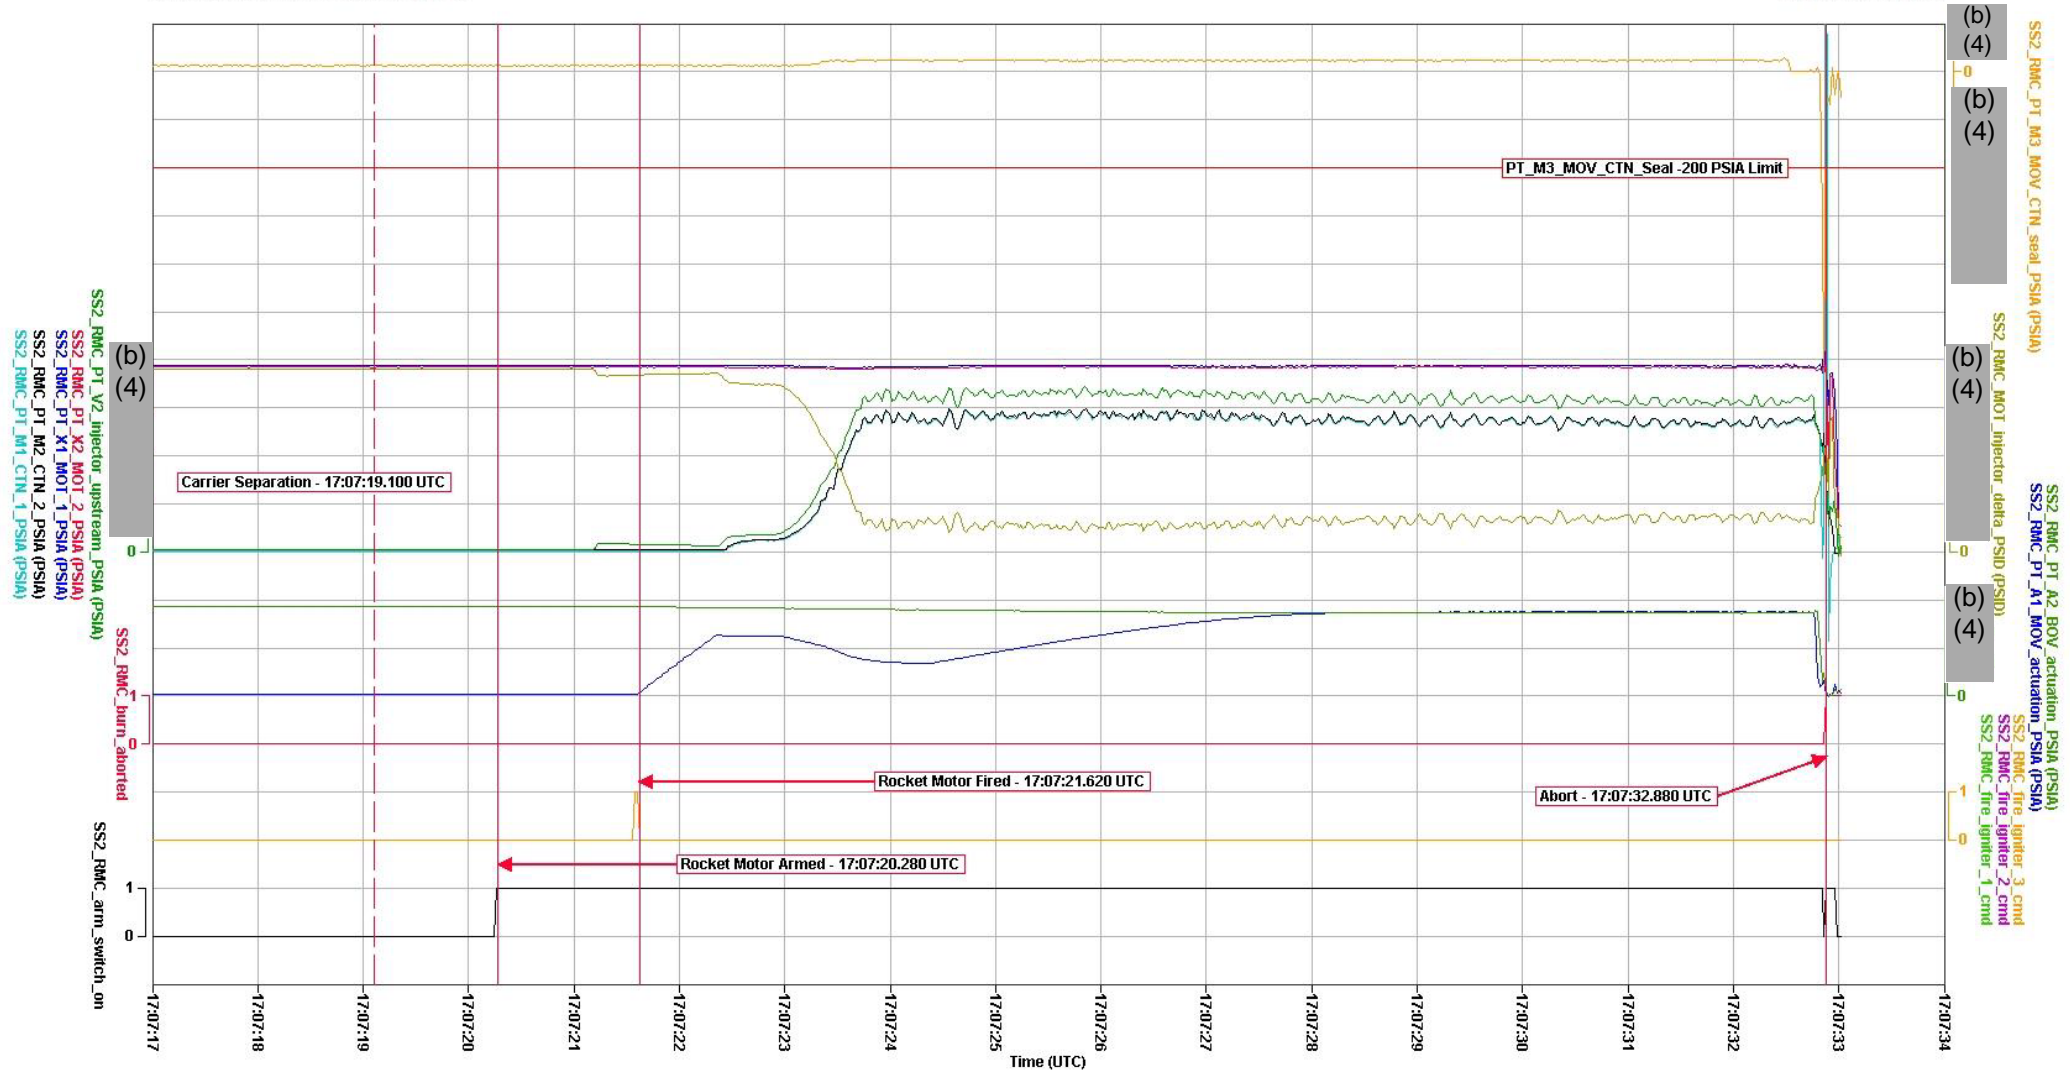
Figure 22 contains selected rocket motor performance parameters obtained via the SODAS compact flash card. The plot covers a total of 17 seconds between 17:07:17 and 17:07:34 UTC, the time interval bounded by carrier separation and loss of signal. The plot focuses on pressure values in the oxidizer tank, oxidizer injector plenum, and the combustion chamber (Case Throat Nozzle region – CTN). The plot shows the pressure rising nominally from the time of rocket motor ignition (17:07:21.620 UTC) until loss of signal. Additionally, the plot shows Main Oxidizer Valve actuation pressure (MOV) and Backup Oxidizer Valve actuation pressure (BOV). Pressure is seen increasing in the MOV actuator nominally from the time of rocket motor ignition. Both parameters drop to near zero pressure readings near the end of the recording.

Figure 22. SODAS RMC Data – Select Rocket Motor Discretes and Pressures – Carrier Separation through Loss of Signal
 Scaled Composites SpaceShipTwo, PF04, N339SS
