**NATIONAL TRANSPORTATION SAFETY BOARD**  
**Office of Aviation Safety**  
**Washington, D.C. 20594**

**EMERGENCY FLOTATION SYSTEM GROUP FACTUAL REPORT**

**NTSB No: ERA18MA099**

Operator: Liberty Helicopters, Inc.  
Aircraft: Airbus Helicopters AS350 B2, Registration N350LH  
Location: New York, New York  
Date: March 11, 2018  
Time: 1908 eastern daylight time

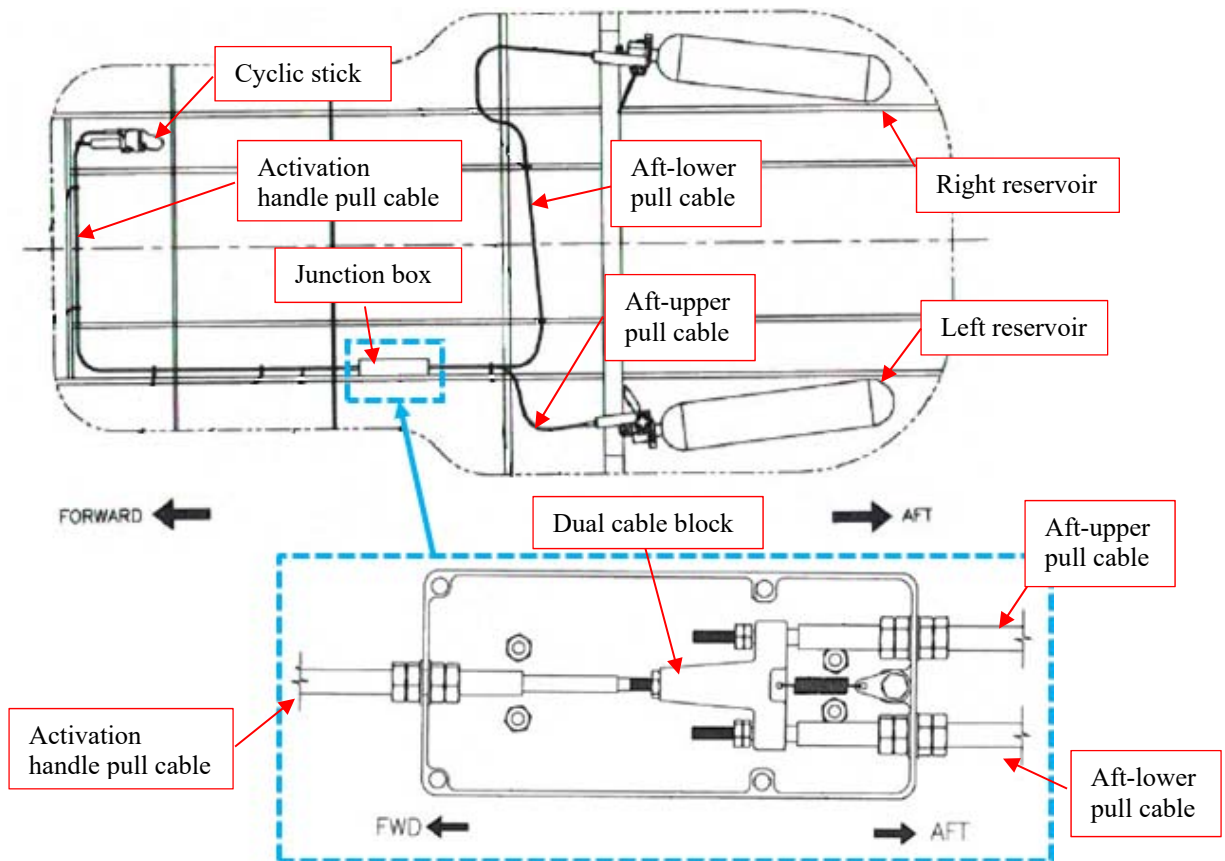
For installations where the pilot cyclic stick is mounted on the right side of the helicopter (Figure 1), the activation handle is connected to a pull cable that is first routed underneath the cockpit floor, laterally across the underside of the airframe, and then routed aft to a junction box. This junction box, installed on the left frame rail, contains a dual cable block that transmits the motion of one pull cable to two separate pull cables. Specifically, the pull cable from the activation handle connects to the forward end of the dual cable block and two separate pull cables, identified as the aft-upper and aft-lower pull cables, are attached to the aft end of the dual cable block. When the activation handle is pulled aft, the activation handle pull cable moves the dual cable block forward. A spring attached to the dual cable block returns the block to its starting position when the activation handle is released. The aft-lower pull cable is first routed aft, then laterally across the underside of the airframe to the valve of the right reservoir assembly. The aft-upper pull cable is routed aft to the valve of the left reservoir assembly. The pull cables are typically secured to the airframe with cable ties or loop clamps.

**Figure 1. Typical routing of the activation pull cables when the pilot cyclic stick is installed on the right side of the helicopter, per Installation Instruction No. II350-600. (Image courtesy of Dart Aerospace)**

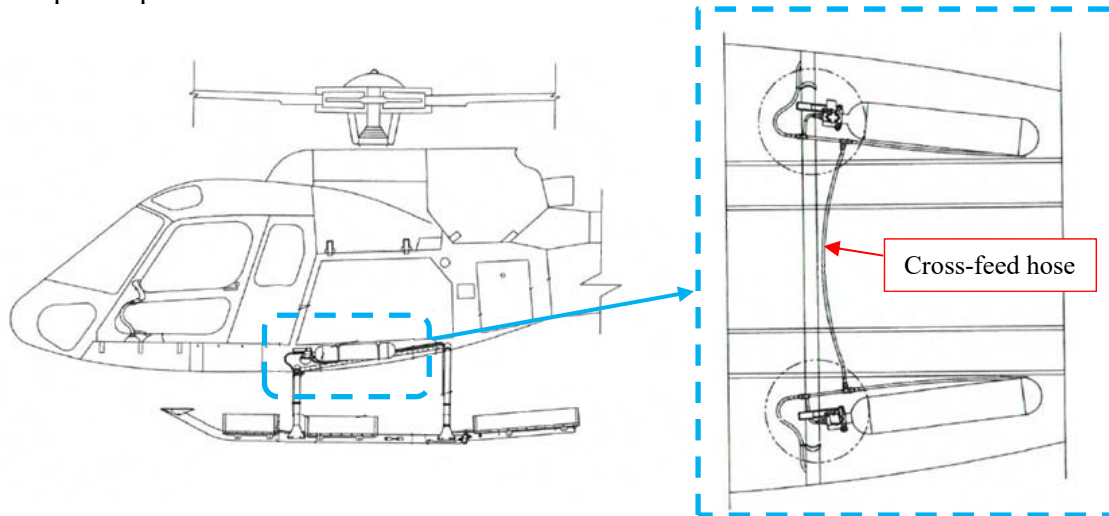
Hoses connect the three left floats to the left manifold, the latter of which is supplied gas by the left reservoir assembly. Similarly, hoses connect the three right floats to the right manifold. A cross-feed hose, installed between the left and right manifolds, allows gas to traverse between the left and right

sides, e.g. the right reservoir assembly can inflate the left floats (Figure 2). The hoses are secured to the skids with loop clamps.

**Figure 2. The cross-feed hose installation.** (Image courtesy of Dart Aerospace)

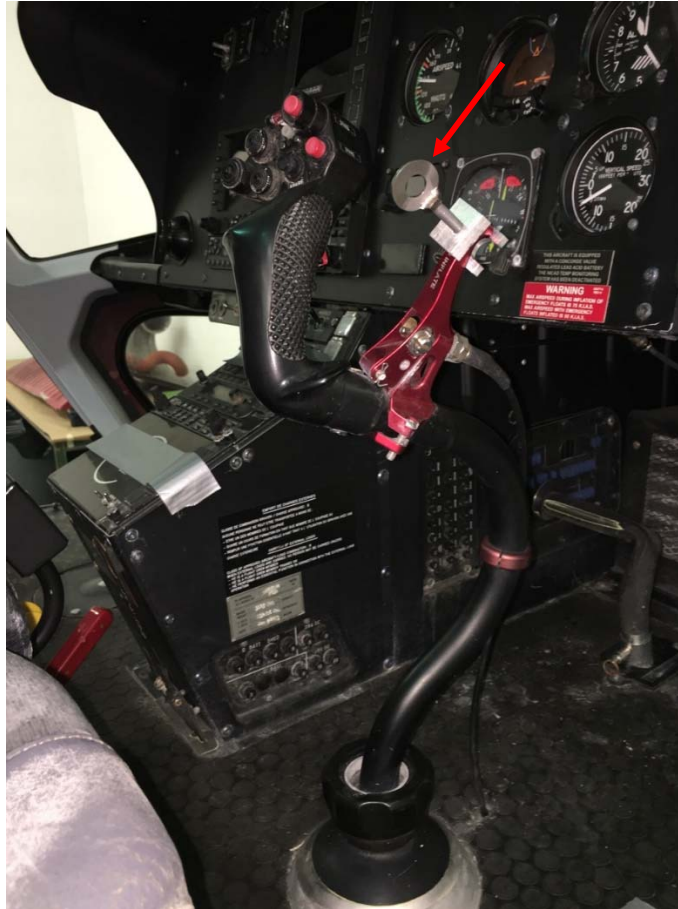
**Figure 14. The red arrow points to the fixture installed on top of the activation handle.**

The cyclic was braced and the force gauge was pulled until a “pop” sound, consistent with a valve activation, was heard. The person pulling the force gauge noted the activation handle did not travel fully aft, but had stopped pulling the activation handle, when the pop sound was heard. The force gauge indicated a peak load of 45.1 pounds. The left valve cable and ball were found outside of its housing, consistent with activation of the left valve. The right valve cable and ball were still contained within their housing, consistent with the right valve not having activated. The dual cable block within the junction box returned to its resting position when the activation handle was released. A gap was visible between aft-upper cable nut, the aft-lower cable nut, and the block surface. However, the aft-upper cable nut was displaced further forward than the aft-lower cable nut, i.e. the aft-upper cable nut had a larger gap between it and the block surface. Without resetting the pull cable system, the force gauge was pulled again by the same person (using one hand to pull the force gauge and the other hand to brace the cyclic) but the right valve did not activate; the force gauge indicated a peak load of 58.4 pounds. Using the left hand to brace the cyclic grip and the right hand to pull the activation handle (without using the force gauge) the same person pulled the handle aft until a “pop” was heard; the right valve was visually confirmed to have activated.

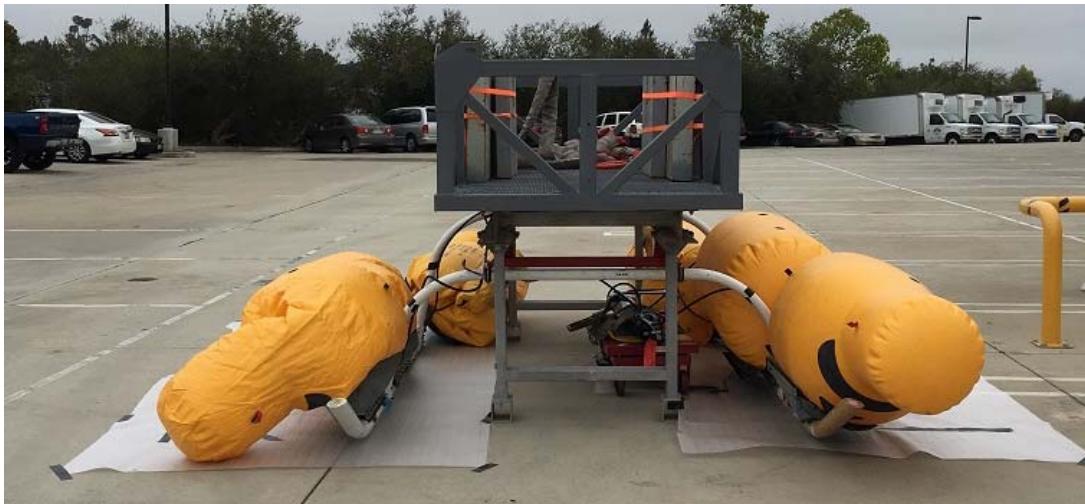
For the first inflation test, the three floats on the left skid appeared visually more inflated than the three floats on the right skid (**Figure 23**). The pattern of inflation

appeared similar to that of the accident helicopter floats. **Table 2** contains the measured inflation of each float chamber for the first inflation test.

**Figure 23. The inflated floats at the conclusion of the first inflation test.**

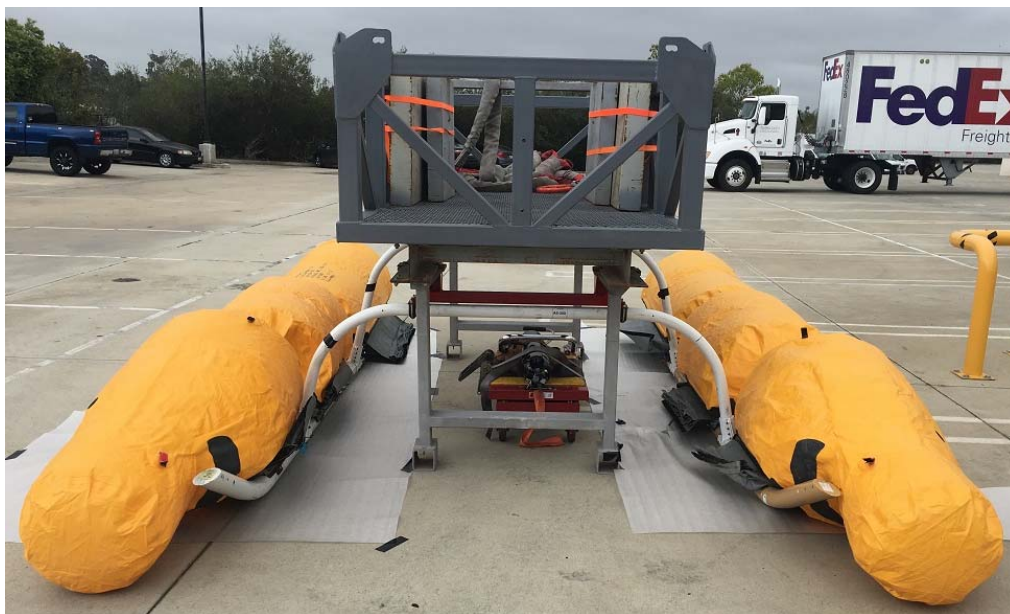
For the third inflation test, the floats on the left and right sides visually appeared similar in fullness (**Figure 25**). **Table 4** contains the measured inflation of each float chamber for the third inflation test.

**Figure 25. The inflated floats at the conclusion of the third inflation test.**

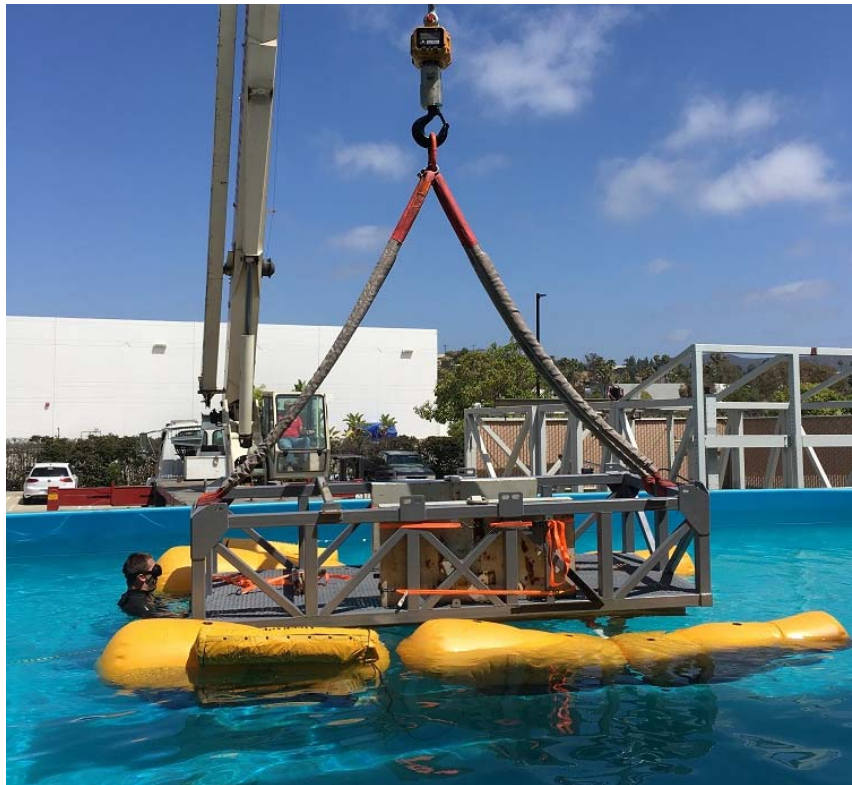
For the second buoyancy stability test, weight was removed from the test rig until it weighed about 5,220 pounds<sup>16</sup> and the straps were installed longitudinally on the forward and aft upper rails of the frame. The pressure within each float chamber was measured prior to placement of the test rig into the pool; the measured pressures can be found in **Table 6**. The test rig was slowly lowered into the pool (**Figure 26**). There was no evidence of significant gas leakage from any of the floats. The test rig floated in the pool for at least 26 seconds (but less than 1 minute), after which it began to roll to the right. The right roll was arrested by the straps attached to the crane, preventing the test rig inverting in the pool. The test rig was raised out of the pool and water was allowed to drain from the test rig for about 1-2 minutes. The test rig was placed back into the pool and the straps were allowed to completely slack, after which the test rig quickly rolled to the right and the right skid hit the bottom of the pool. Testing was stopped at this point.

**Figure 26. The test rig after placement into the pool.**
