ENGINE EXAMINATION REPORT

ENGINE MODEL	IO-520-E
ENGINE SERIAL NUMBER	215503-R
AIRCRAFT MAKE & MODEL	Aero Commander 500A
AIRCRAFT SERIAL NUMBER	500A-914-22
AIRCRAFT REGISTRATION	N41AV
FILE NUMBER	14-308

EXAMINATION		ACCIDENT DATA	
DATE	04/14/2015	NTSB ACCIDENT #	CEN15FA056
FACILITY	Continental Motors Inc.	NTSB INVESTIGATOR	Jason Aguilera
ADDRESS	2039 S Broad St Mobile, AL 36615	FAA INVESTIGATOR	Brian Fricker
		ACCIDENT DATE	11/23/2014
		ACCIDENT LOCATION	McDade, Texas

Inspection of the engine revealed that the engine displayed oil starvation signatures. It was reported that the oil gage housing extension was not installed in the oil gage housing at the accident site. Inspection of the oil gage housing and housing extension revealed the rubber hose was not properly installed when compared to SIL14-6.

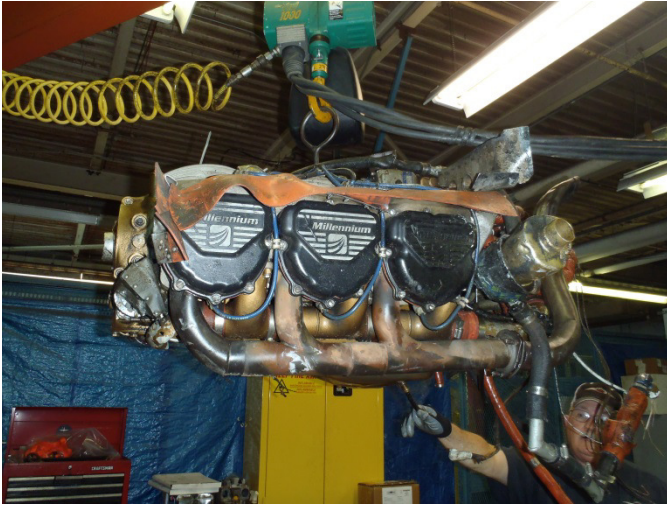
EXHAUST SYSTEM

Condition: The exhaust system displayed damage consistent with impact damage; the damage was more prevalent to the right side exhaust system. There were no anomalies noted with the exhaust system.

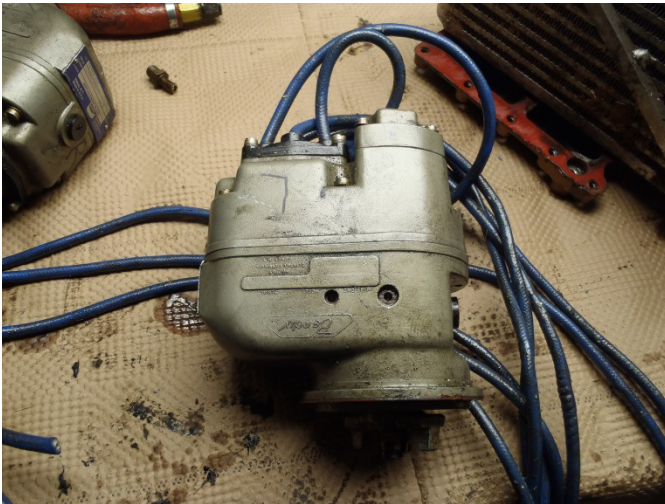
MAGNETO-TO-ENGINE TIMING	Specification: 22° BTDC	L/H: Unable to determine	R/H: Unable to determined
LEFT MAGNETO	Manufacturer: CMI	P/N: 10-600606-1	S/N: 716055
Condition:	The left magneto remained attached to its respective mounting pad and displayed damage consistent with impact and mechanical damage; the top magneto cap was broken. Due to the impact damage the magneto could not be tested on a test bench. The magneto was disassembled and there were no anomalies noted with the internal components.

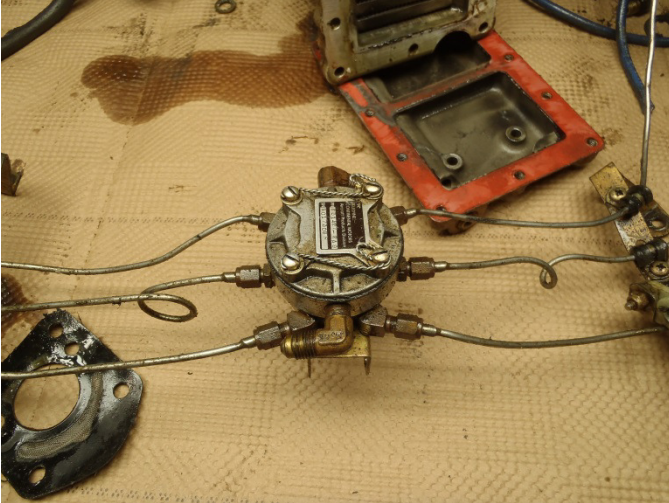
FUEL MANIFOLD VALVE	Manufacturer: CMI	P/N: 631427-2A9	S/N: B017308R
----------------------------	-------------------	-----------------	---------------

Condition:	The fuel manifold valve remained attached to its respective installation point and was undamaged. The manifold valve was disassembled and the internal components were inspected. There were no anomalies noted with the internal components and the screen was clear of contaminates.
-------------------	--

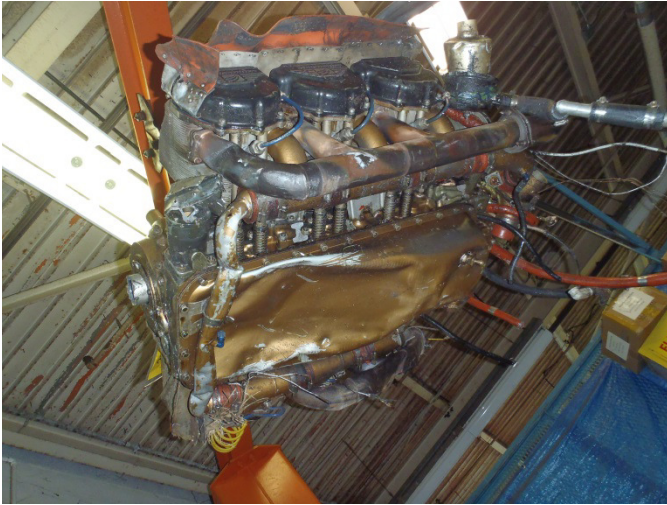
OIL SUMP

Condition: The oil sump sustained damage consistent with impact damage. The oil sump was removed and it was noted only residual oil remained within the oil sump. The oil sump also contained a significant amount of metallic material consistent with connecting rods, bearings, crankcase material, and other unidentifiable metallic debris.

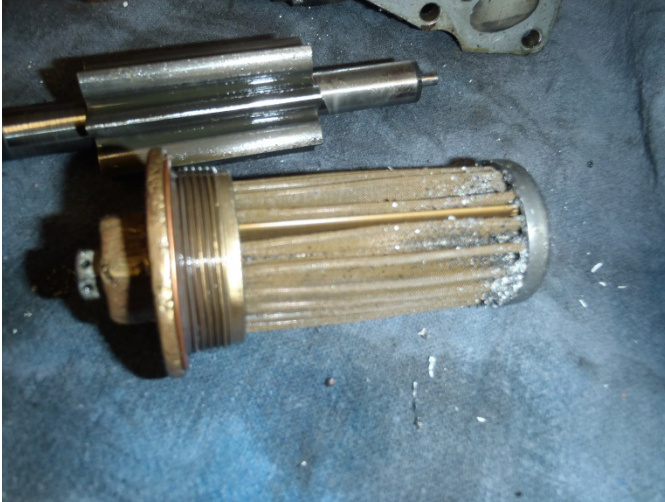
OIL SCREEN

Condition: The oil screen remained secure in its respective installation point and was undamaged. The screen was removed and it was noted there was a significant amount of metallic material present in the oil screen.

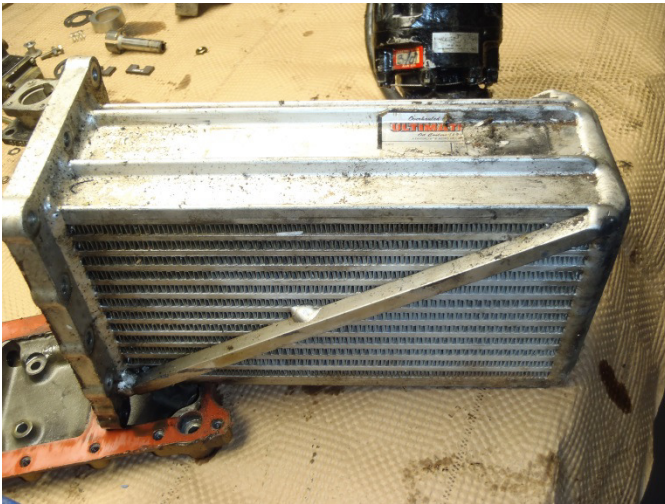
OIL COOLER

Condition: The oil cooler remained attached to the oil cooler adapters and displayed minor impact damage signatures and normal operating signatures. There were no anomalies noted with the oil cooler

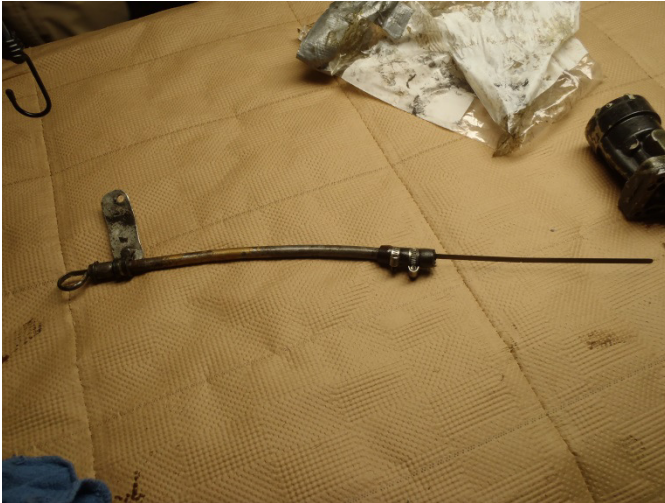
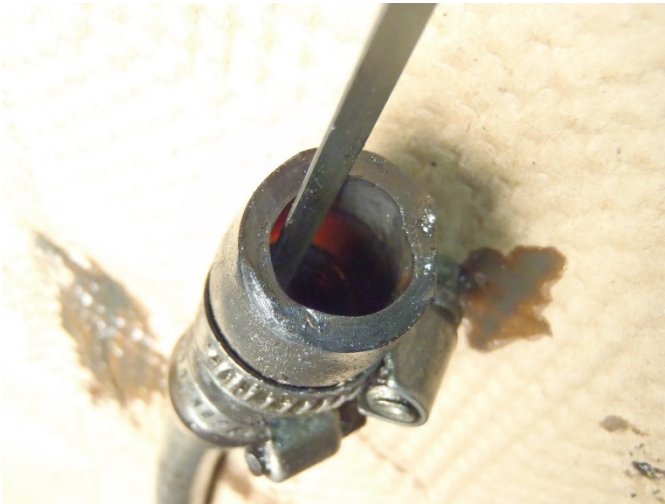
OIL GAGE

Condition: According to the on scene investigator the oil gage housing extension was found detached from its oil gage housing in the engine crankcase. The oil gage housing extension was inspected and there were no signs of impact damage. The oil gage hose was not positioned in such a way to place the oil gage housing extension joint in the middle of the hose; according to SIL14-6 the hose should be centered over the connection joint. It was also noted that the top hose clamp was placed below the oil gage housing extension bead; the bead on the oil gage housing extension is designed to fit securely against the oil gage housing. The hose material was not as specified in CMI parts manual.

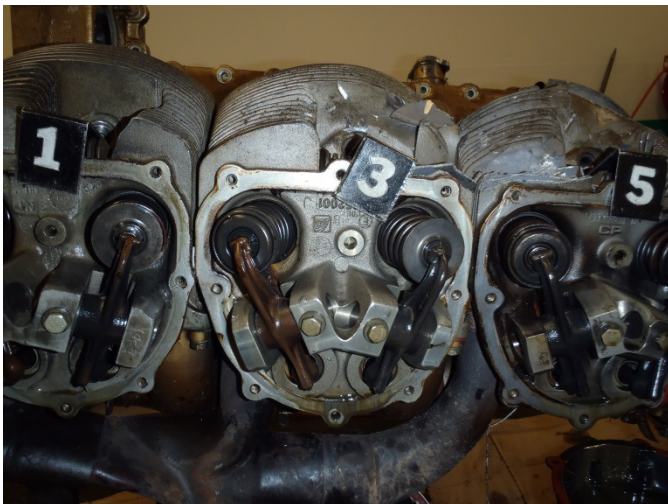
CYLINDER #3	P/N: SA52006-A1	S/N: 526-113-12630	
Condition:	The cylinder remained attached to its respective cylinder bay and displayed damage consistent with impact damage. The cylinder was removed and it was noted that the valve heads, cylinder bore, and combustion chamber displayed normal operating and combustion signatures. The cylinder skirt displayed damage consistent with mechanical damage. The overhead components displayed normal operating signatures.

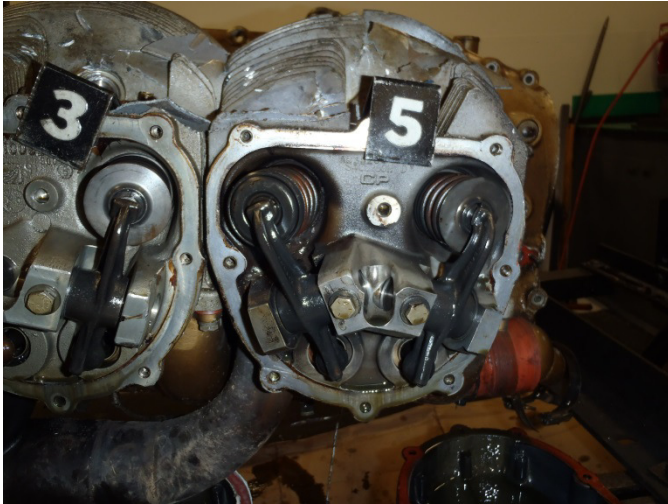
CYLINDER #5 P/N: Illegible S/N: Illegible

Condition: The cylinder remained attached to its respective cylinder bay and displayed damage consistent with impact damage. The cylinder was removed and it was noted that the valve heads, cylinder bore, and combustion chamber displayed some corrosion and normal operating and combustion signatures. The cylinder skirt was undamaged. The overhead components displayed normal operating signatures.

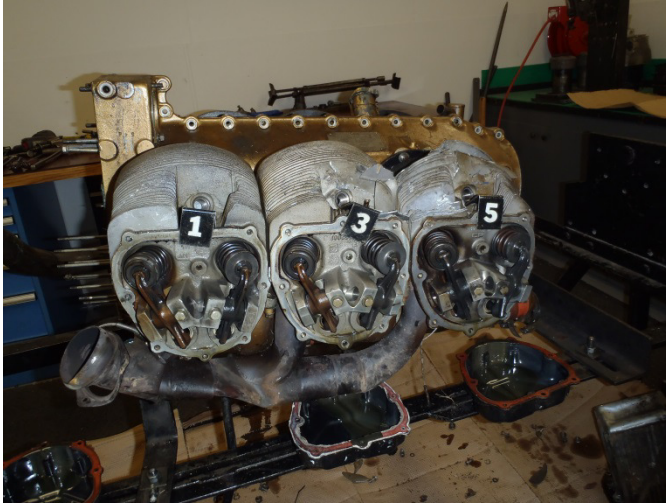
ROCKER ARMS AND SHAFTS

Condition: All of the rocker arms displayed normal operating signatures. There were no anomalies noted with the rocker arms.

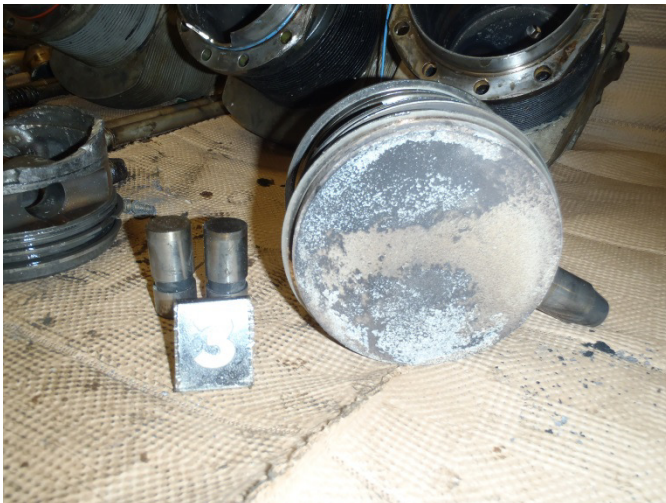
The piston head displayed normal combustion deposits. The piston skirt displayed normal operating signatures and the back of the piston displayed damage consistent with mechanical damage. All of the piston rings were intact and free to move in their respective grooves.

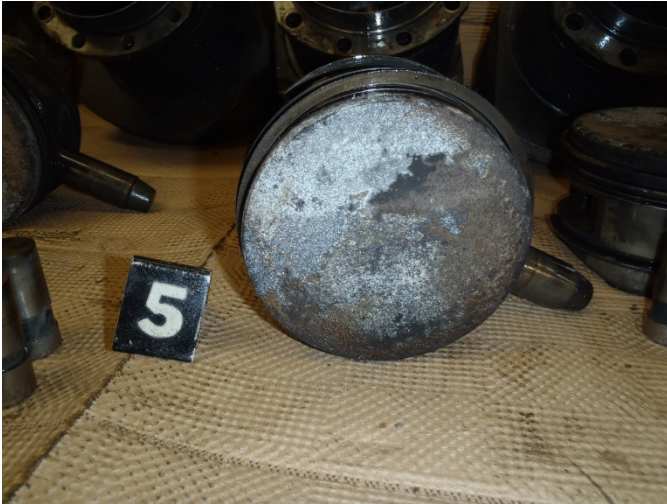
#5 PISTON, RINGS AND PIN	Piston P/N: 654850
-------------------------------------	--------------------

Condition: The piston head displayed normal combustion deposits. The piston skirt displayed normal operating signatures and the back of the piston displayed damage consistent with mechanical damage. All of the piston rings were intact and free to move in their respective grooves.

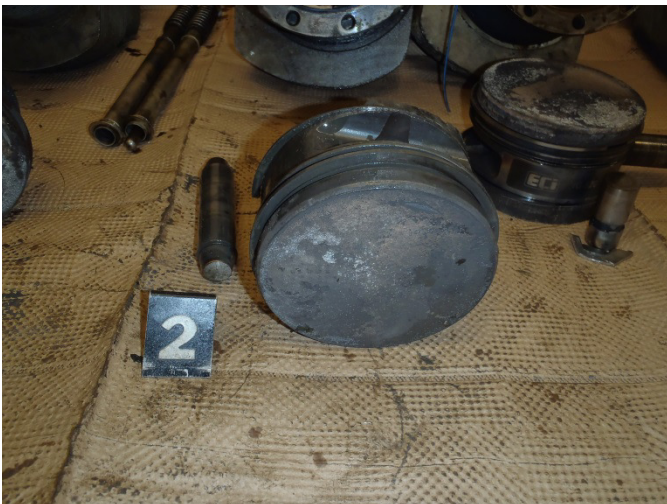
#2 PISTON, RINGS AND PIN	Piston P/N: 2654850
-------------------------------------	---------------------

Condition: The piston head displayed normal combustion deposits and had two semicircular indentions consistent with valve strikes. The piston skirt displayed normal operating signatures and the back of the piston displayed damage consistent with mechanical damage; a portion of the piston had broken free from the rest of the piston. The rear piston ring had broken which was consistent with the mechanical damage to the piston. The remaining piston rings were intact and free in their respective grooves.

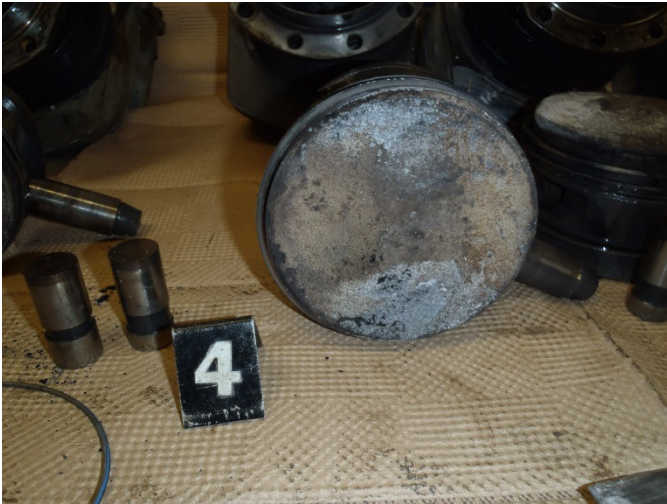
#4 PISTON, RINGS AND PIN	Piston P/N: SA648013
-------------------------------------	----------------------

Condition: The piston head displayed normal combustion deposits. The piston skirt displayed normal operating signatures and the back of the piston displayed damage consistent with mechanical damage; a portion of the piston had broken free from the rest of the piston. The rear piston ring had broken which was consistent with the mechanical damage to the piston. The remaining piston rings were intact and free in their respective grooves.

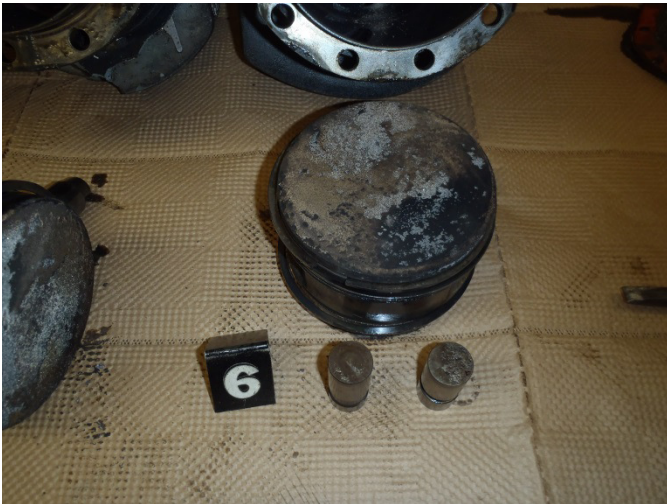
#6 PISTON, RINGS AND PIN	Piston P/N: SA648013
-------------------------------------	----------------------

Condition: The piston head displayed normal combustion deposits. The piston skirt displayed normal operating signatures and the back of the piston displayed damage consistent with mechanical damage. All of the piston rings were intact and free to move in their respective grooves.

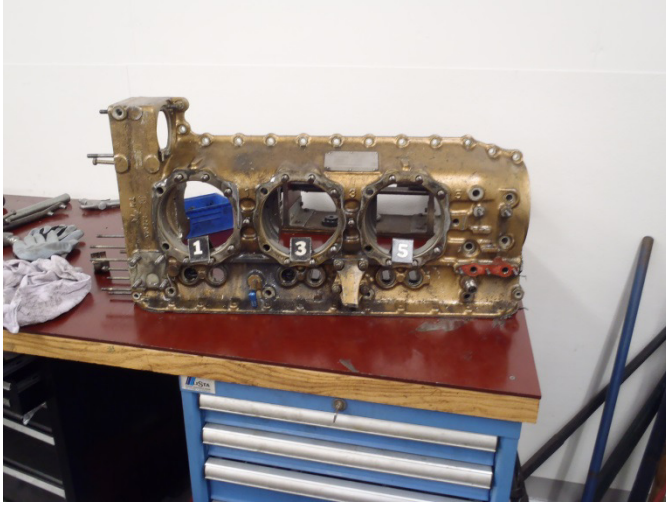
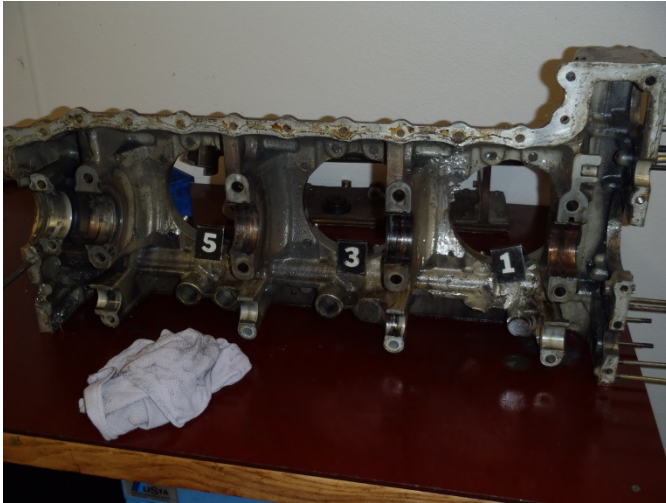
CRANKCASE	Casting Number:	1-3-5: 649043	2-4-6: 649042	S/N: A9 96 05 R
Condition:	The crankcase displayed damage in a form of a large hole at the #2 cylinder bay; the damage was consistent with mechanical damage from a released connecting rod. The internal portion of the crankcase displayed mechanical damage to the #1, #2, and the #4 cylinder bays. There were no signs of bearing movement or blockages of the oil galleys.

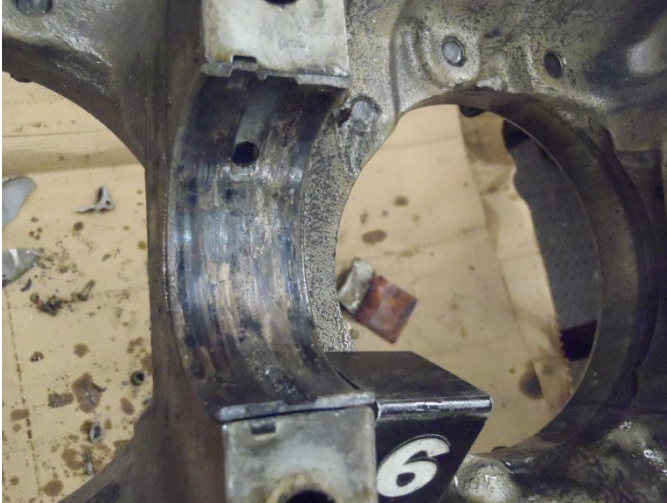
Left

#3 MAIN BEARINGS	P/N: SA642720	Date Code: 2-07
Condition:	The bearing was in place in the bearing saddle and displayed damage consistent with lubrication distress. The bearing displayed scoring and thermal smearing of the surface babbit.

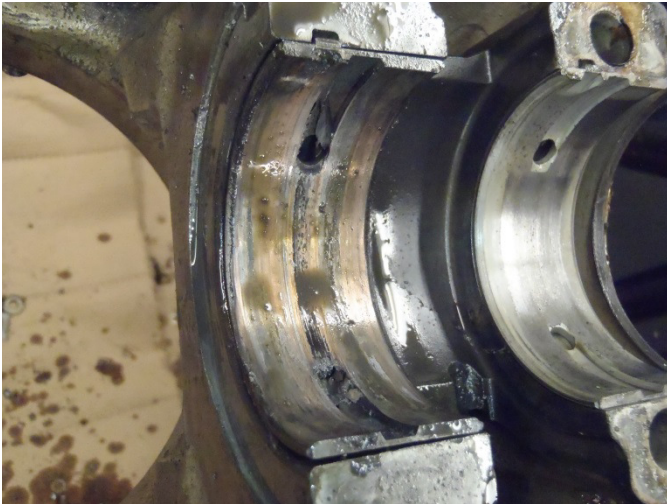
Left

#4 MAIN BEARINGS	P/N: SA642720	Date Code: 2-07
Condition:	The bearing was in place in the bearing saddle and displayed damage consistent with lubrication distress. The bearing displayed scoring and thermal smearing of the surface babbit.

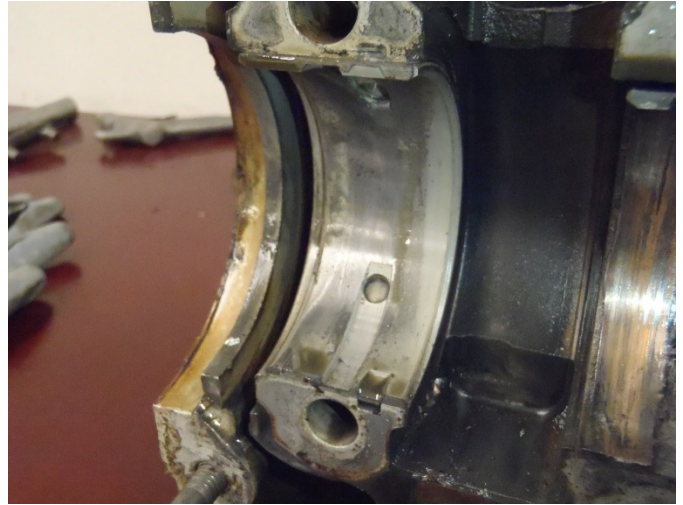
1-3-5

Condition: The bearing was in place in the bearing saddle and displayed normal operating signatures. There were no signs of bearing movement or distress with the bearing.

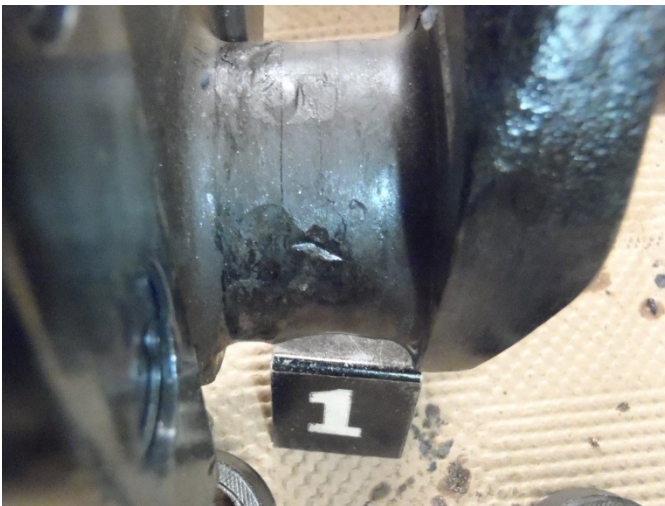
#1 Connecting Rod Journal

CRANKSHAFT	Forging Number: 649130	S/N: Propeller Flange Not returned	Heat code: HAO
Condition:	The propeller flange had broken free from the rest of the crankshaft and was not returned with the rest of the engine. The rest of the crankshaft was intact and the crankshaft gear was intact, secure, and the bolts were safety wired. The crankshaft main bearing displayed varying amount of lubrication distress; all of the connecting rod journal displayed lubrication distress signatures. The #1 and the #2 connecting rod bearings displayed the most thermal damage and also displayed some mechanical damage. The #1 and the #2 connecting rod journal oil galleys could not be inspected due to displaced journal material. The remaining oil galleys were intact and clear of any obstruction.
