Continental Motors, Inc.

ENGINE FIELD INSPECTION REPORT

ENGINE MODEL: TSIO-520-R9B

REGISTRATION: N1631X

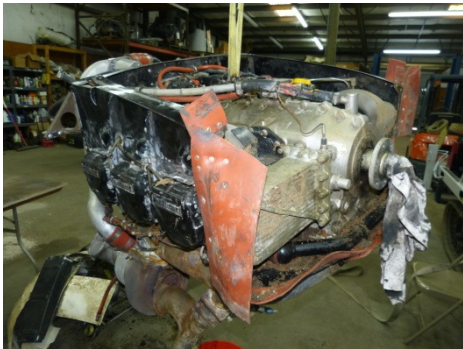
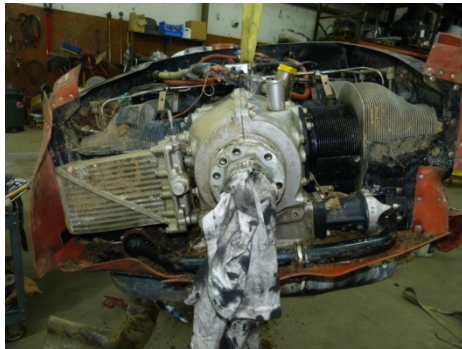
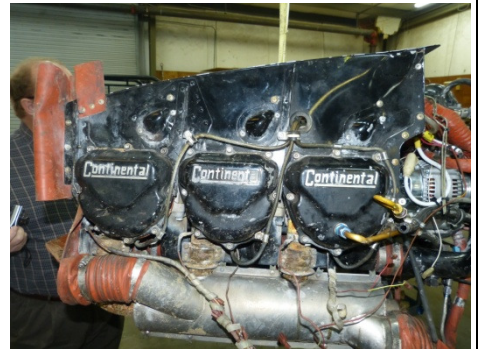
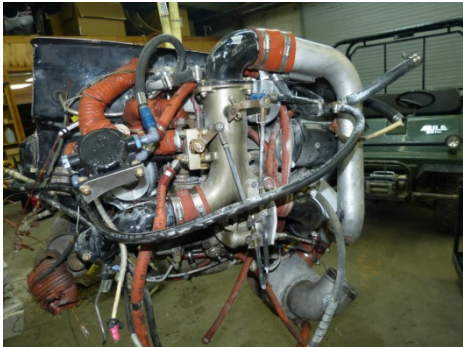
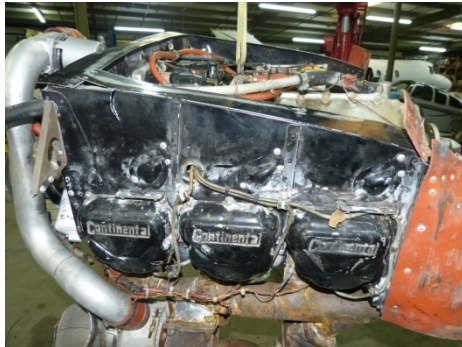
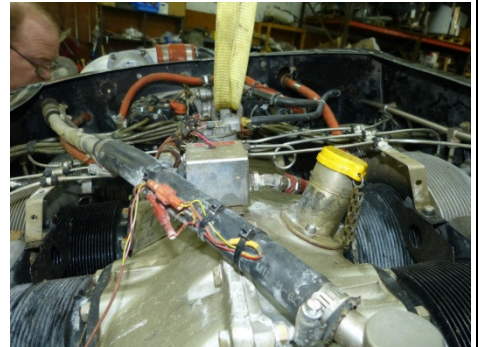
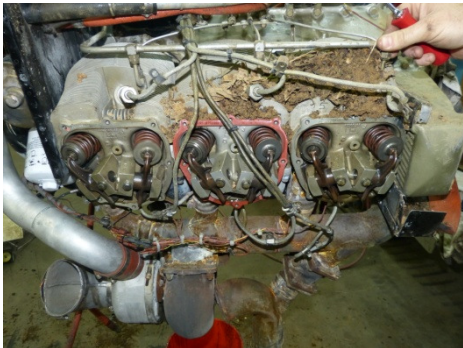
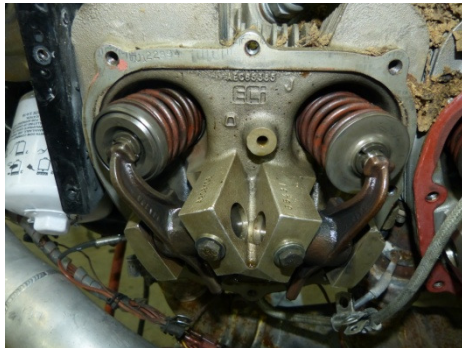
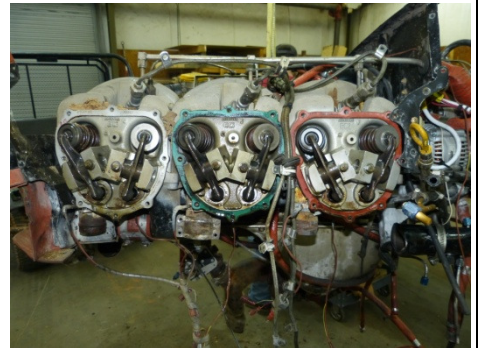
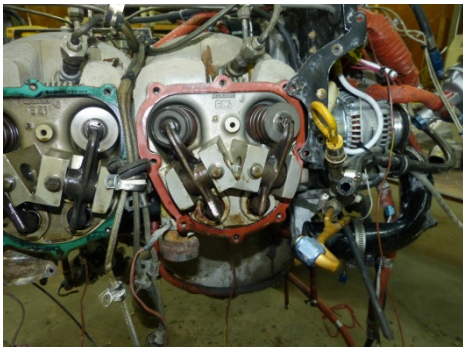
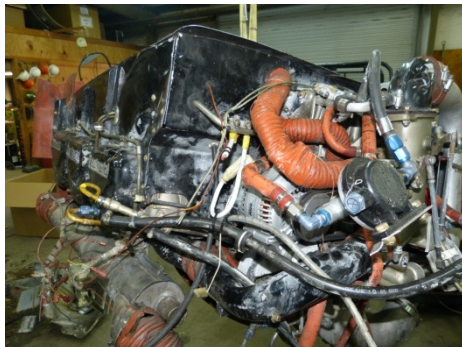
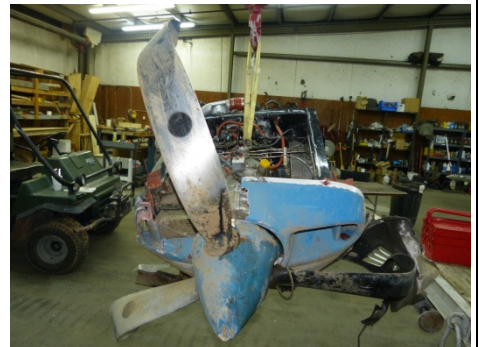
The engine was intact with all of the accessories attached. The exhaust pipes were impact damaged, and the oil scavenge line was broken loose from the oil scavenge pump. The manifold pressure line was separated from the intake pipe. All of the cylinders were ECI cylinders.

The wreckage recovery crew reported that when they rotated the crankshaft using the propeller that the accessories on the rear of the engine did not rotate.

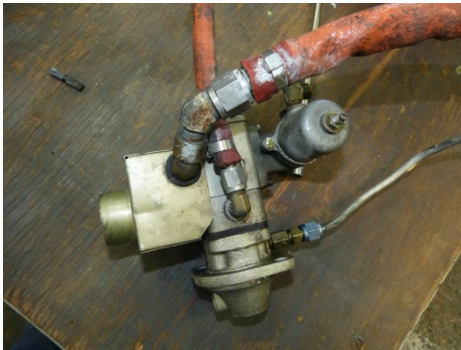
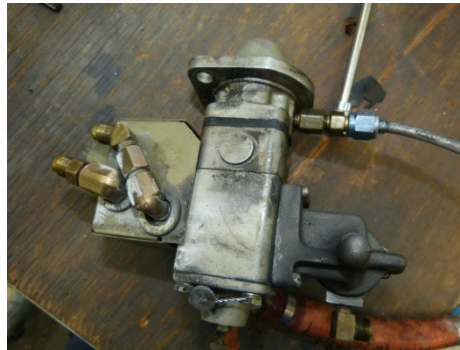
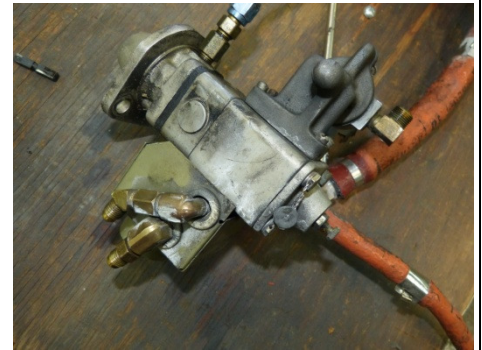
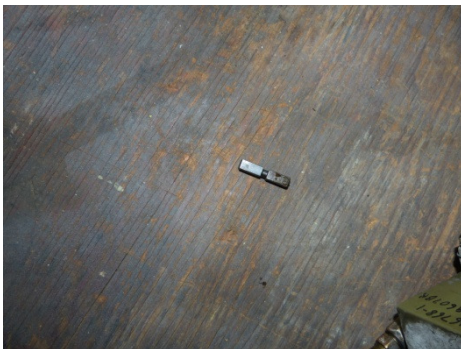
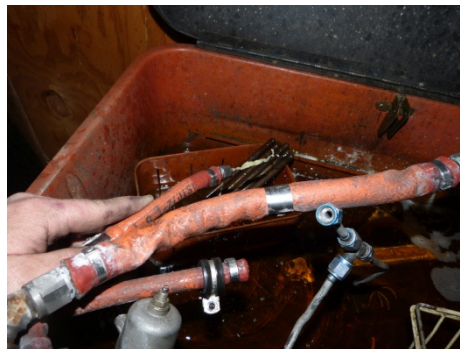
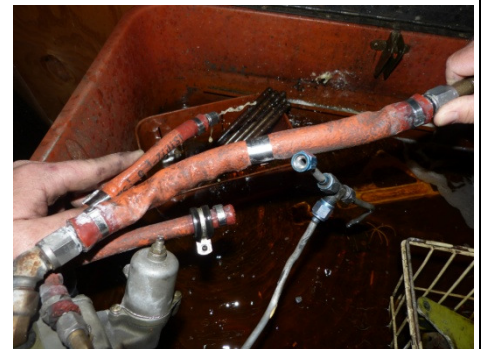
The fuel pump was in place and not damaged. The drive coupling was not damaged. The drive shaft was free to rotate. The fuel pump was tested using an electric drill, and it pumped solvent when the drive shaft was rotated with the electric drill.

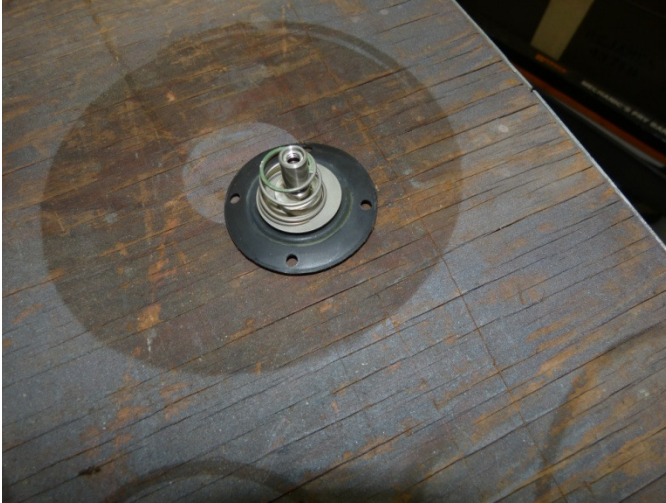
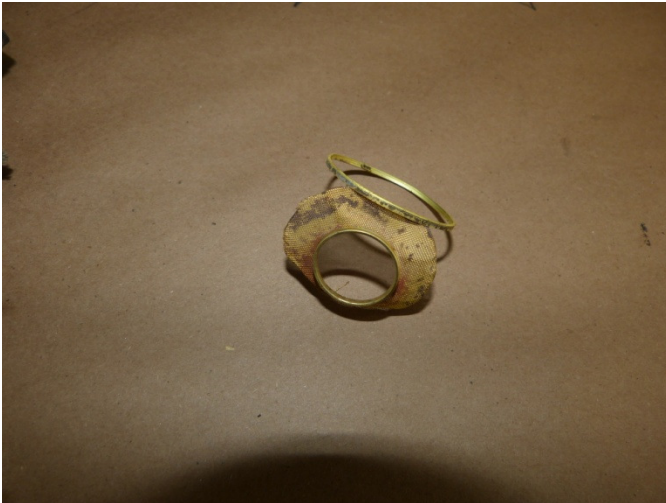
The Throttle Body and Metering Unit were not damaged. The throttle and mixture controls were hooked up and were free to move. A small amount of debris was observed on the fuel screen.

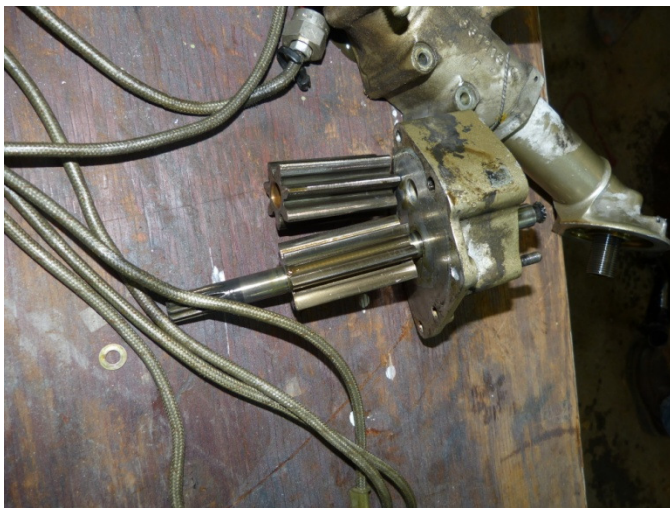
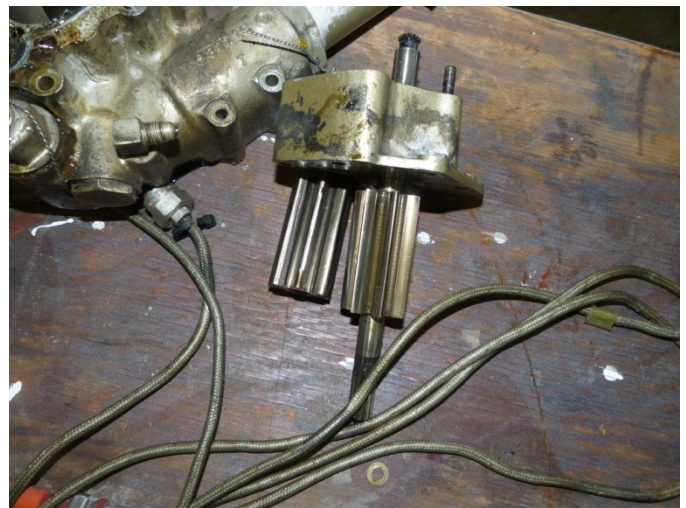
Oil Pump: The oil pump was in place and free to rotate. A few metal particles were observed in the pump cavity. The scavenge pump was in place and free to rotate. The pump gears were coated with oil.

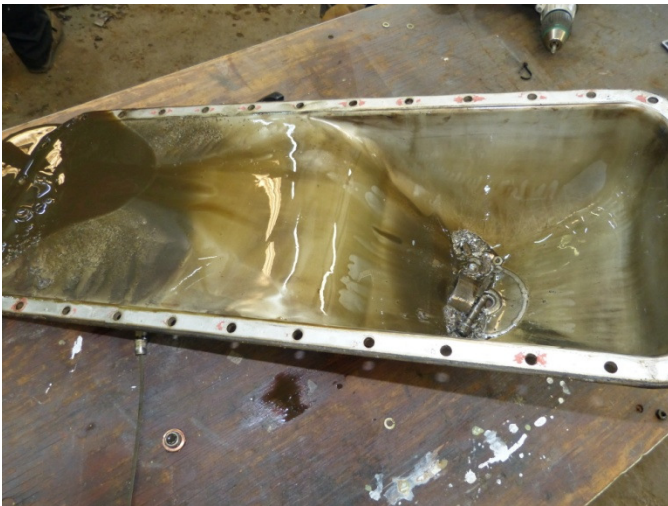
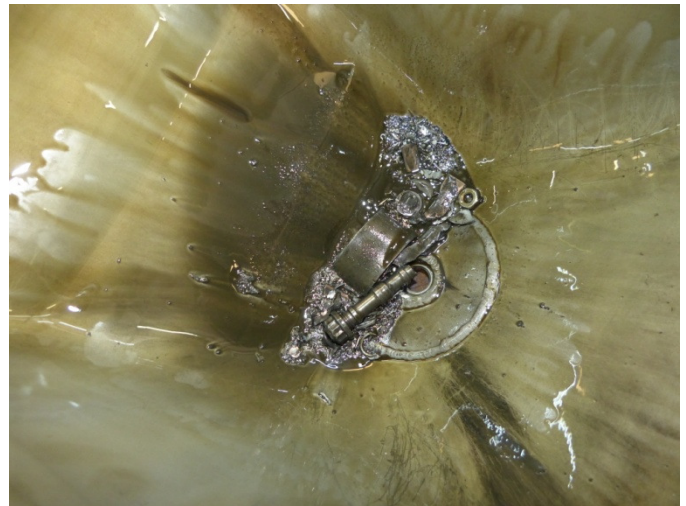
Oil Sump: The oil sump was not damaged. Some oil and a few metal particles were observed in the sump.

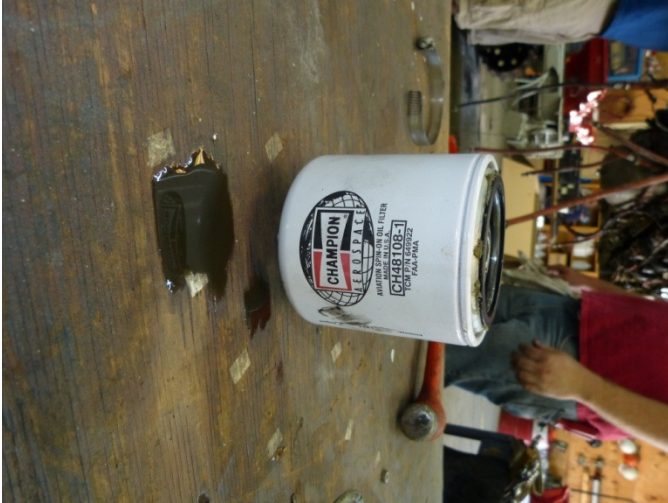
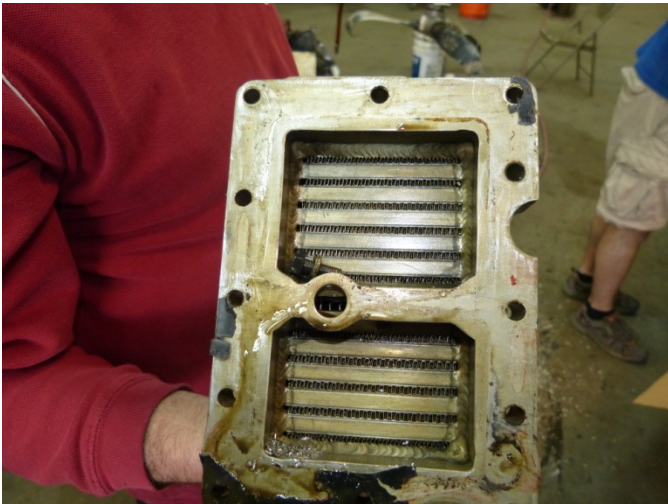
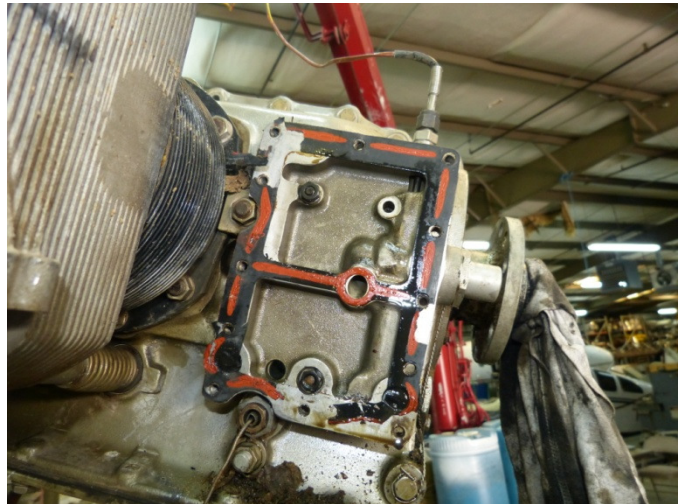
Oil Cooler: No tag was observed on the oil cooler. Two bolts were broken of the oil cooler mount bracket. Clear oil poured from the cooler along with metal particles.

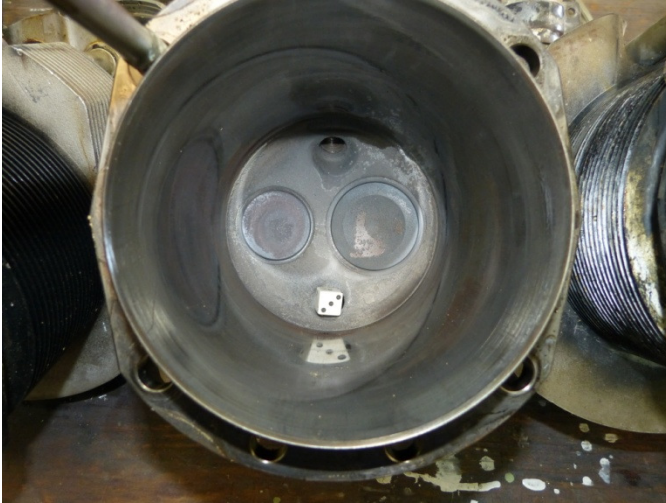
The pistons were not damaged. The number one piston could not be removed from the number one cylinder. All of the rings were in place and coated with oil. Light combustion deposits were observed on the piston faces.

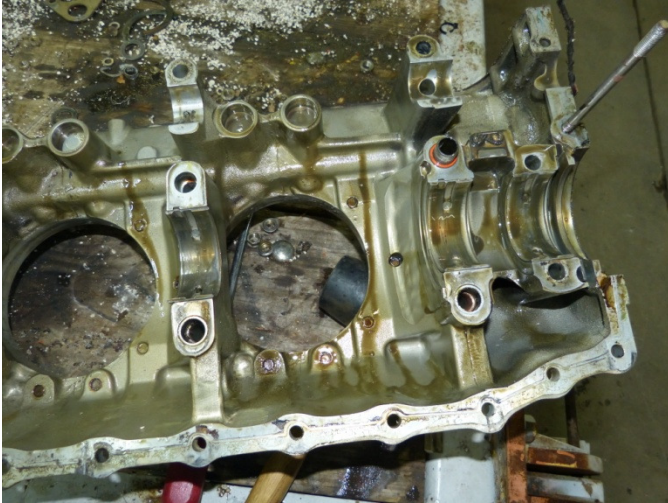
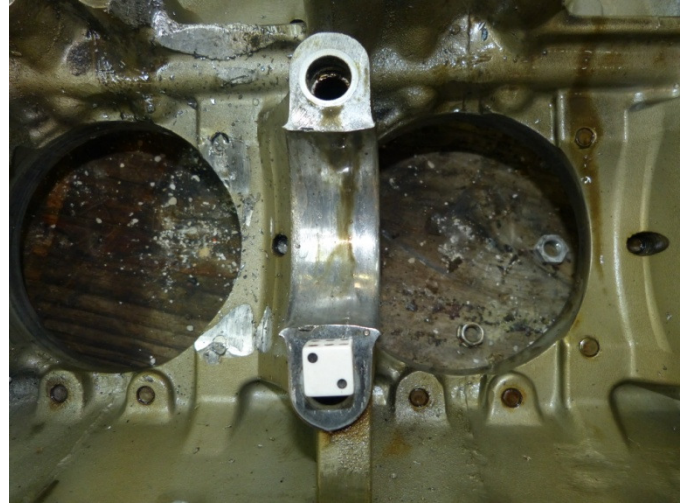
The crankshaft was separated at the point where the number two main journal meets the number two crank cheek. All of the main journals and rod journal were coated with oil. The crankshaft was retained by the NTSB for further examination.

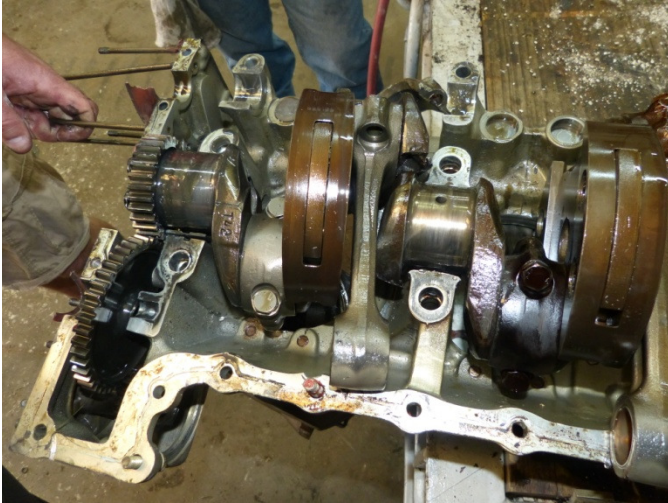
Main Bearings: SA642720-M10

All of the main bearings were in place and coated with oil. The number two main bearing was in the bearing saddle and had heavy impact damage, but did not show any signs of heat discoloration. It was extruded over the edge of the crankcase bearing saddle.

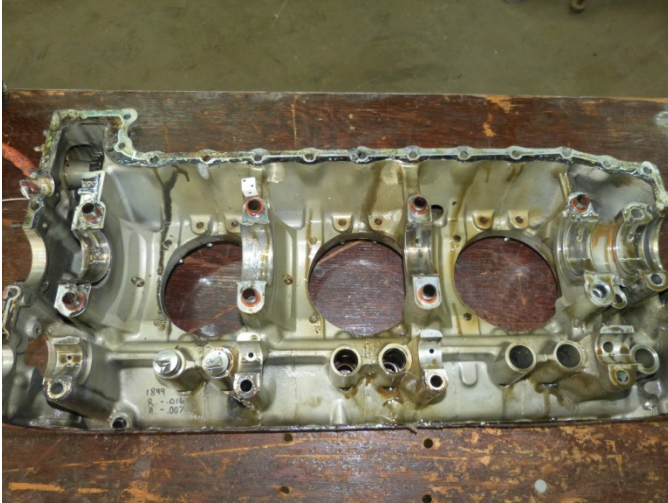
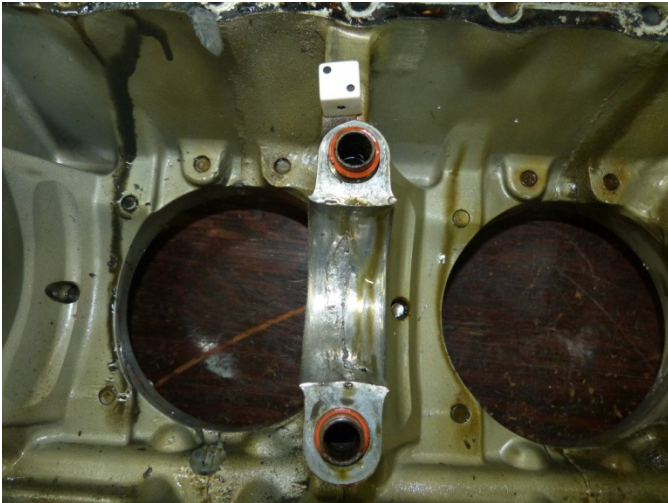
Connecting Rods: 632041F MI

The connecting rods were not damaged. The number two connecting rod had one rod cap bolt separated.

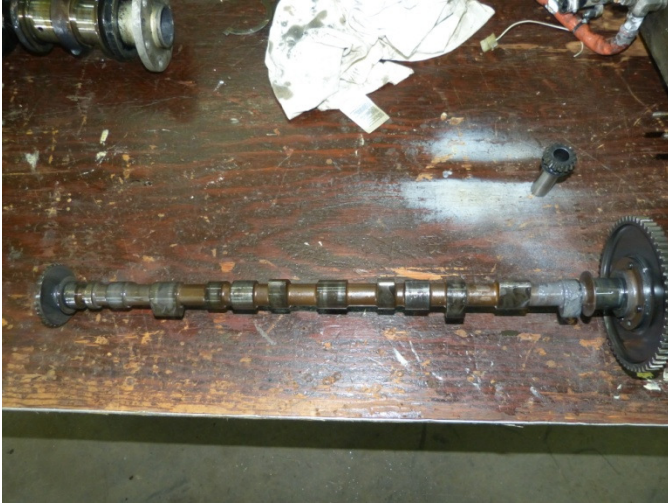
Camshaft: 655384D-Z04KA215

The camshaft was intact with some impact damage. The camshaft lobes were coated with oil, and had scoring.

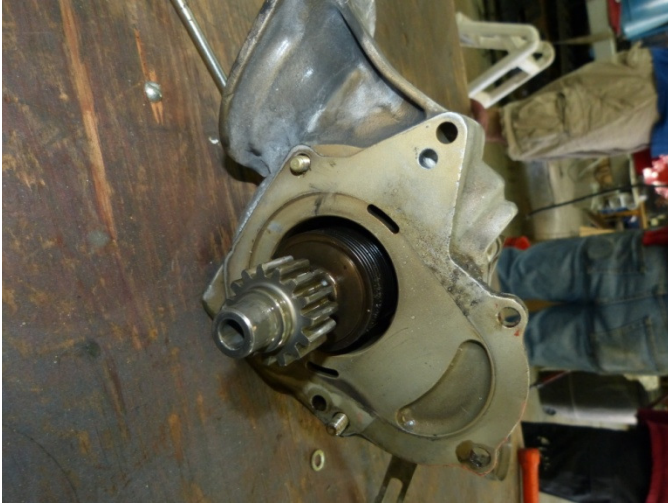
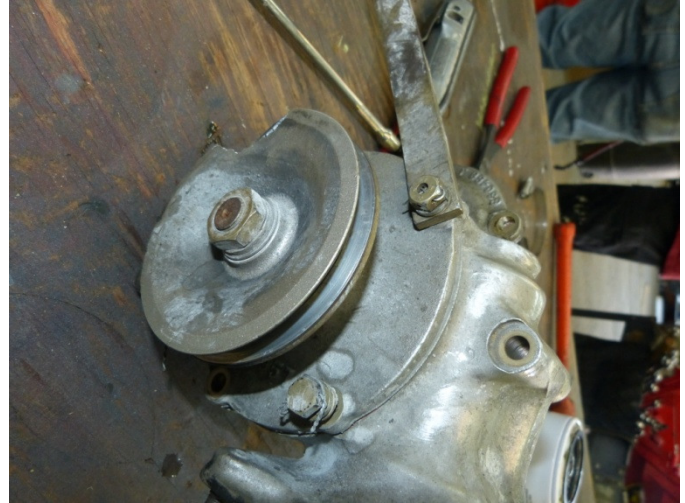
Alternator: Planepower AL24-F60C, SN-46-140303 24V
The Alternator was not damaged and the drive shaft was free to rotate.

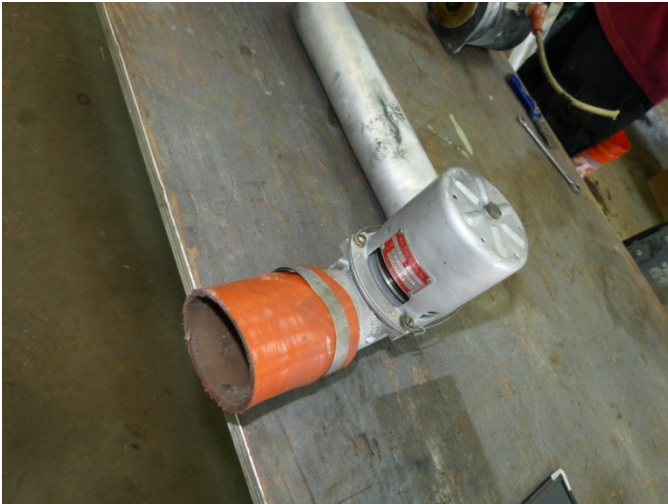
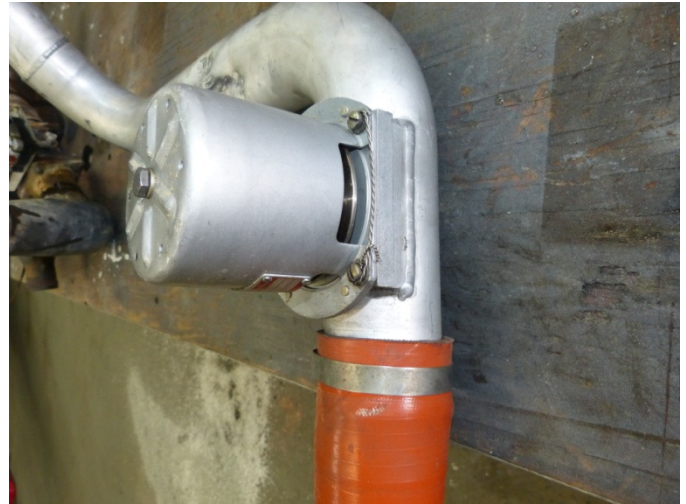
Controller: Kelly, PN-470638-7, SN-HE0134
The controller was in place and not damaged.

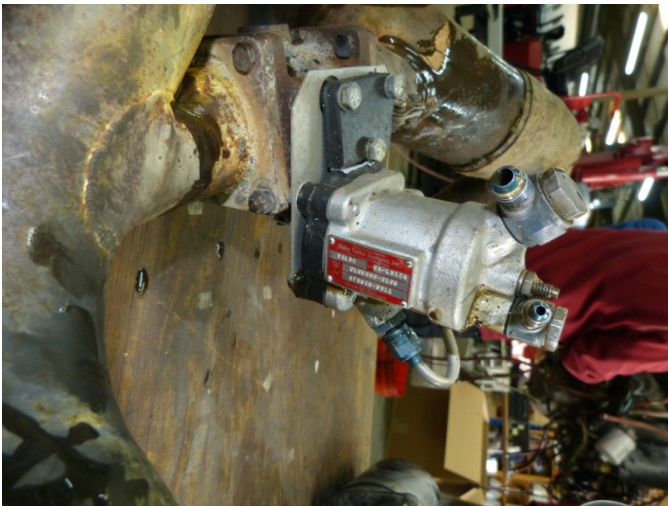
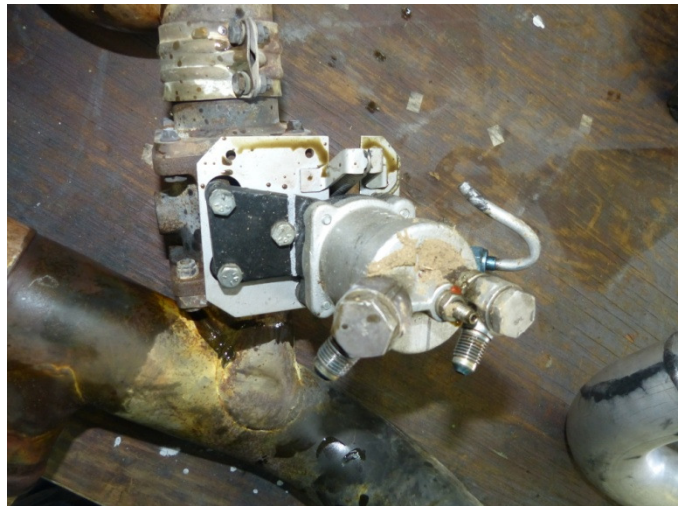
Wastegate: The wastegate was attached and had some impact damage. It was not disassembled.

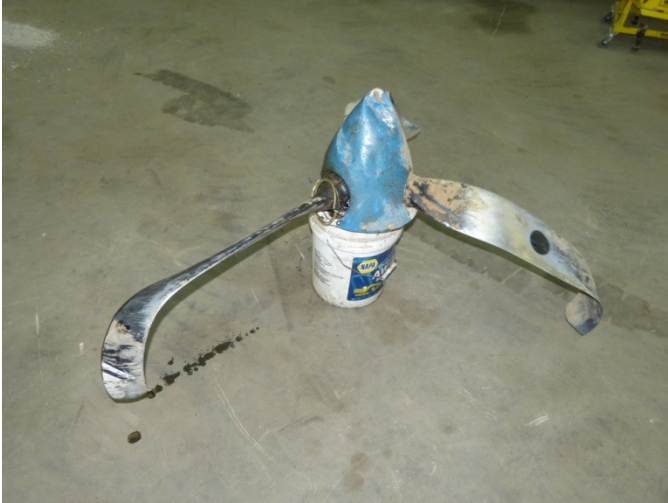
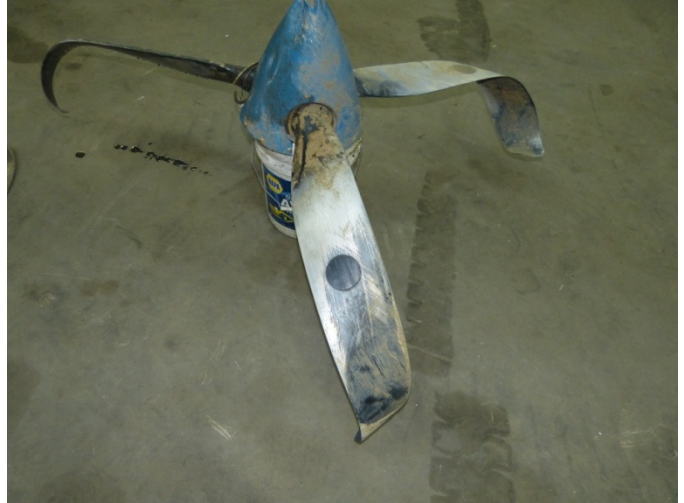
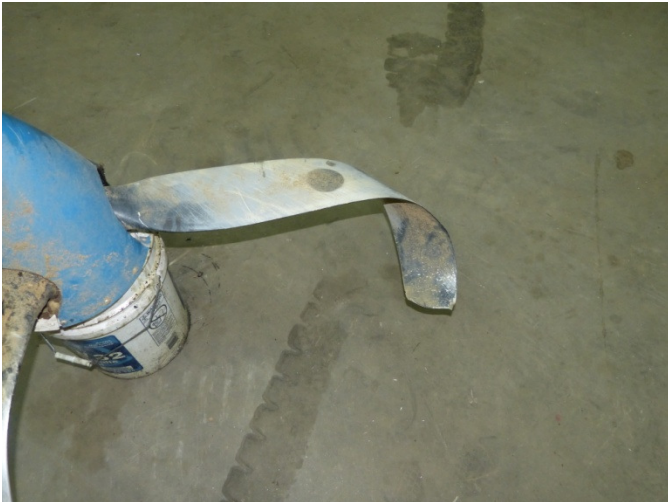
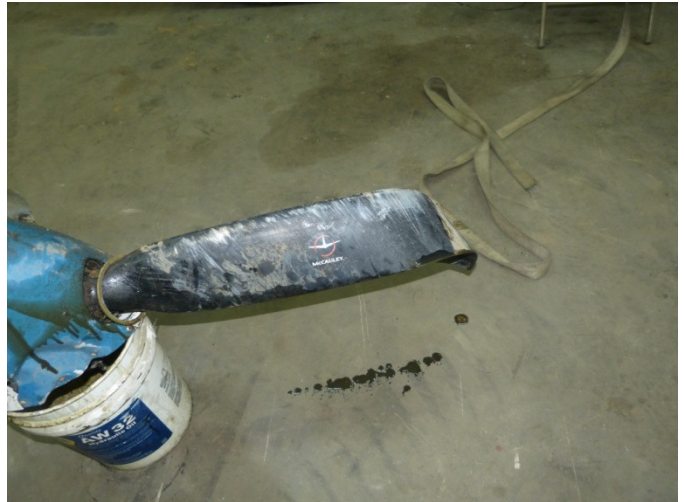
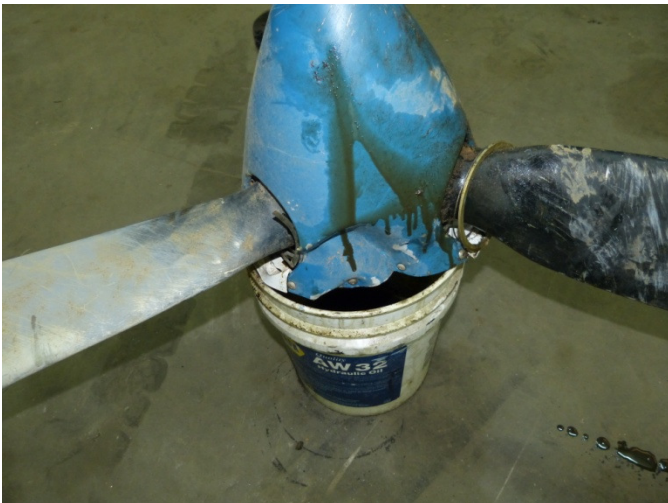
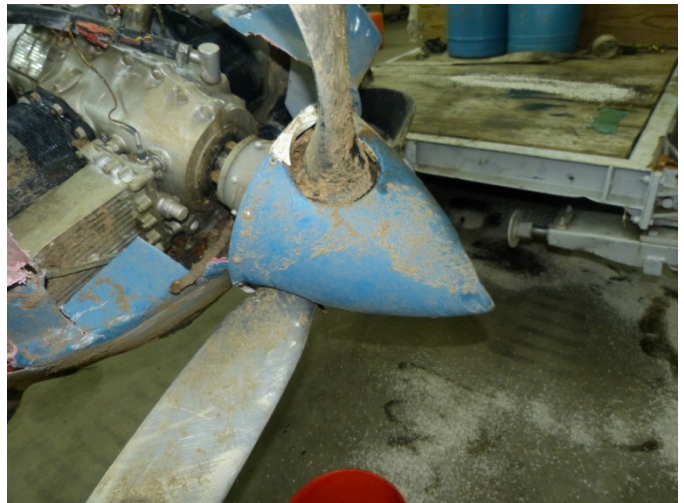
Propeller: McCauley, D3A34C402C, SN-920528

The propeller remained attached to the crankshaft, and the spinner was dented. All three blades were curled toward the direction of rotation and had some chordwise scaring.
