# Continental Motors

## ENGINE EXAMINATION REPORT LEFT

ENGINE MODEL	TSIO520EB (8B)
ENGINE SERIAL NUMBER	271215-R
AIRCRAFT MAKE & MODEL	Cessna 335
AIRCRAFT SERIAL NUMBER	335-0023
AIRCRAFT REGISTRATION	N2707J
FILE NUMBER	18-174

## ENGINE EXAMINATION REPORT RIGHT

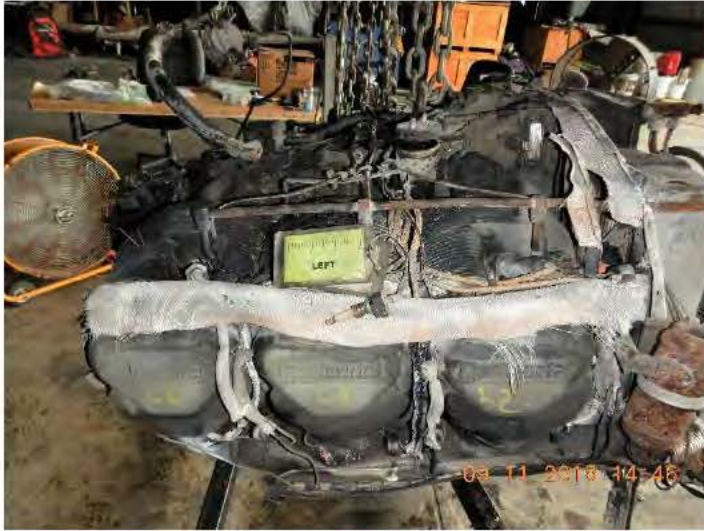
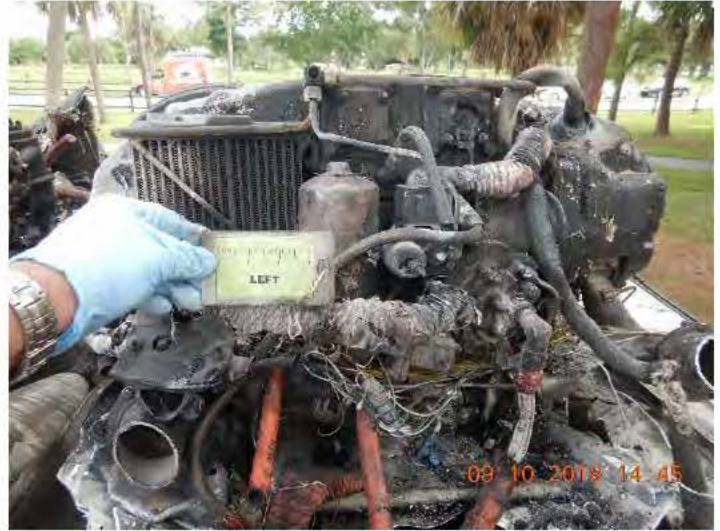
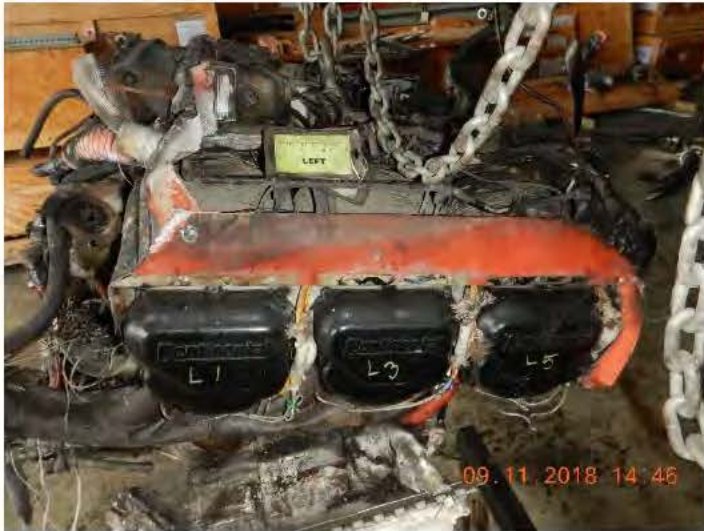
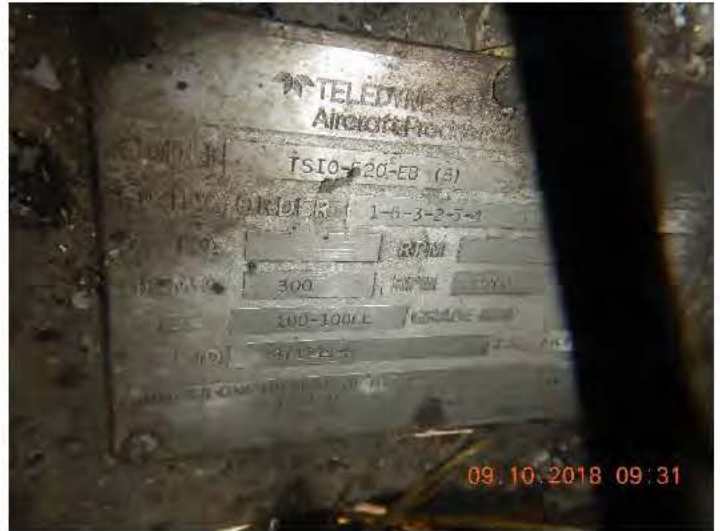
The left engine exhibited impact and thermal damage. The propeller separated on impact by breaking the propeller attachment bolts. The engine crankshaft propeller flange remained intact.

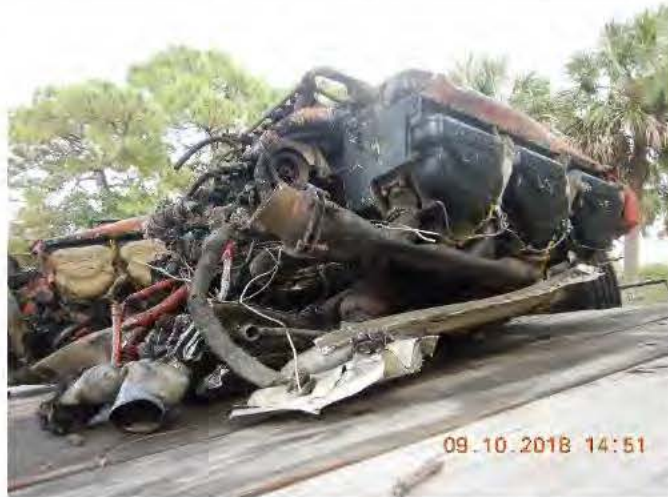
**Condition:** The exhaust components were impact damaged.

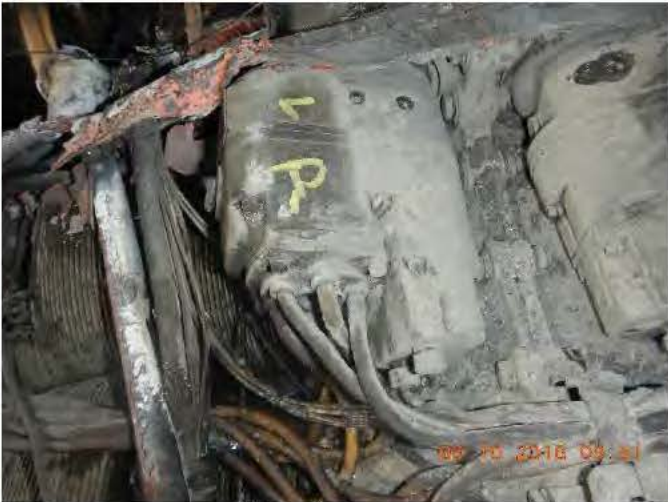
<b>RIGHT MAGNETO</b>	Manufacturer: Bendix	P/N: 10-163060-1	S/N: 801229
Condition:	The right magneto produced sparks at all ignition leads when the magneto was manually rotated using a drill motor.

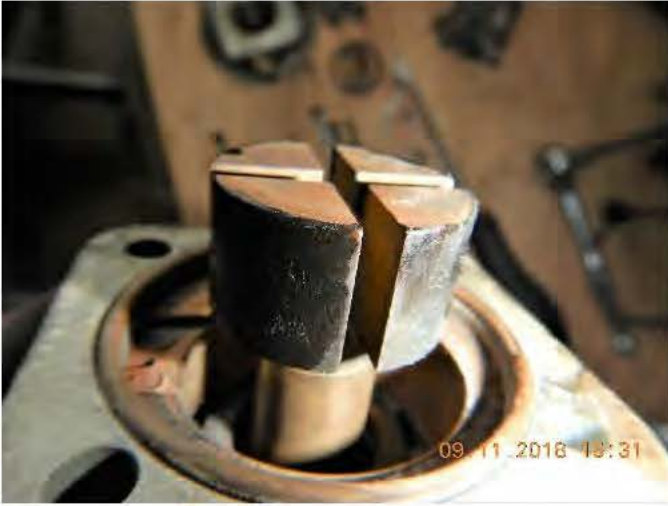
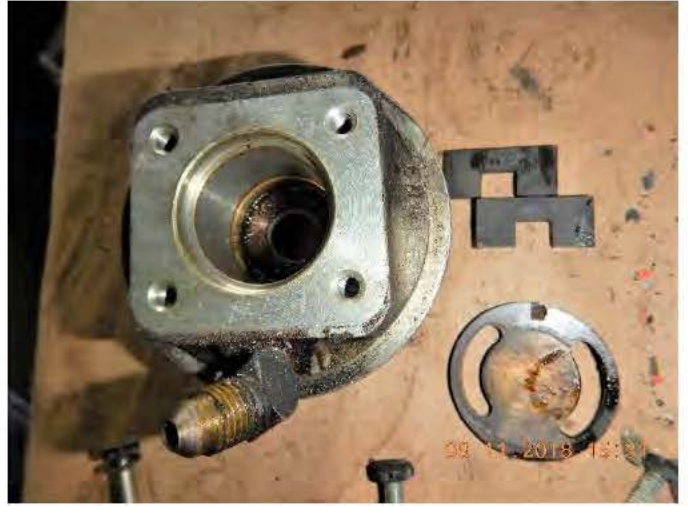
The fuel pump was rotated manually, and no fuel was expelled. The pump input shaft was thermally damaged and the pump impeller blades were intact. The unmetered fuel adjustment screw was impact damaged. The fuel pump case at the bellows assembly was broken.

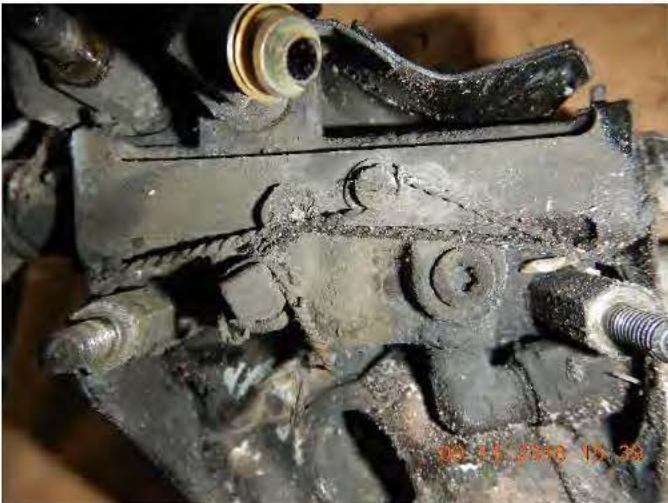
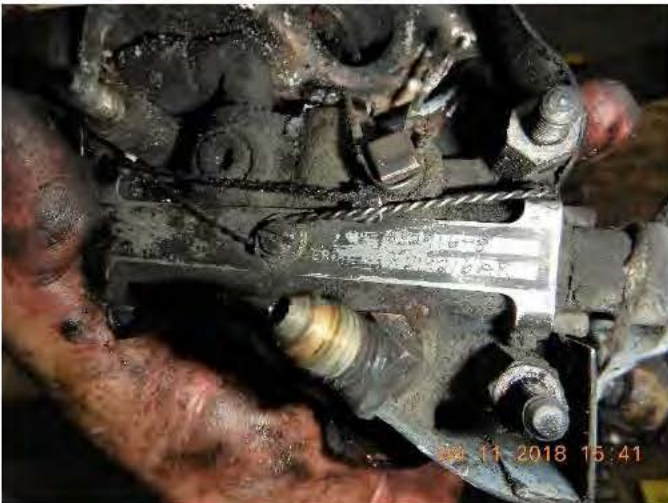
The fuel metering unit was intact but exhibited thermal damage. The control cable was attached properly, and the fastener was tight on the shaft. The fuel screen was not secured with safety wire as required. The fuel screen was removed and was damaged during the removal process. The solder from the assembly of the screen melted attaching the mesh to the throttle body housing. The screen appeared to be uncontaminated.

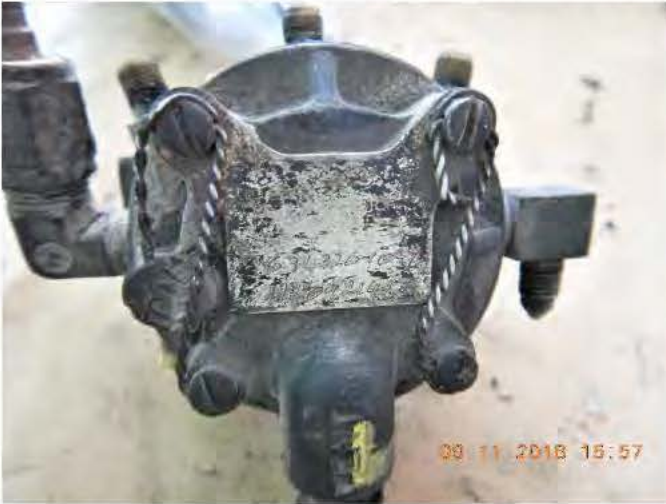
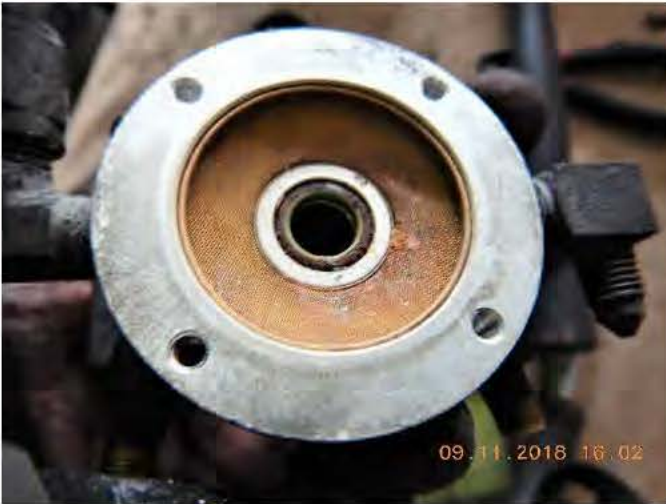
The assembly screws were correctly secured with safety wire and a lead seal was intact. The assembly screws were removed, and the spring and diaphragm were intact. The fuel screen was uncontaminated, but the manifold cavity contained a small amount of unidentified debris. The debris was attracted to a test magnet.

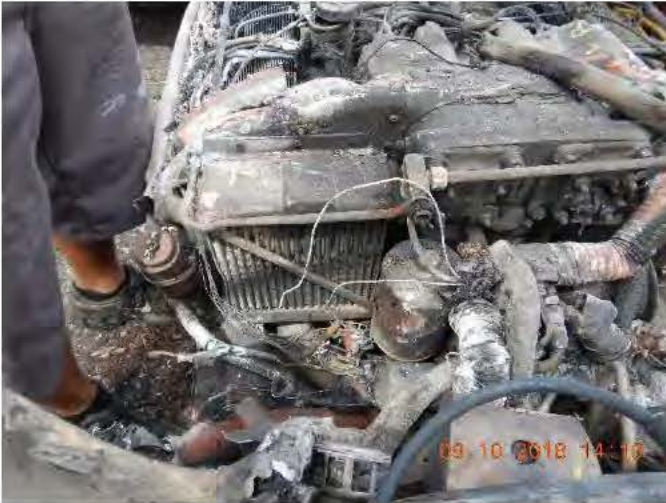
No data plate was attached to the oil cooler. The oil cooler was intact with thermal distress to the lower portion where it had been exposed to the post impact fire.

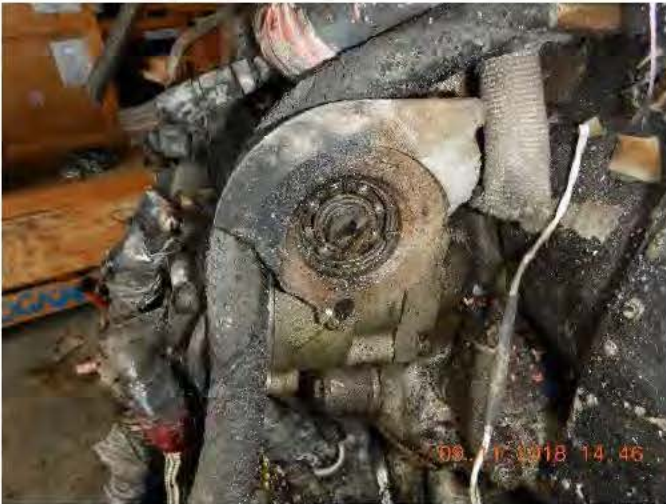
<b>STARTER</b>	Manufacturer: Undetermined	P/N: Undetermined	S/N: Undetermined
Condition:	The starter motor separated from the starter adapter was not presented for inspection.		
<b>STARTER ADAPTER</b>	P/N: Undetermined		
Condition:	The starter adapter was thermally damaged. The starter motor separated and the starter mount was broken. The oil scavenge pump remained intact and attached to the starter adapter.

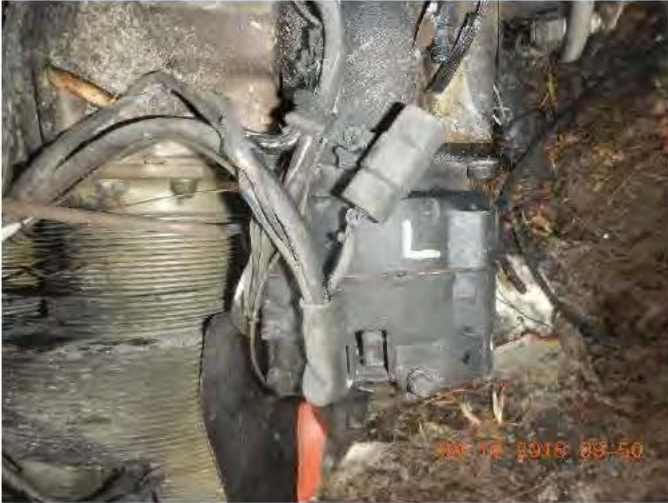
<b>ALT/GEN #1</b>	Manufacturer: TCM	P/N: 649304	S/N: L129403
Condition:	The engine driven alternator received impact damage.

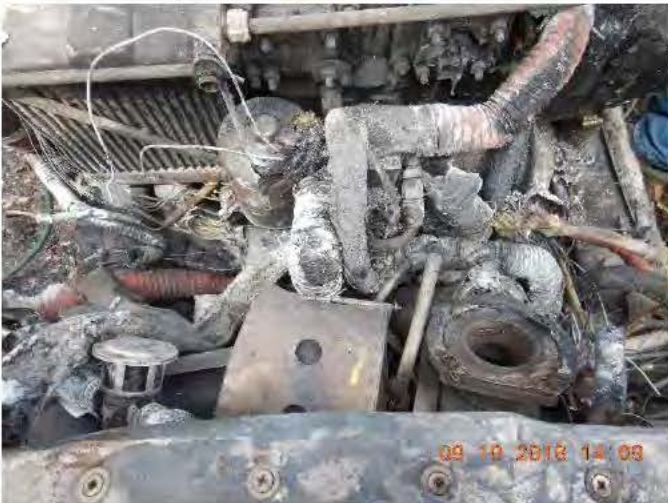
<b>TURBO</b>	Manufacturer: Undetermined	P/N: Undetermined	S/N: Undetermined
Condition:	The turbocharger was exposed to the post impact fire. The compressor and turbine wheels were free to rotate.

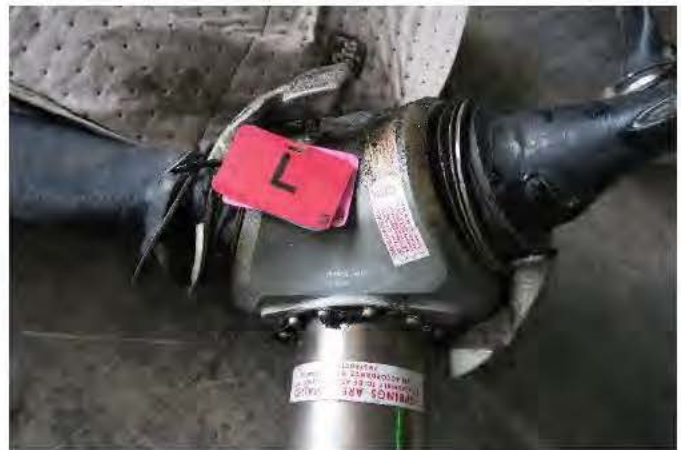
<b>PROPELLER</b>	Manufacturer: McCauley	P/N: Undetermined	S/N: 650681
Blade 1 S/N:	Undetermined		
Blade 2 S/N:	Undetermined		
Blade 3 S/N:	Undetermined		
Condition:	The propeller hub and spinner received impact damage. The propeller blades were relatively straight without cordwise scratching or gouging. Blade C exhibited paint transfer from contact with the ground.

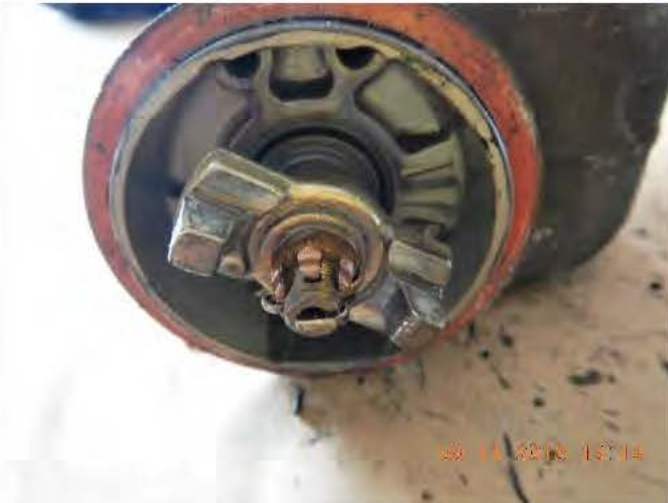
Condition: The right magneto produced sparks at all ignition leads when the magneto was manually rotated using a drill motor.

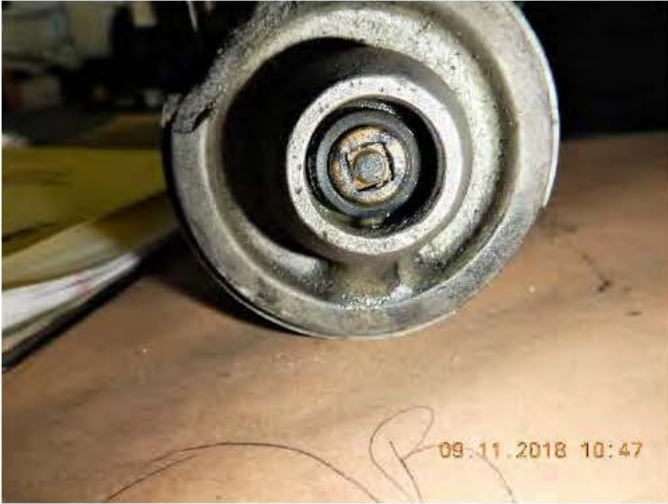
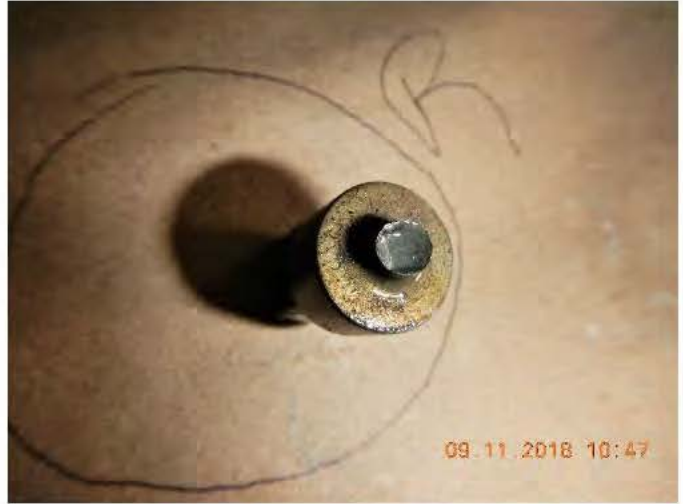
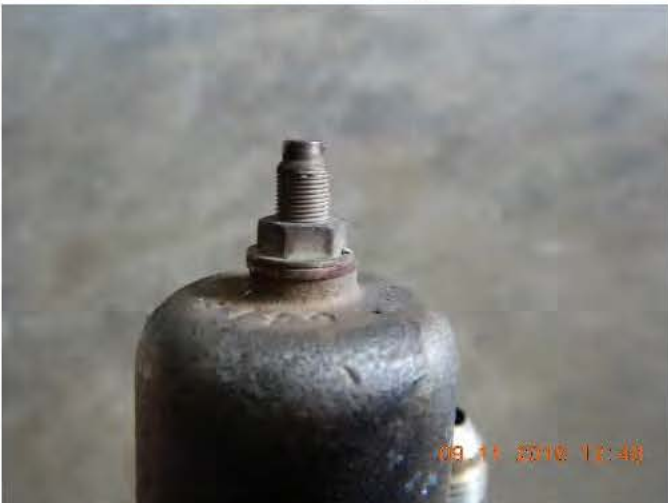
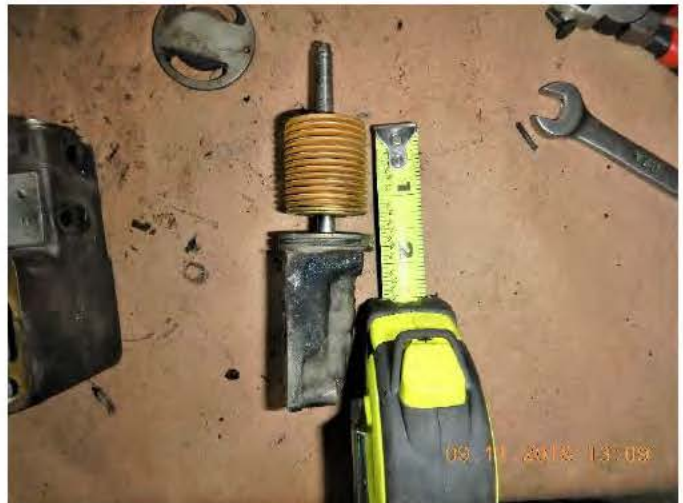
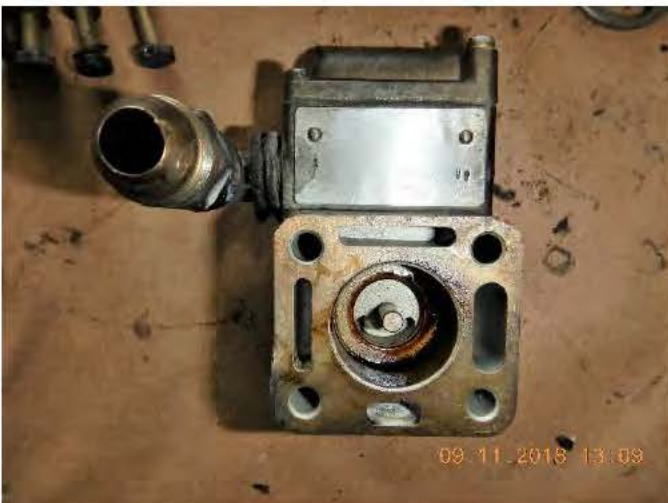
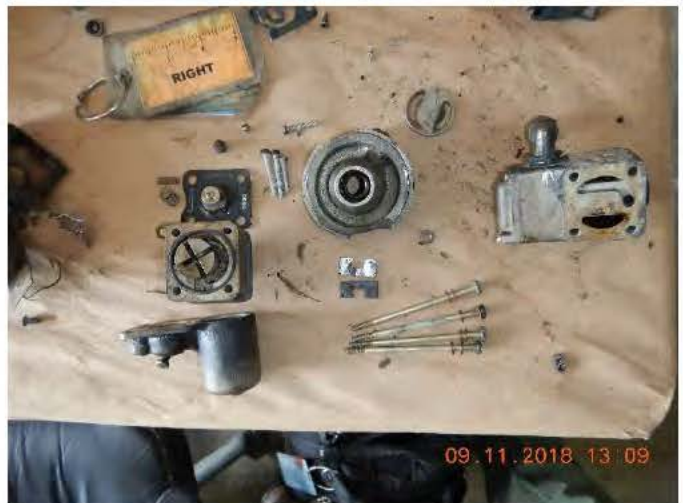
The engine driven fuel pump exhibited thermal and impact damage. The lower portion of the pump was dark and the surfaces sooty from a post-impact fire. The unmetered fuel pressure adjustment bolt and lock nut received impact damage. The drive coupler was broken, and a sharp edge was evident around the circumference of the separated shaft. The broken area was concave/convex in shape. The broken portion of the drive coupler was removed, and the impeller shaft rotated smoothly when manually manipulated. A minute amount of fuel leaked from the pump cavity when the pump was disassembled. The pump shaft and impeller blades were intact. The outer mounting flange was partially broken. Fuel fittings were broken and remained with the thermally damaged flexible fuel hoses. The fuel pump and drive coupling will be examined at CMI at a later date and a metallurgical report prepared.

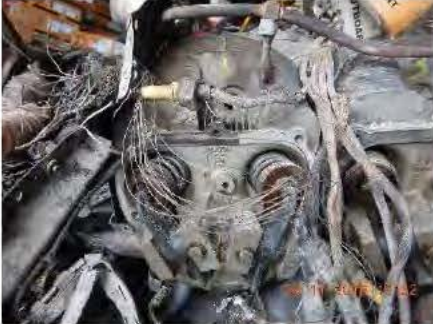
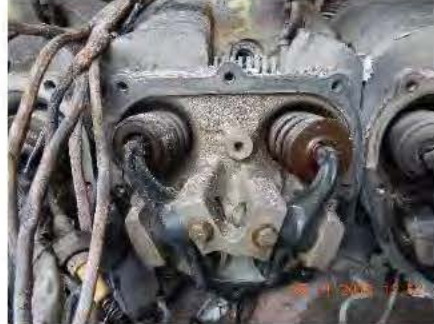
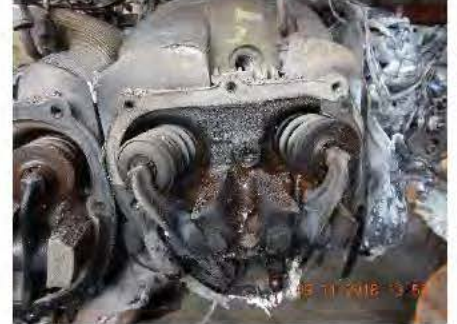
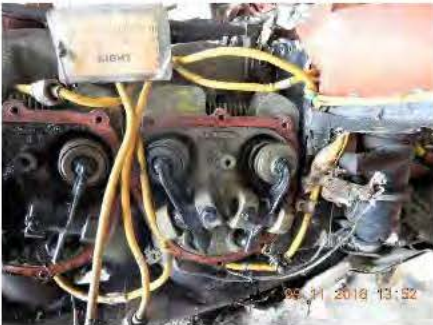
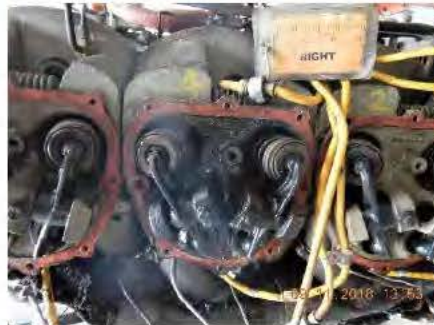
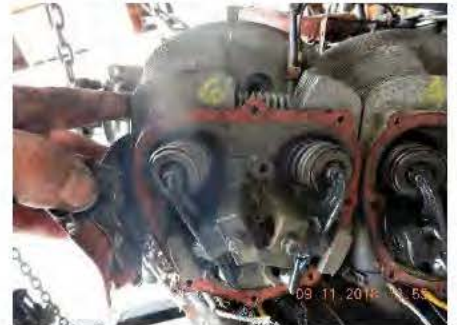
All rocker arms, springs and pushrods operated normally when the engine was manually rotated except # 5 which exhibited impact damage.

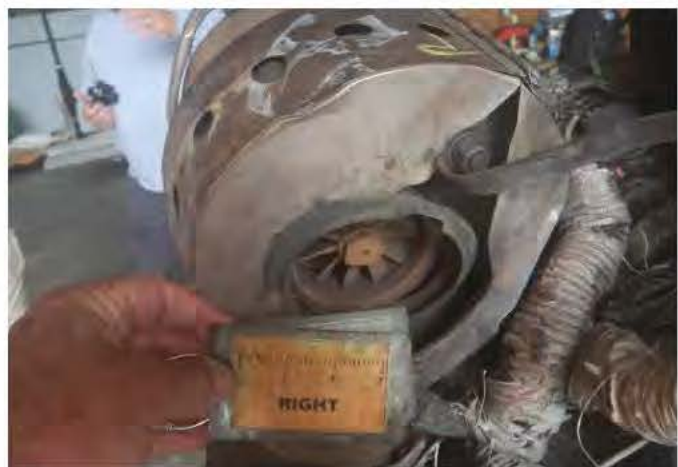
Condition: The turbine wheel was free to rotate in the housing.

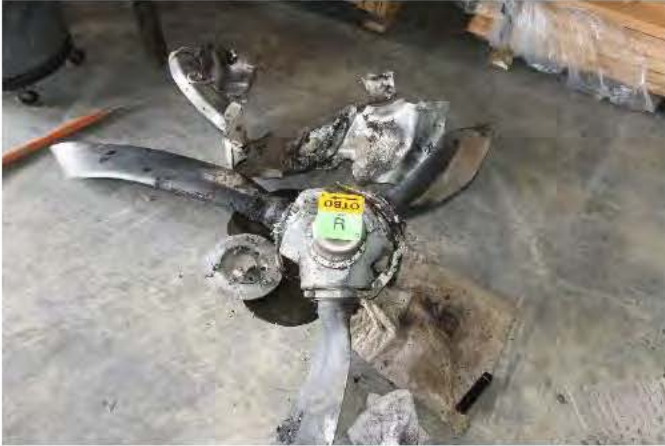
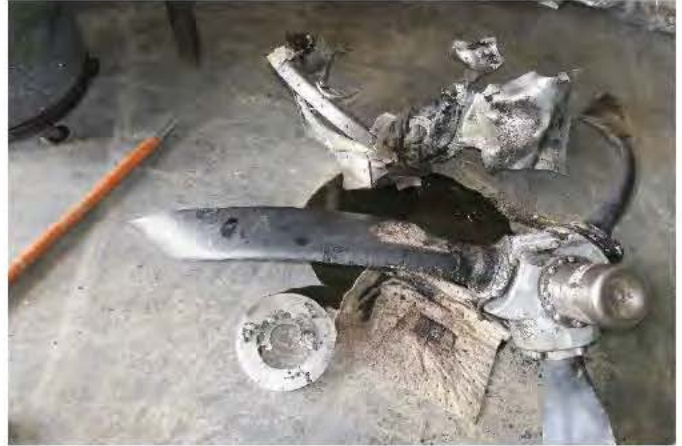
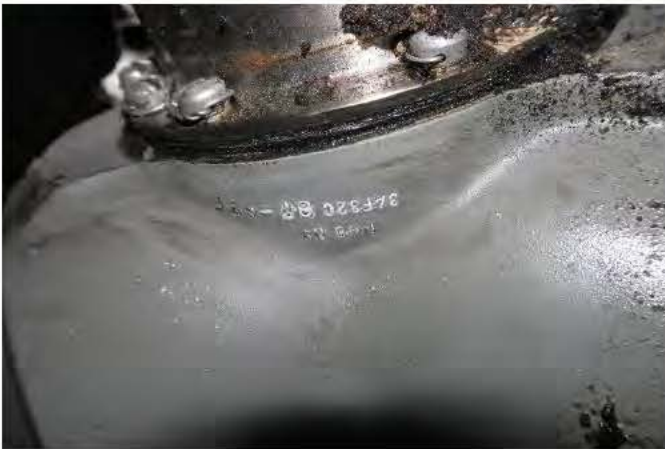
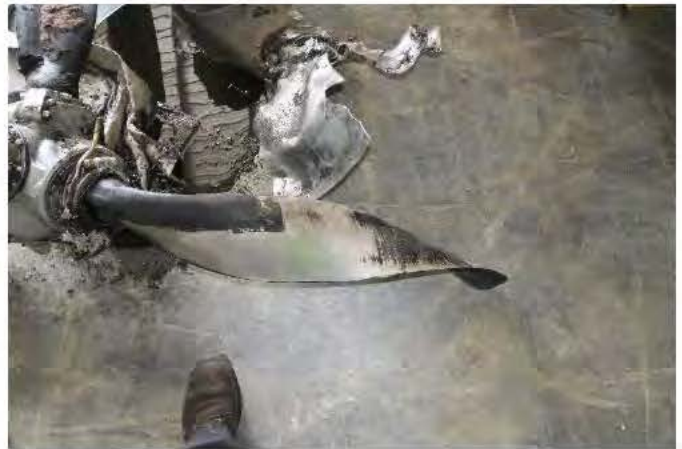
<b>PROPELLER</b>	Manufacturer: McCauley	M/N:3AF32087-N2R	S/N: Undetermined
Blade 1 S/N:	Undetermined		
Blade 2 S/N:	Undetermined		
Blade 3 S/N:	Undetermined		
Condition:	All three propeller blades exhibited s-bending, paint transfer and cordwise scratching/gouging. All three blades were loose inside the hub due to impact forces.
