Turbomeca On Site Examination Report

NTSB Reference:
 TM USA Reference:
 TM FR Reference:
 Event Date/Time:
 Event Location:
 Operator:
 Aircraft Type:
 Aircraft S/N:
 Aircraft Registration:
Engine 1
 Variant:
 Engine S/N:
Engine 2
Variant:
 Engine S/N:

<i>ERA13LA242</i>
<i>(A-2013-006)</i>
<i>(RA/13/112)</i>
<i>(08MAY2013) /(0925)</i>
<i>(South Bay, FL, USA)</i>
<i>Mile High Inc.</i>
<i>AS318C</i>
<i>2031</i>
<i>N318DB</i>
<i>0236045100</i>
<i>Astazou IIA2</i>
<i>678</i>

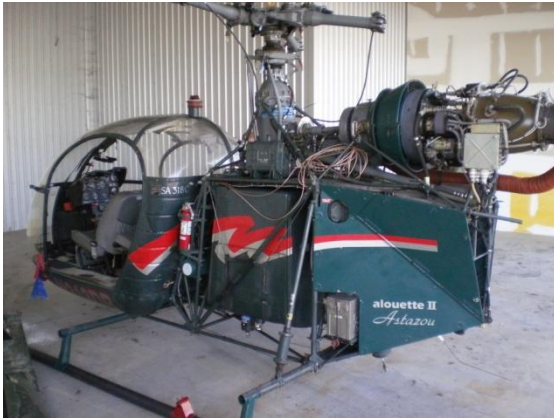
Engine as Found Photos

Other than a distorted exhaust pipe the engine appeared to be undamaged. The air intake cowling was removed and the gas generator could be easily turned by hand. All fuel, oil, and air lines were tight and secured properly. No engine anomalies could be found that would prevent normal operation.
