Continental Motors

ENGINE RUN REPORT

| ENGINE MODEL | TSIO520R |
| FILE NUMBER | 14-491 |

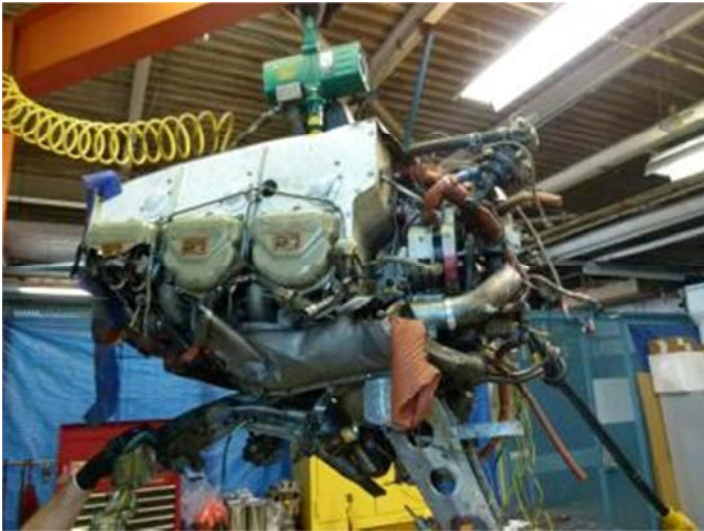
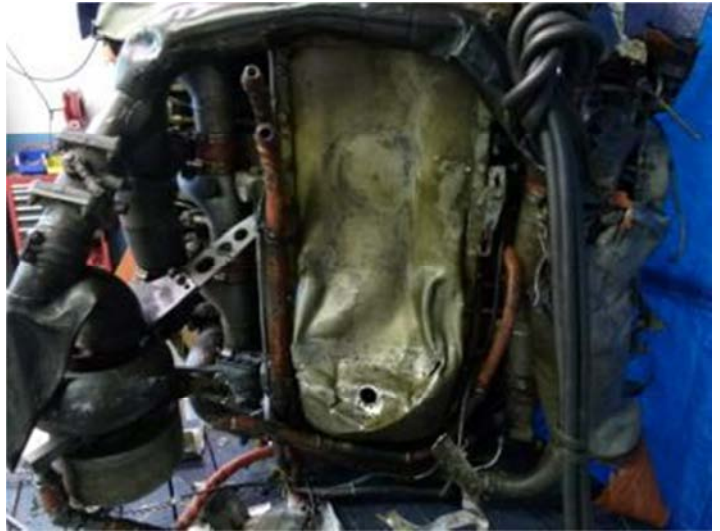
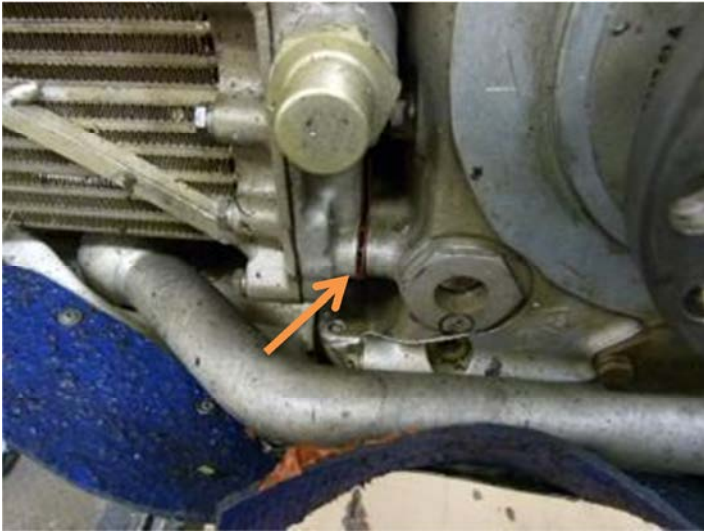
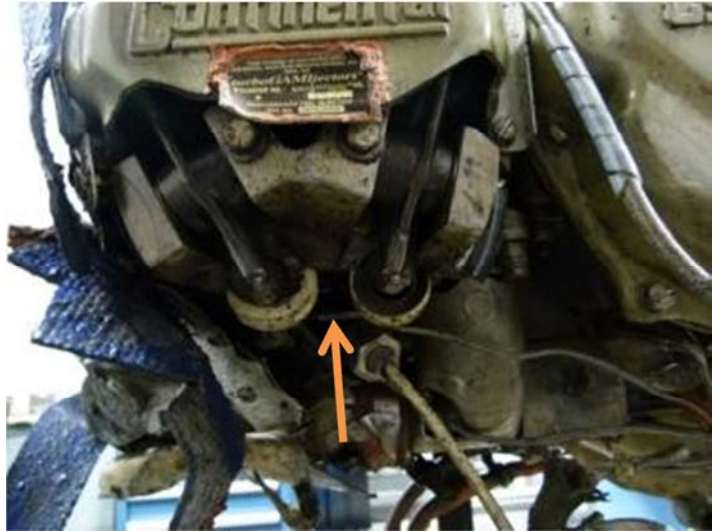
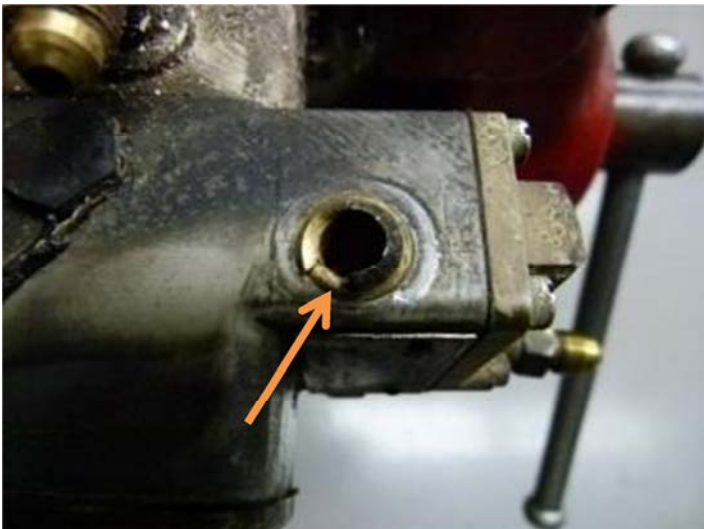
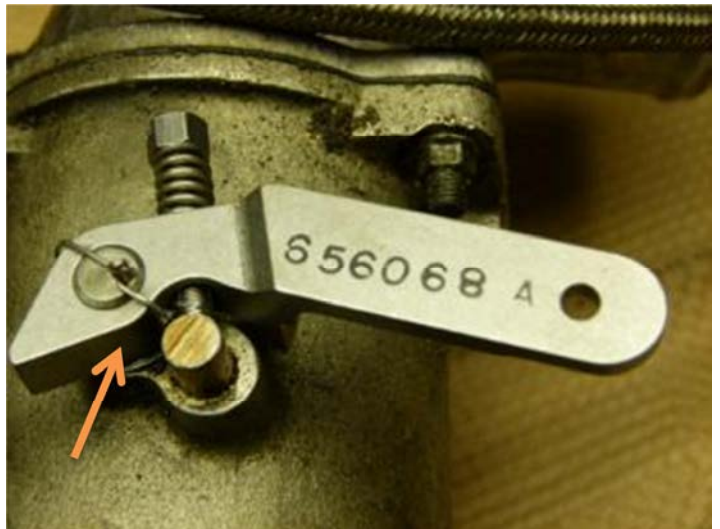
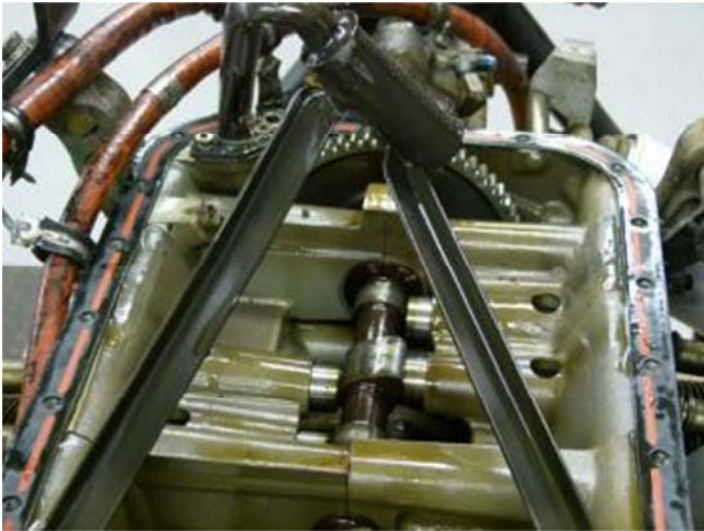
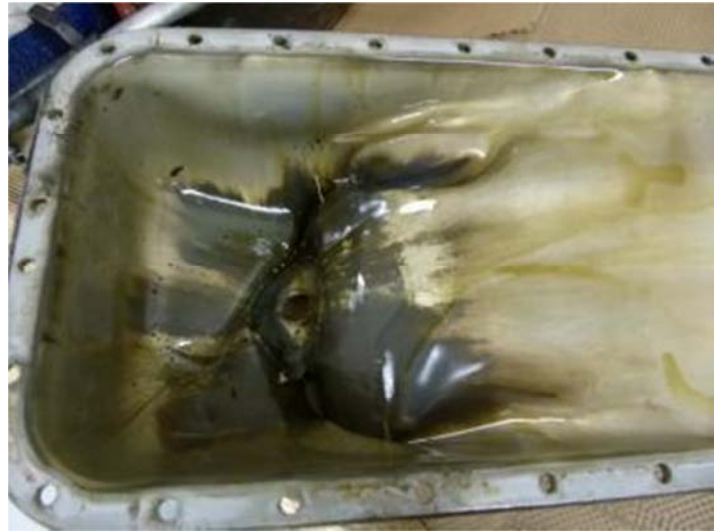
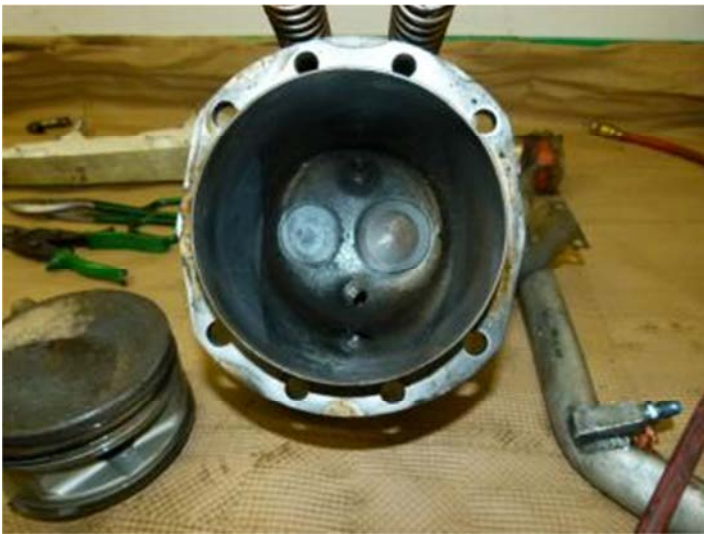
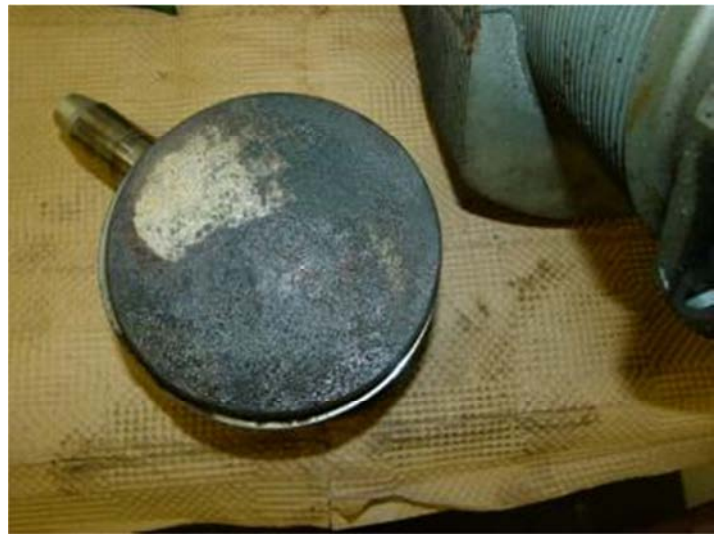
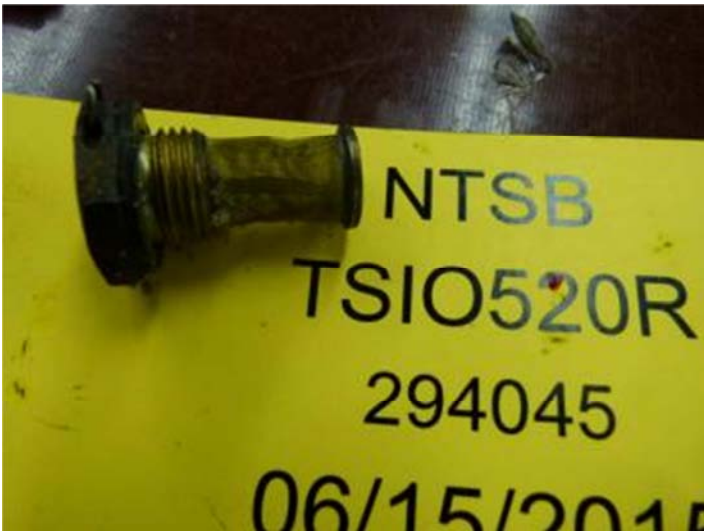
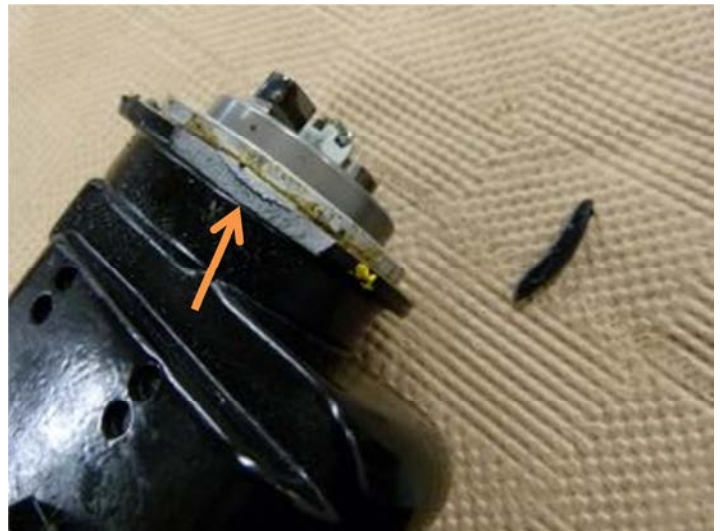
The engine exhibited impact damage to the left front side of the engine. The number six cylinder push rod housing seat was fractured away and the cylinder was replaced for test run. The oil sump was crushed upward to the bottom of the engine and was replaced for the test run. The inlet fuel fitting on the fuel pump was fracture and replaced for the test run. The throttle arm was not returned with the engine and was replaced. The induction runners and exhaust system were impact damaged and replaced with slave units for the test run. The left front and rear engine mounts were fractured and replaced. The number six rocker cover was fractured and replaced for the test run. The right magneto was impact damaged and the flange fractured at the mount hold down clip. The oil cooler lower mounting studs were fractured and replaced for the test run.
