National Transportation Safety Board

Marine Accident Brief

Engine Room Fire Aboard Cruise Ship *Carnival Liberty*

Accident no.	DCA15FM035
Vessel name	<i>Carnival Liberty</i>
Accident type	Engine room fire
Location	West Indian Company Dock, Charlotte Amalie, St. Thomas, US Virgin Islands 18°20'N, 64°55.3'W
Date	September 7, 2015
Time	1133 Atlantic standard time (coordinated universal time – 4 hours)
Injuries	None
Property damage	\$1.725 million est.
Environmental damage	None
Weather	Daylight, clear skies, temperature 86°F (30°C), southeast winds at 10 knots
Waterway information	Port of Charlotte Amalie, St. Thomas

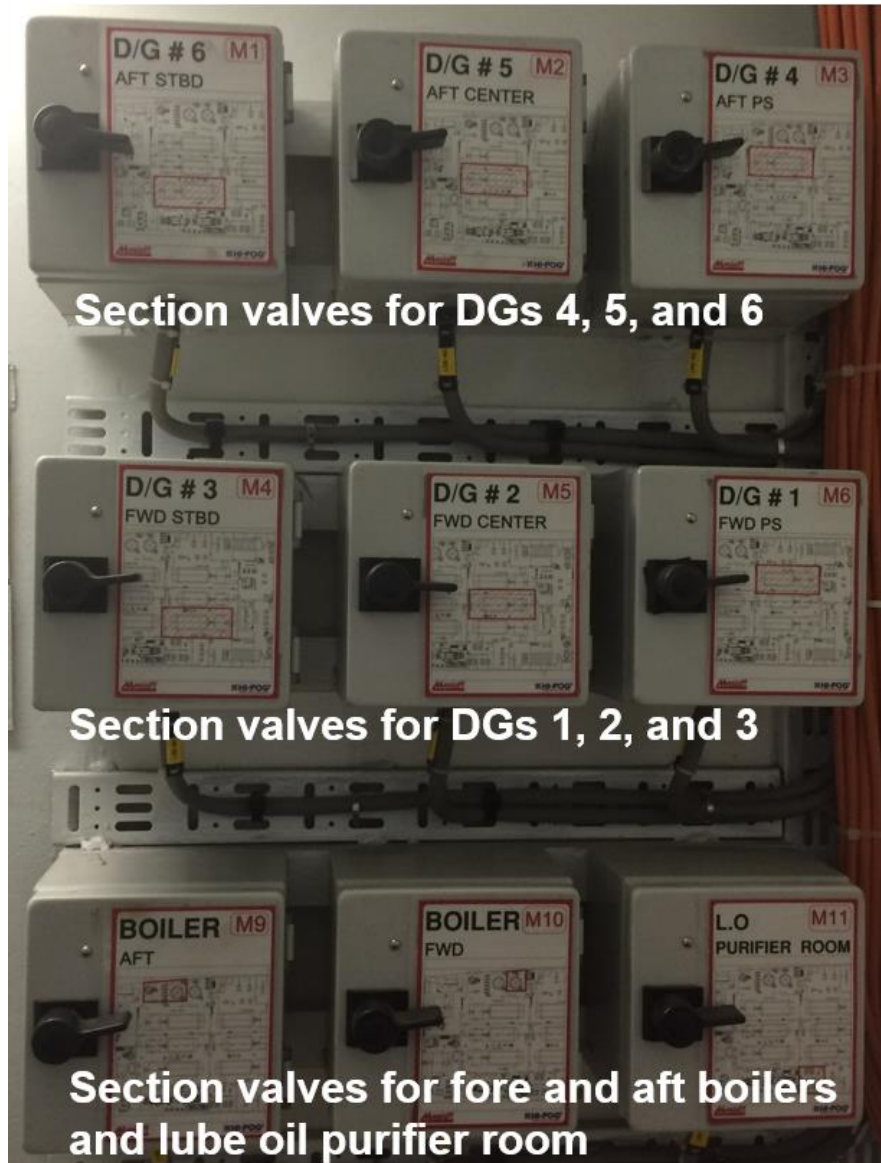
At the stairway, the fire patrolman met the third engineer and the motorman who had already started opening the manual-release boxes to activate the HI-FOG system locally. According to the third engineer, he activated all the buttons that were available at that location because he was not able to see the exact location of the fire in the aft engine room once the watertight door was closed. The ship's IAS recorded the first HI-FOG release at a section valve for DG 4 at 1134. Immediately thereafter, IAS documented the release of HI-FOG section valves also for the aft engine room port cable trays, the aft boiler, the forward boiler, DG 5, the aft engine room starboard cable tray, and DG 6. After a few more seconds, at 1135 according to IAS, the section valves released for DGs 1–3, the forward port and starboard cable trays, the forward engine room bilge, and the forward engine room (port and starboard).

Once the buttons were pushed, the third engineer exited the forward engine room by stairway 100 and returned to the ECR; the fire patrolman remained behind. He told investigators that he once again pushed the HI-FOG buttons for DGs 4–6 because he was unsure if they had activated (he could not see into the aft engine room behind the closed watertight door, but he saw the HI-FOG system operating in the forward engine room). He exited the area shortly after hearing the alpha code announcement and went to his emergency station, where he joined the quick-response team. Before leaving, the fire patrolman instructed the welding contractors to evacuate the area, which they did.

HI-FOG activation boxes inside stairway 100 on deck C in the forward engine room.
