## ENGINE EXAMINATION REPORT

<b>ENGINE MODEL</b>	TSIO-520-NB
<b>ENGINE SERIAL NUMBER</b>	503140
<b>AIRCRAFT MAKE &amp; MODEL</b>	Cessna 414A
<b>AIRCRAFT SERIAL NUMBER</b>	414A0495
<b>AIRCRAFT REGISTRATION</b>	N789UP
<b>FILE NUMBER</b>	14-488

<b>EXAMINATION</b>		<b>ACCIDENT DATA</b>	
<b>DATE</b>	09/02/2015	<b>NTSB ACCIDENT #</b>	CEN15FA190
<b>FACILITY</b>	Continental Motors	<b>NTSB INVESTIGATOR</b>	Todd Fox
<b>ADDRESS</b> [REDACTED] Mobile, AL 36615		<b>FAA INVESTIGATOR</b>	Stanley Swank II
		<b>ACCIDENT DATE</b>	04/07/2015
		<b>ACCIDENT LOCATION</b>	Bloomington, IL

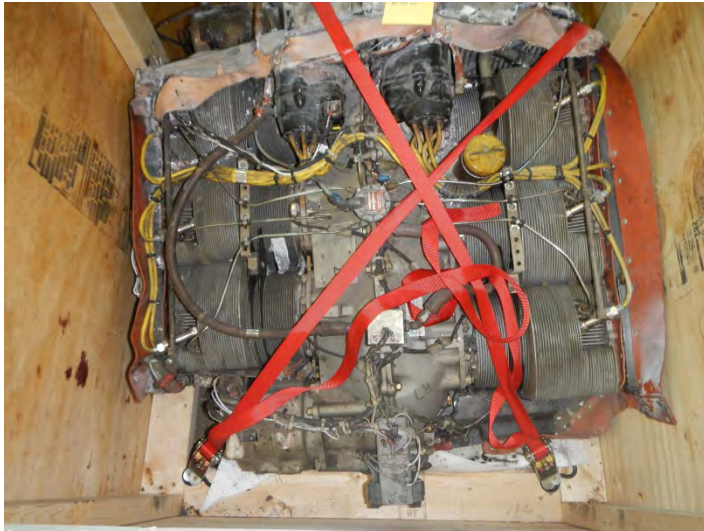
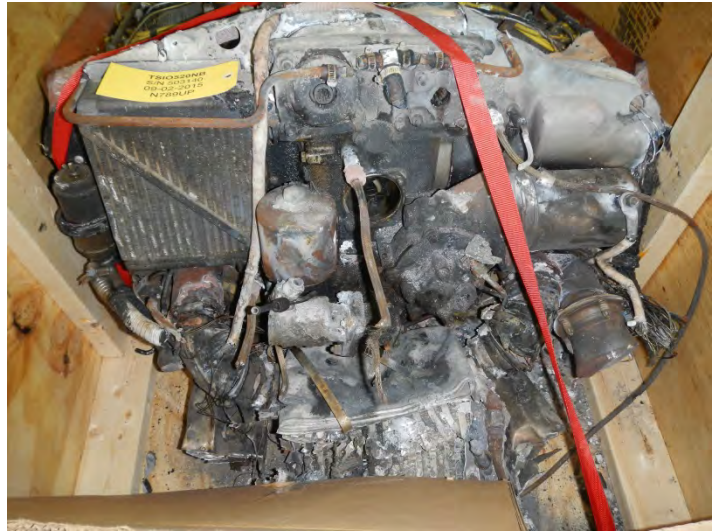
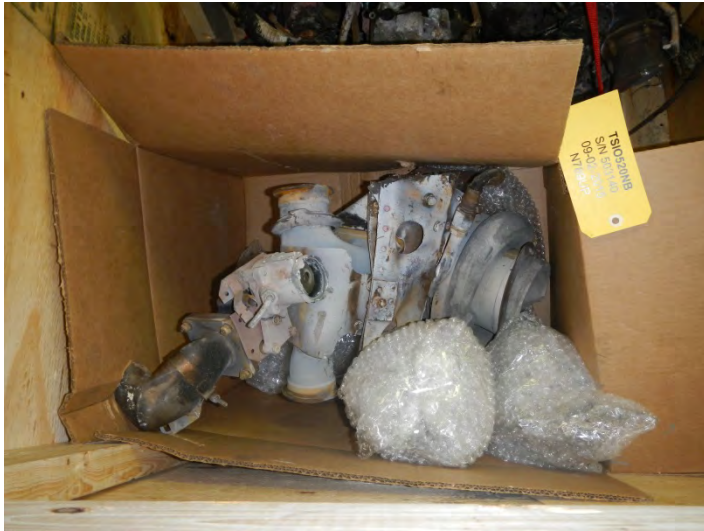
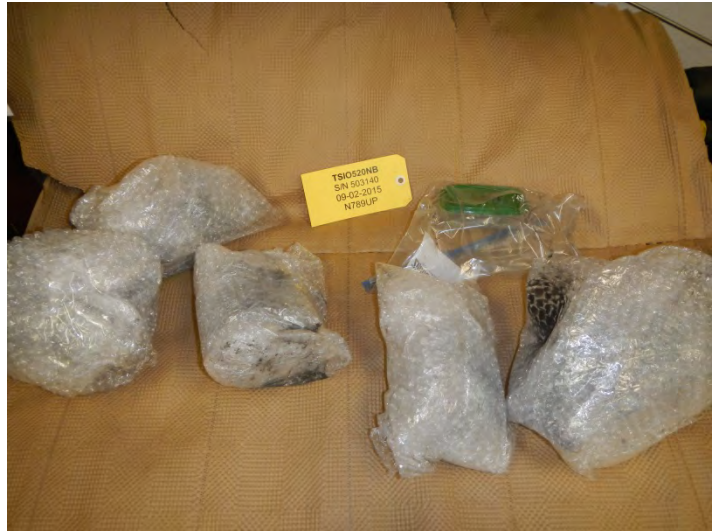
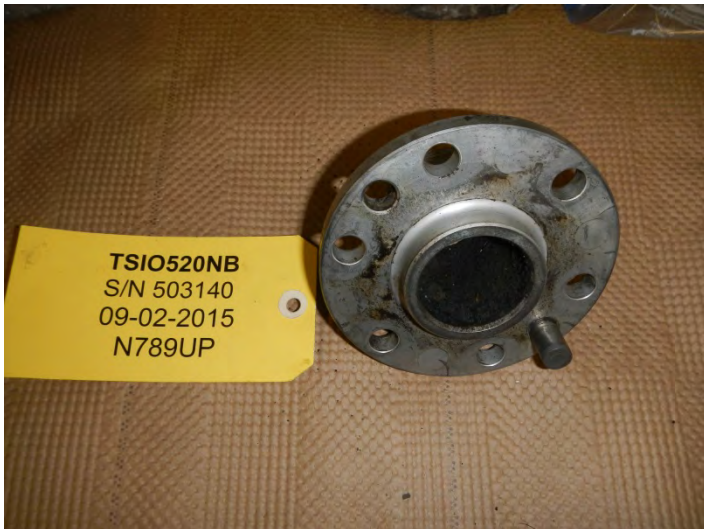
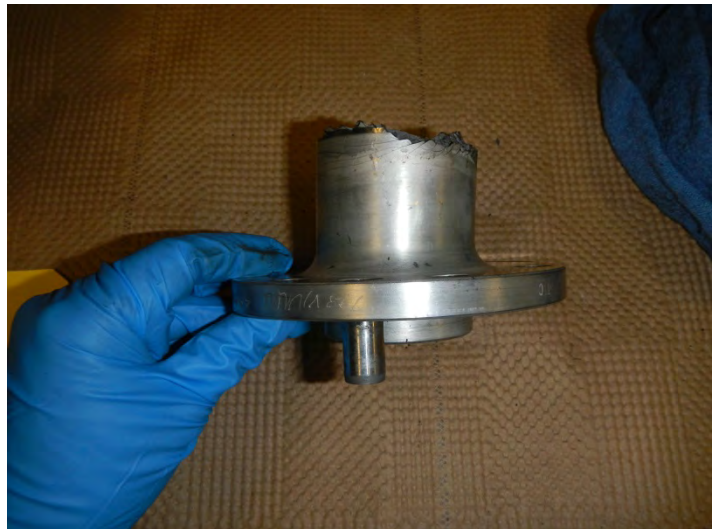
The bottom side of the engine nacelle was crushed upward around the oil sump and remained with the engine. The intercooler remained attached to the engine/nacelle and was displaced upward into the backside of the engine. The oil sump was crushed from the bottom side up as were the exhaust manifolds and front side exhaust risers. The exhaust manifolds on both sides were flattened. The intake manifolds also sustained impact, puncture, and deformation damage on the bottom sides. The induction balance tube was flattened.

The backside of the engine and its related components sustained thermal damage.

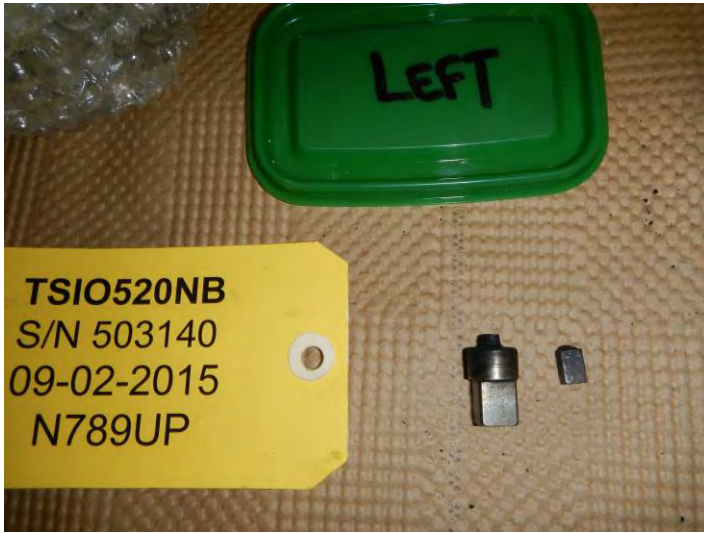
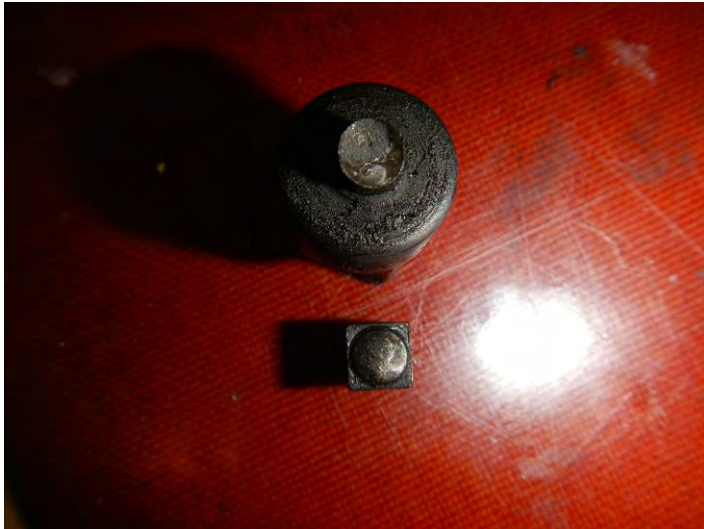
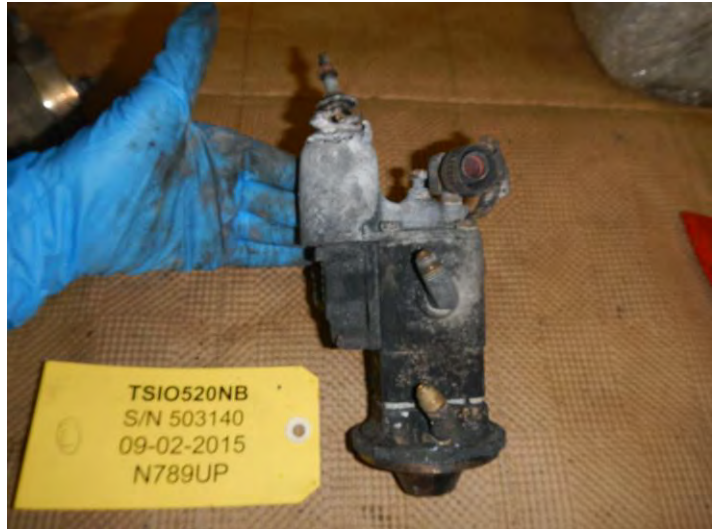
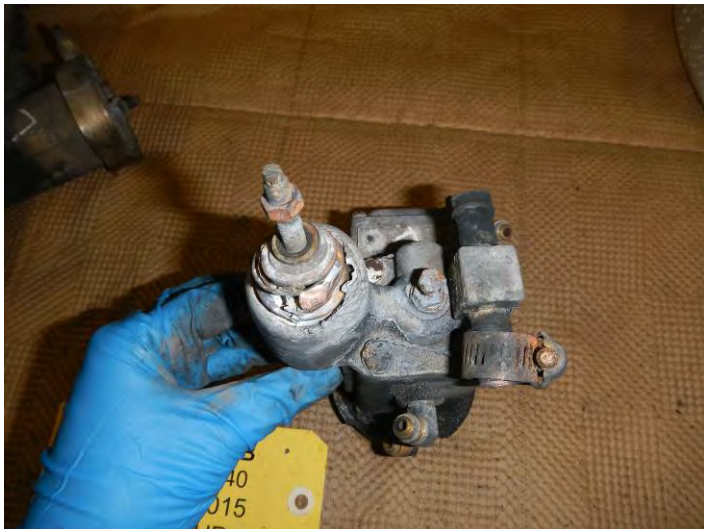
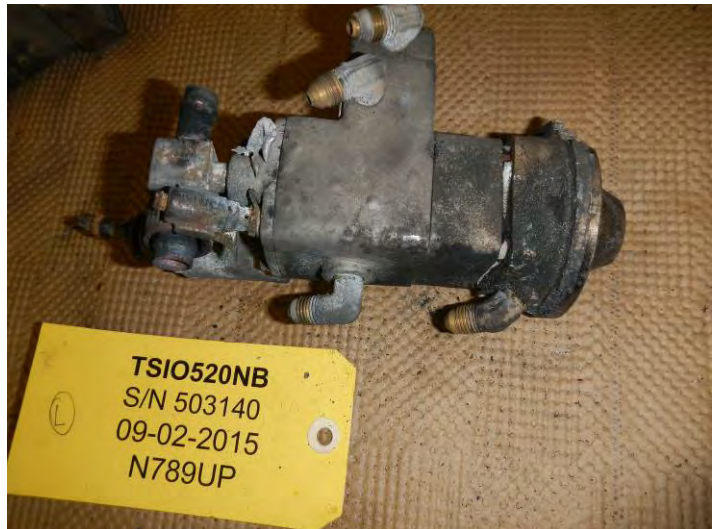
According to the NTSB IIC, the engine-driven fuel pump was partially separated from the backside of the engine at the accident site. The NTSB IIC rotated the crankshaft prior to the complete removal of the engine-driven fuel pump. The drive coupling was found fractured. Close examination of the drive coupling revealed that the fracture surface was irregular in shape with bending observed adjacent to the fracture surfaces. There was no soot noted on the fracture surface. Examination of the fracture surface by a Continental Motors metallurgist revealed that the fracture was a result of overload.

The engine-driven fuel pump's aneroid housing was thermally damaged, exposing the thermally damaged aneroid. Re-solidified molten metal was adhering to the safety wire. The pump was exposed the thermal stresses significant enough to char the diaphragm and compromise the insulator. Disassembly of the fuel pump revealed that the pump vanes were intact and no pre-accident anomalies were noted with the internal components.

The throttle body/fuel metering unit was thermally damaged and the mixture and throttle levers were bent. The throttle housing was partially melted away and the valve was loose and detached from the housing remnants. The fuel metering unit was removed from the throttle body and the fuel inlet screen was removed. Some debris consistent with soot and dirt was observed in the inlet area; however, the screen was clear and free from any obstructions. The throttle and mixture cams were removed and charred debris was observed in the metering unit body, but the metering plug holes were not obstructed. Besides the thermal damage and debris, no pre-accident anomalies were noted with the observed components.

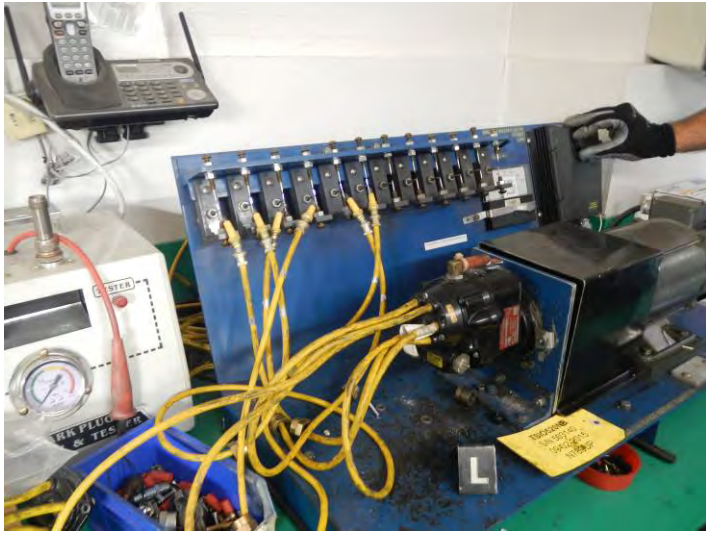
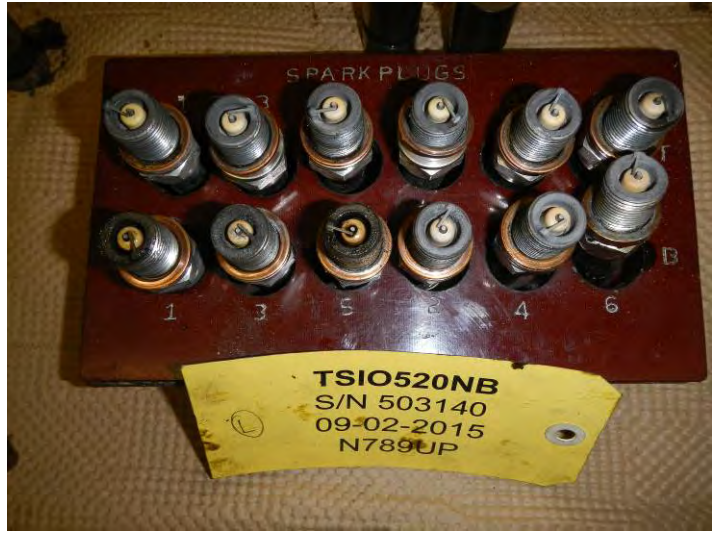
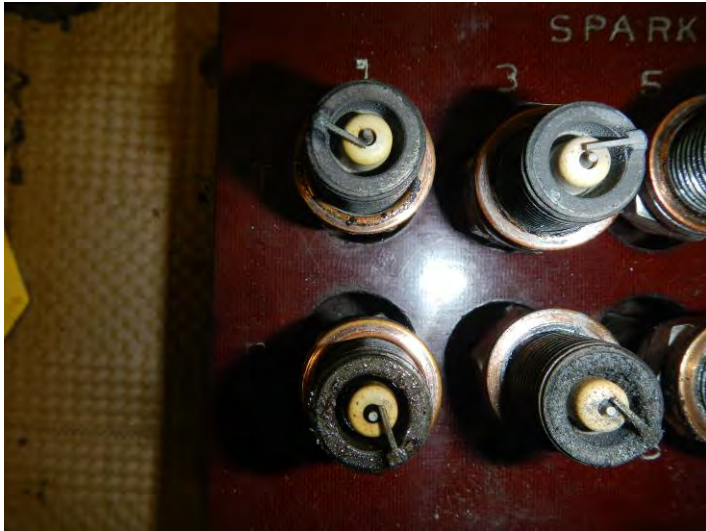
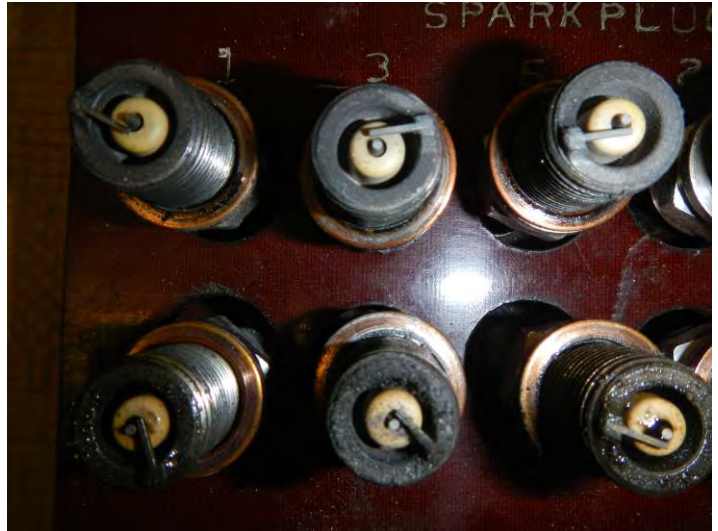
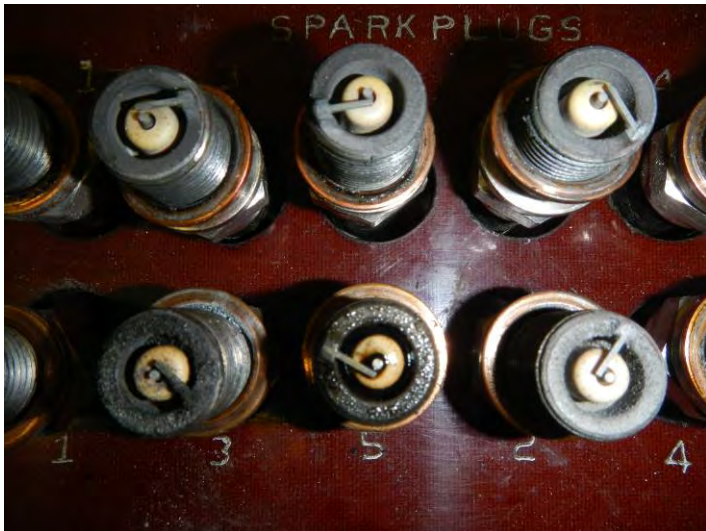
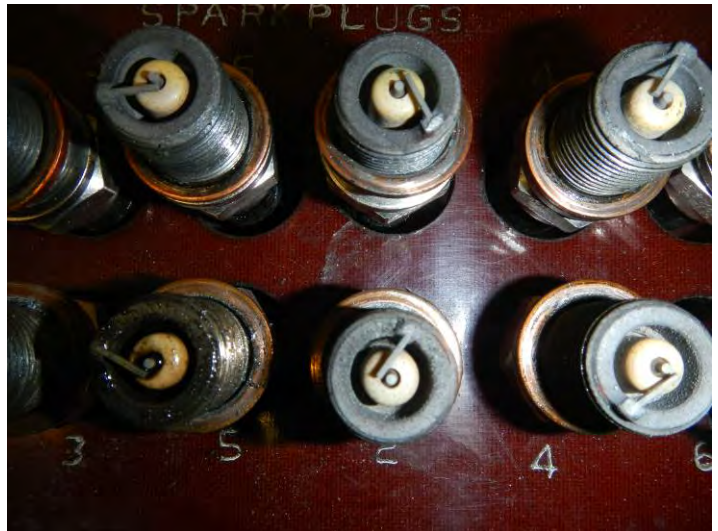
The magnetos remained in place and secured to the mount flanges. The ignition harness sustained damage in the accident that separated a few leads. The terminal ends remained attached to their respective sparkplugs and the sparkplugs remained secured to their cylinders. The ignition harnesses were removed and the magnetos were placed on a test bench with replacement ignition harnesses. Both magnetos produced a blue spark across a 7mm gap during all RPM ranges. No pre-accident anomalies were noted with either magneto.

The top sparkplugs were removed during the on-scene portion of the investigation. All of the sparkplugs were removed and they all displayed little-to-no wear. They were all covered with normal combustion deposits. The #1 and #5 bottom sparkplugs were oil coated and the #1, #3, and #5 sparkplugs bottom sparkplugs were covered with debris; however, there was no sign of fouling.

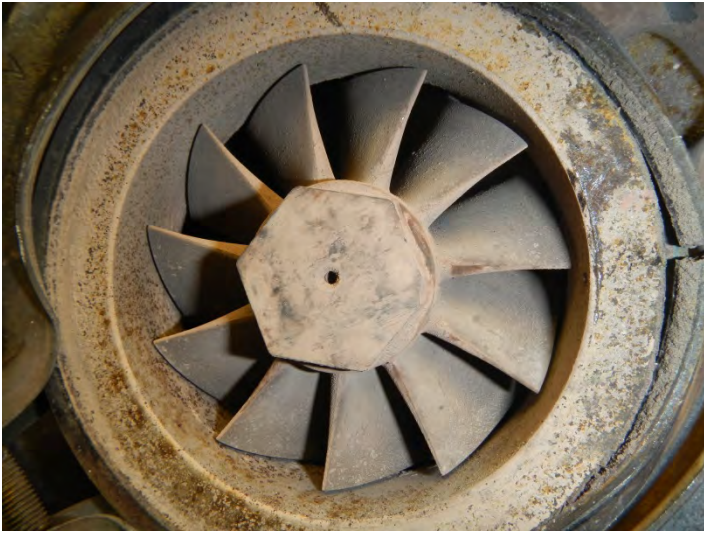
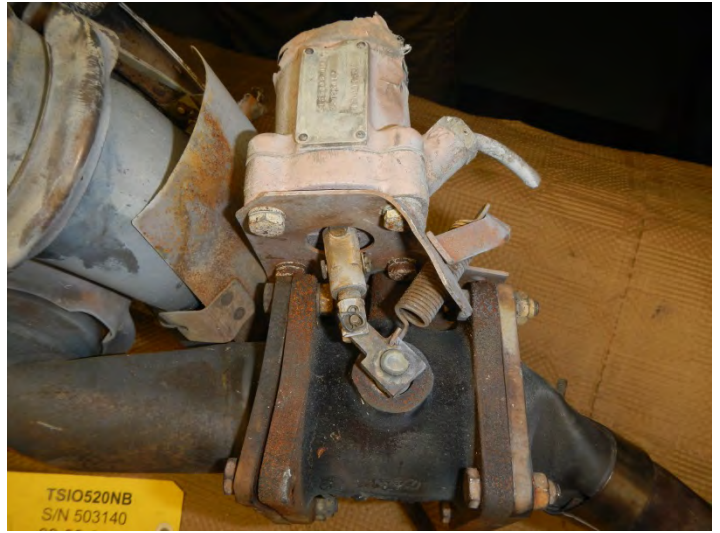
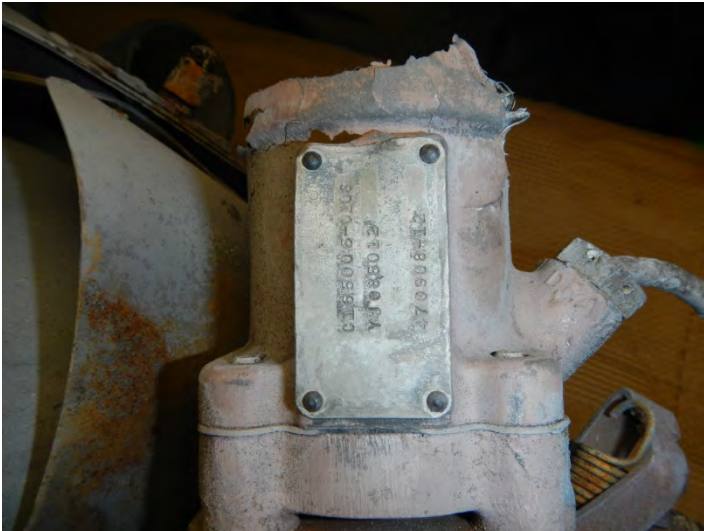
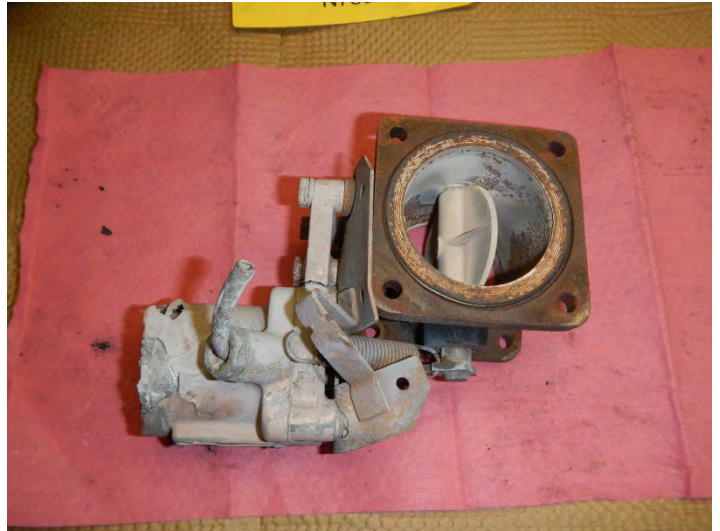
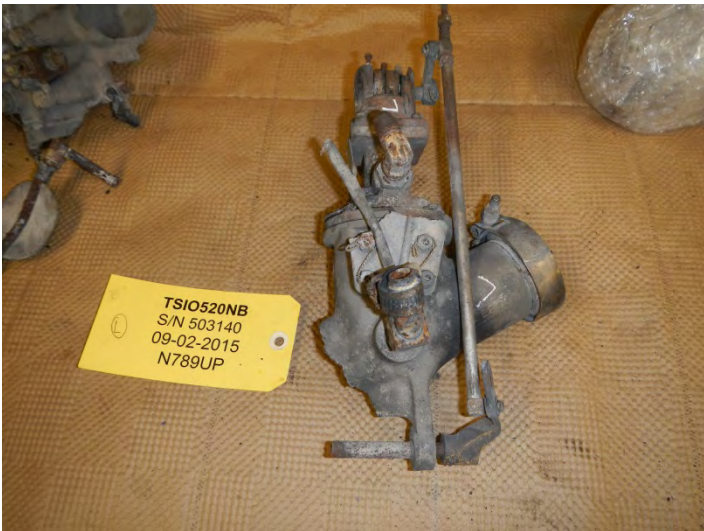
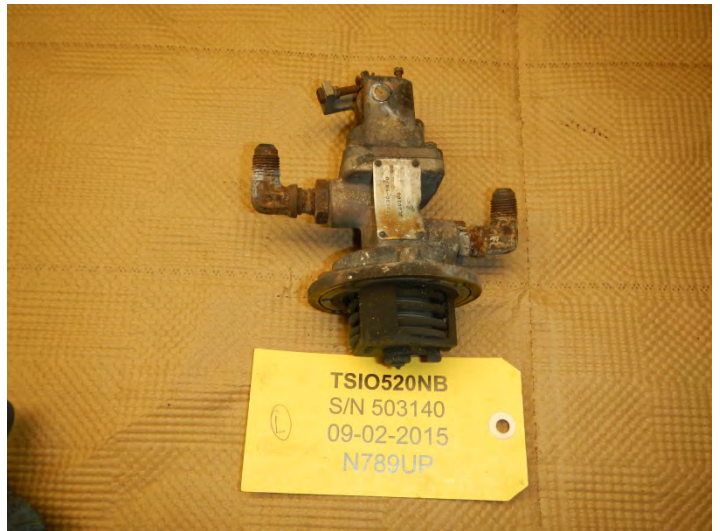
The turbocharger components were visually examined and readied for transport to the Hartzell facility. The overboost valve was not observed and is presumed destroyed. No external pre-accident anomalies were noted with any of the components.

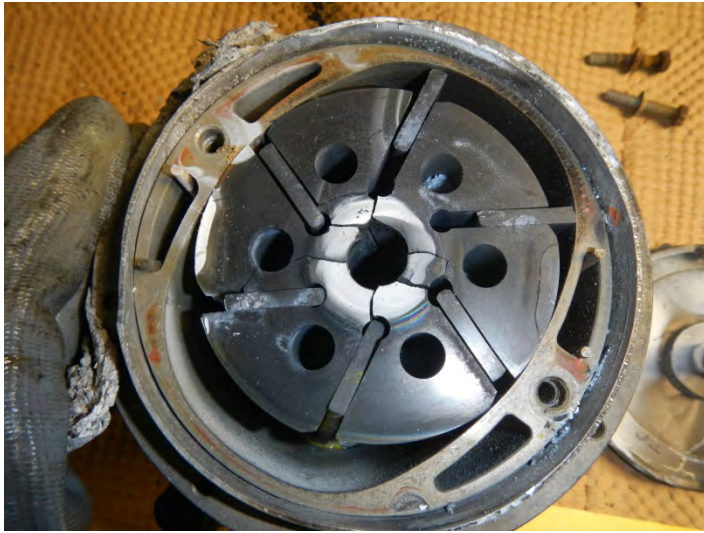
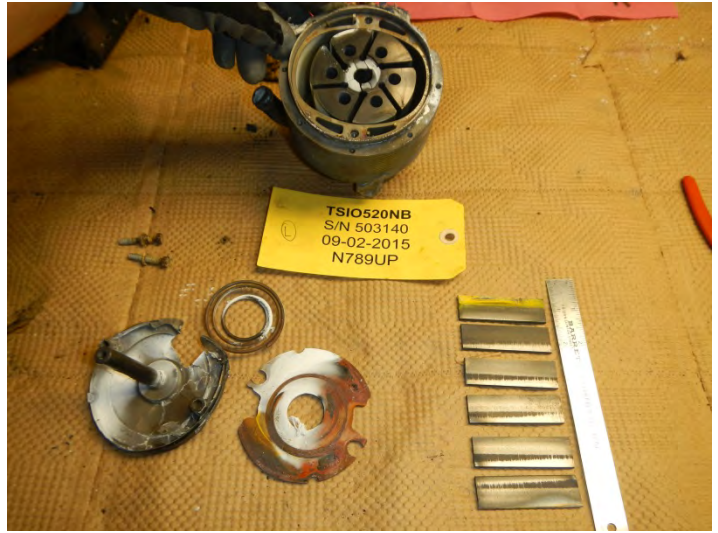
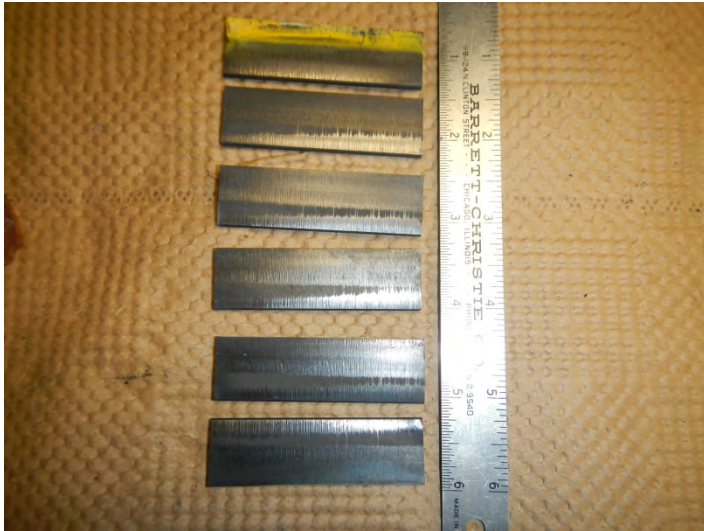
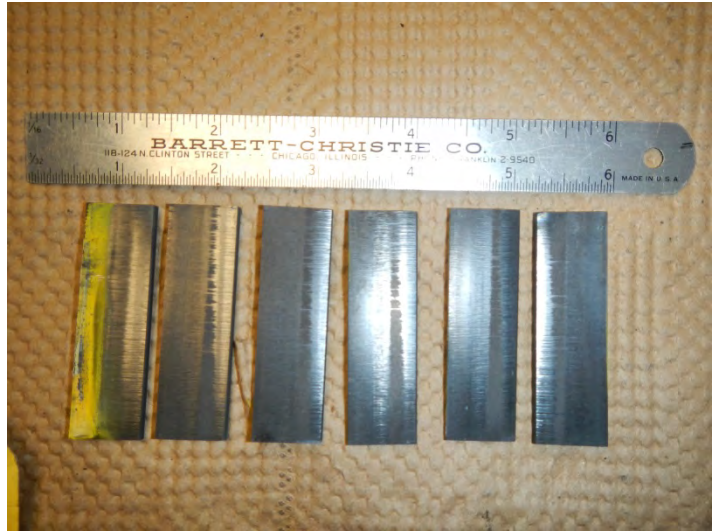
**VACUUM PUMP**

The vacuum pump was removed from the engine prior to the examination and it sustained impact and thermal damage that exposed some of the internal components. Removal of the cap revealed that all of the vanes were intact, but the rotor was fractured.

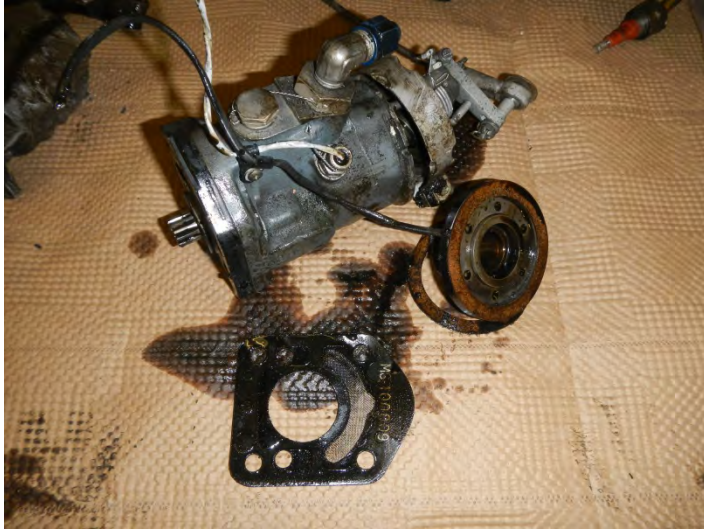
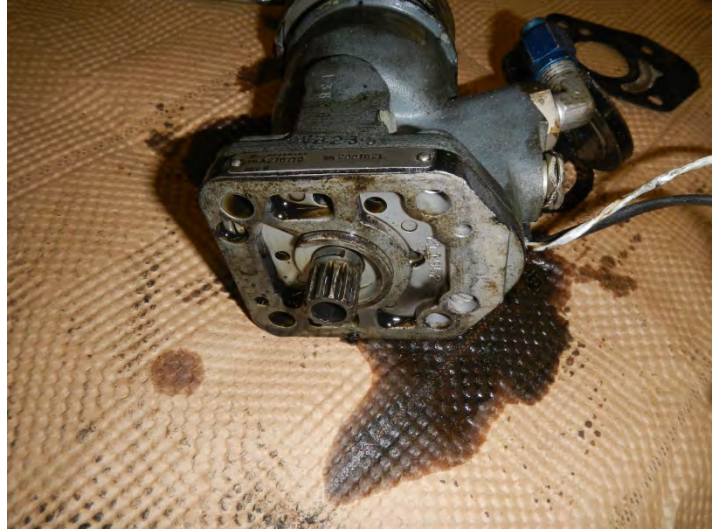
No pre-accident anomalies were noted with the alternator, starter motor and starter adapter, or the propeller governor.
