## ENGINE EXAMINATION REPORT

<b>ENGINE MODEL</b>	TSIO-520-NB
<b>ENGINE SERIAL NUMBER</b>	519303
<b>AIRCRAFT MAKE &amp; MODEL</b>	Cessna 414A
<b>AIRCRAFT SERIAL NUMBER</b>	414A0495
<b>AIRCRAFT REGISTRATION</b>	N789UP
<b>FILE NUMBER</b>	14-488

<b>EXAMINATION</b>		<b>ACCIDENT DATA</b>	
<b>DATE</b>	09/01/2015	<b>NTSB ACCIDENT #</b>	CEN15FA190
<b>FACILITY</b>	Continental Motors	<b>NTSB INVESTIGATOR</b>	Todd Fox
<b>ADDRESS</b>	[REDACTED] Mobile, AL 36615	<b>FAA INVESTIGATOR</b>	Stanley Swank II
		<b>ACCIDENT DATE</b>	04/07/2015
		<b>ACCIDENT LOCATION</b>	Bloomington, IL

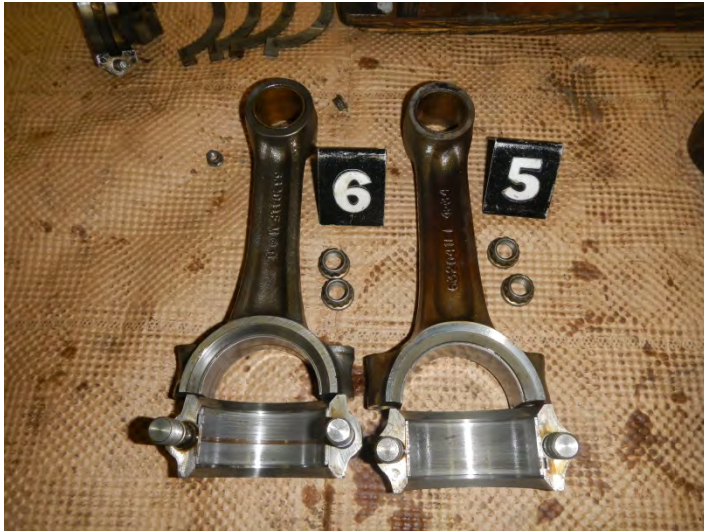
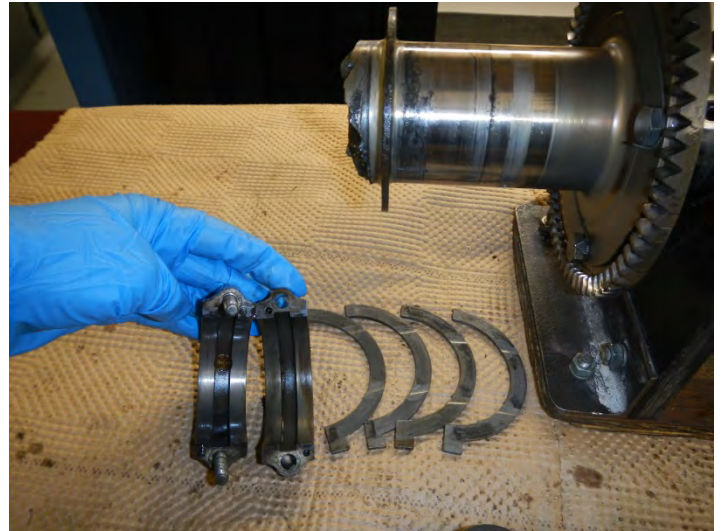
The crankshaft was intact with the exception of the fracture noted aft of the propeller flange. There were no pre-accident anomalies noted on any of the crankshaft main journals, connecting rod journals, crankshaft gear, or counterweights.

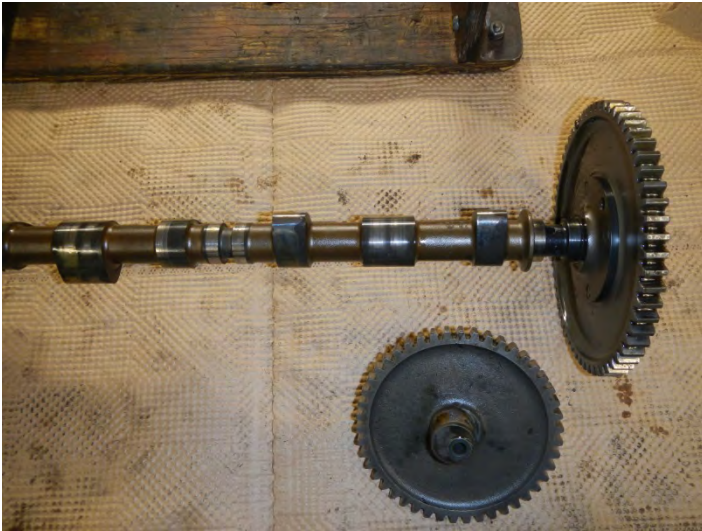
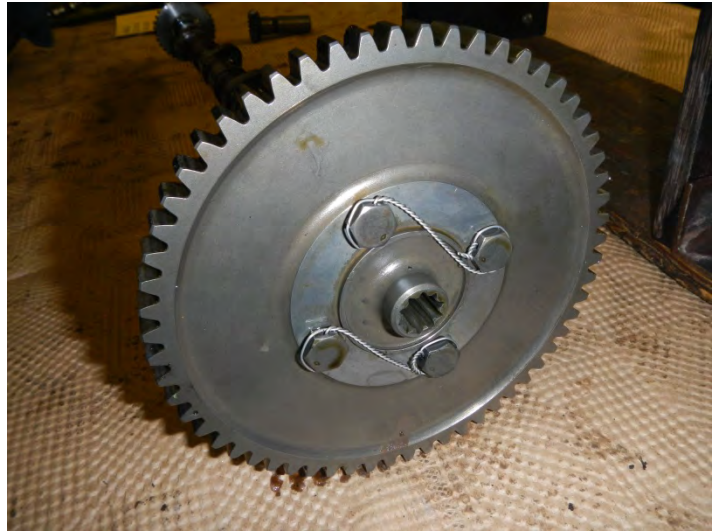
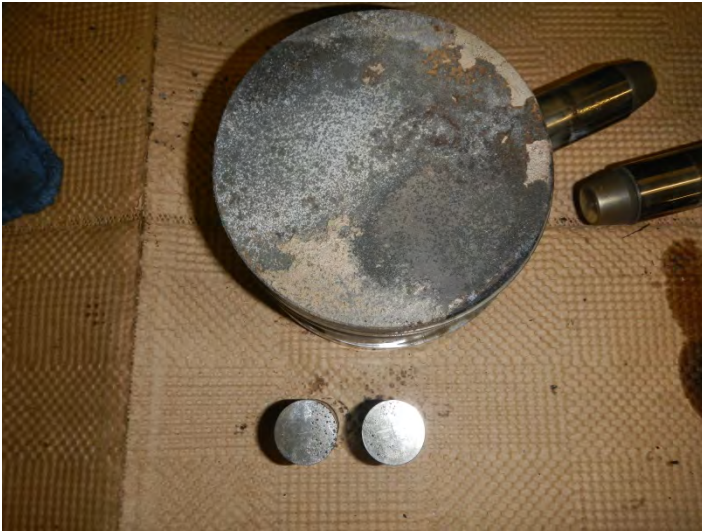
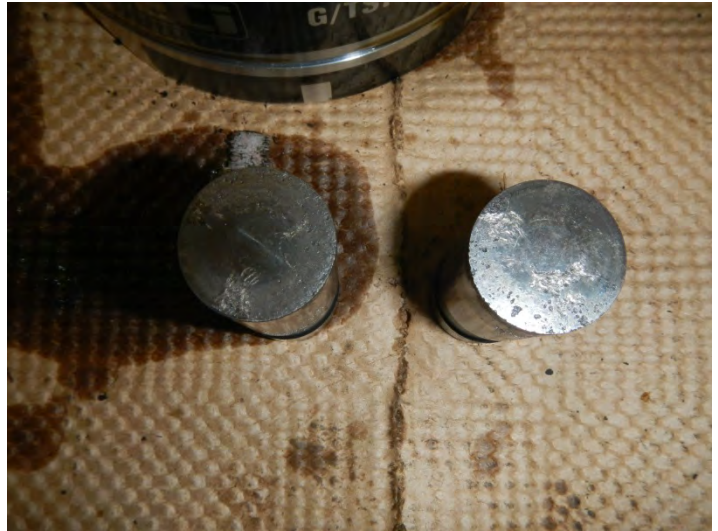
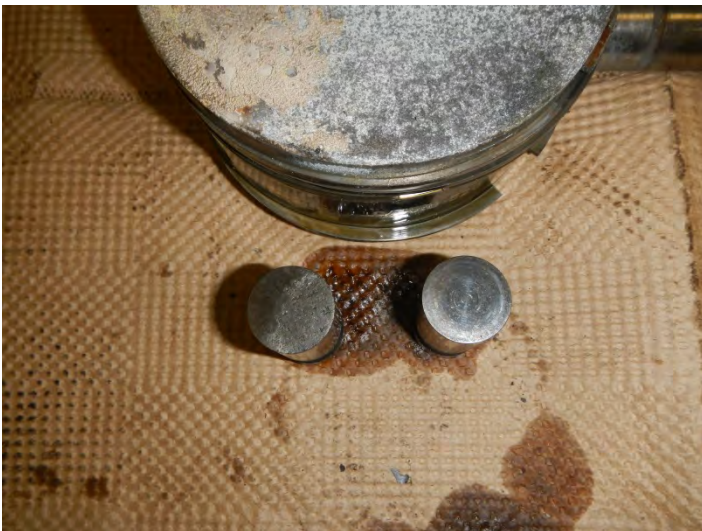
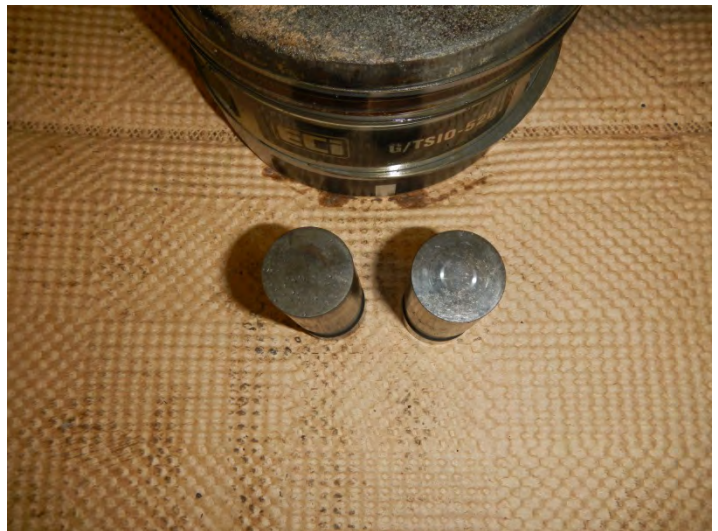
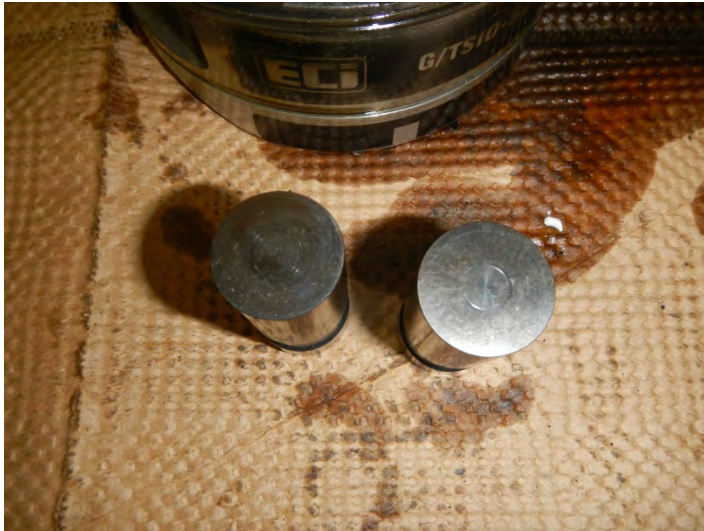
Some of the lifters displayed spalling damage. The camshaft lobes did not display any anomalies or signs of excessive wear. The camshaft gear did not display any pre-accident anomalies.
