# EC135 ALERT SERVICE BULLETIN

## Indicating and Recording Systems – Instrument Panel – Inspection and modification of switches ENG CONTROL on switch unit 20VE

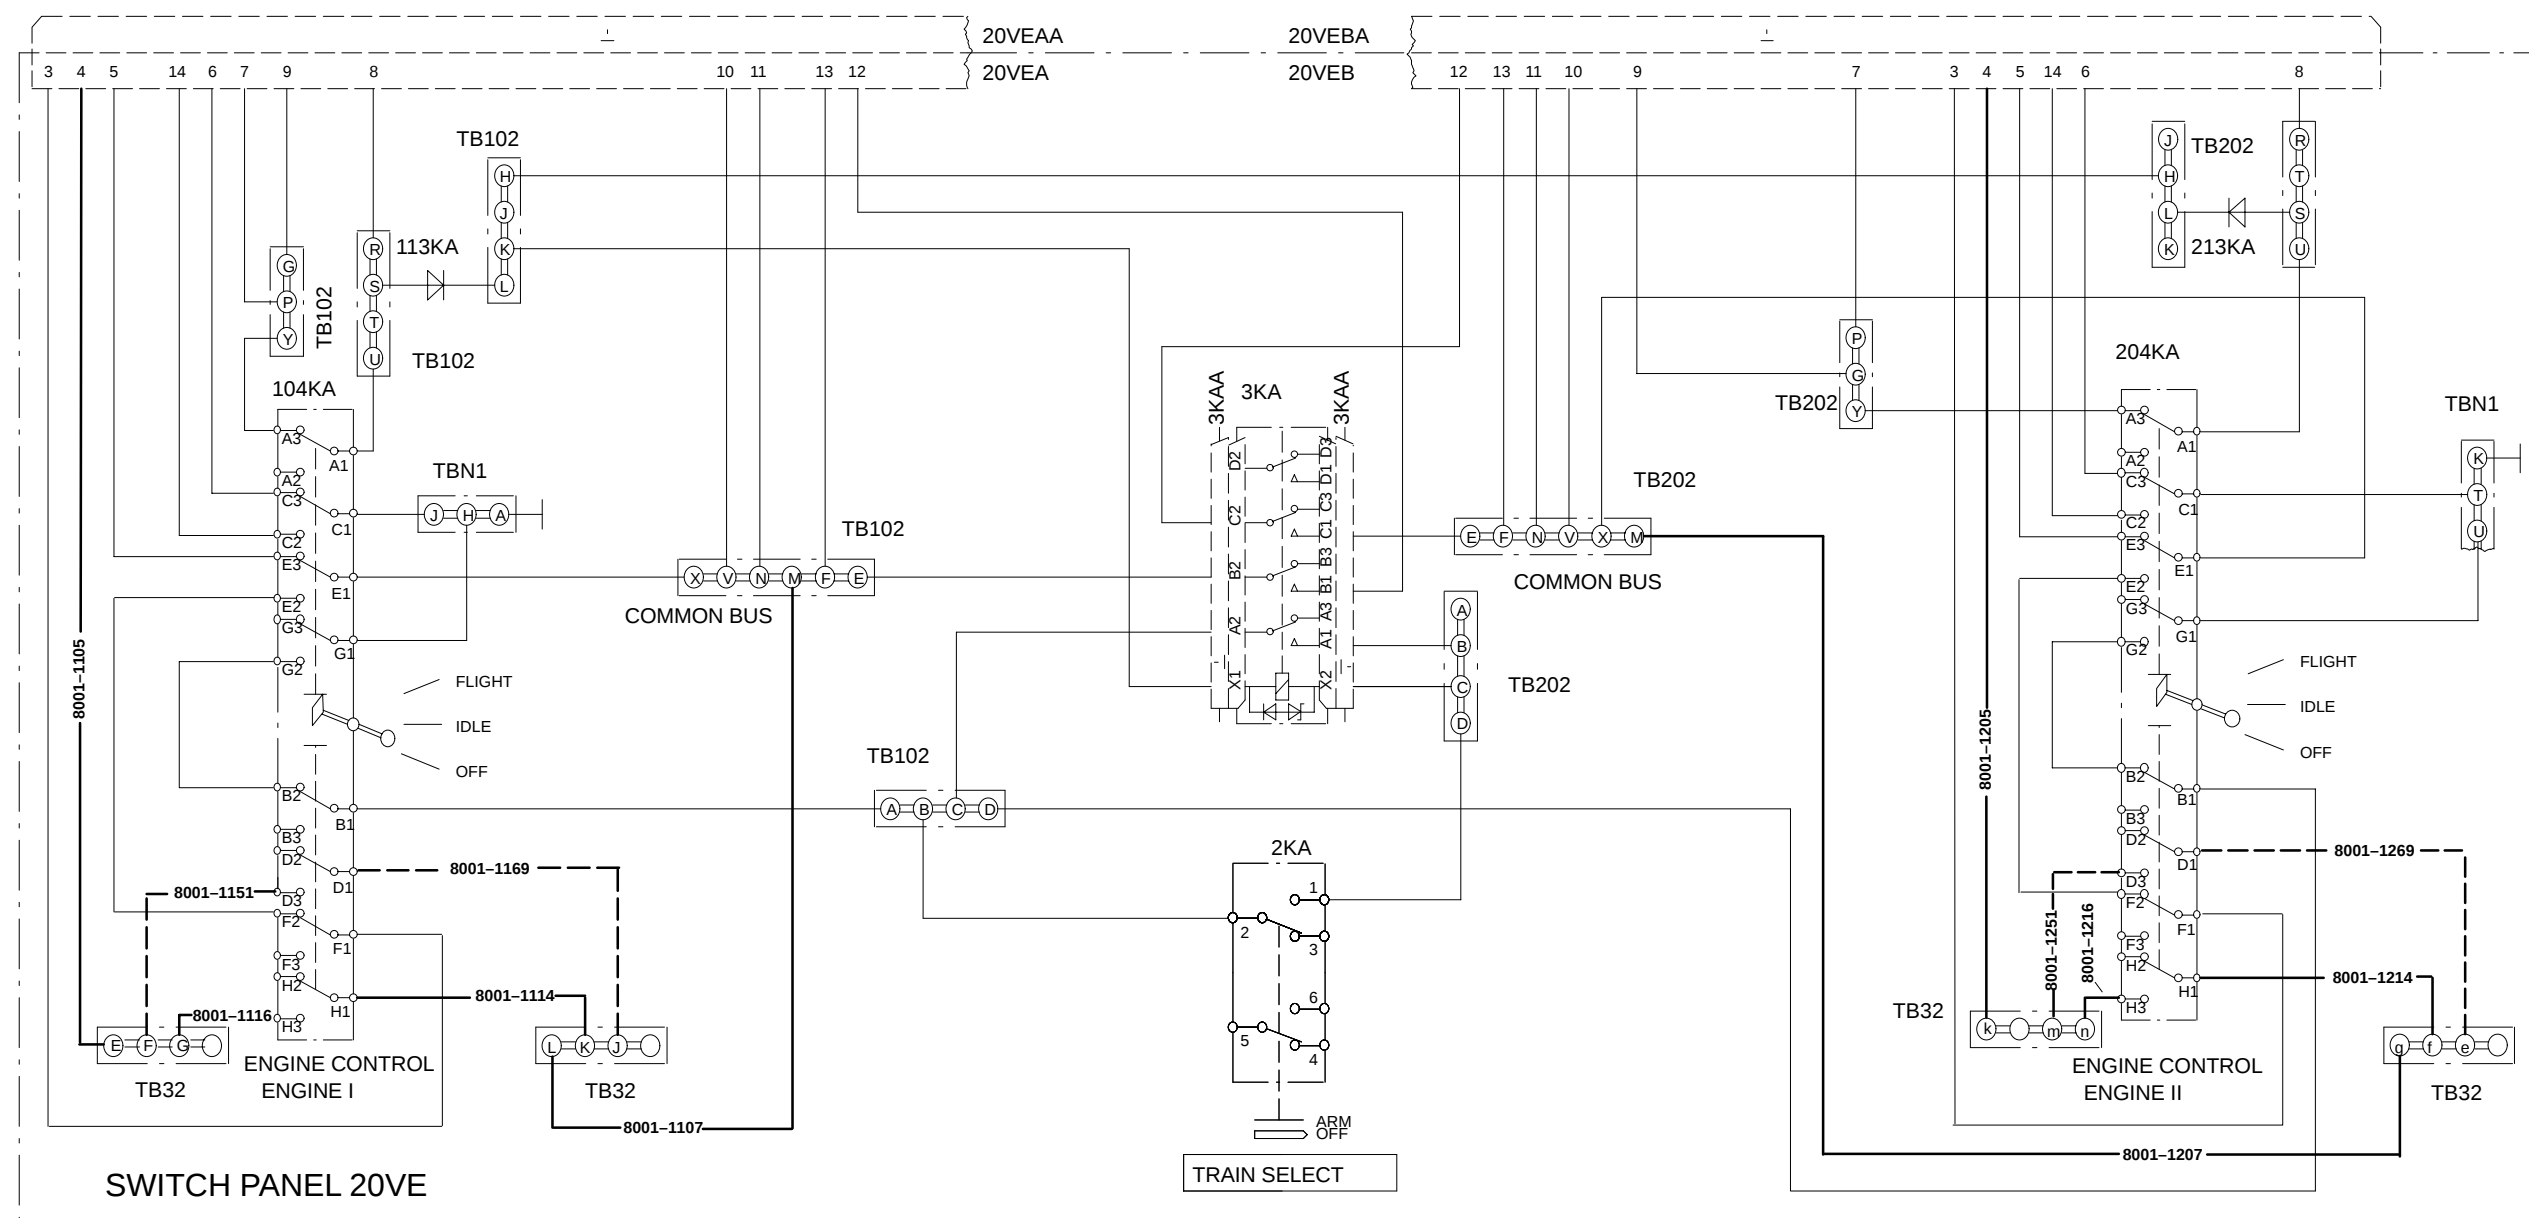
Possible Variants of Switch Units (up to and including H/C S/N 0168)  
Figure 5

- (3) Compare switch unit with the possible variants shown in Figure 3 – Figure 5 and verify new part number.
- (4) Using a permanent, black pen, write verified part number onto placard (8, Figure 2).
- (5) If switch unit 20VE cannot be verified contact ECD customer support.
