INCIDENT INVESTIGATION REPORT IRN000102 Issue 1

MEGGITT RETURN No	N/A	PART No	DAP00100-07	QTY	1
DESCRIPTION	BCU	SERIAL No	230000159		
DATE OF MANUFACTURE	Aug 2011	MOD. STATE	1		
OPERATOR	Flight Options LLC	REPORTED USAGE	Unknown		
AIRCRAFT	EMB-505	DATE OF INCIDENT	05/08/2013		
CONSTRUCTOR	Embraer	CUSTOMER ORDER	N/A

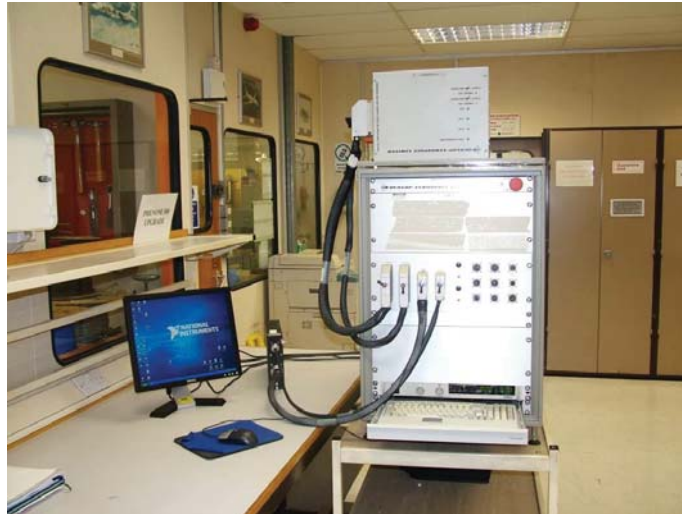
Figure1

- BCUTE F2895
- BCU Main Connector Harness F2895_1
- BCU Test Connector Harness F2895_2
- Adaptor Module DAA05451-00
- Adaptor 1 Harness F2907_1
- Adaptor 2 Harness F2907_2
