2. FINDINGS OF PART NUMBER 2524644 SERIAL NUMBER 324947.

NTSB ID WPR13FA119

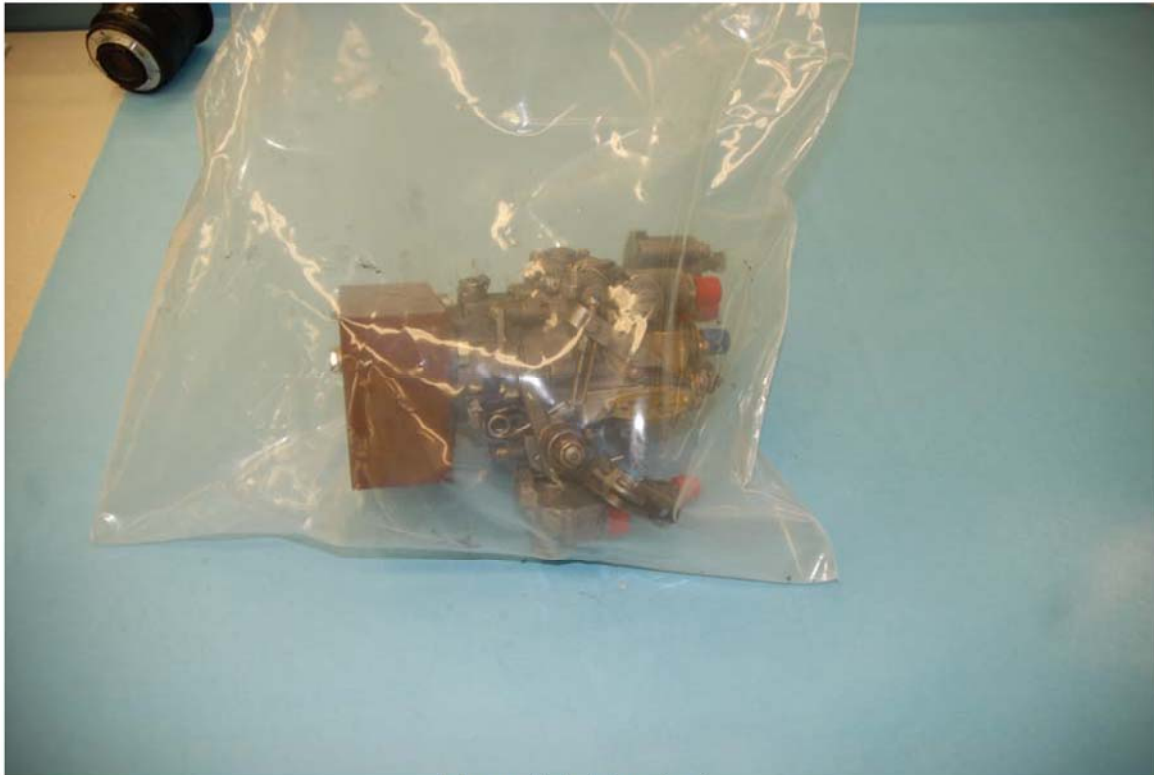
Figure 1 As Received

- 2.1.1. All Lock wire and seals were in place.
- 2.1.2. The PLA Shaft was bent but rotated normally.
- 2.1.3. The Drive Shaft rotated normally.
- 2.1.4. The Cut-off Lever was bent inboard to the FCU.
- 2.1.5. PR, PG, PY and PC fittings were found to be unobstructed.

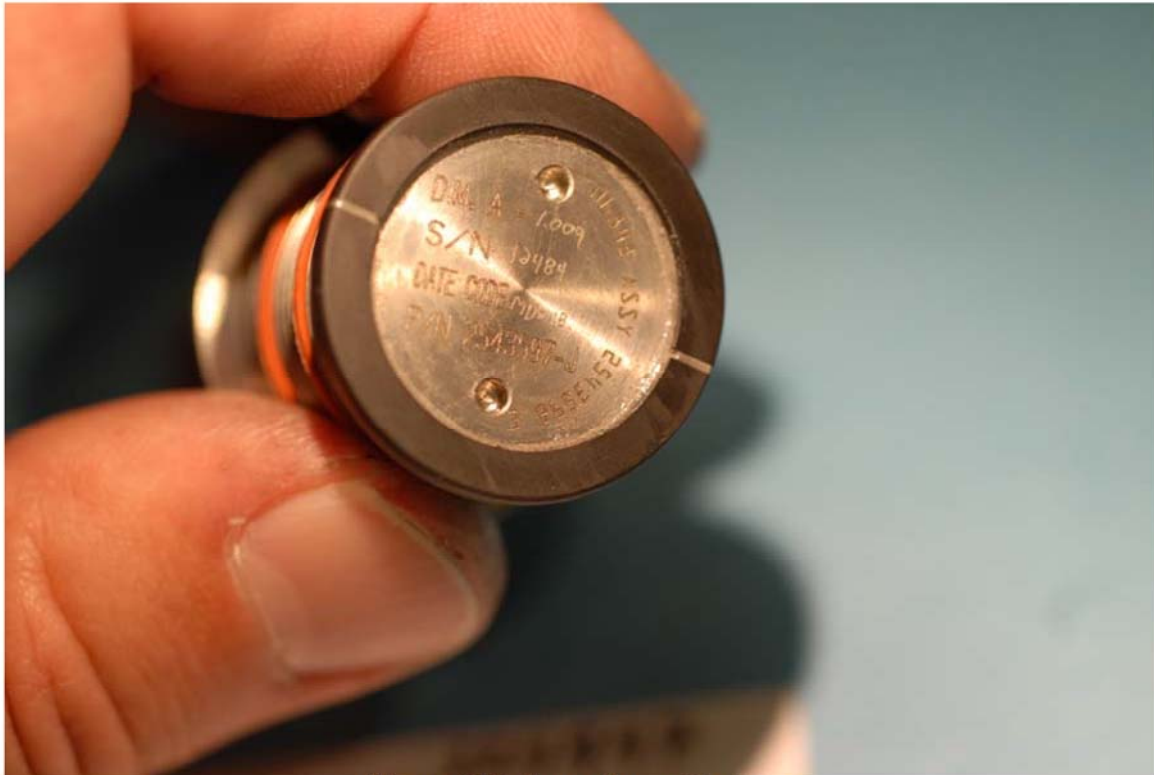
Figure 17 Bellows Assembly Data

- 2.3.9. The Acceleration Bellows length was checked and found to be 1.012 and deemed to be acceptable. Manufacturer recorded length was 1.009.
- 2.3.10. No anomalies were found with the Cut-off Valve Assembly.

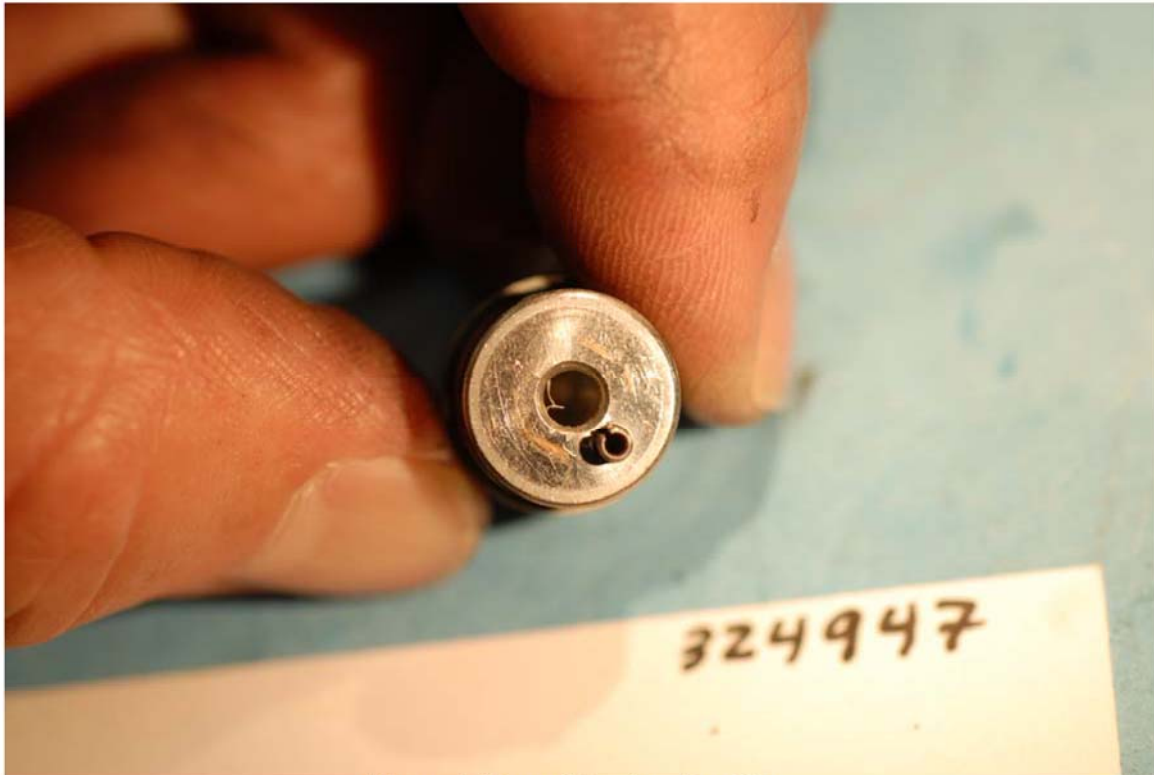
Figure 21 Spool Bearing Bushing

- 2.3.14. The Spool Bearing and Cap were found to be in good condition. Based on the appearance and finish of the spool bearing cap it is not a genuine Honeywell part and is considered a PMA part. Reference figure 26.

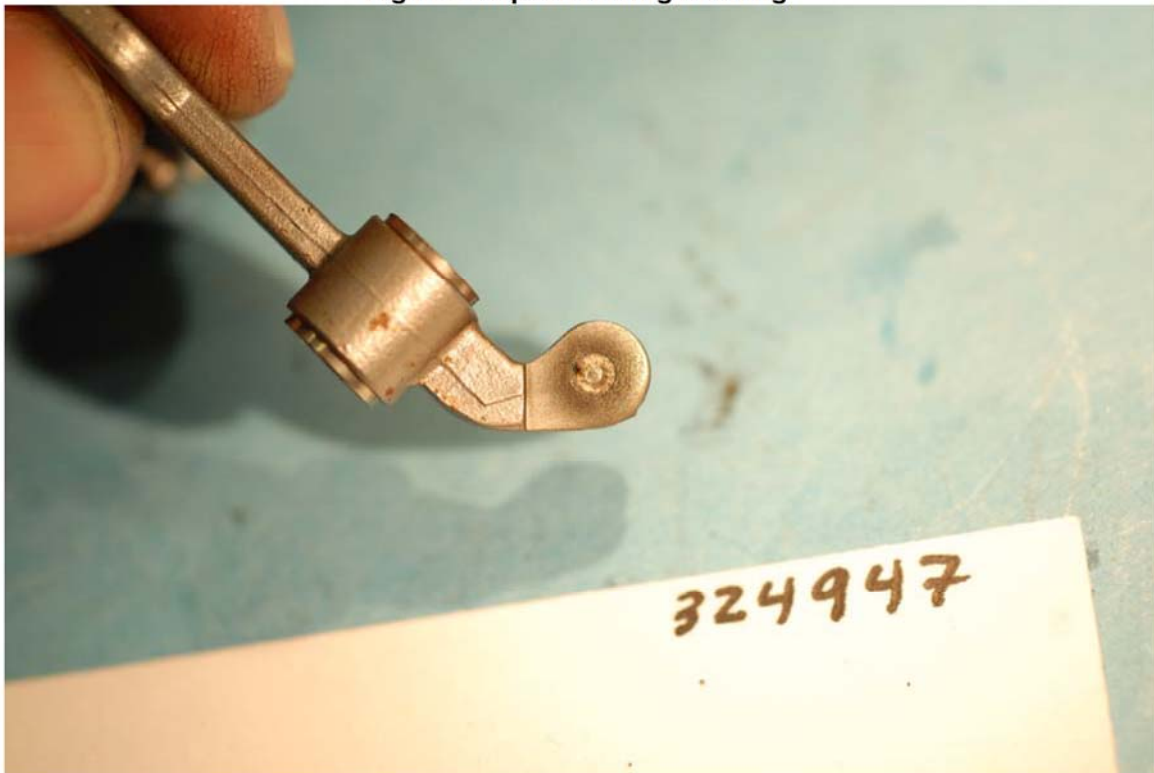
Figure 22 Px Governor Lever

- 2.3.16. The PX and PY orifices were found to be normal.
- 2.3.17. The PX and PY lever pads had uniform circular contact witness marks from the corresponding orifices.
