**Report of Preconstruction Condition
Survey Services**

**ADJACENT PROPERTIES TO
THE WHARF – PHASE I
WASHINGTON, DC**

ECS PROJECT NO. 37:1306

OCTOBER 6, 2014

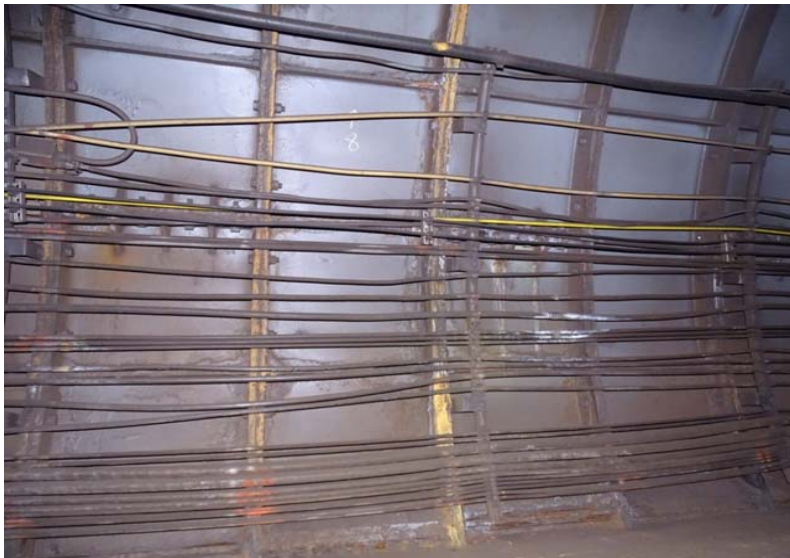
Photograph No. 3
Station 69+60 - corrosion on the east wall.

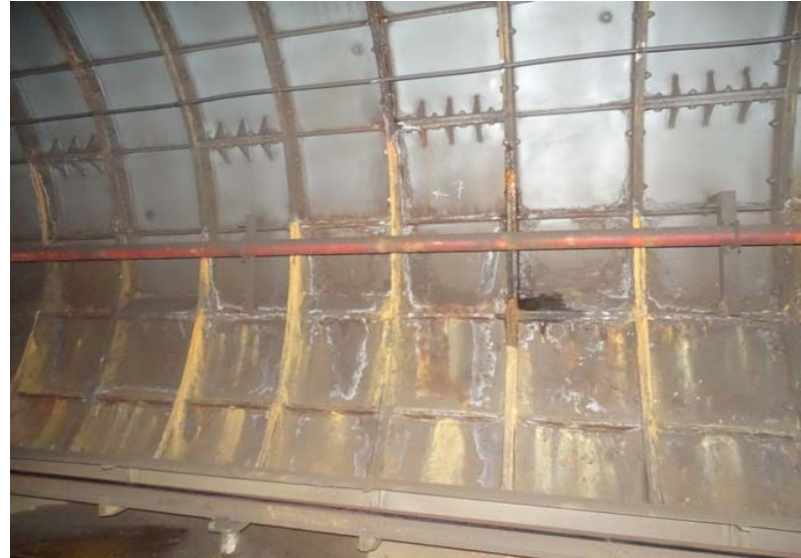
Photograph No. 6
Station 69+60 - active leak and corrosion on the west wall.

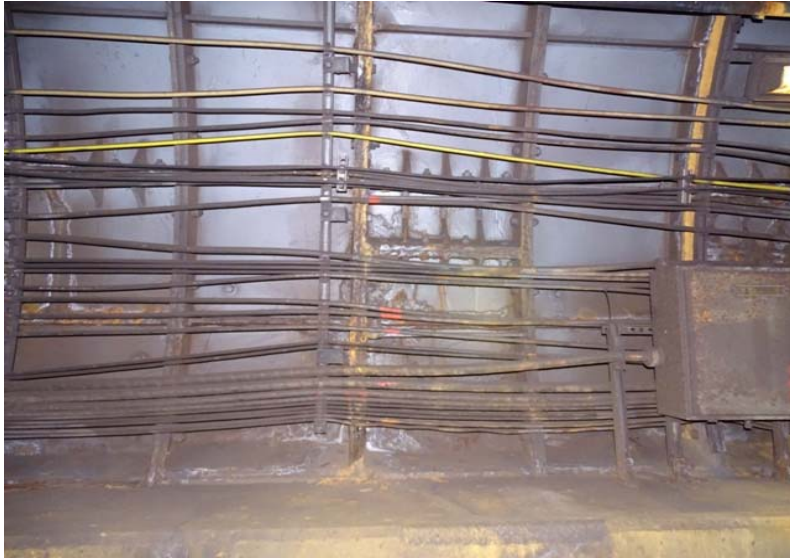
Photograph No. 9
Station 69+80 - corrosion on the east wall.

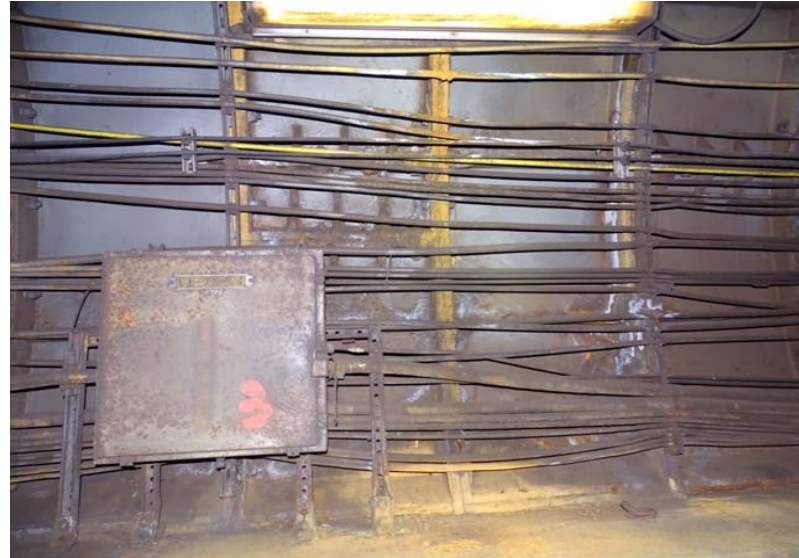
Photograph No. 10
Station 69+80 - corrosion on the east wall.

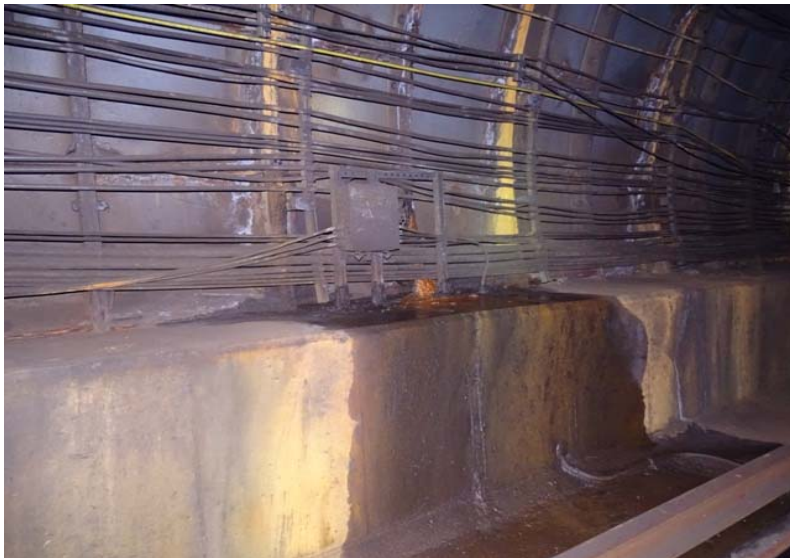
Photograph No. 11
Station 69+80 - active leak on the east wall.

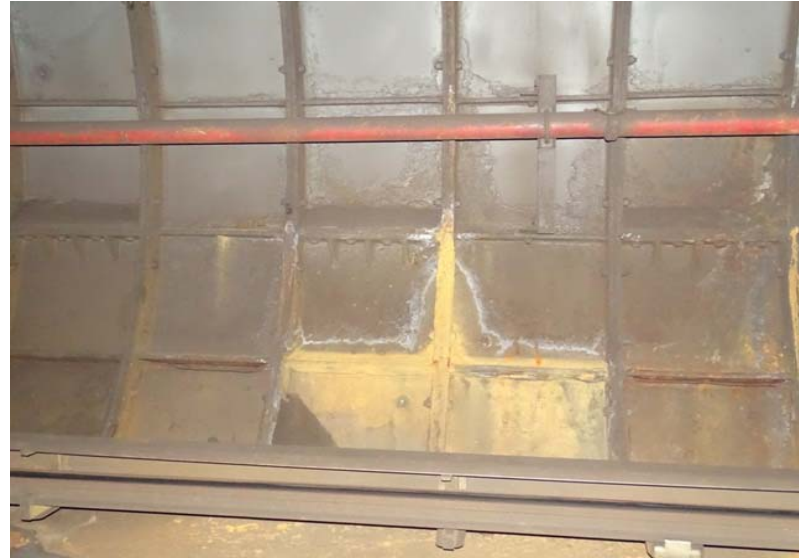
Photograph No. 14
Station 69+80 - corrosion on the west wall.

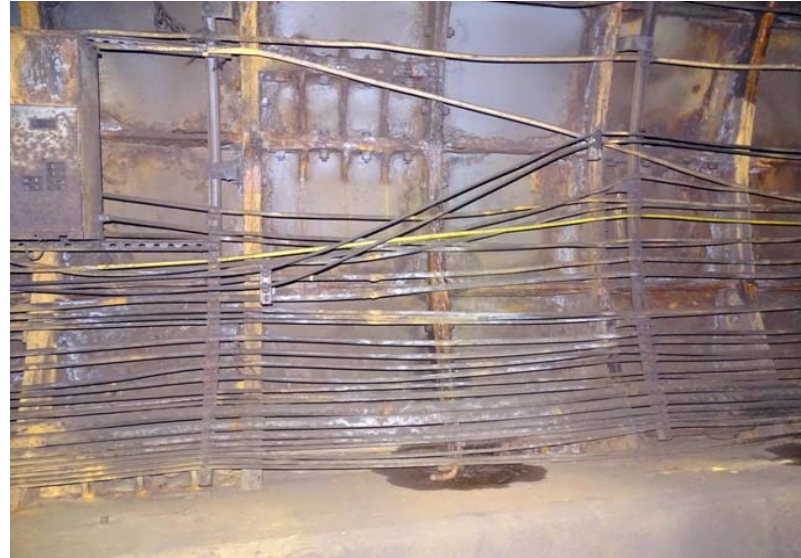
Photograph No. 18
Station 70+00 - active leak and corrosion on the east wall.

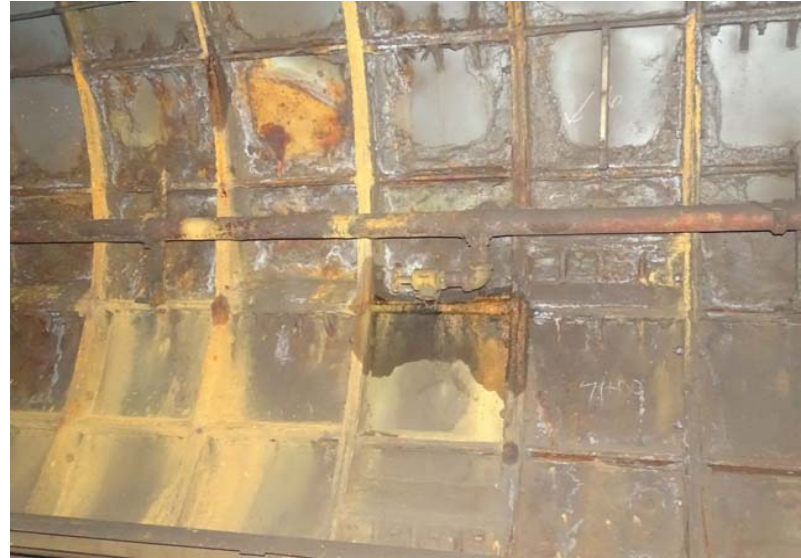
Photograph No. 22
Station 70+00 - active leak, stains, and corrosion on the west wall.

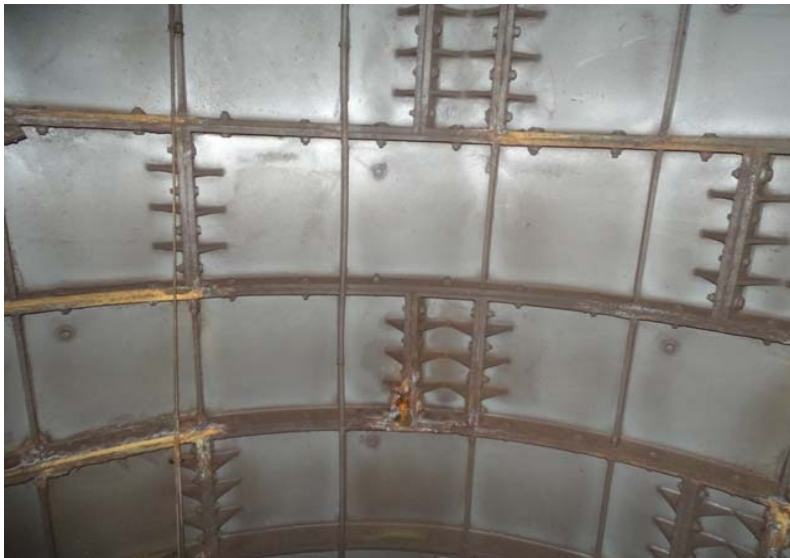
Photograph No. 27
Station 70+20 - corrosion on the ceiling.

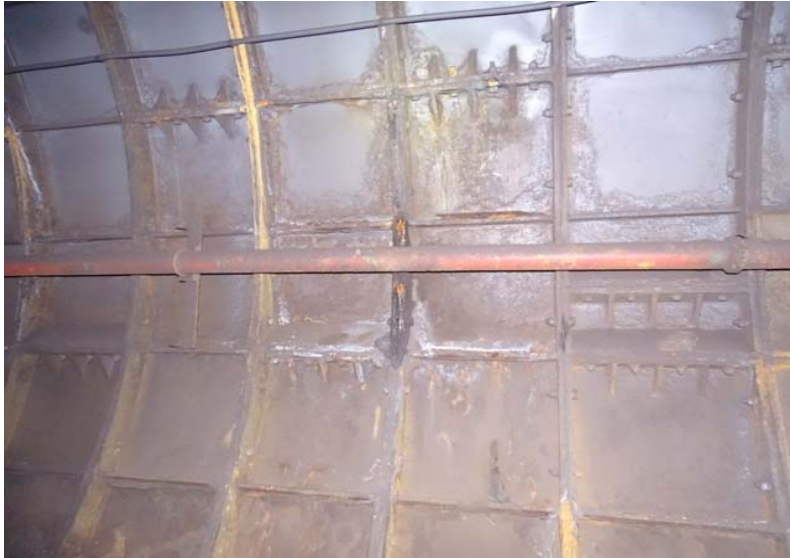
Photograph No. 29
Station 70+20 - active leak and stains on the west wall.

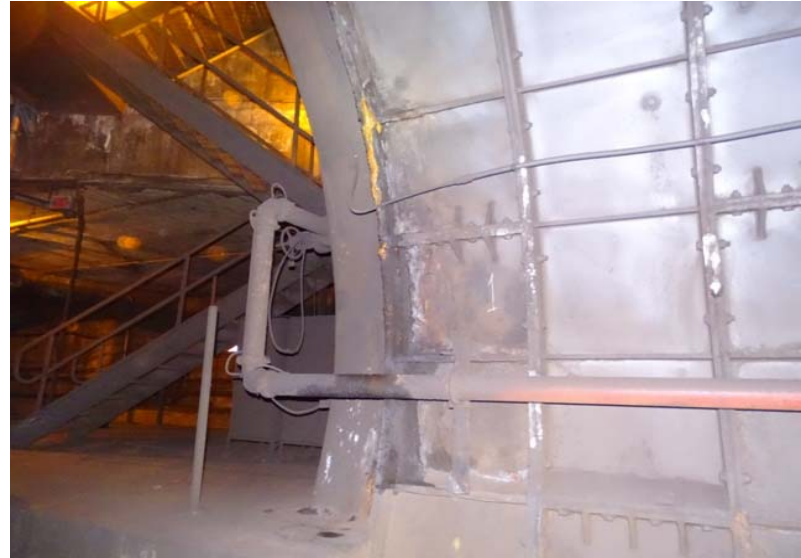
Photograph No. 30
Station 70+20 - stains and corrosion on the west wall.

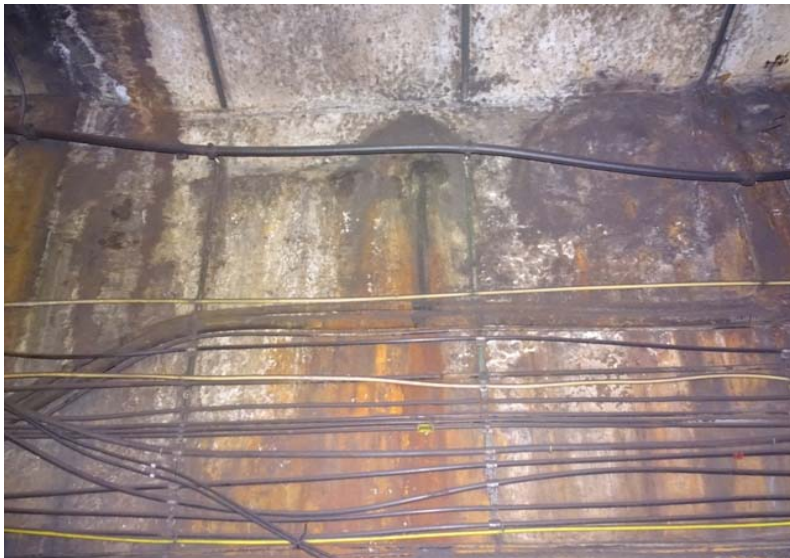
Photograph No. 39
Station 70+80 - stains on the east wall.

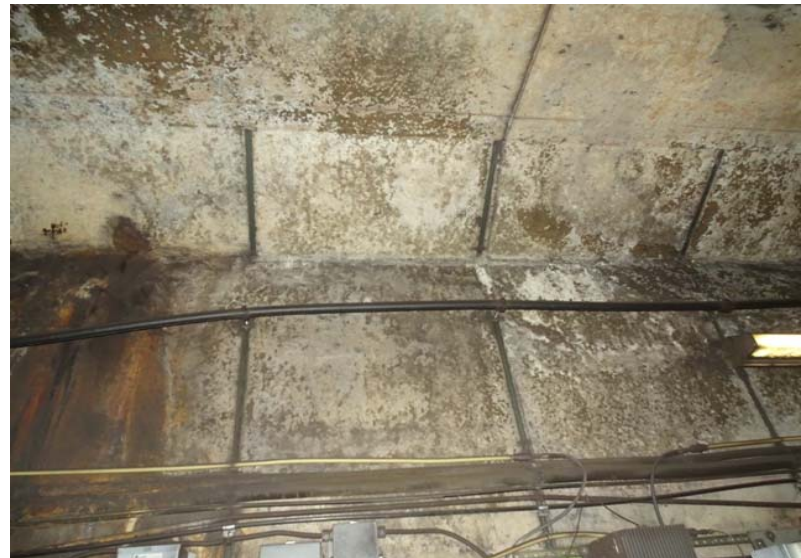
Photograph No. 40
Station 70+80 - stains on the east wall.

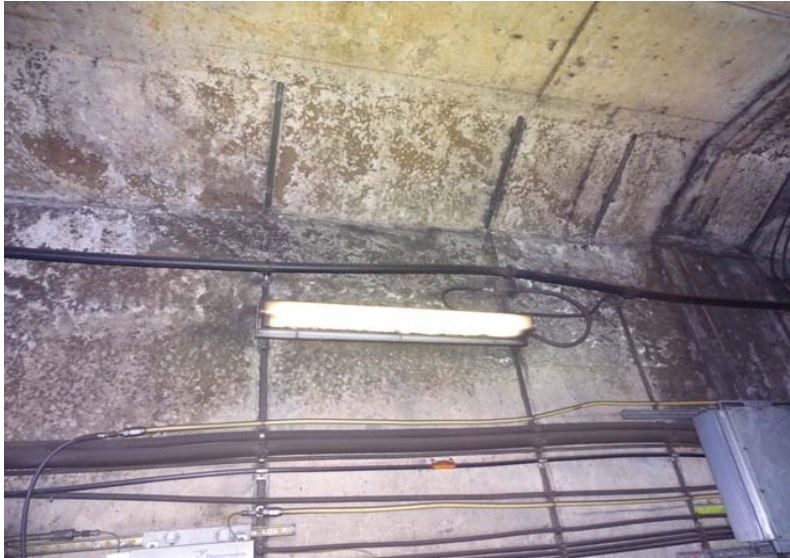
Photograph No. 41
Station 70+80 - stains on the east wall.

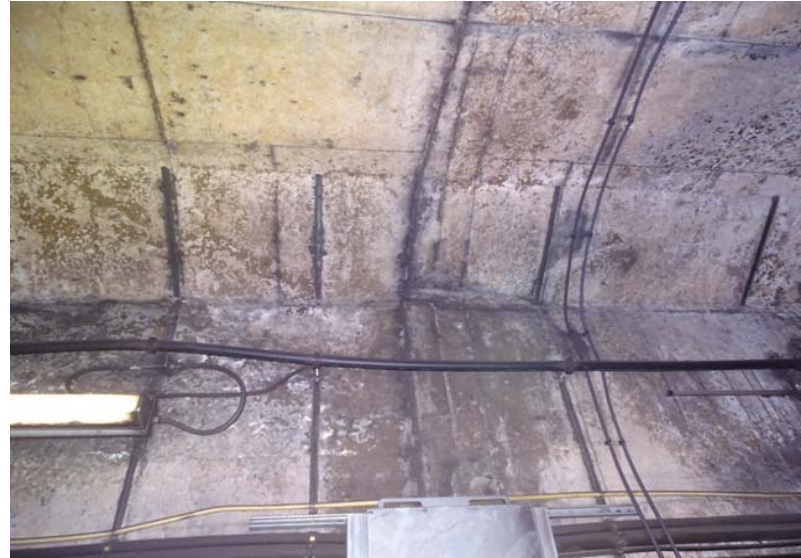
Photograph No. 42
Station 70+80 - stains on the east wall.

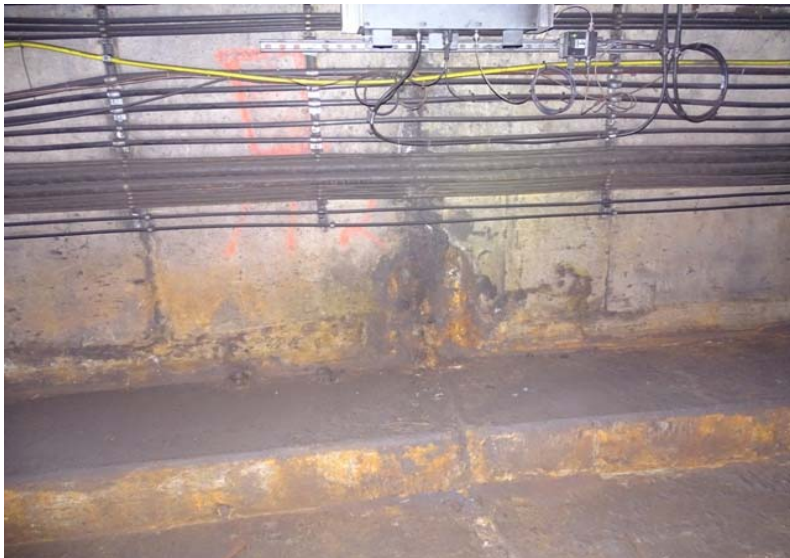
Photograph No. 43
Station 70+80 - stains on the east wall.

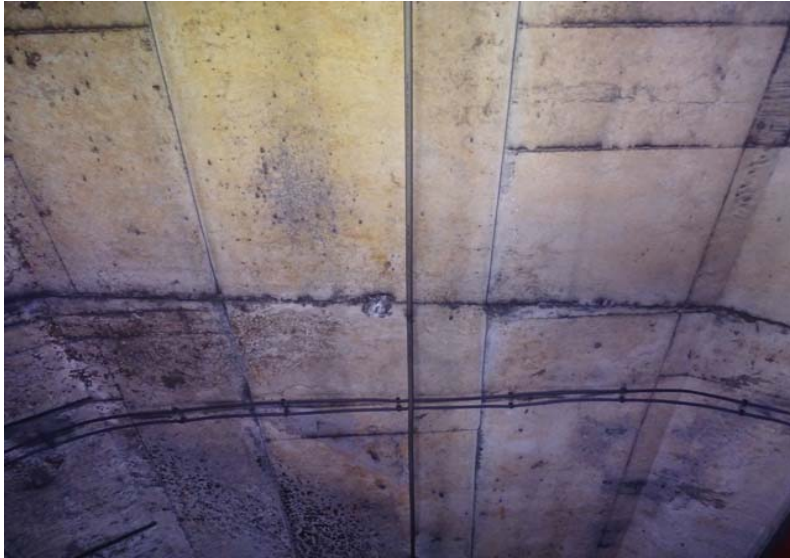
Photograph No. 45
Station 70+80 - stains at a construction joint on the ceiling.

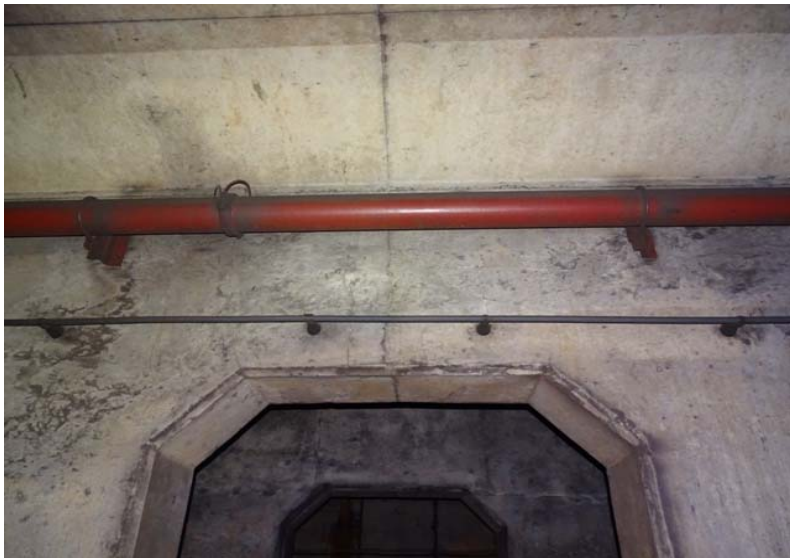
Photograph No. 47
Station 70+80 - construction joint above west arch.

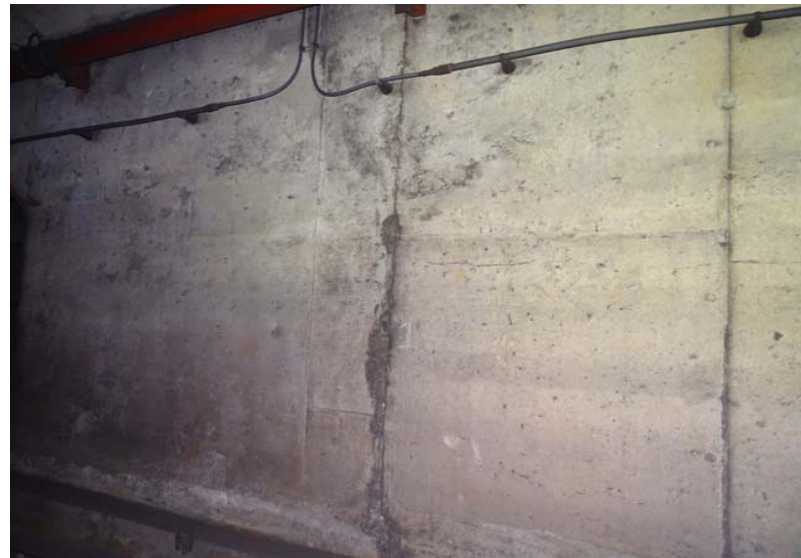
Photograph No. 48
Station 70+80 - damaged concrete at the west wall.

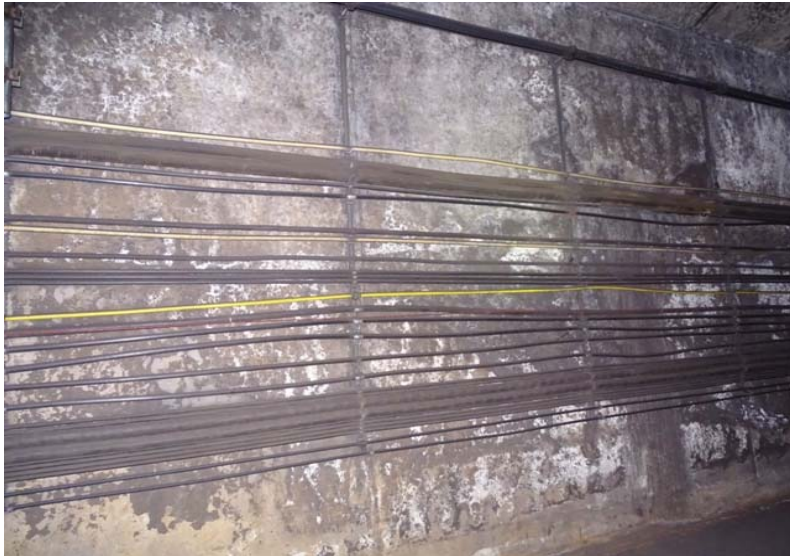
Photograph No. 51
Station 71+20 - stains on the east wall.

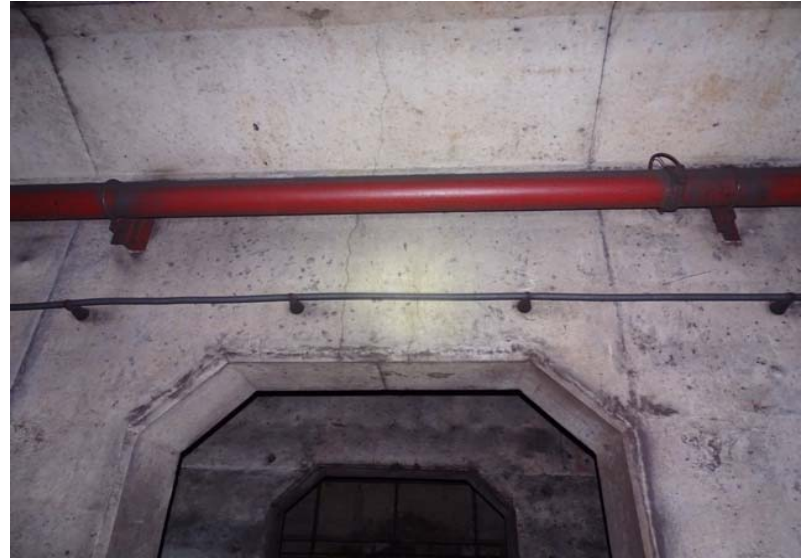
Photograph No.54
Station 71+20 - cracks above west arch.

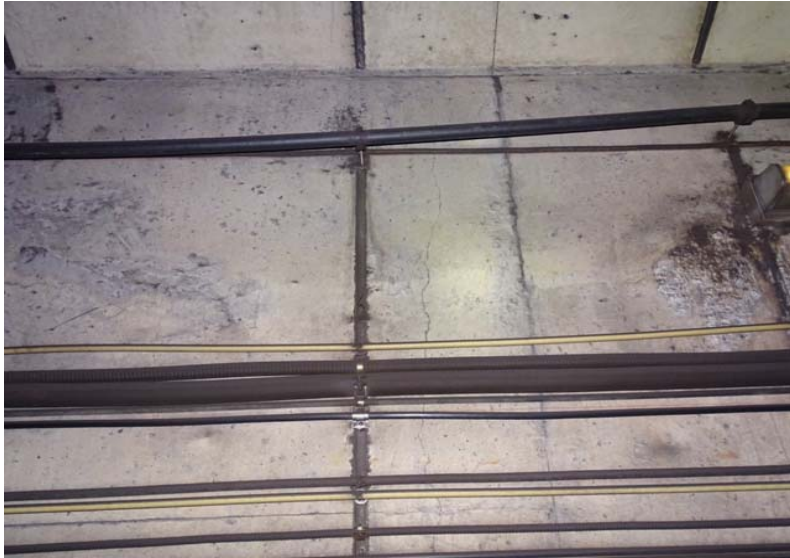
Photograph No. 57
Station 71+40 - crack on the east wall.

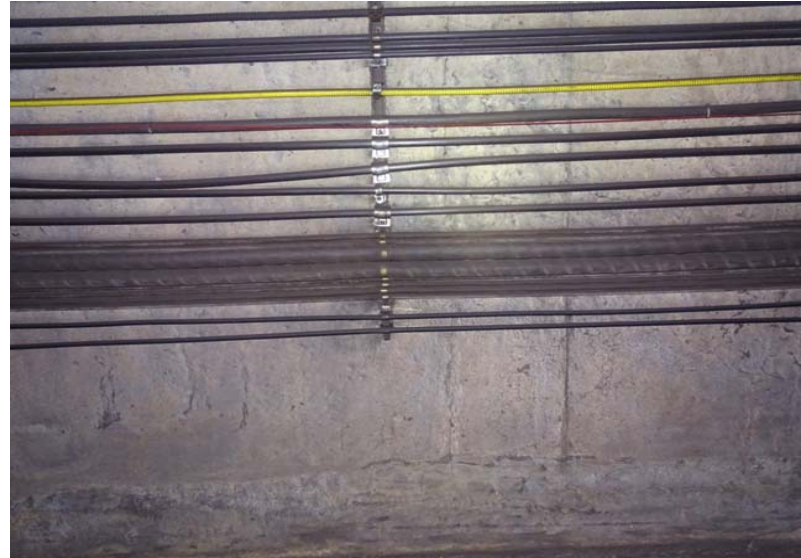
Photograph No. 58
Station 71+40 - crack on the east wall.

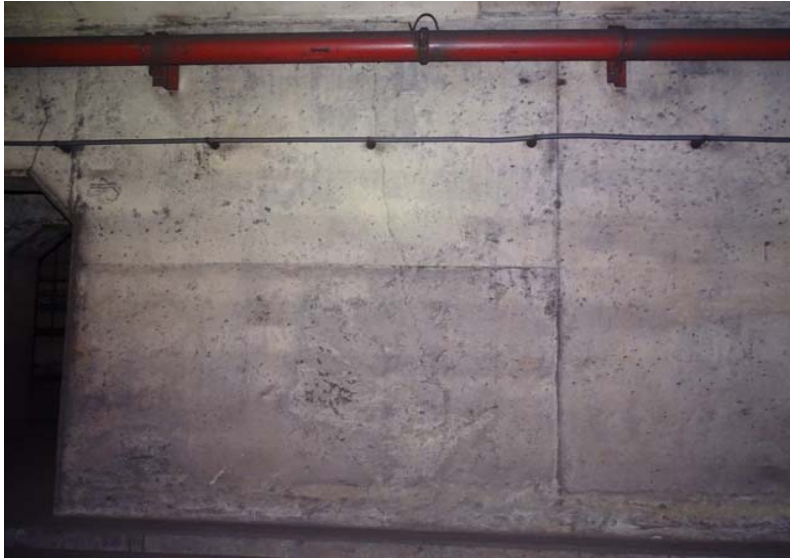
Photograph No. 61
Station 71+40 - crack on the west wall.

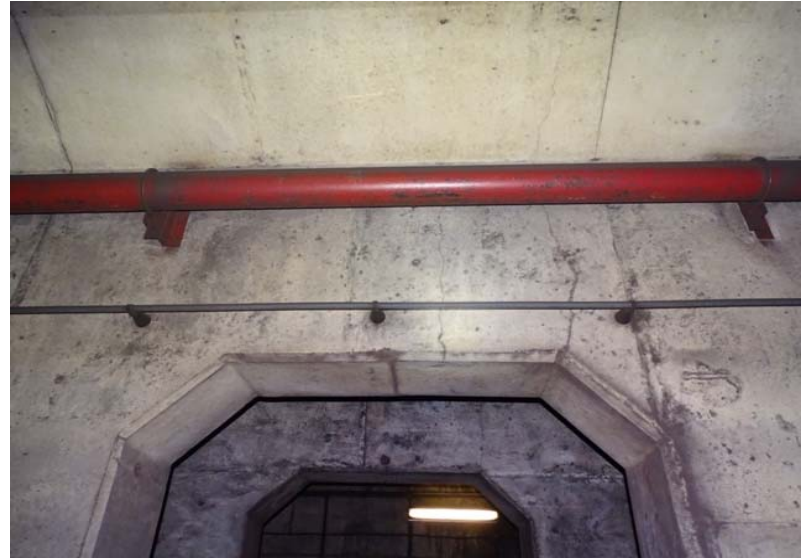
Photograph No. 62
Station 71+40 - cracks above west arch.

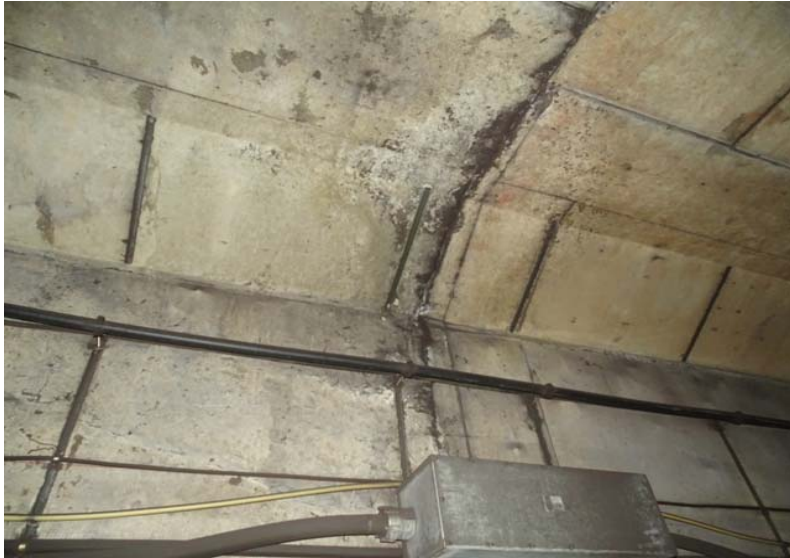
Photograph No. 65
Station 71+60 - stains on the east wall.

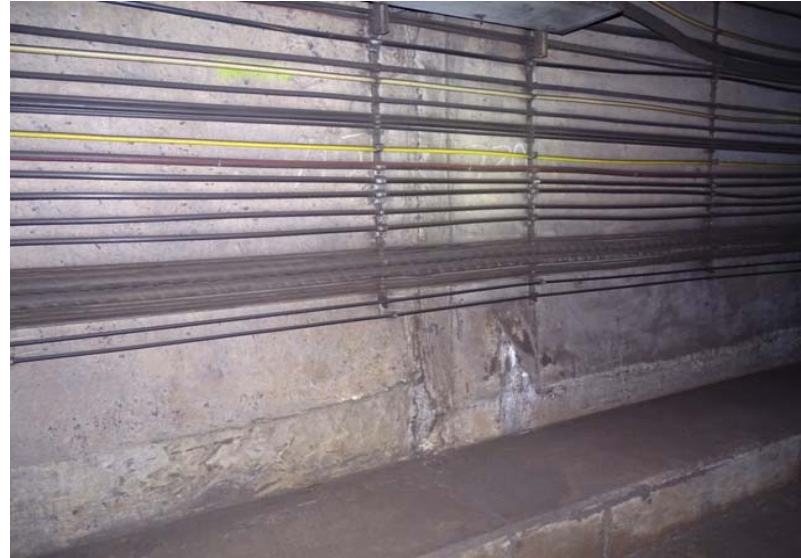
Photograph No. 66
Station 71+60 - efflorescence on the east wall.

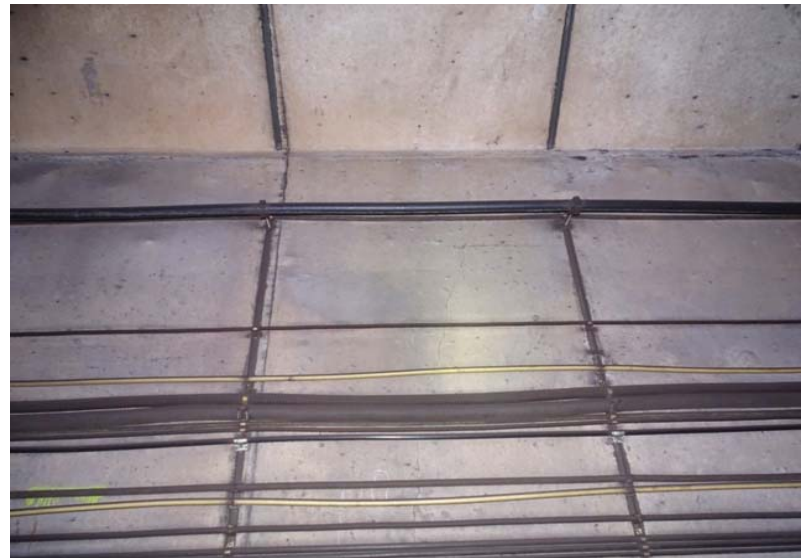
Photograph No. 72
Station 71+80 - crack on the east wall.

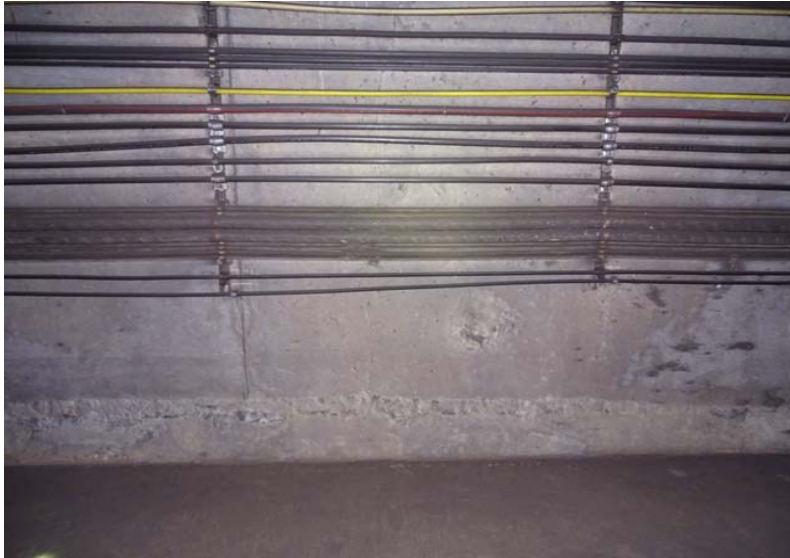
Photograph No. 73
Station 71+80 - crack on the east wall.

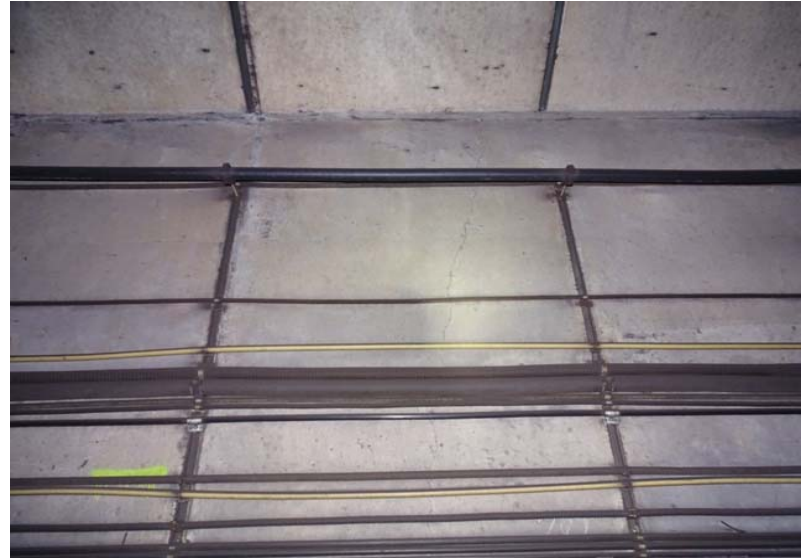
Photograph No. 74
Station 71+80 - crack on the east wall.

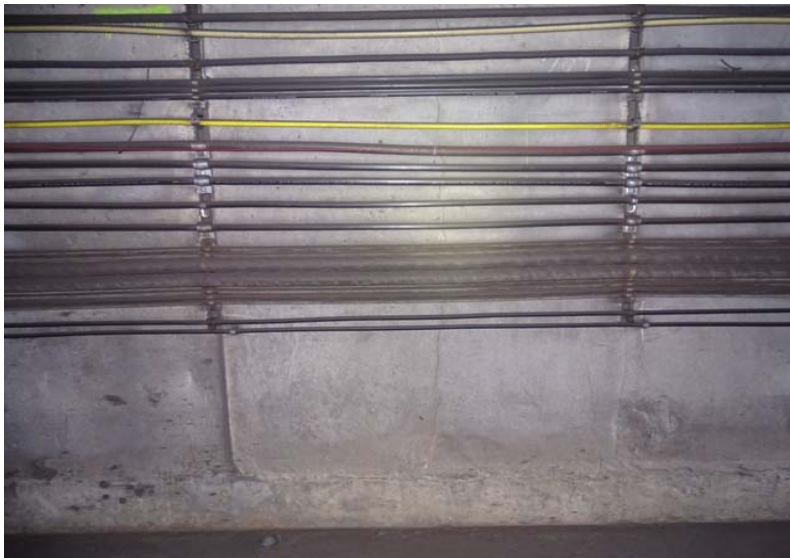
Photograph No. 75
Station 71+80 - crack on the east wall.

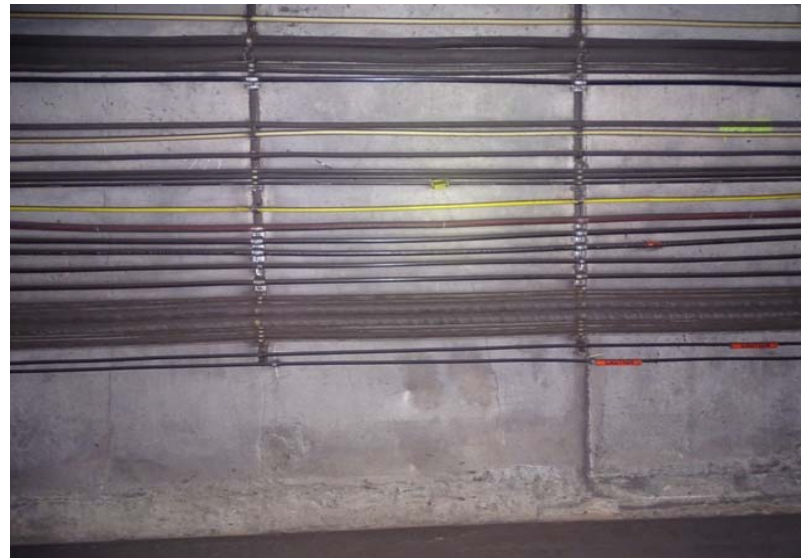
Photograph No. 76
Station 71+80 - cracks on the east wall.

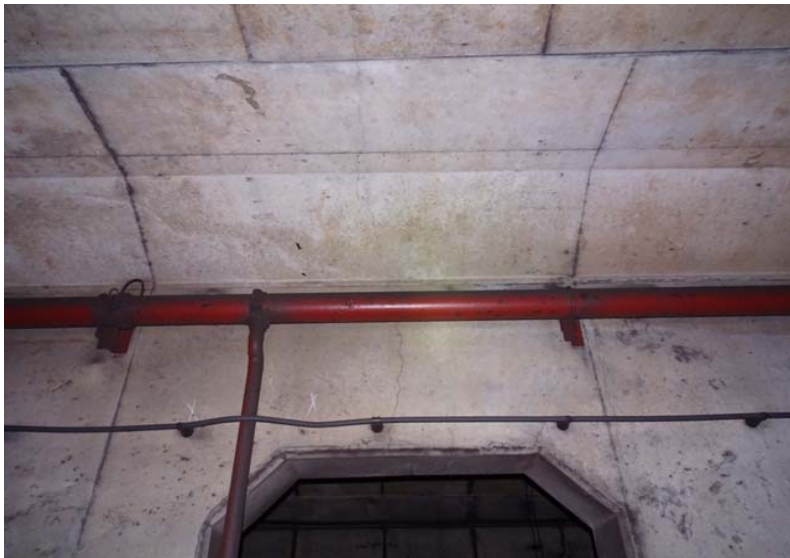
Photograph No. 79
Station 71+80 - crack above west arch.

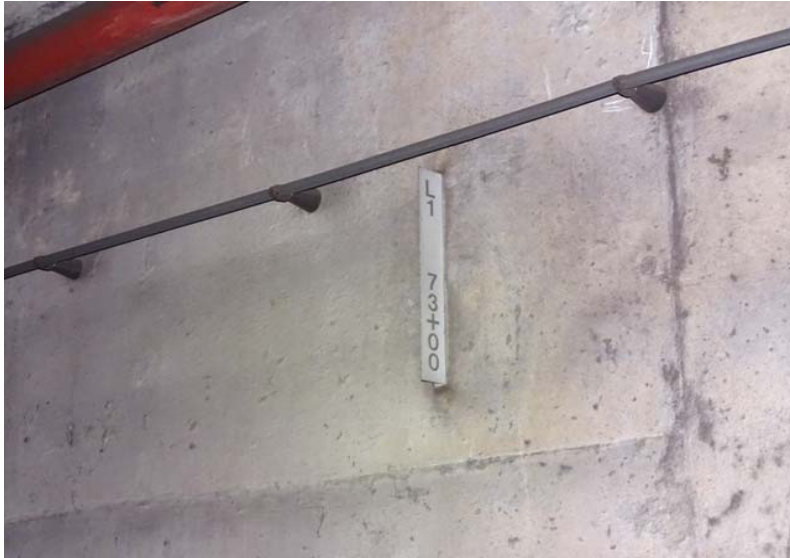
Photograph No. 80
Station 71+80 - crack in the concrete.

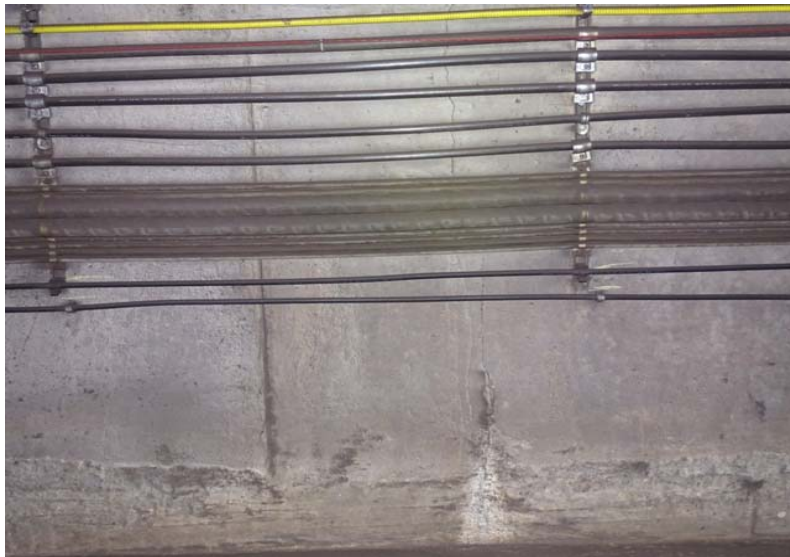
Photograph No. 84
Station 72+00 - crack on the east wall.

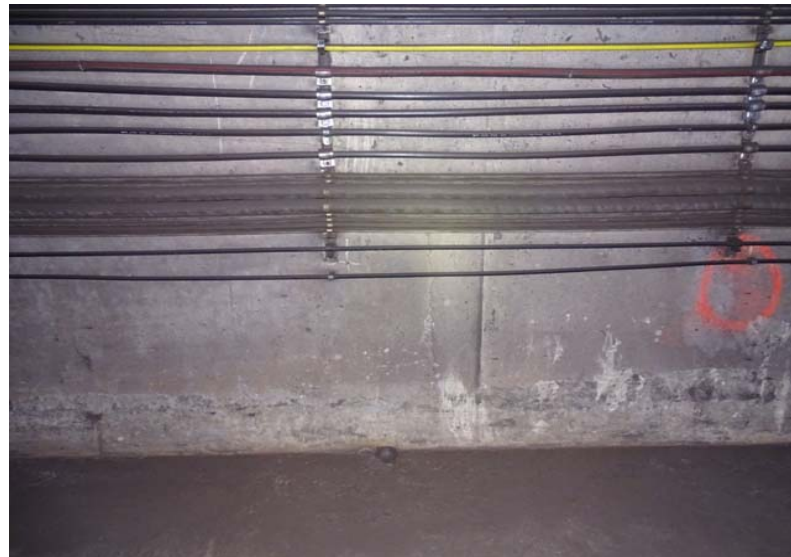
Photograph No. 85
Station 72+00 - crack on the east wall.

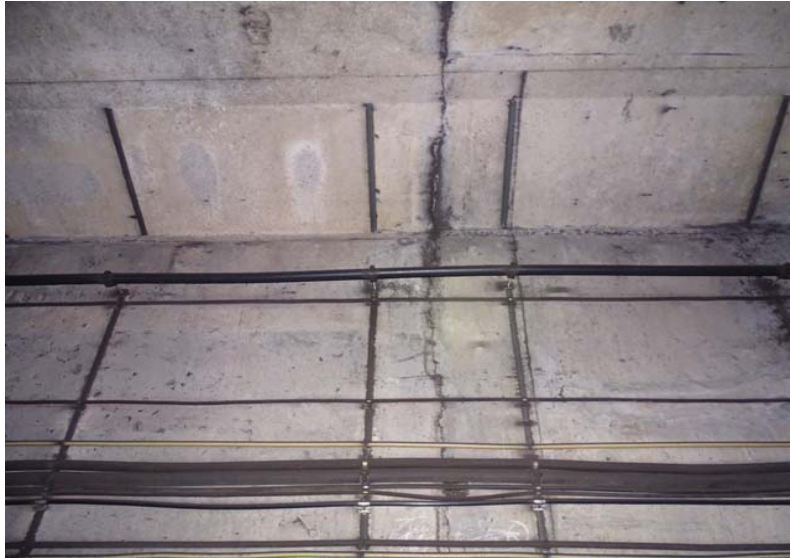
Photograph No. 92
Station 72+20 - crack on the east wall.

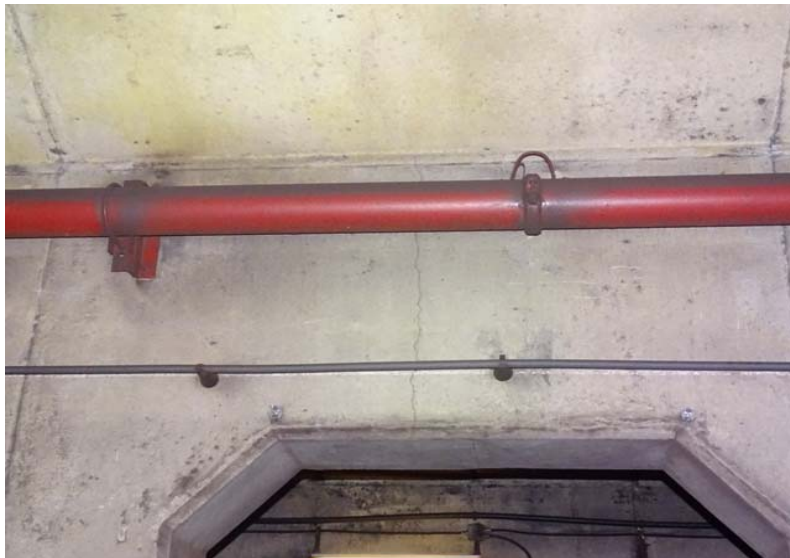
Photograph No. 98
Station 72+20 - crack on the west wall.

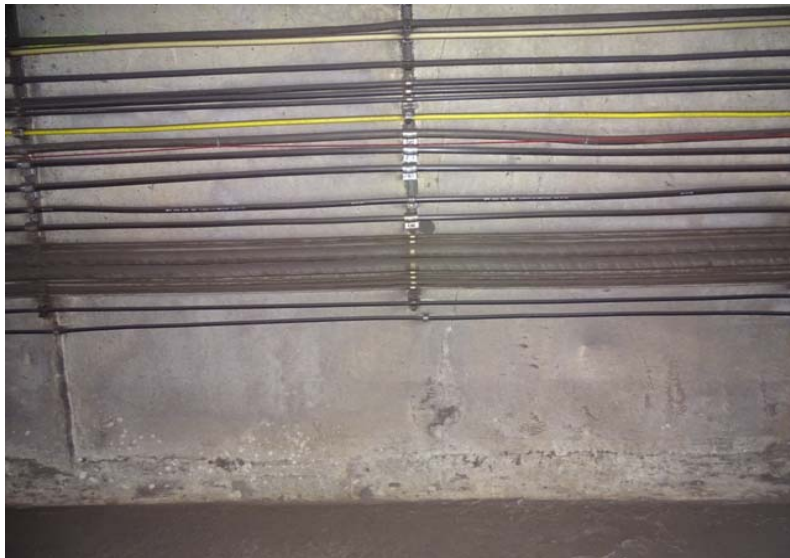
Photograph No. 102
Station 72+40 - crack on the east wall.

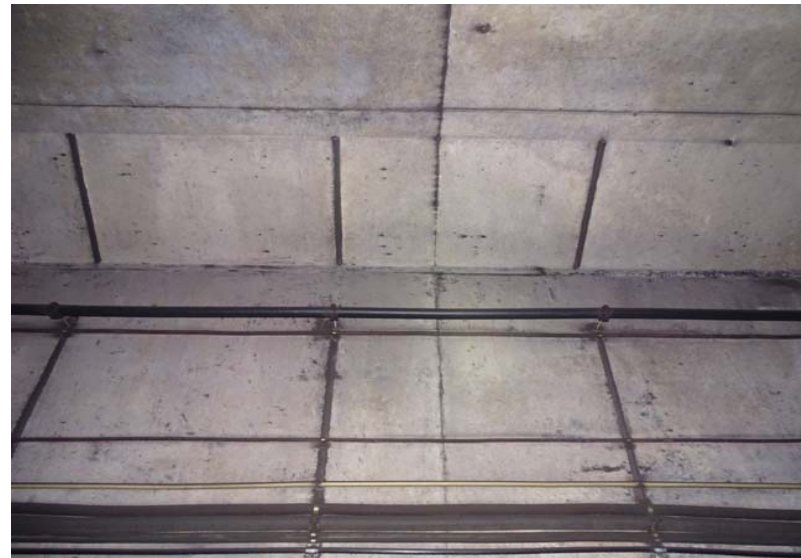
Photograph No. 103
Station 72+40 - crack on the east wall.

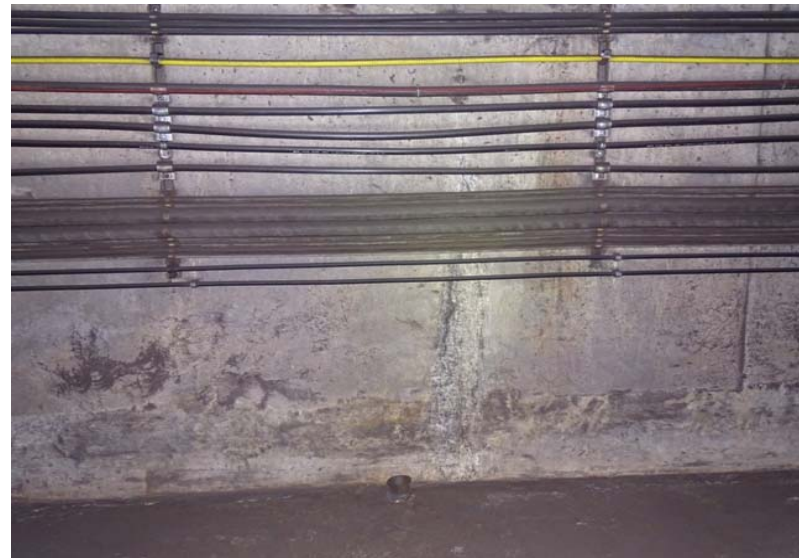
Photograph No. 111
Station 72+60 - crack on the east wall.

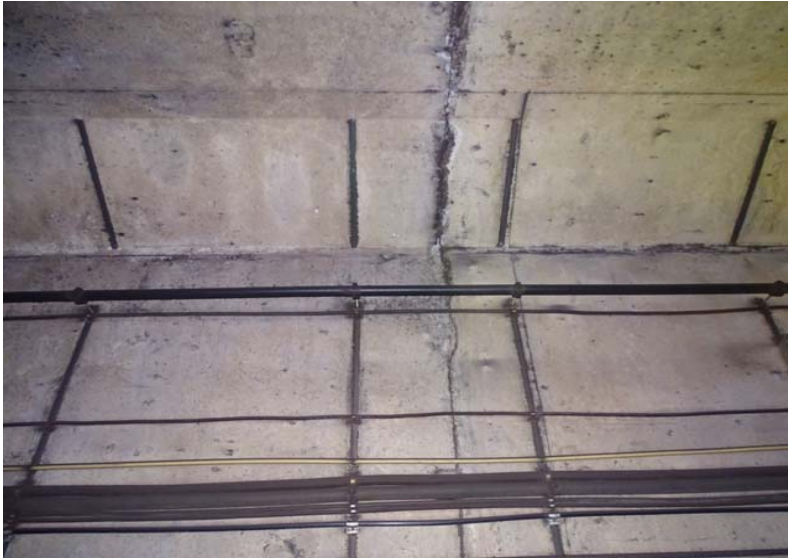
Photograph No. 112
Station 72+60 - crack on the east wall.

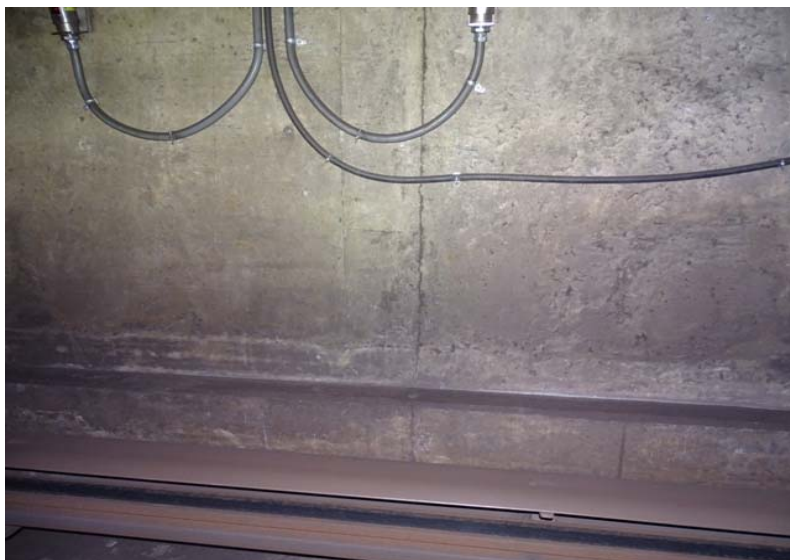
Photograph No. 118
Station 72+60 - crack on the west wall.

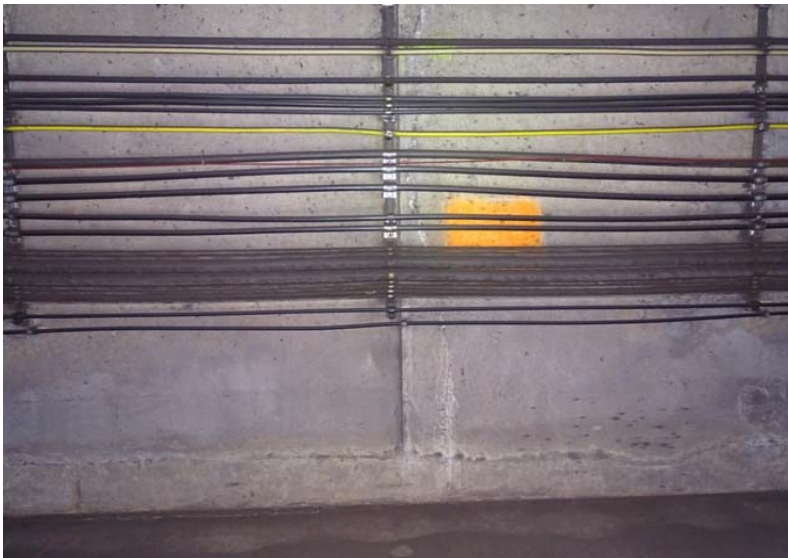
Photograph No. 122
Station 72+80 - crack on the east wall.

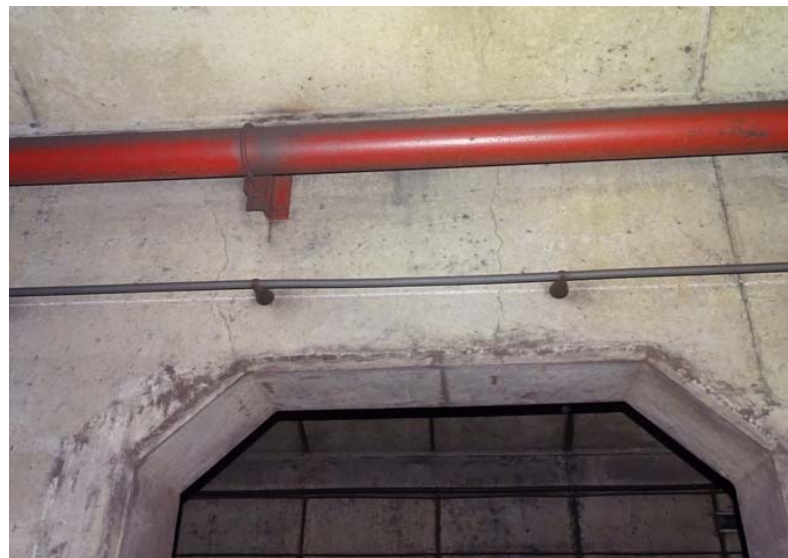
Photograph No. 126
Station 72+80 - cracks above west arch.

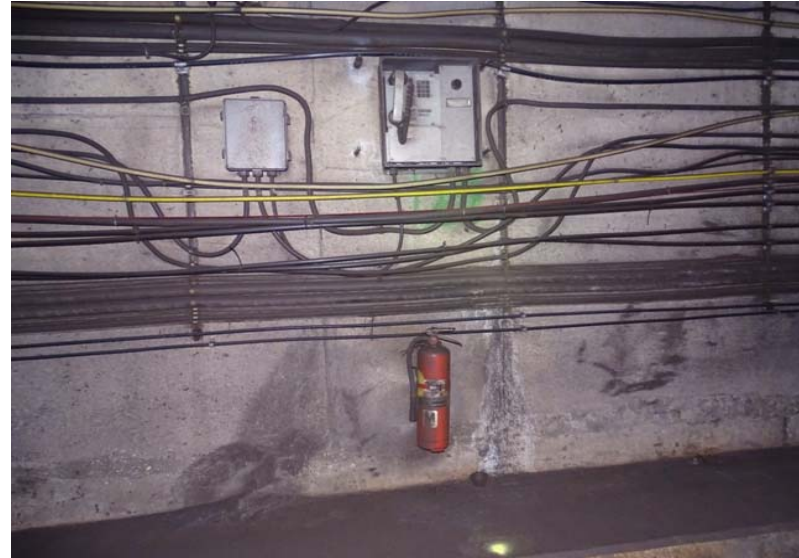
Photograph No. 130
Station 73+00 - stains and efflorescence on the east wall.

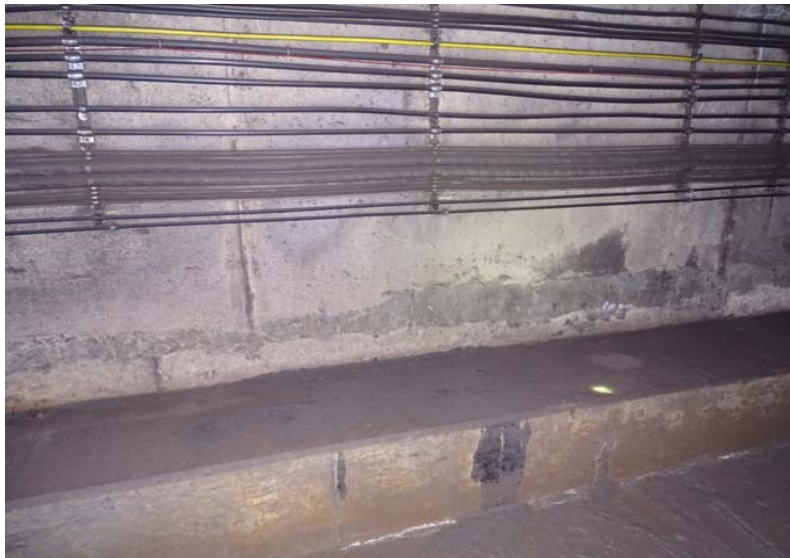
Photograph No. 131
Station 73+00 - previous concrete repair.

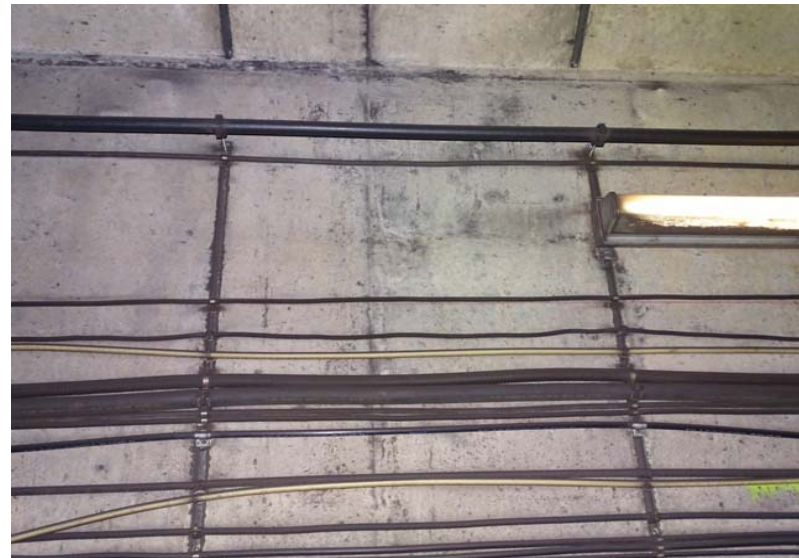
Photograph No. 132
Station 73+00 - stains on the east wall.

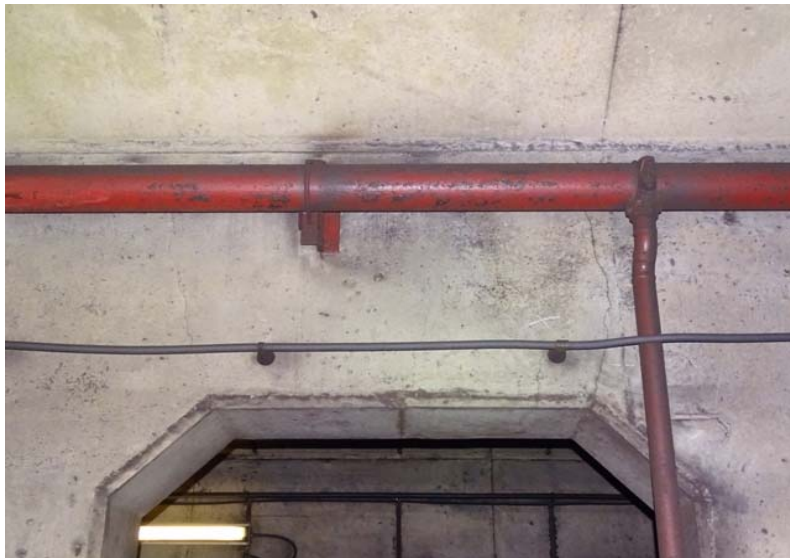
Photograph No. 135
Station 73+00 - cracks above west wall.

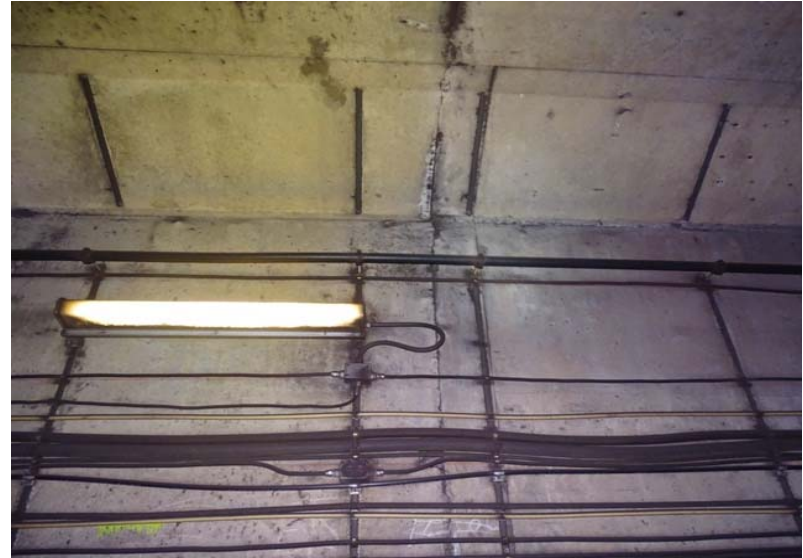
Photograph No. 138
Station 73+20 - crack and stains on the east wall.
