**Report of Preconstruction Condition
Survey Services**

**ADJACENT PROPERTIES TO
THE WHARF – PHASE I
WASHINGTON, DC**

ECS PROJECT NO. 37:1306

OCTOBER 6, 2014

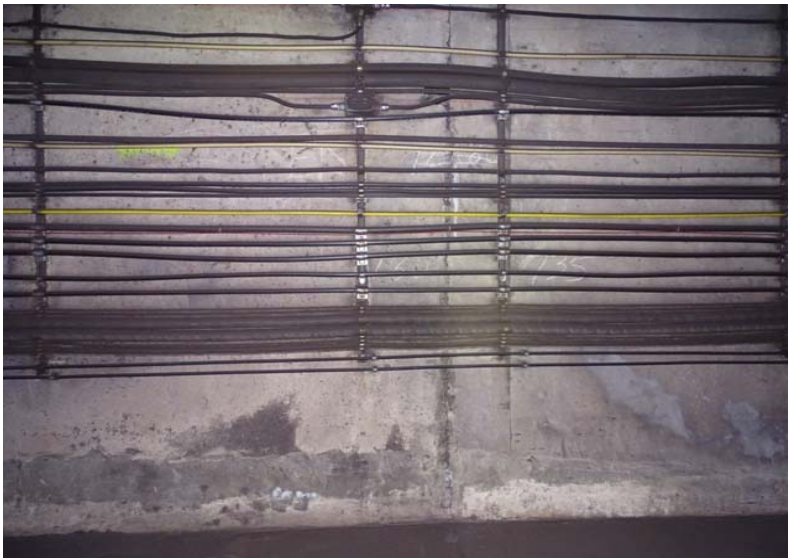
Photograph No. 139
Station 73+20 - crack and stains on the east wall.

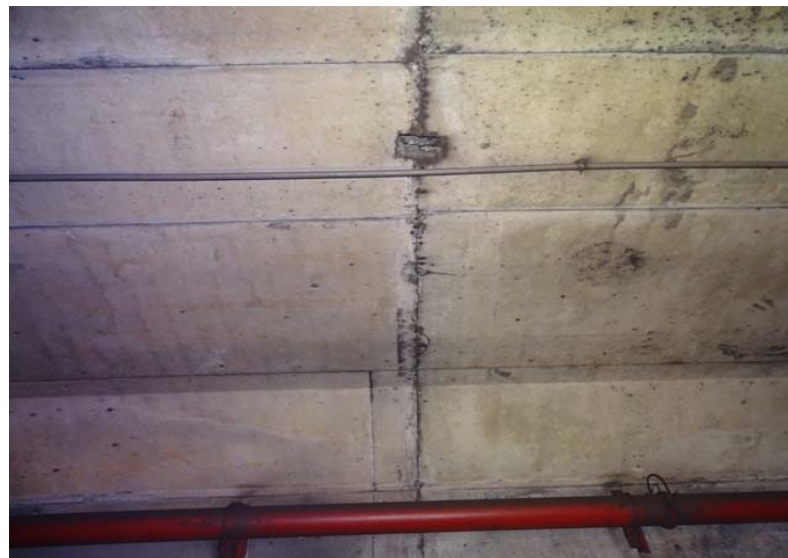
Photograph No. 142
Station 73+20 - crack and stains on the west wall.

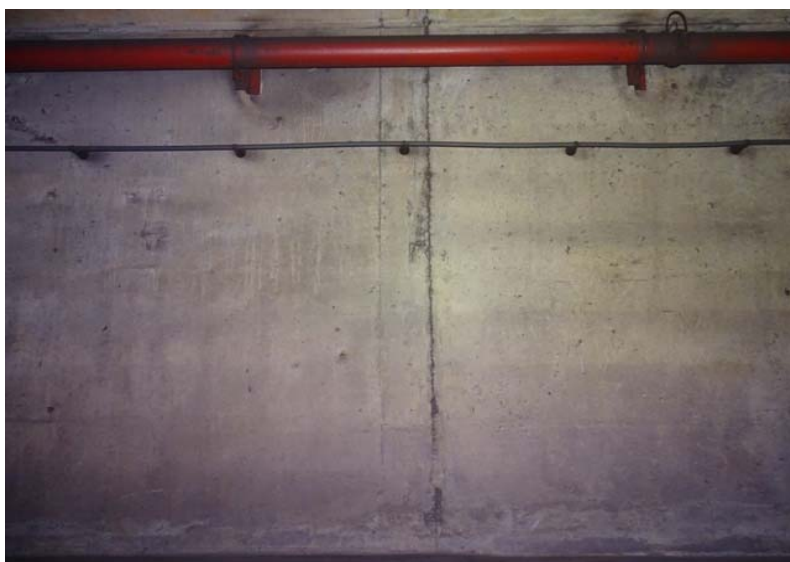
Photograph No. 143
Station 73+20 - crack and stains on the west wall.

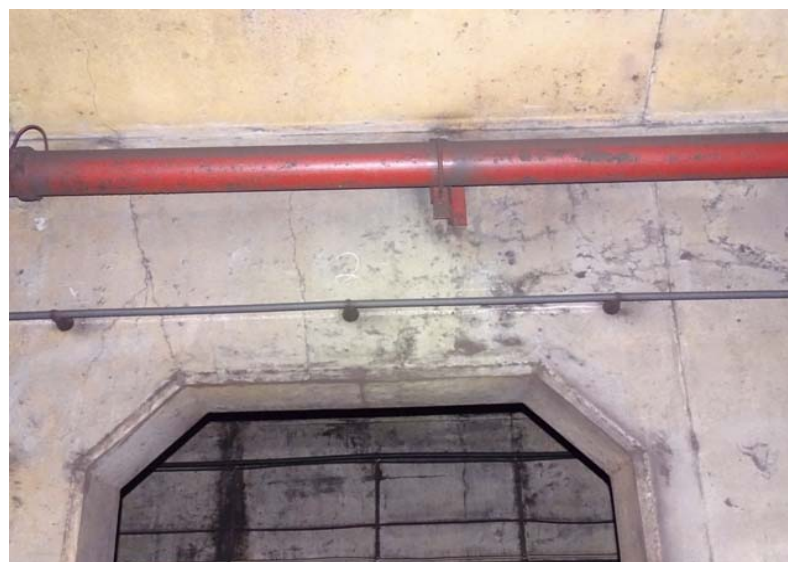
Photograph No. 144
Station 73+20 - cracks and stains above west arch.

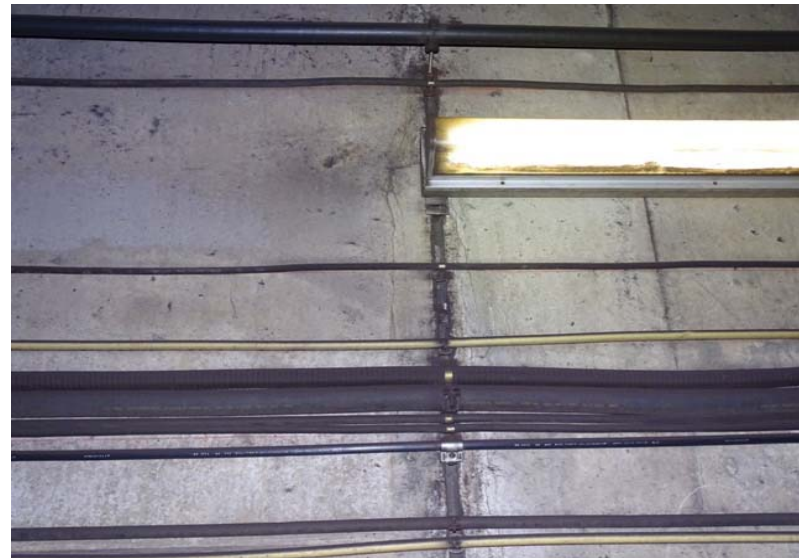
Photograph No. 152
Station 73+60 - cracks on the east wall.

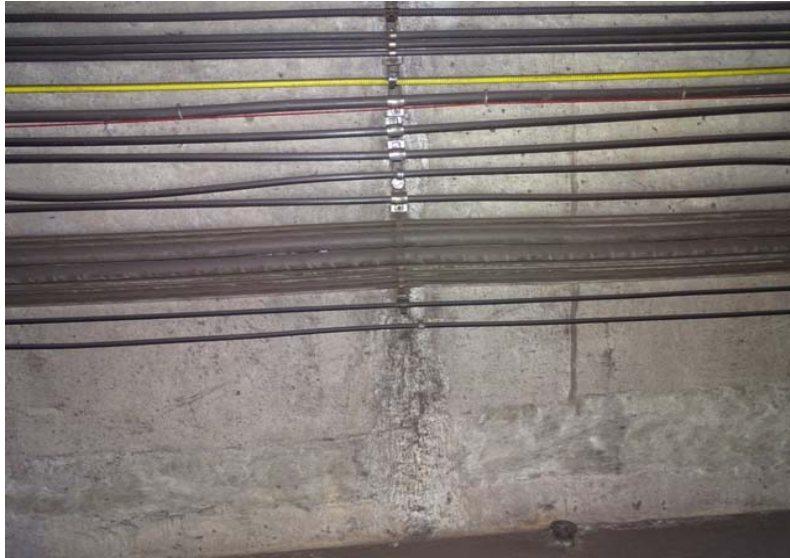
Photograph No. 153
Station 73+60 - stains and efflorescence on the east wall.

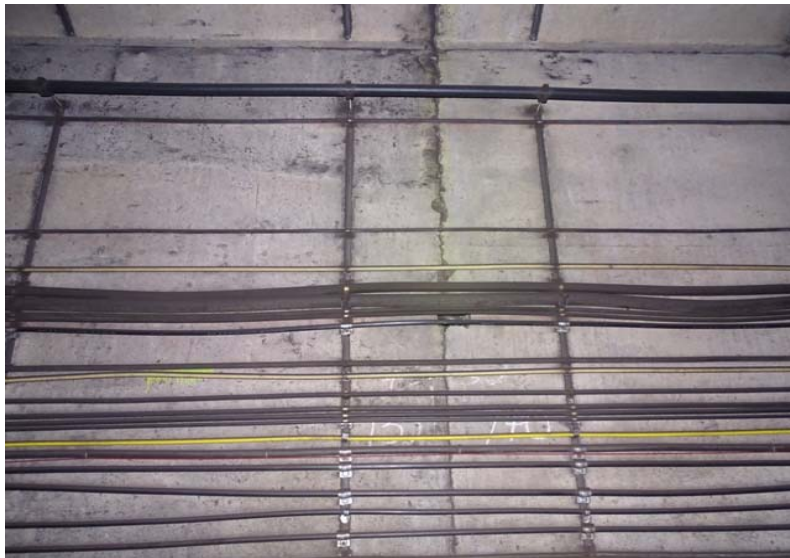
Photograph No. 155
Station 73+60 - damaged concrete at a construction joint on the east wall.

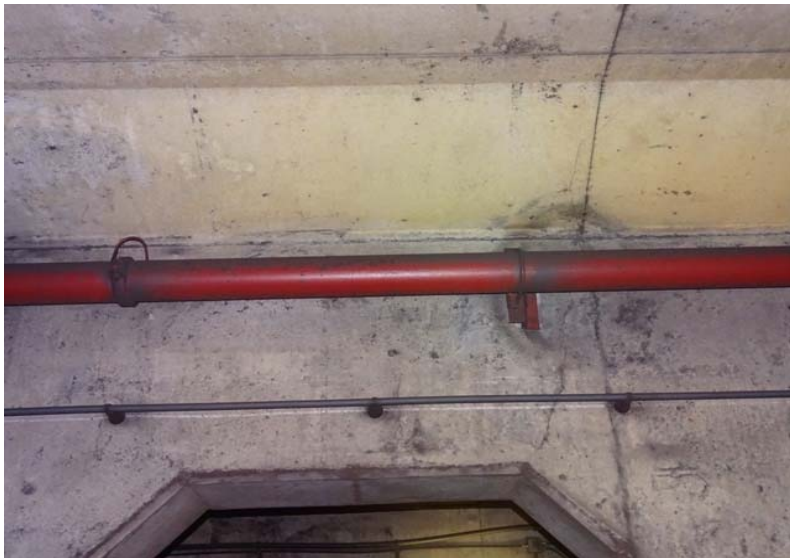
Photograph No. 159
Station 73+60 - cracks and stains above west arch.

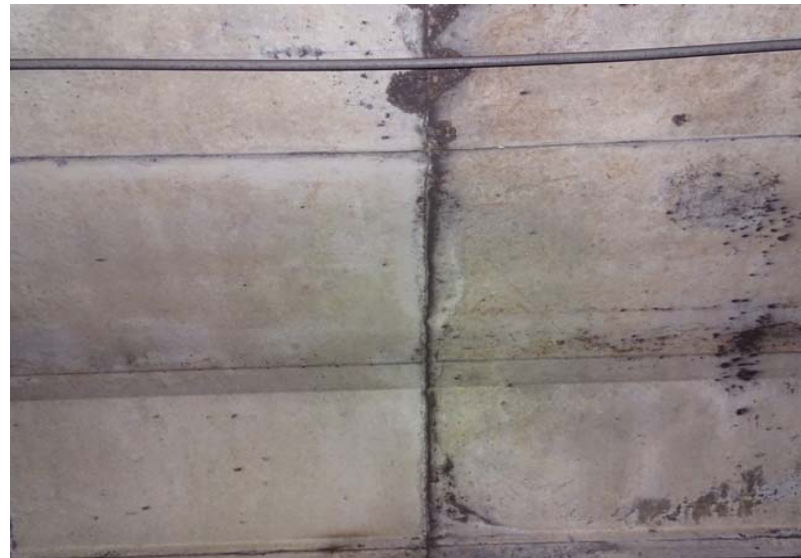
Photograph No. 160
Station 73+60 - damaged concrete on the ceiling, looking west.

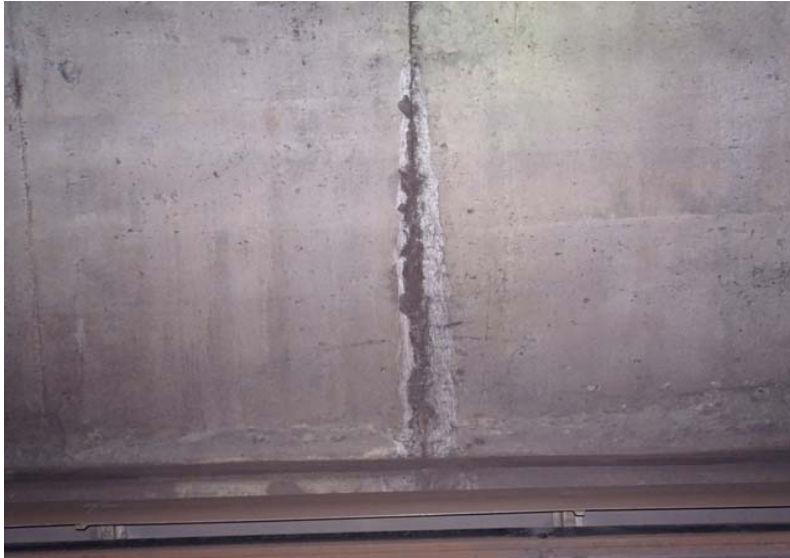
Photograph No. 161
Station 73+60 - stains and efflorescence on the west wall.

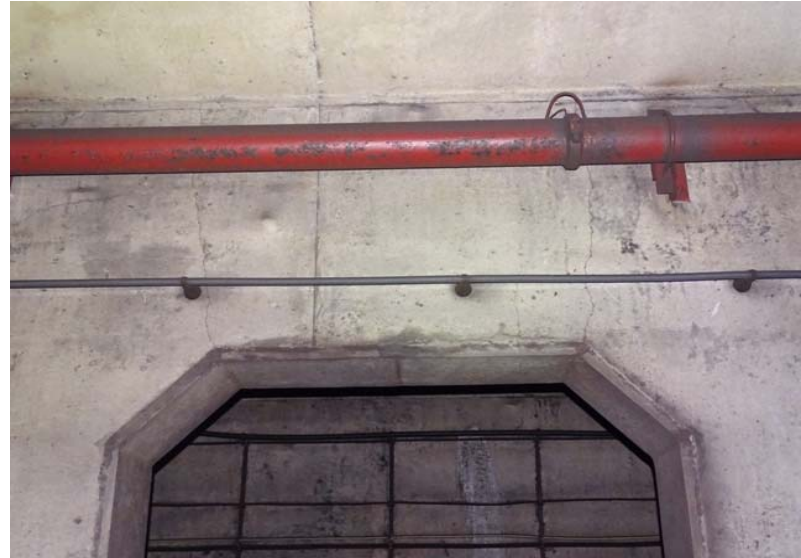
Photograph No. 166
Station 73+80 - cracks above west arch.

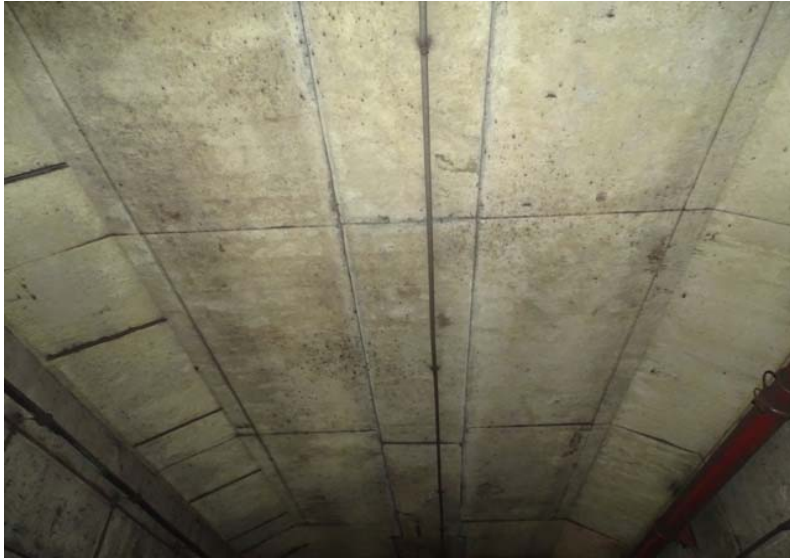
Photograph No. 169
Station 74+00, ceiling.

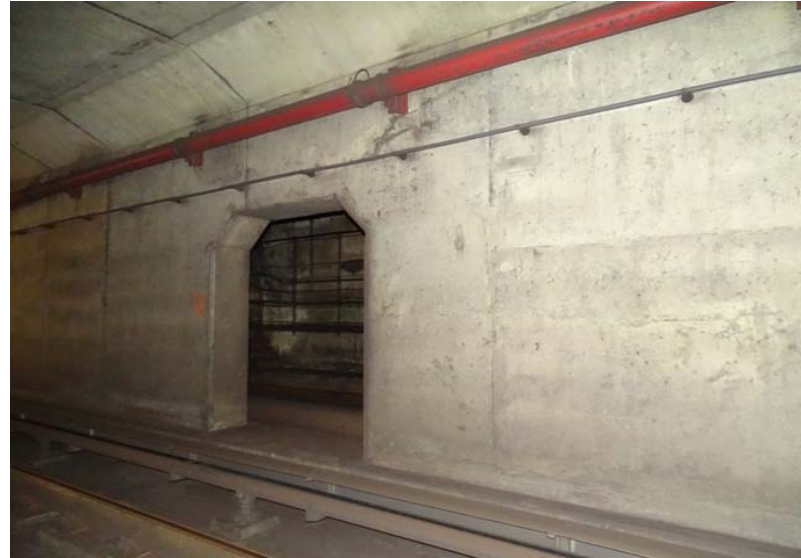
Photograph No. 170
Station 74+00, west wall.

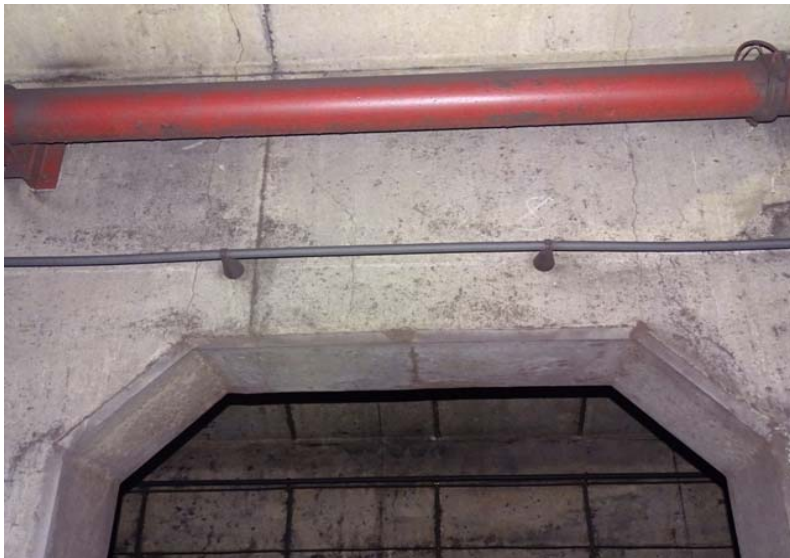
Photograph No. 171
Station 74+00 - cracks above west arch.

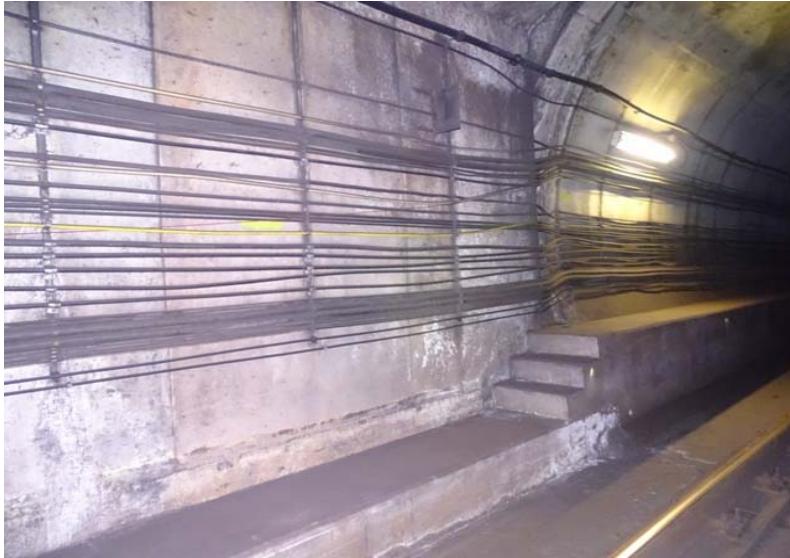
Photograph No. 173
Station 74+20, east wall.

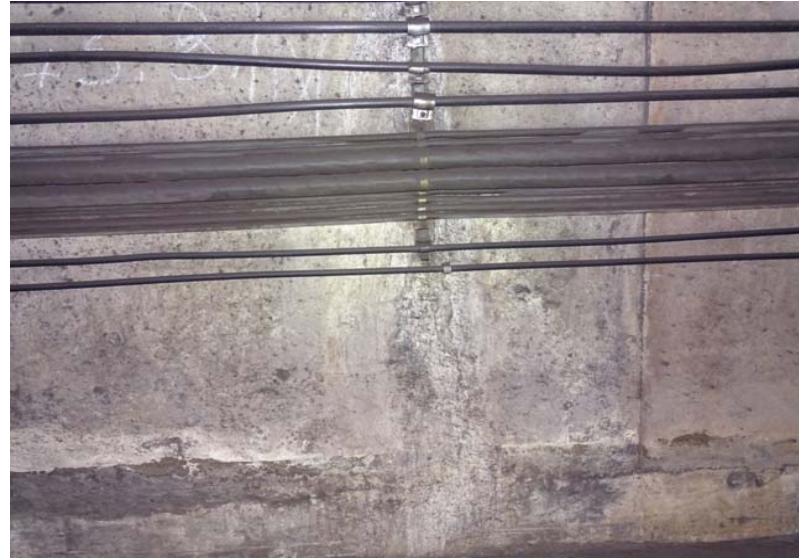
Photograph No. 174
Station 74+20 - crack and stains on the east wall.

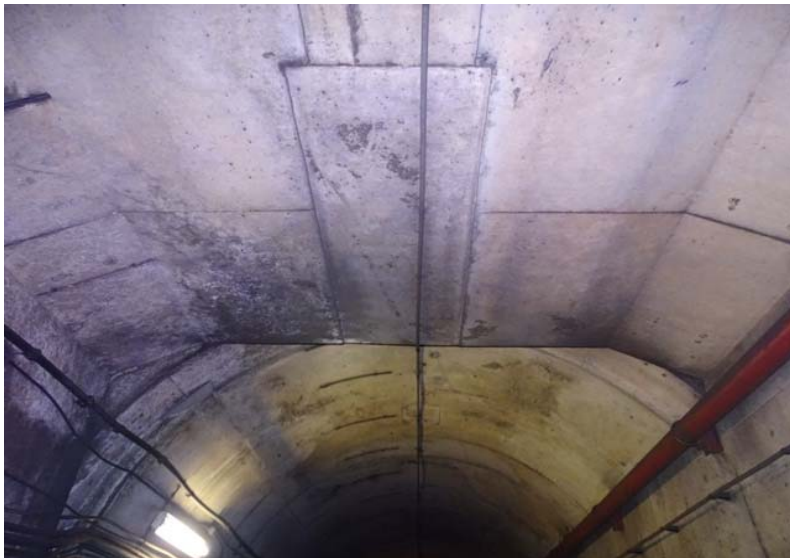
Photograph No. 175
Station 74+20, ceiling.

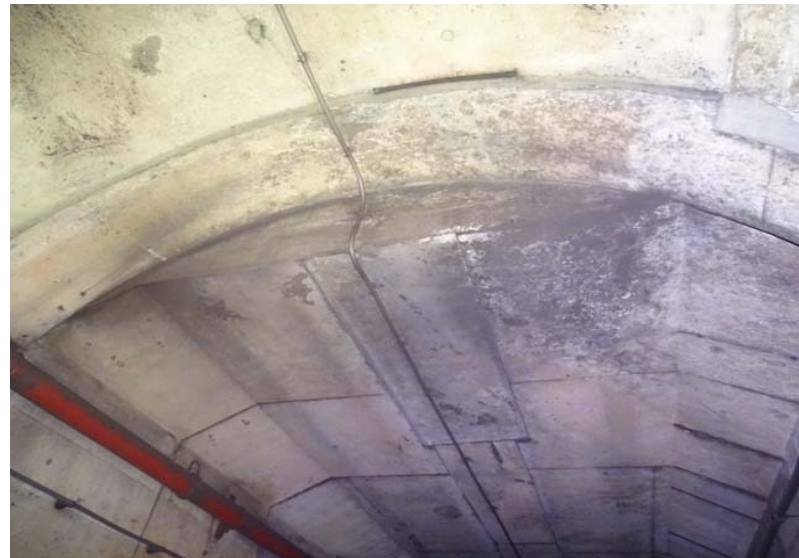
Photograph No. 176
Station 74+20, ceiling, looking north.

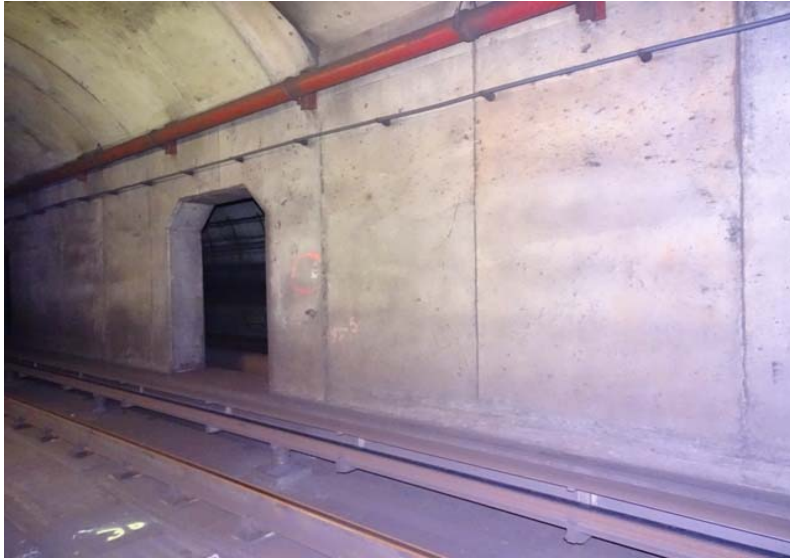
Photograph No. 177
Station 74+20, west wall.

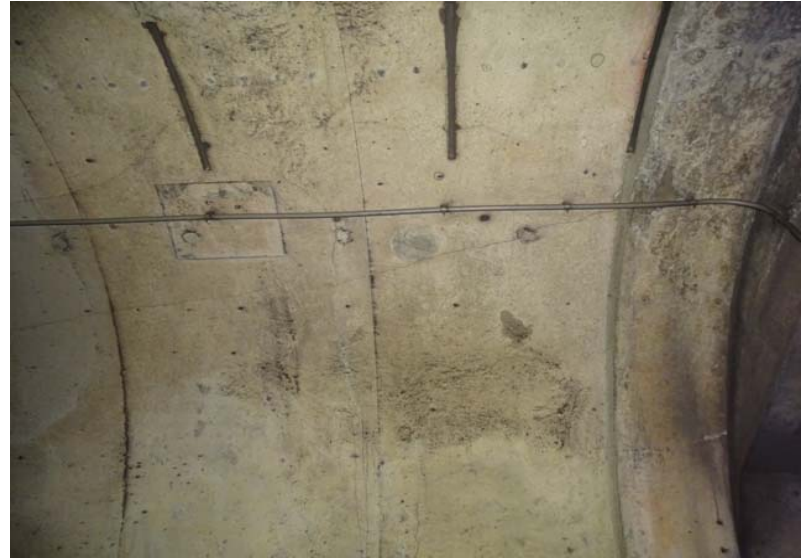
Photograph No. 178
Station 74+20 - cracks on the ceiling, looking west.

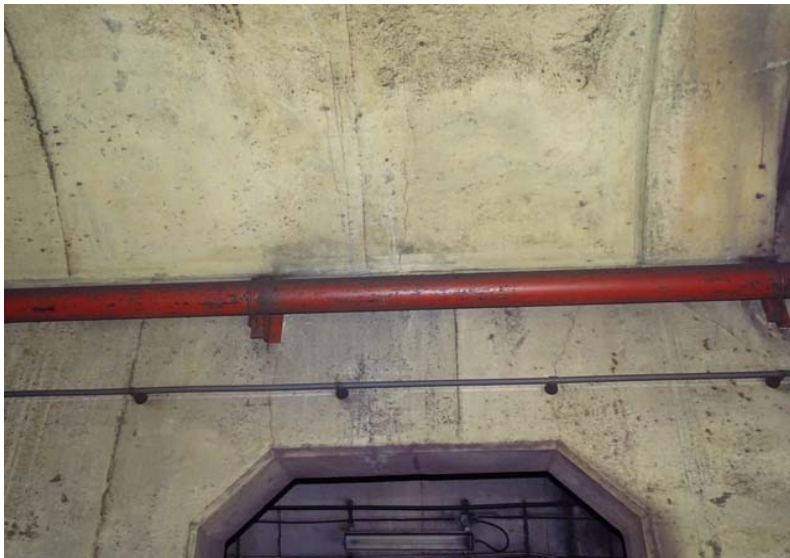
Photograph No. 179
Station 74+20 - cracks above west arch.

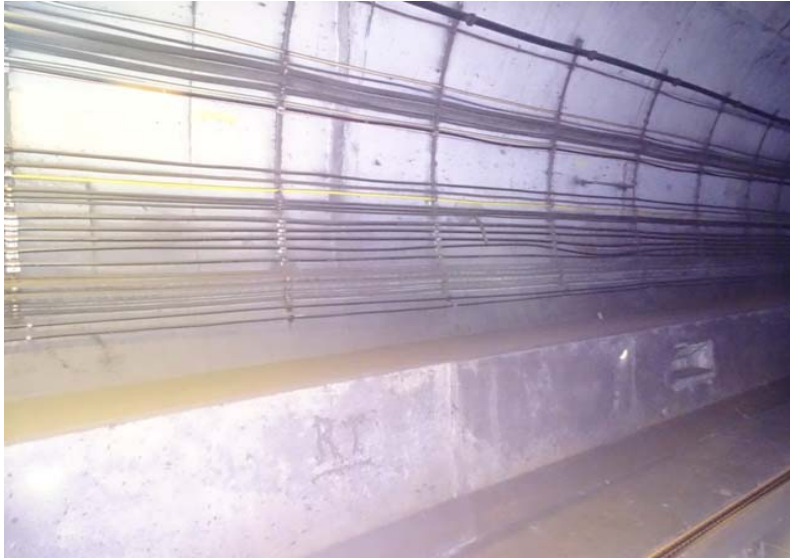
Photograph No. 181
Station 74+40, east wall.

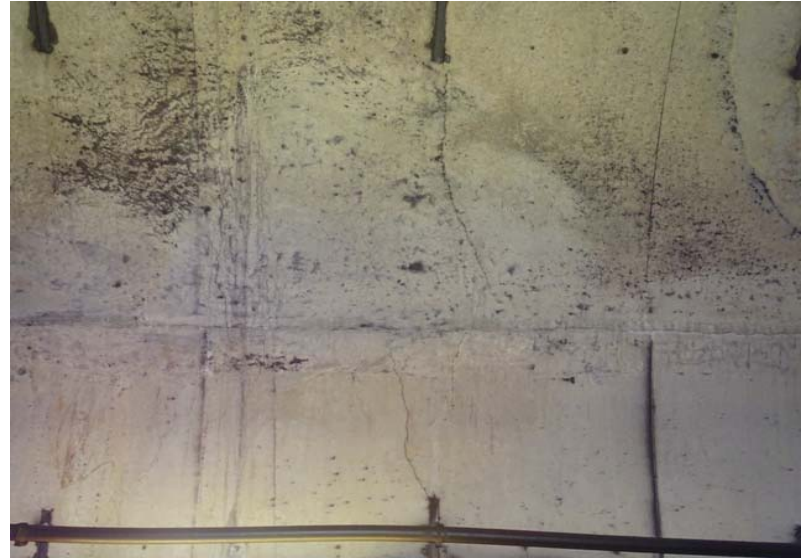
Photograph No. 182
Station 74+40 - cracks on the east wall.

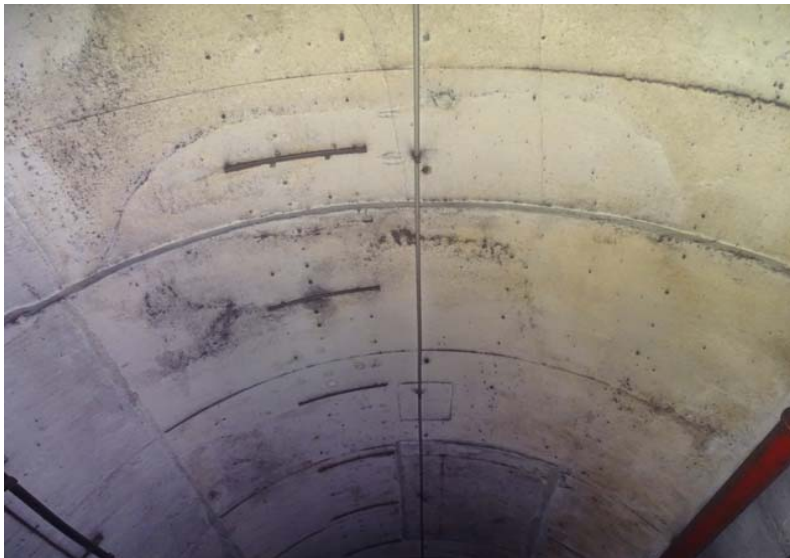
Photograph No. 183
Station 74+40, ceiling.

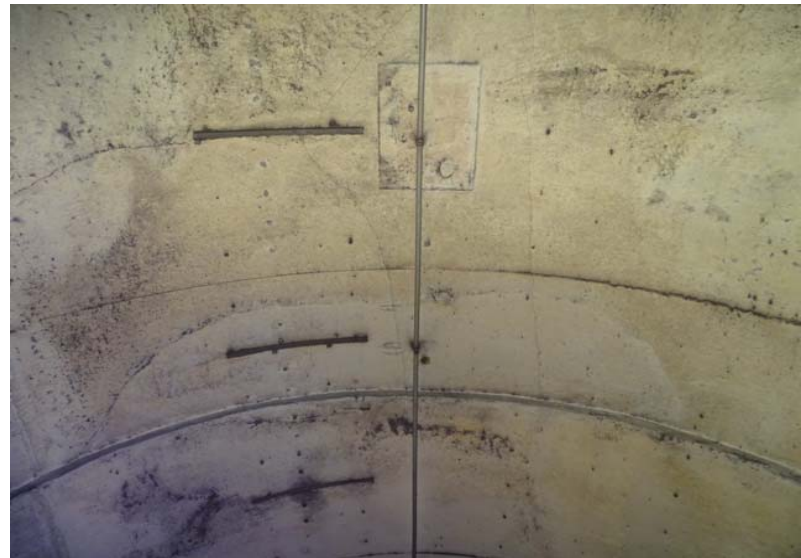
Photograph No. 184
Station 74+40 - cracks on the ceiling.

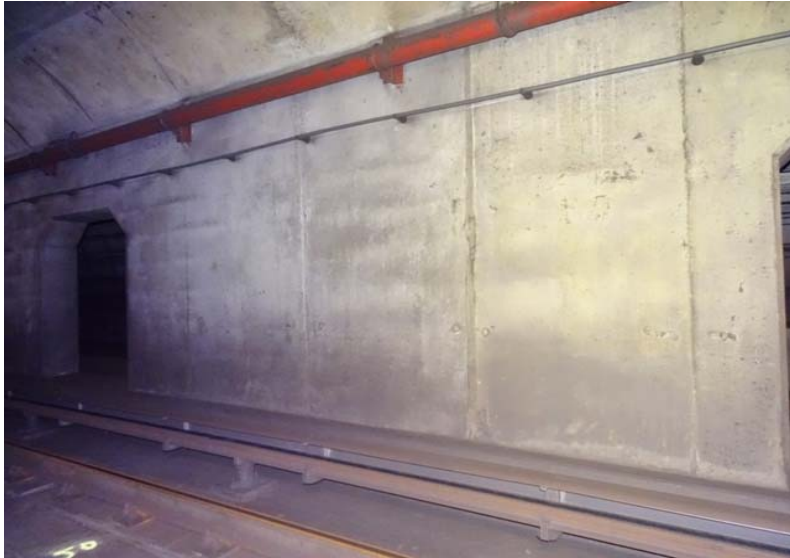
Photograph No. 185
Station 74+40, west wall.

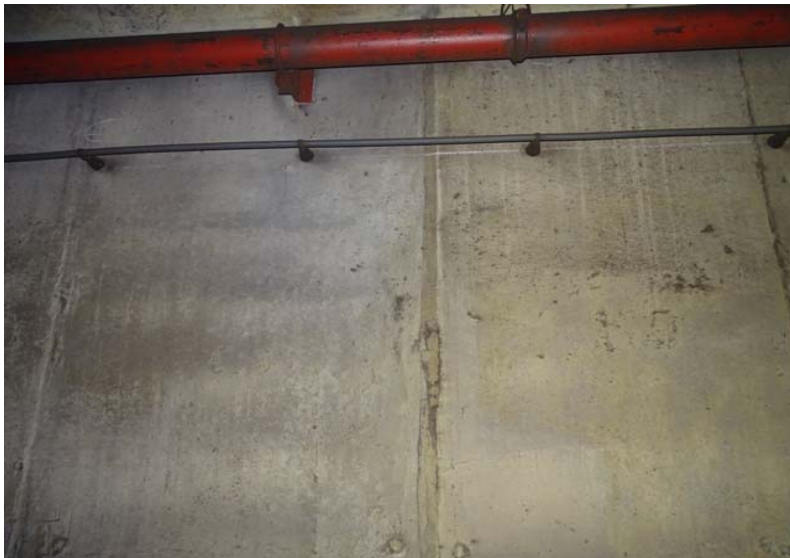
Photograph No. 187
Station 74+40 - previous repair at the joint.

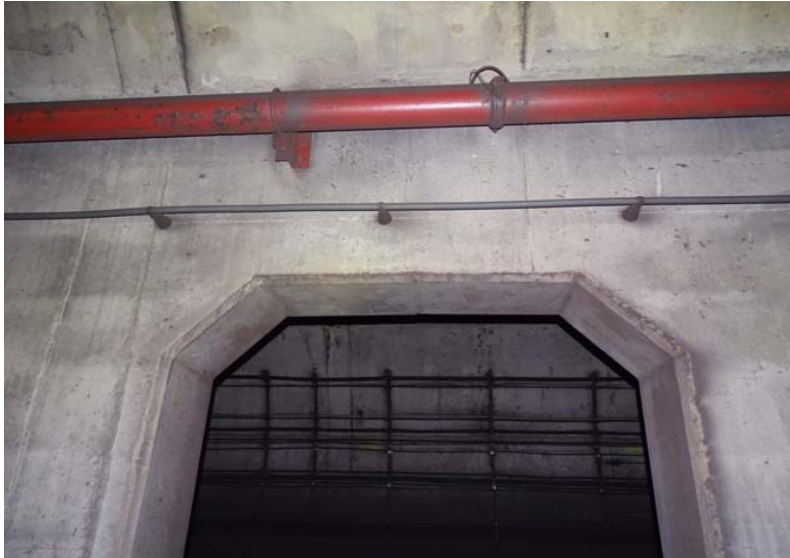
Photograph No. 189
Station 74+40 - cracks above west arch.

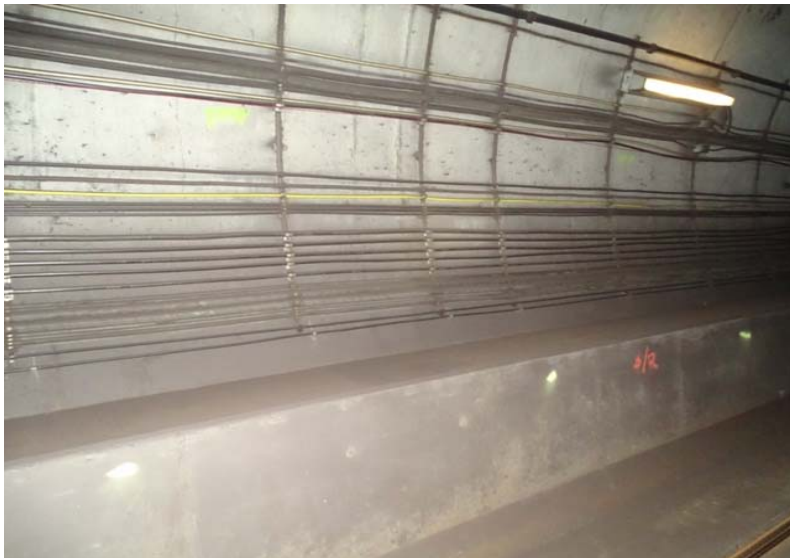
Photograph No. 191
Station 74+60, east wall.

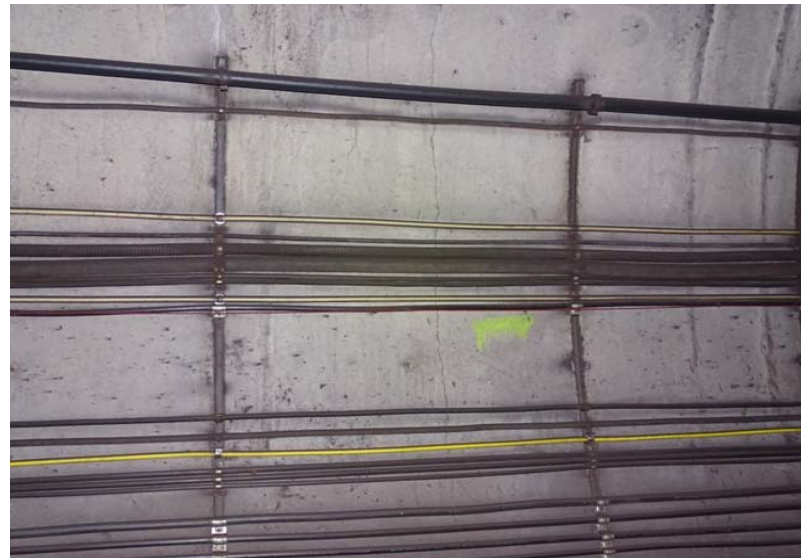
Photograph No. 192
Station 74+60 - crack on the east wall.

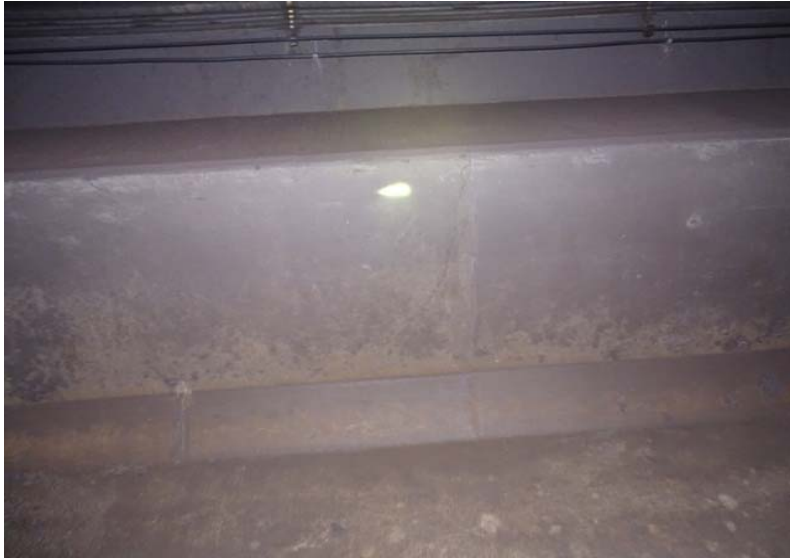
Photograph No. 193
Station 74+60 - crack on the catwalk.

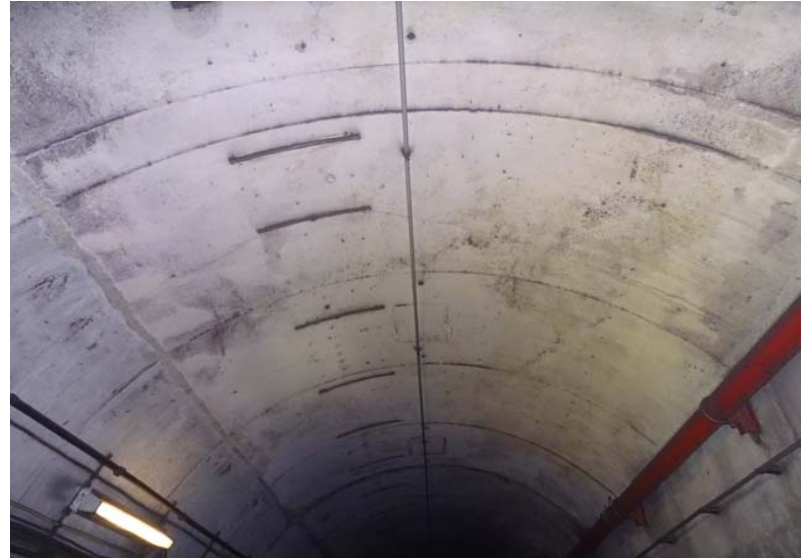
Photograph No. 194
Station 74+60, ceiling.

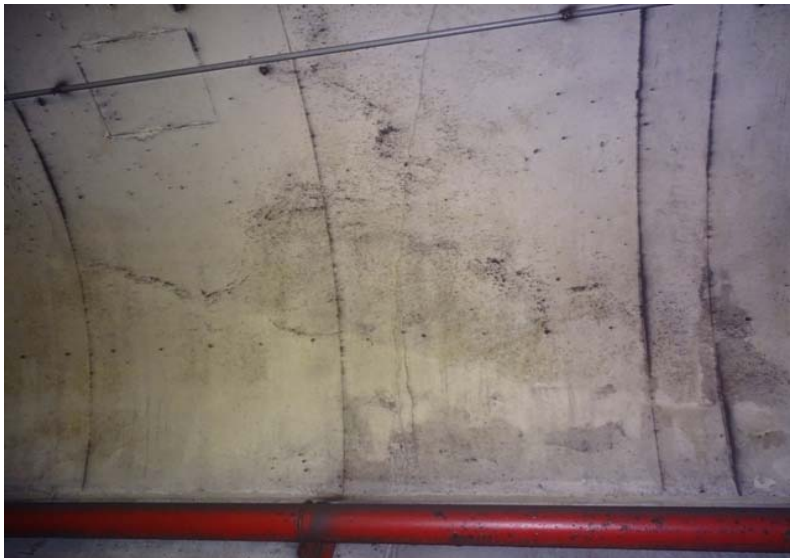
Photograph No. 195
Station 74+60 - crack on the ceiling, looking west.

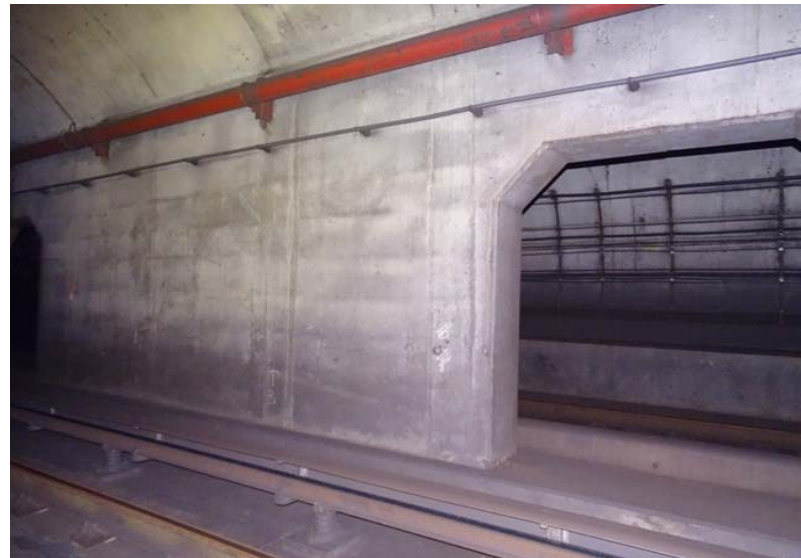
Photograph No. 196
Station 74+60, west wall.

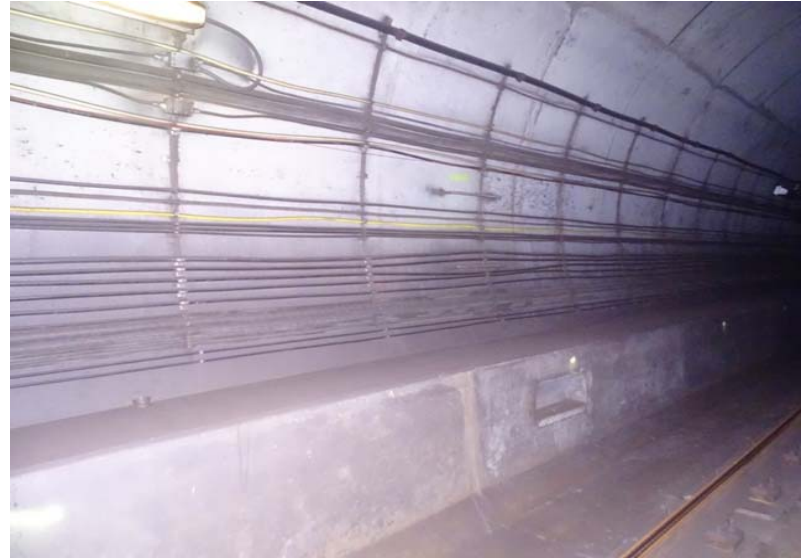
Photograph No. 198
Station 74+80, east wall.

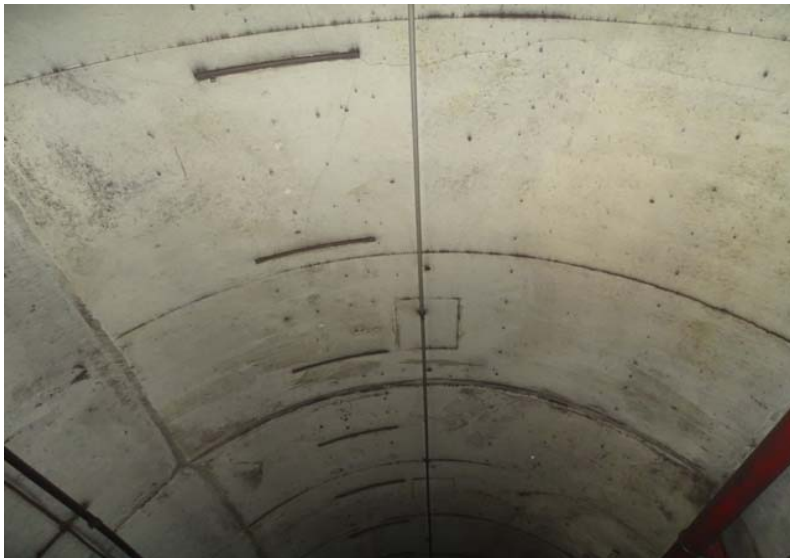
Photograph No. 199
Station 74+80, ceiling.

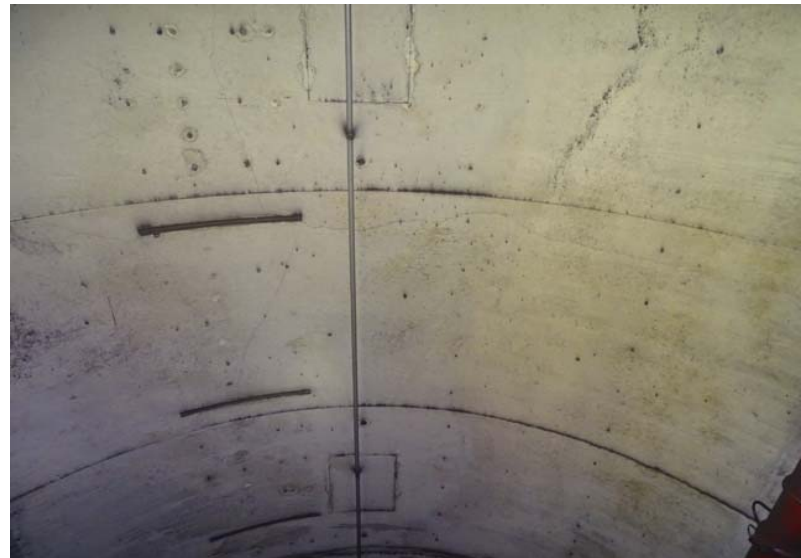
Photograph No. 200
Station 74+80 - cracks on the ceiling.

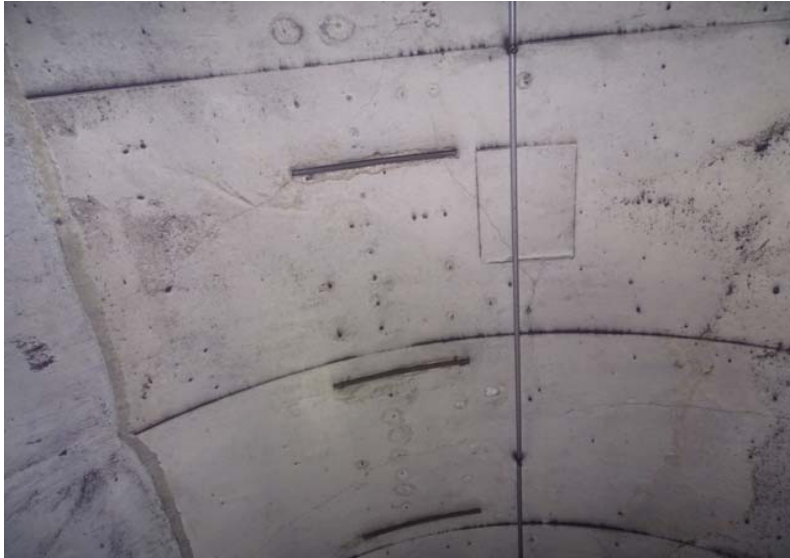
Photograph No. 201
Station 74+80 - cracks on the ceiling.

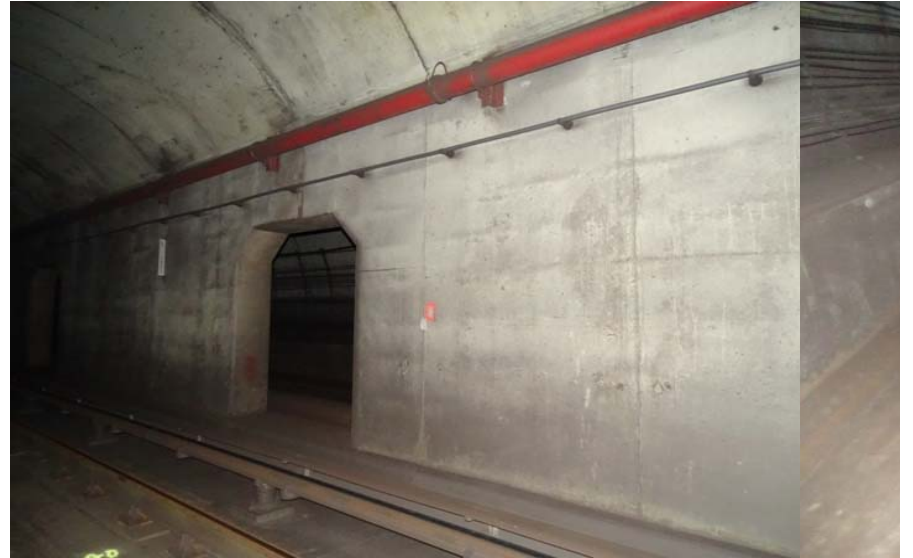
Photograph No. 202
Station 74+80, west wall.

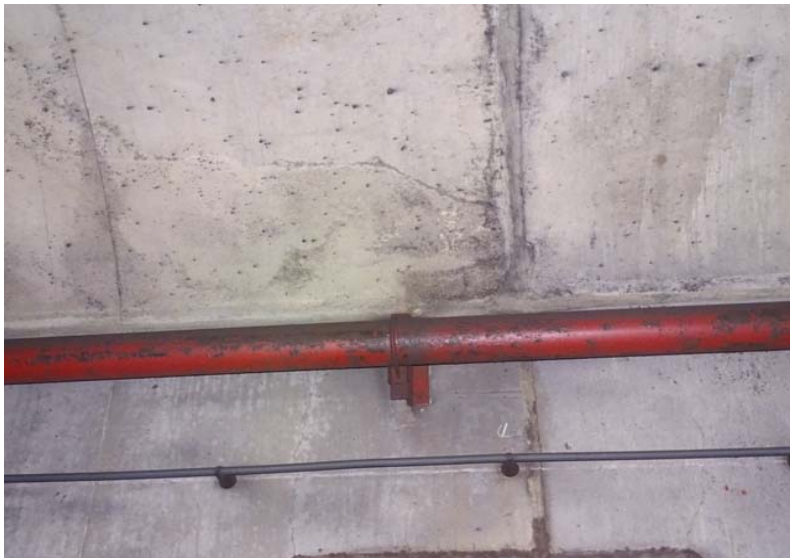
Photograph No. 203
Station 74+80 - cracks on the west wall.

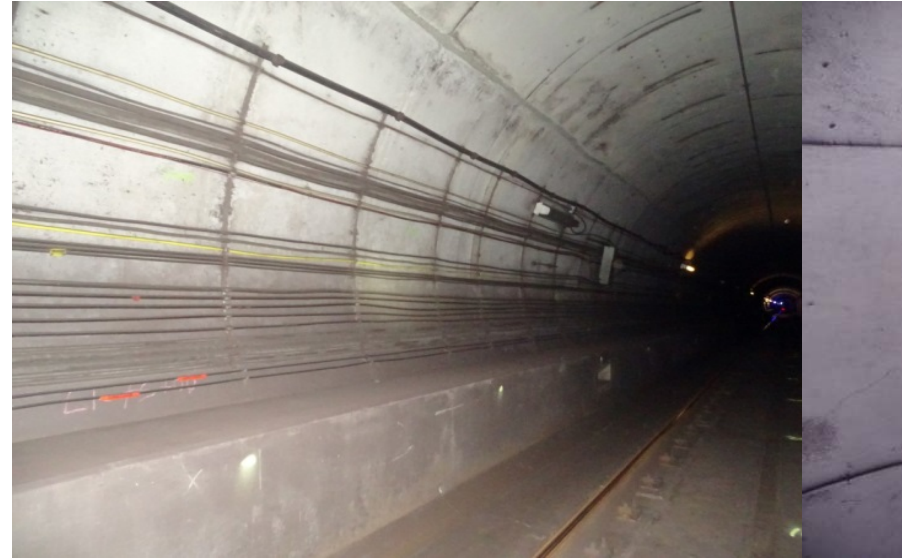
Photograph No. 206
Station 75+00, east wall.

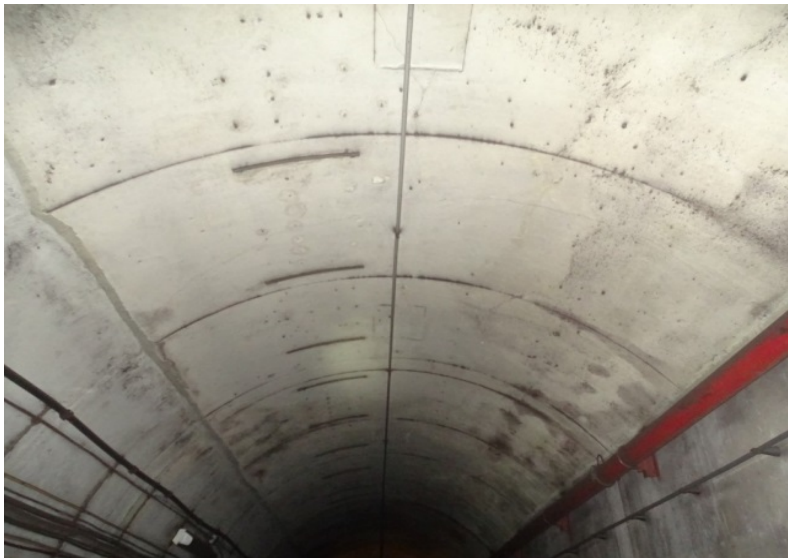
Photograph No. 207
Station 75+00, ceiling.

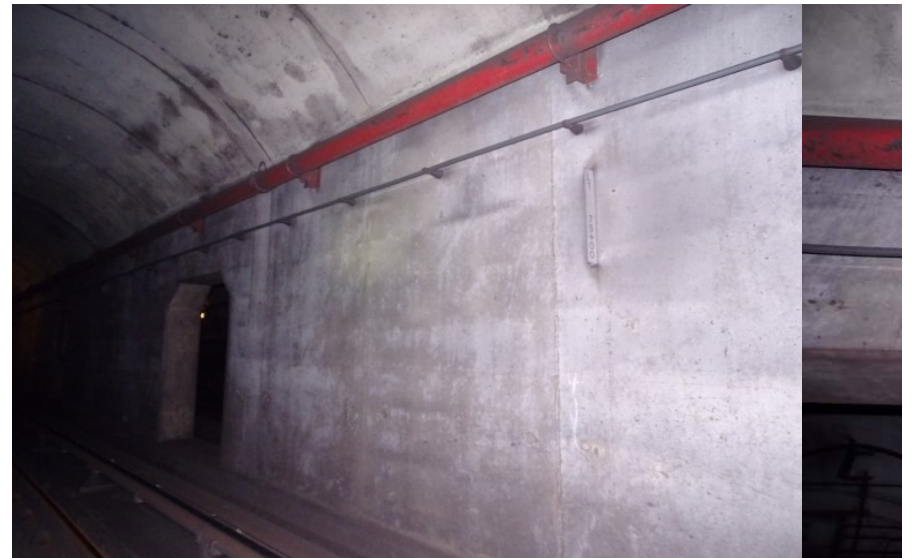
Photograph No. 208
Station 75+00, west wall.

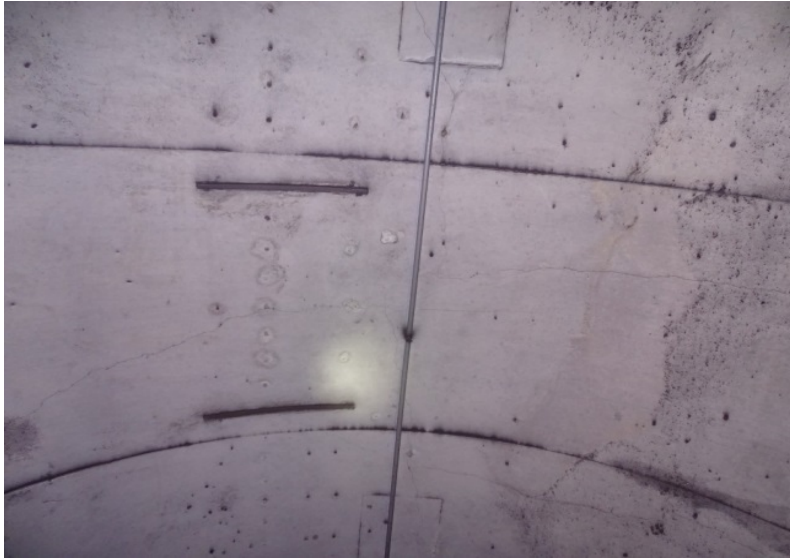
Photograph No. 209
Station 75+03 - transverse ceiling crack.

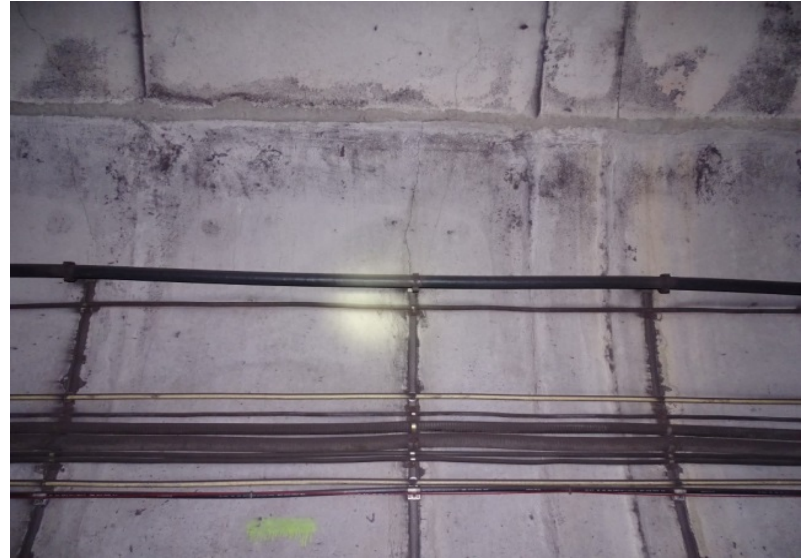
Photograph No. 210
Station 75+10 - crack on east wall.

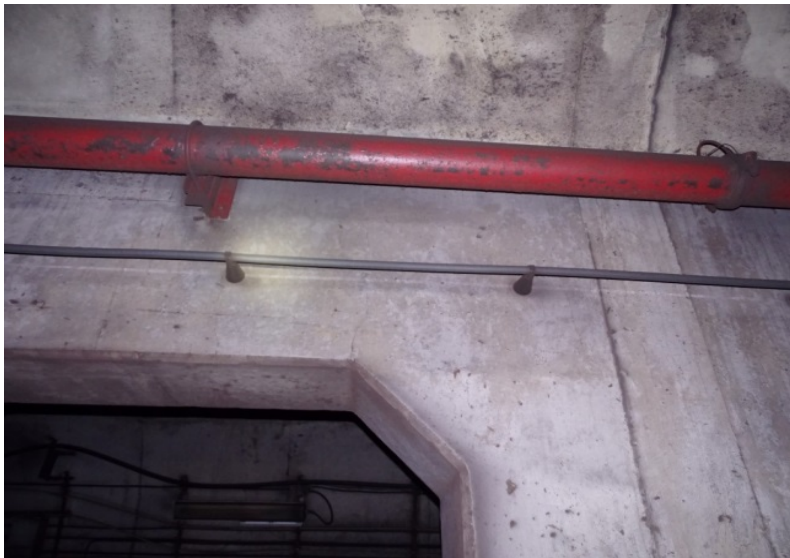
Photograph No. 211
Station 75+15 - crack above west arch.

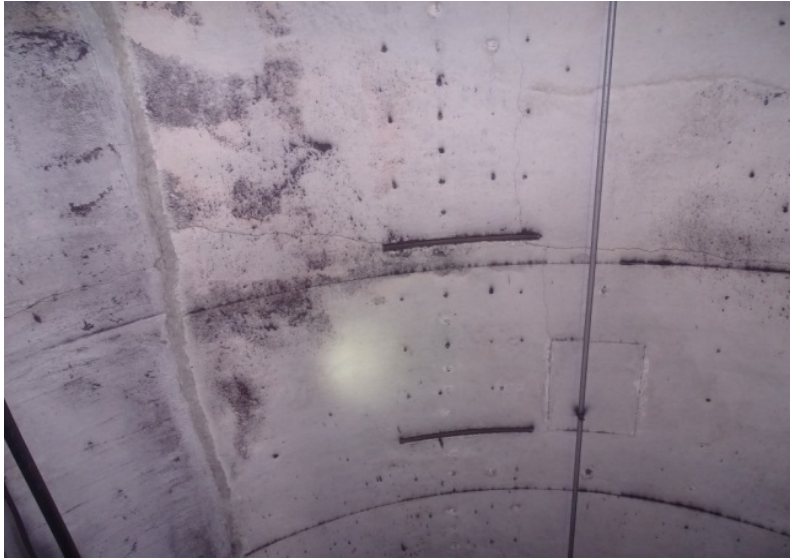
Photograph No. 216
Station 75+20 - crack above west arch.

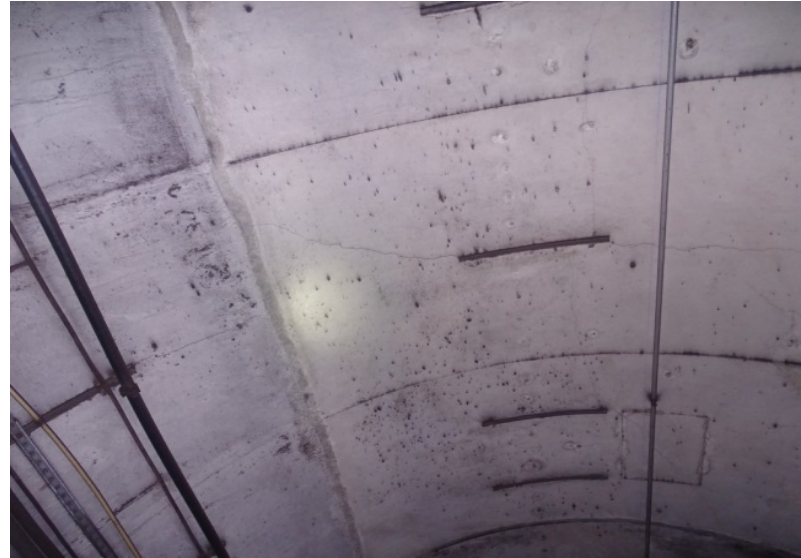
Photograph No. 217
Station 75+20 - crack in ceiling.

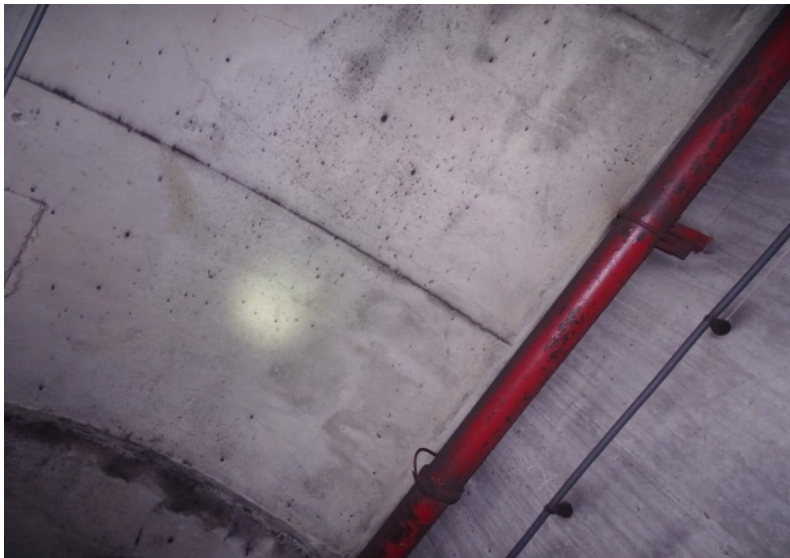
Photograph No. 218
Station 75+25 - crack in ceiling.

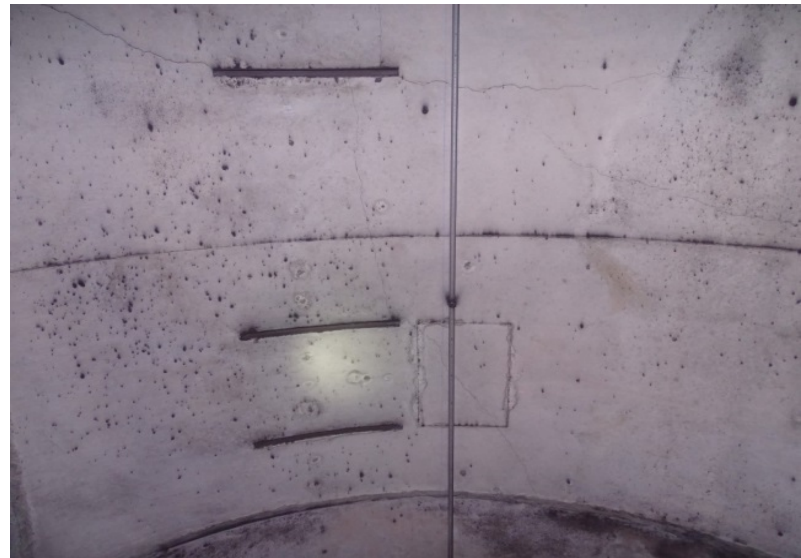
Photograph No. 219
Station 75+30 - crack in ceiling.
