**Report of Preconstruction Condition
Survey Services**

**ADJACENT PROPERTIES TO
THE WHARF – PHASE I
WASHINGTON, DC**

ECS PROJECT NO. 37:1306

OCTOBER 6, 2014

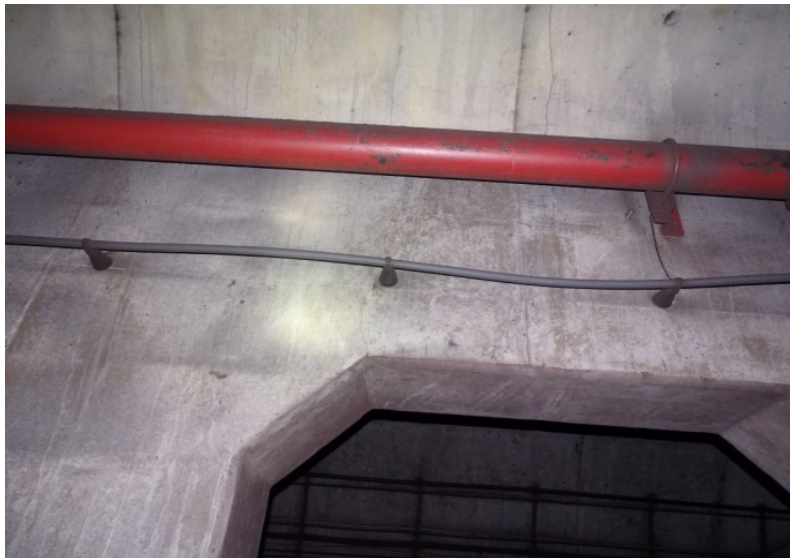
Photograph No. 226
Station 75+45 - cracks in ceiling.

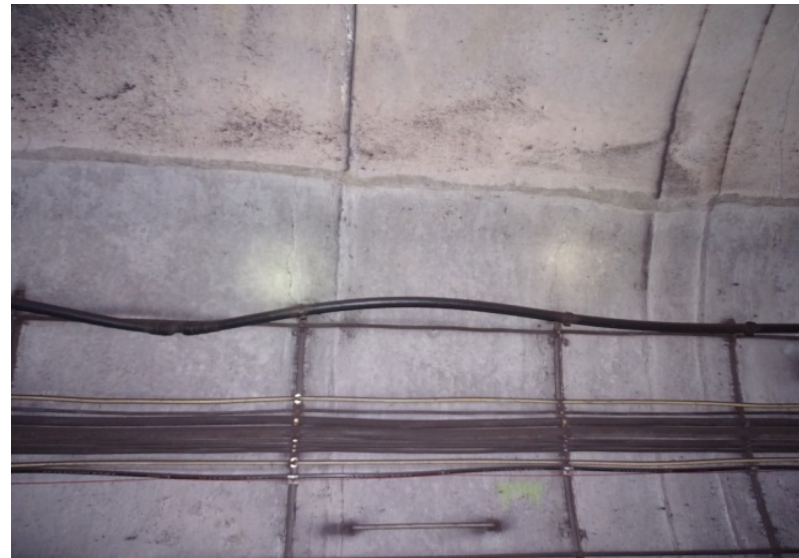
Photograph No. 227
Station 75+45 - crack above west arch.

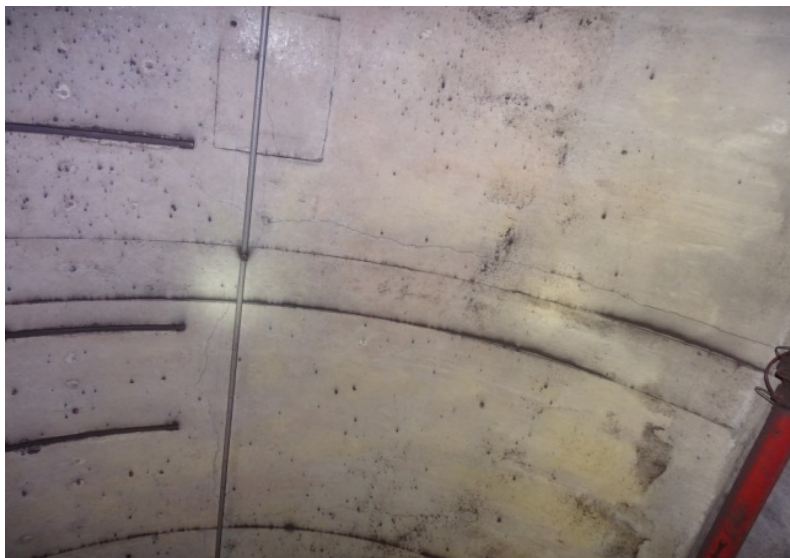
Photograph No. 228
Station 75+50 - vertical crack in east wall.

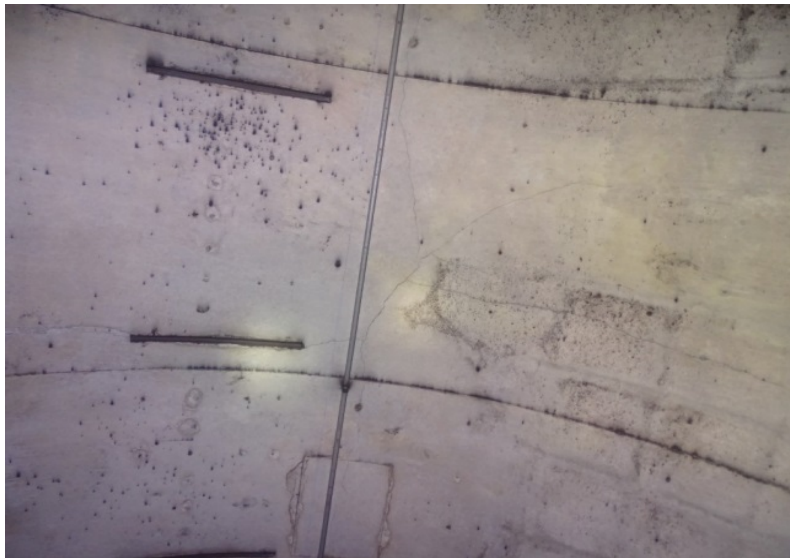
Photograph No. 234
Station 75+61 - transverse crack in ceiling.

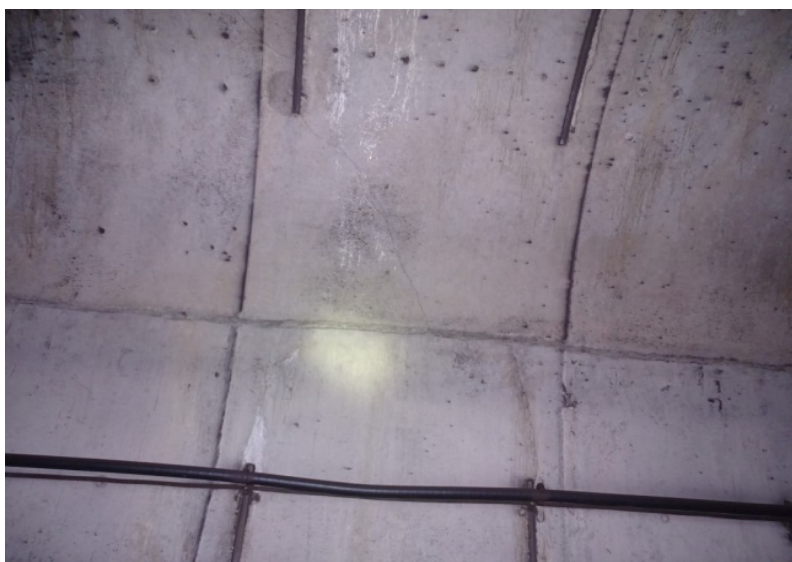
Photograph No. 242
Station 75+82 - transverse crack in ceiling.

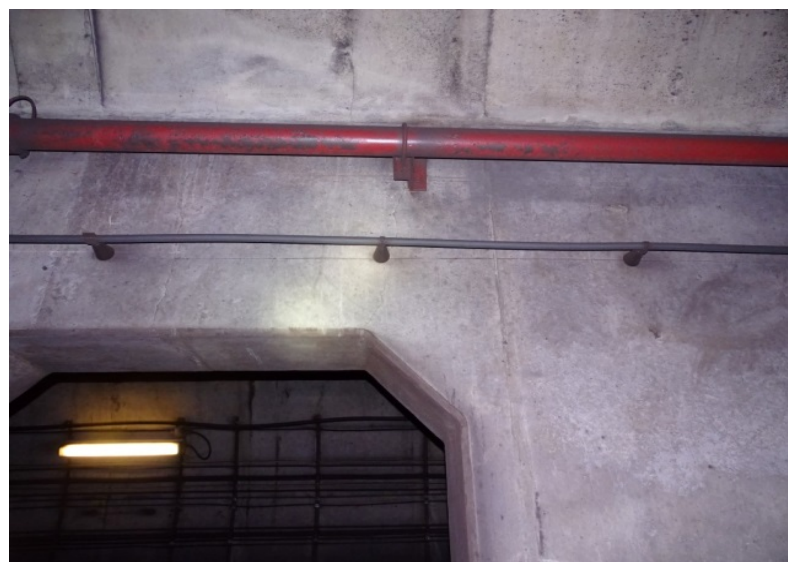
Photograph No. 243
Station 75+87 - vertical crack in east wall.

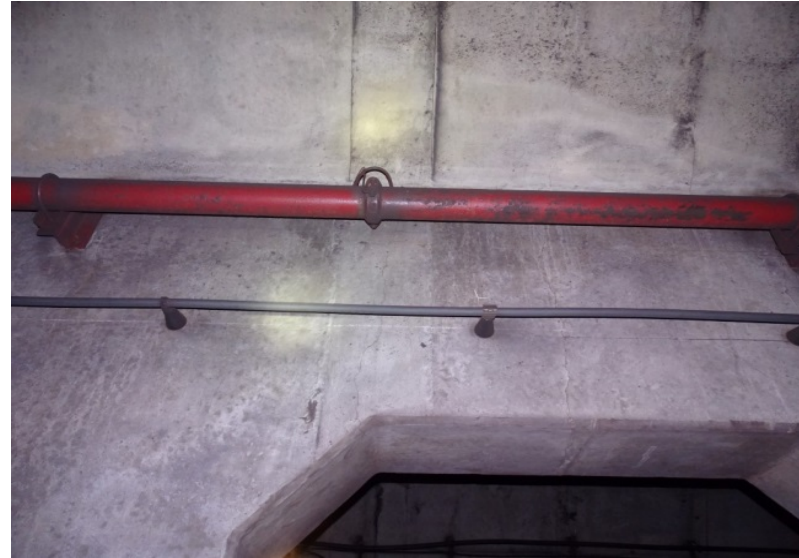
Photograph No. 245
Station 75+95 - crack in ceiling.

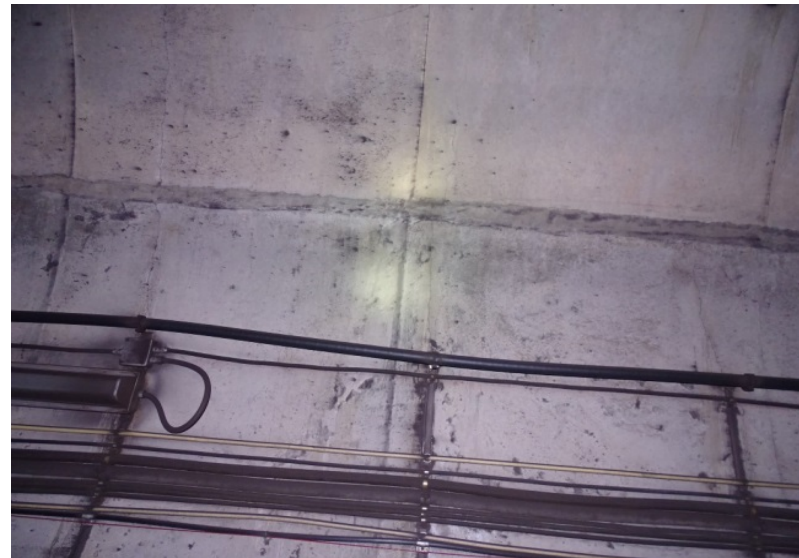
Photograph No. 252
Station 76+05 - vertical crack in east wall.

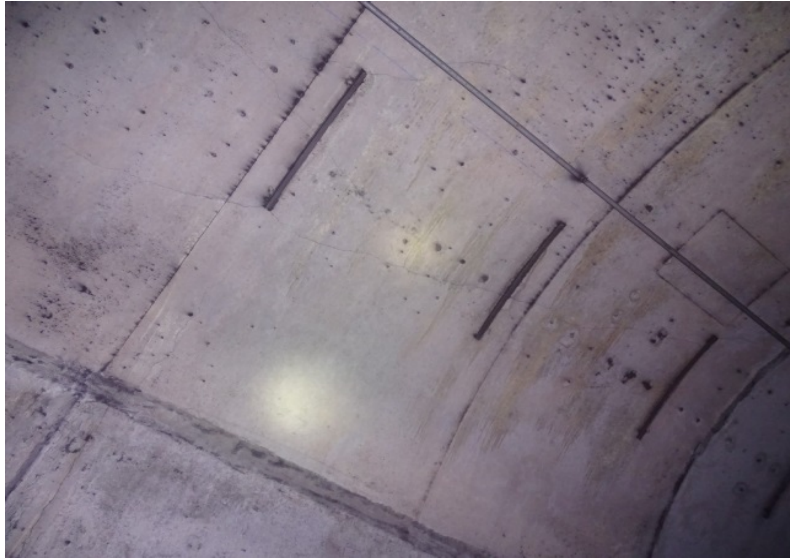
Photograph No. 253
Station 76+05 - crack in ceiling.

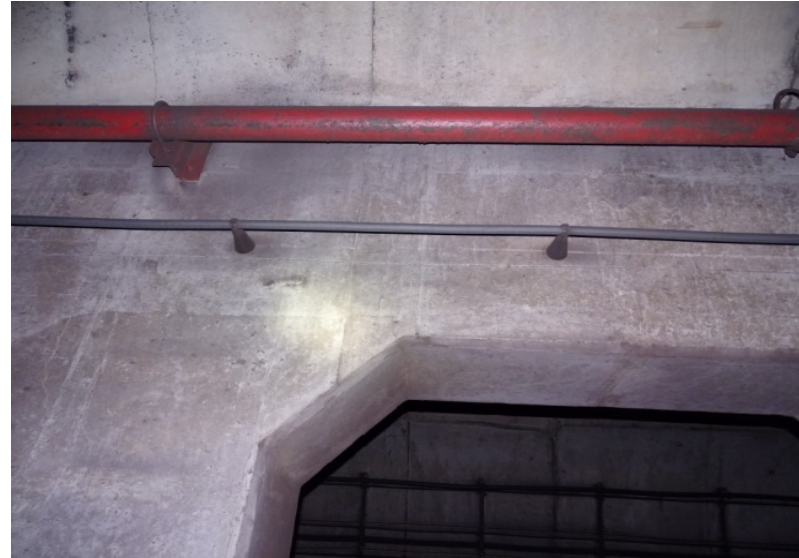
Photograph No. 258
Station 76+22, crack above west arch.

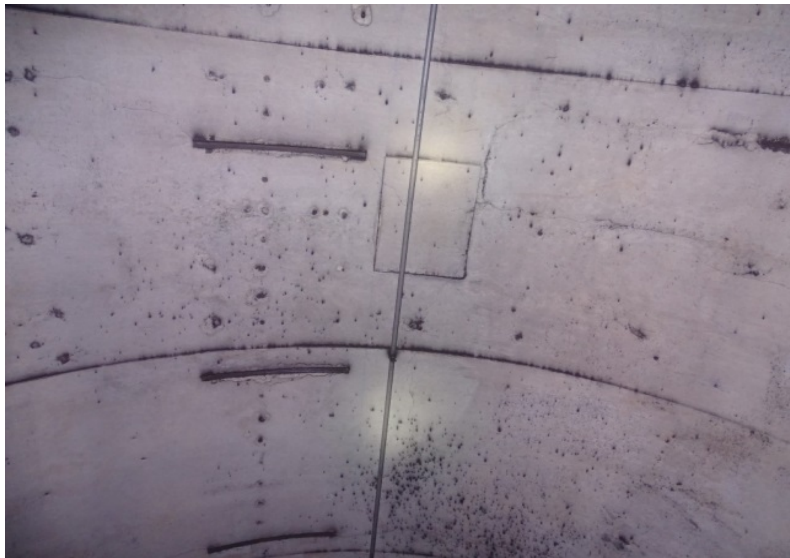
Photograph No. 259
Station 76+22 - crack in ceiling.

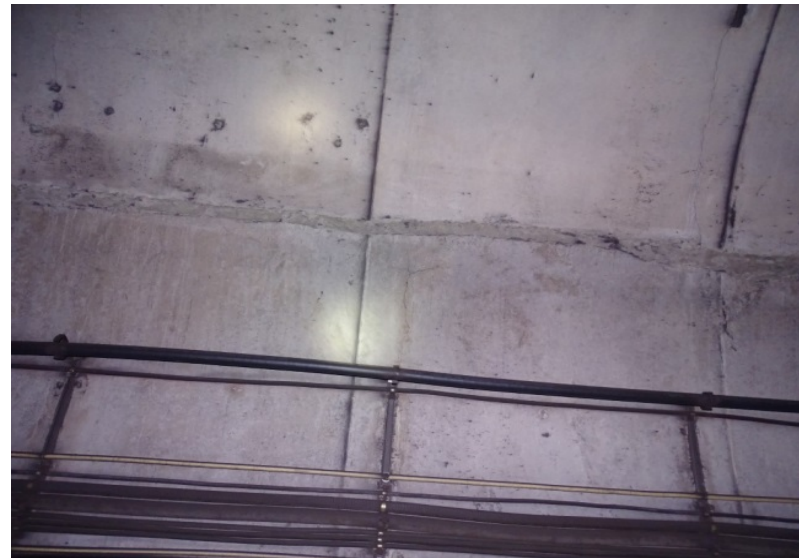
Photograph No. 260
Station 76+25 - vertical crack in east wall.

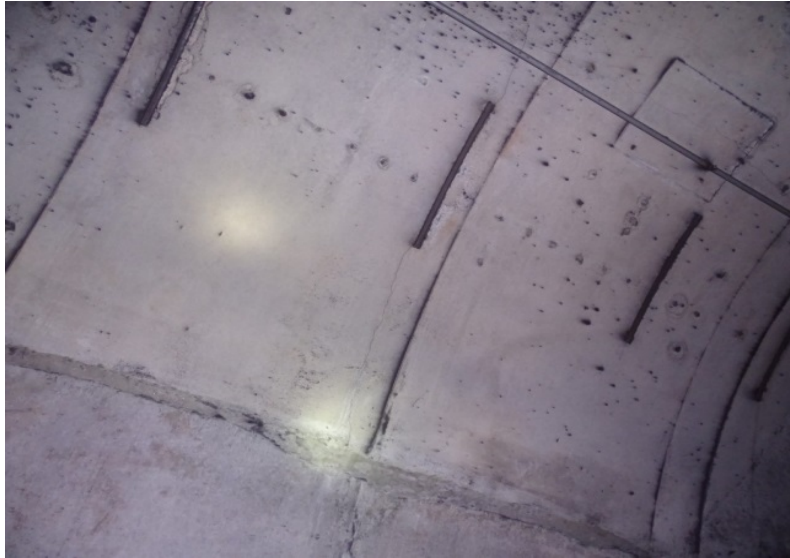
Photograph No. 261
Station 76+30 - vertical crack in east wall.

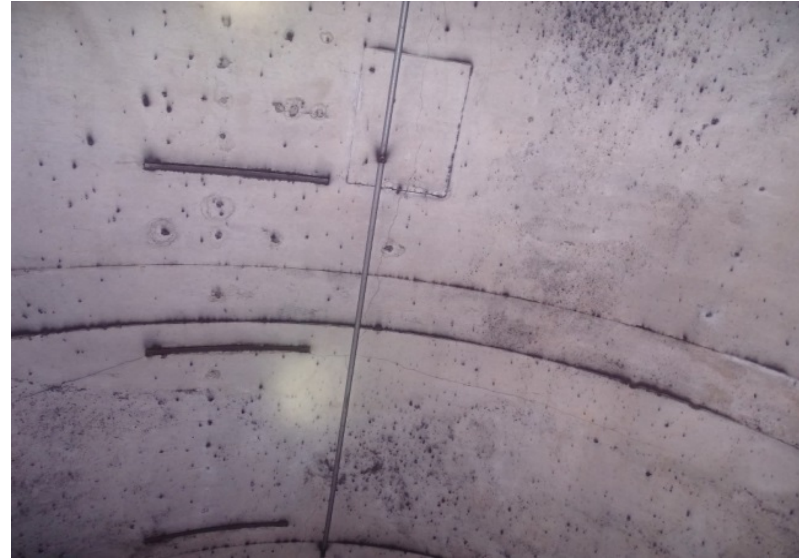
Photograph No. 262
Station 76+35 - transverse crack in ceiling.

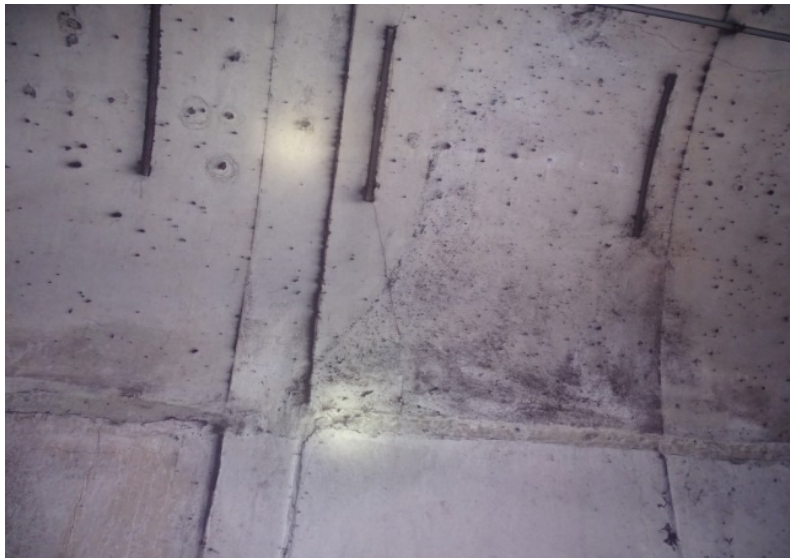
Photograph No. 263
Station 76+37 - vertical crack in east wall.

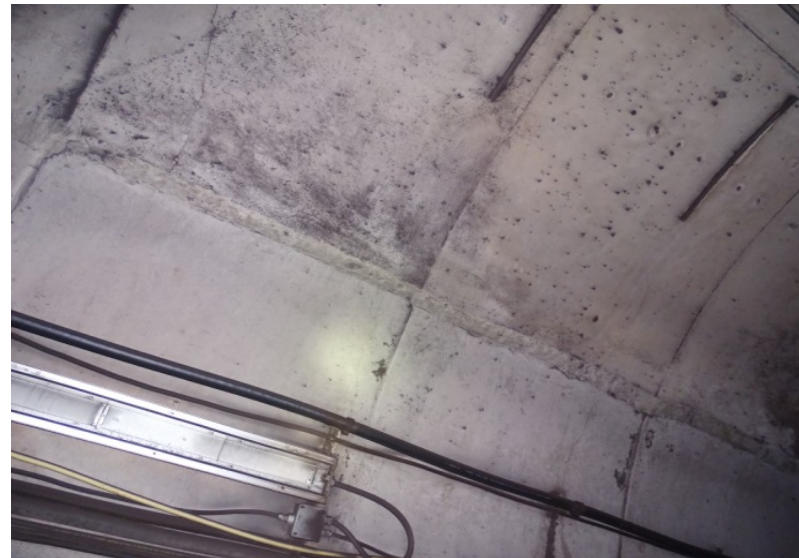
Photograph No. 268
Station 76+41 - vertical crack in east wall.

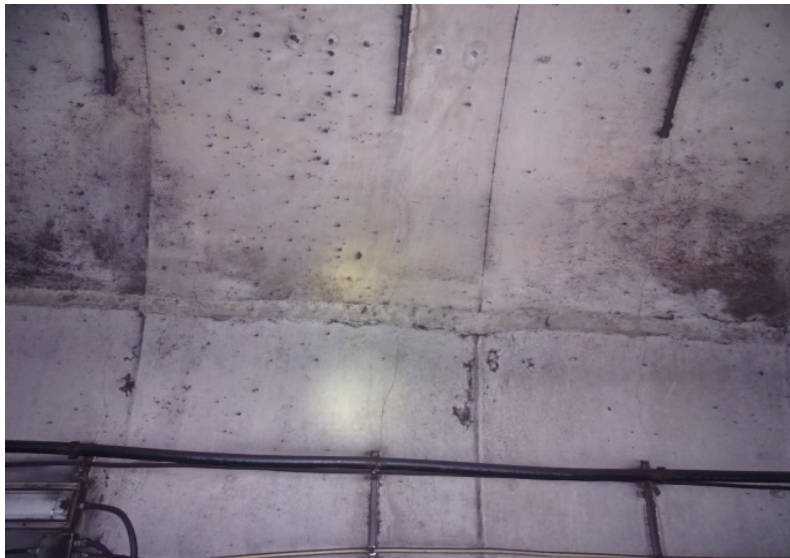
Photograph No. 271
Station 76+45 - vertical crack in east wall.

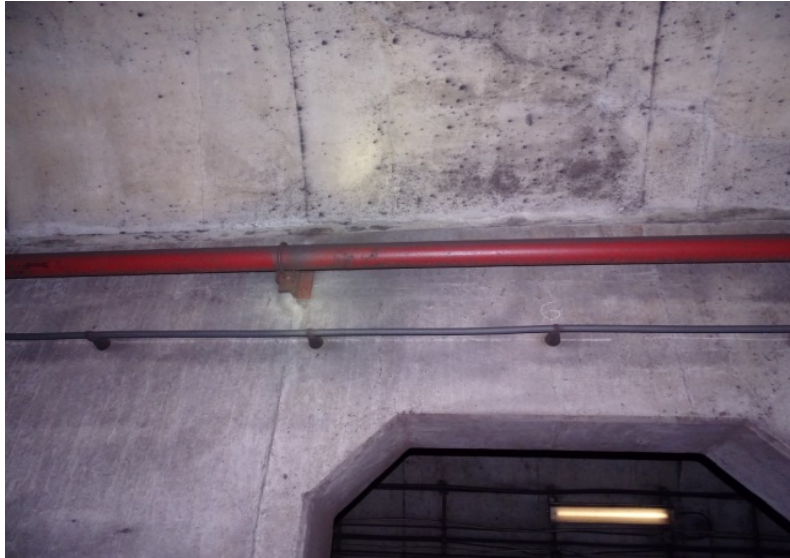
Photograph No. 273
Station 76+45 - crack above west arch.

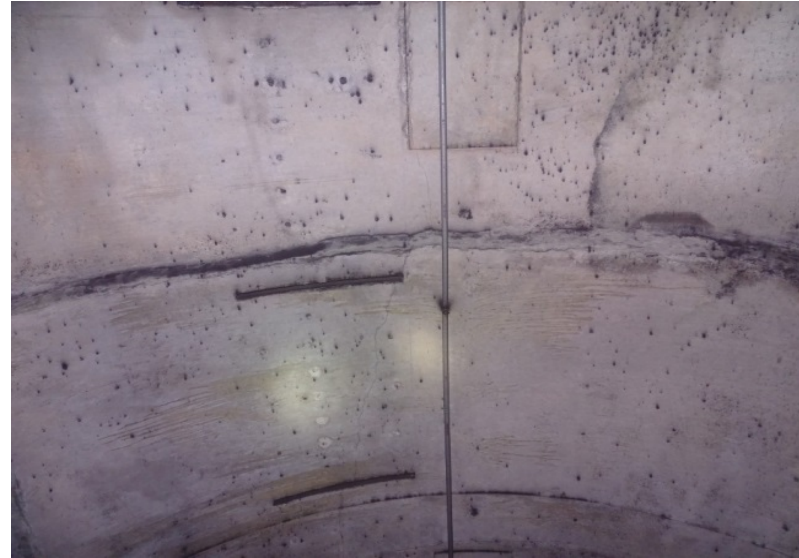
Photograph No. 274
Station 76+56 - crack in ceiling.

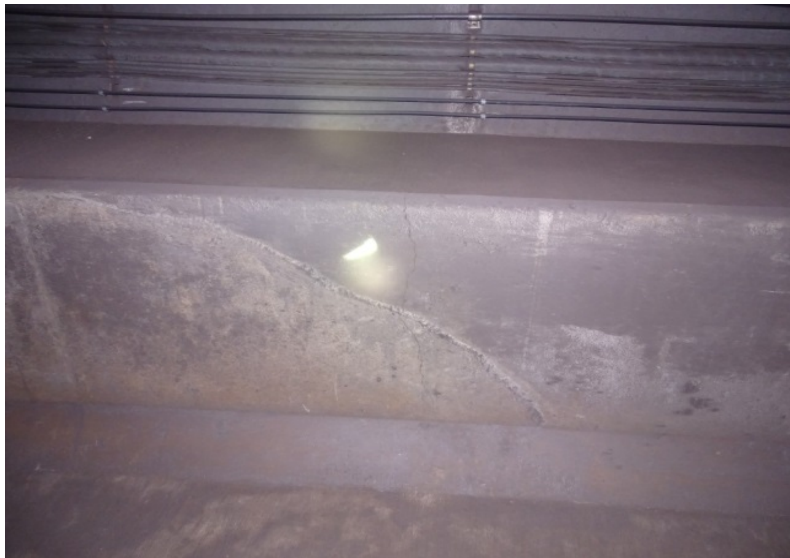
Photograph No. 279
Station 76+61 - crack in east walkway.

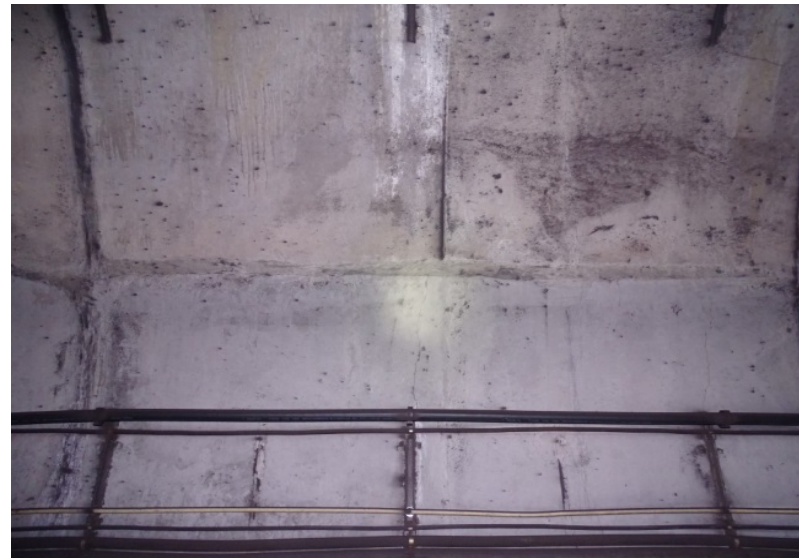
Photograph No. 280
Station 76+61 - crack in east wall.

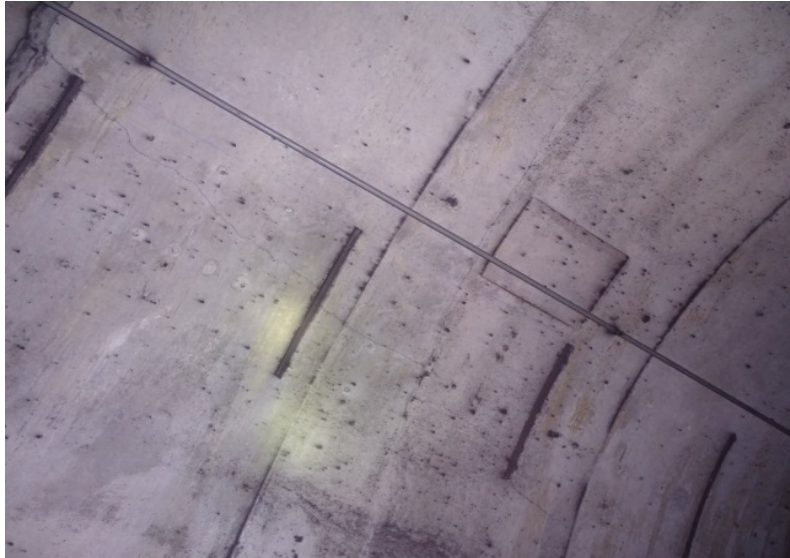
Photograph No. 281
Station 76+61 - crack in ceiling.

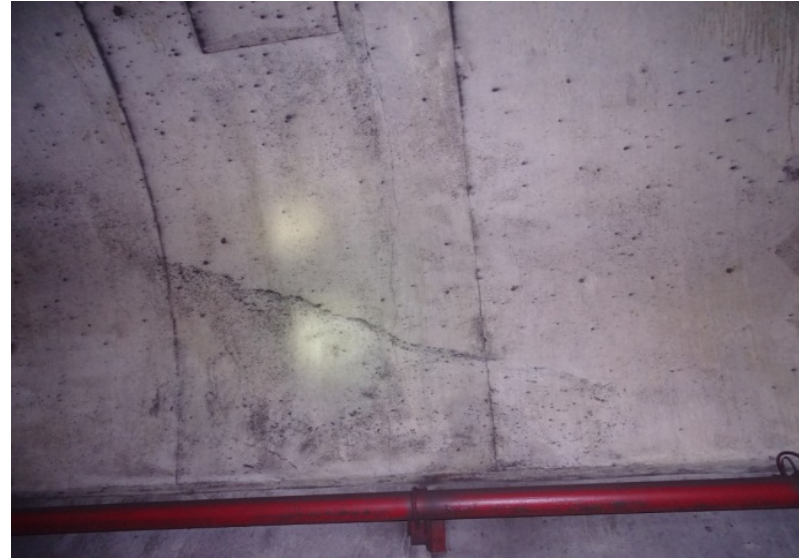
Photograph No. 282
Station 76+61 - crack in west wall.

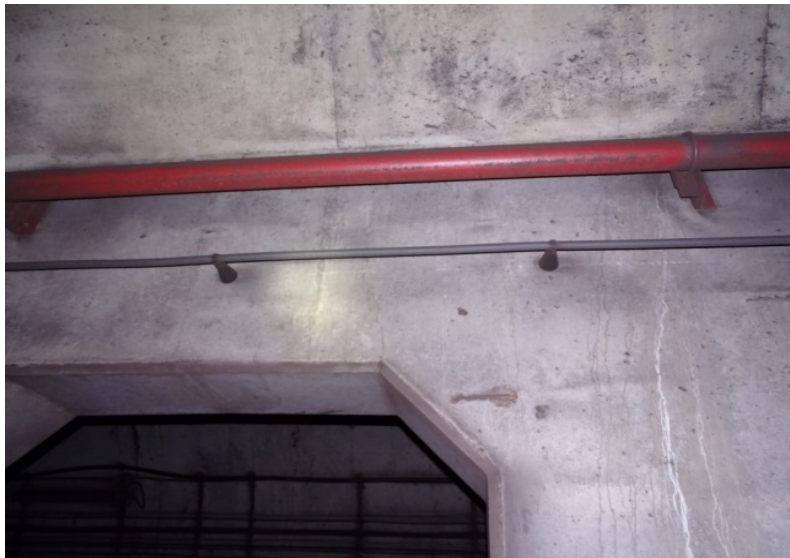
Photograph No. 283
Station 76+61 - crack above west arch.

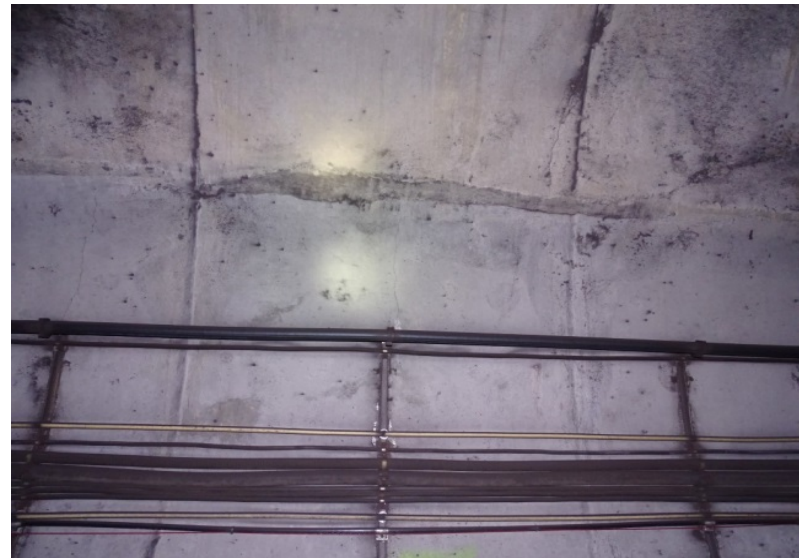
Photograph No. 284
Station 76+70 - crack in east wall.

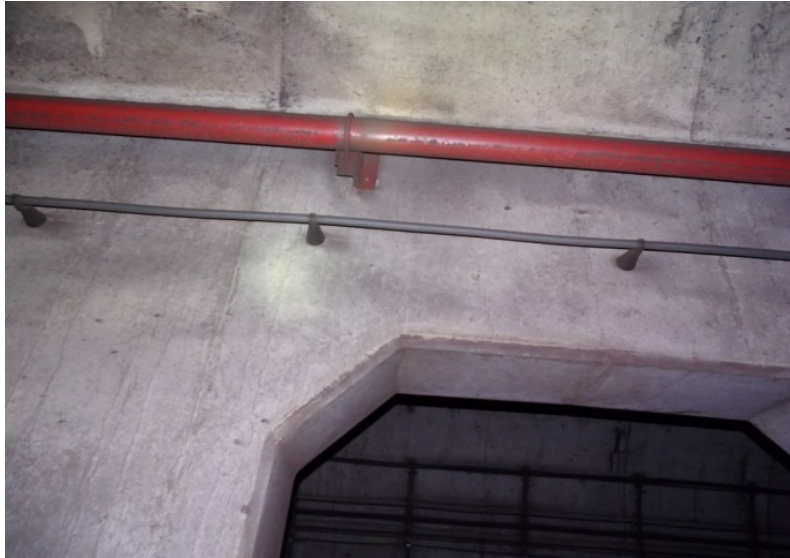
Photograph No. 285
Station 76+70 - crack above west arch.

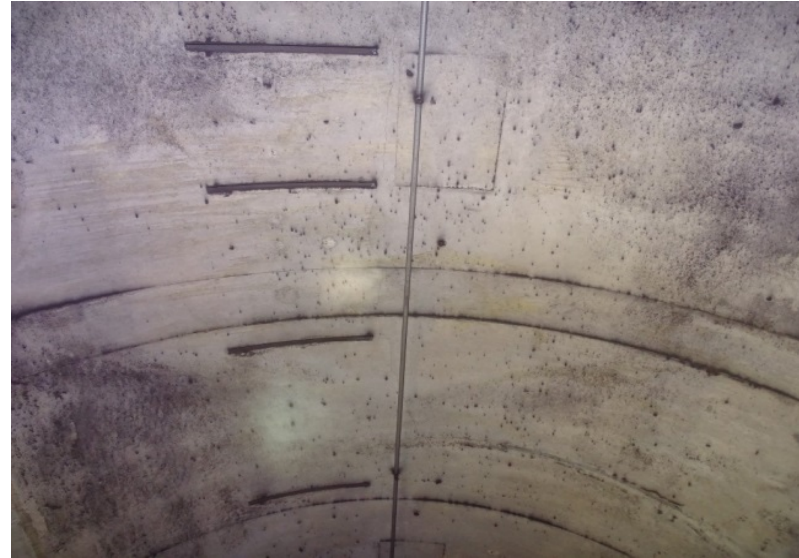
Photograph No. 286
Station 76+75 - typical transverse crack in ceiling.

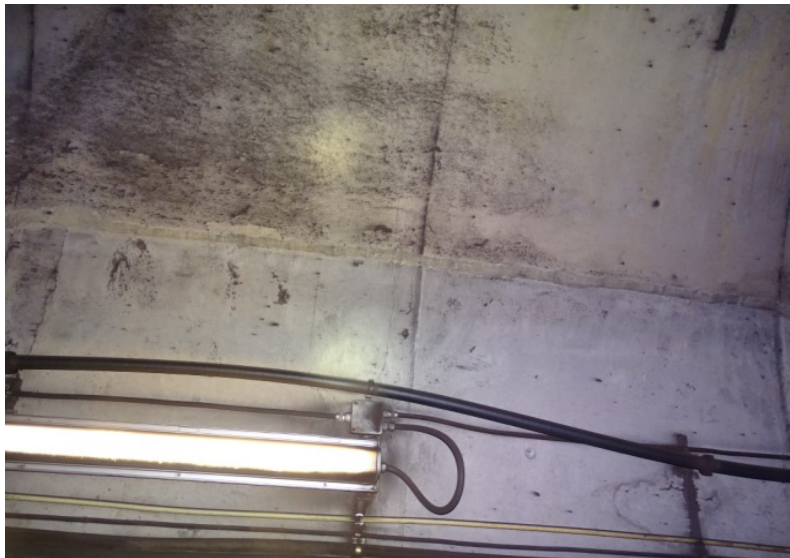
Photograph No. 291
Station 76+82 - vertical crack in east wall.

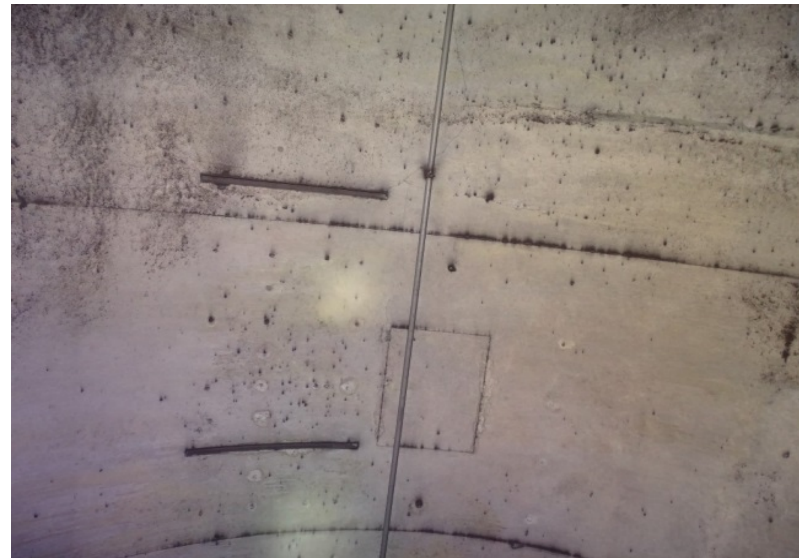
Photograph No. 292
Station 76+82 - transverse crack in ceiling.

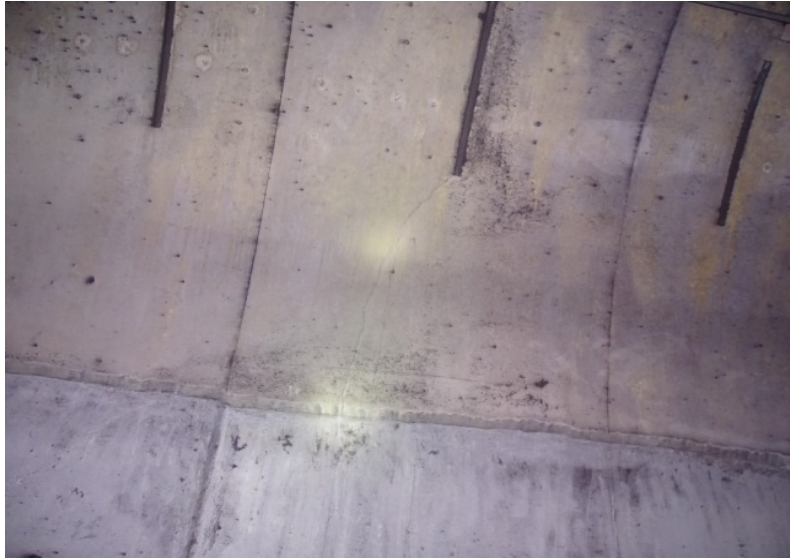
Photograph No. 293
Station 76+90 - vertical crack in east wall.

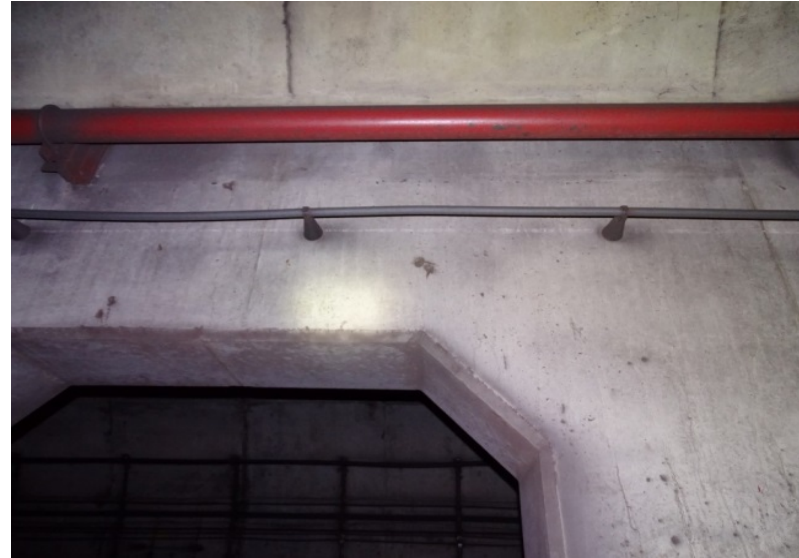
Photograph No. 294
Station 76+91 - vertical crack above west arch.

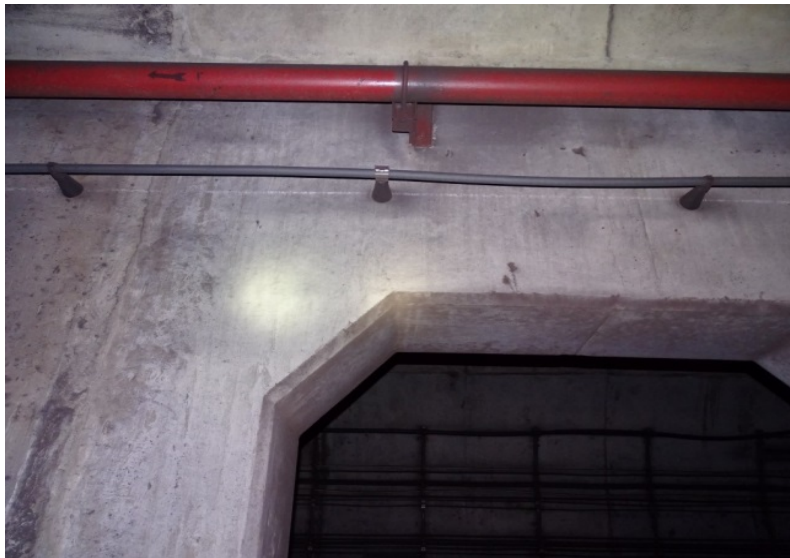
Photograph No. 295
Station 76+95 - vertical crack above west arch.

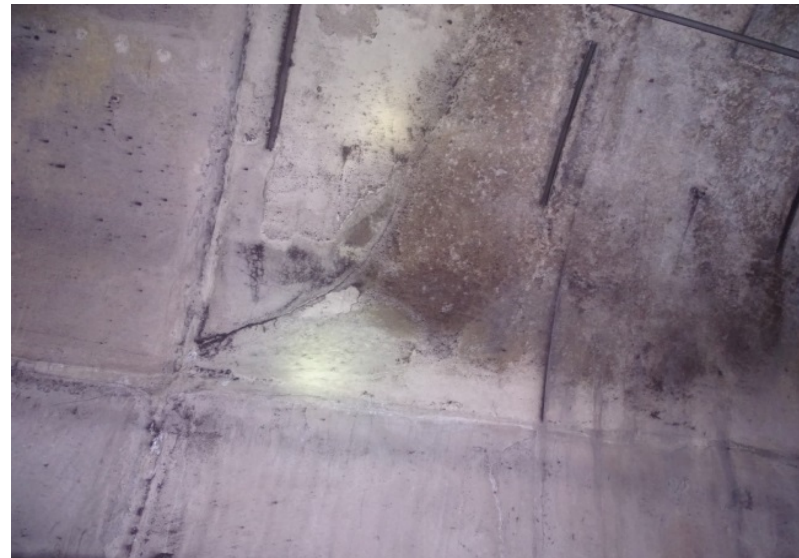
Photograph No. 300
Station 77+00 - crack in east wall.

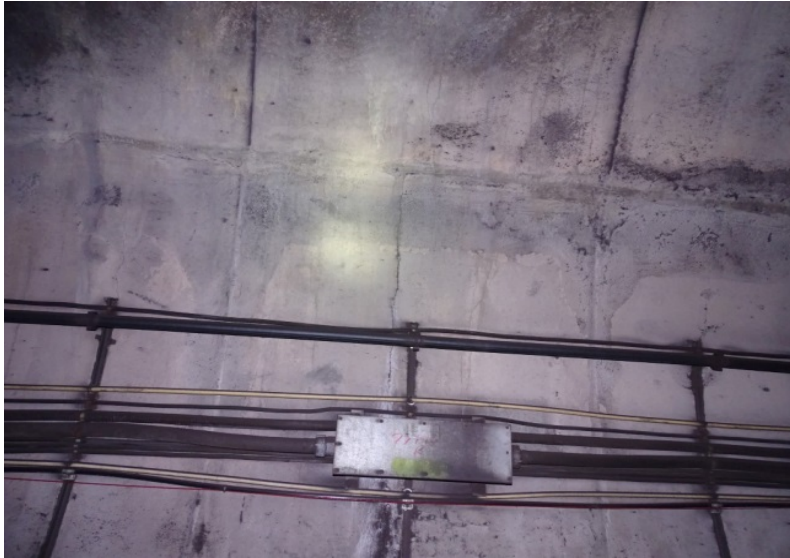
Photograph No. 301
Station 77+10 - vertical crack in east wall.

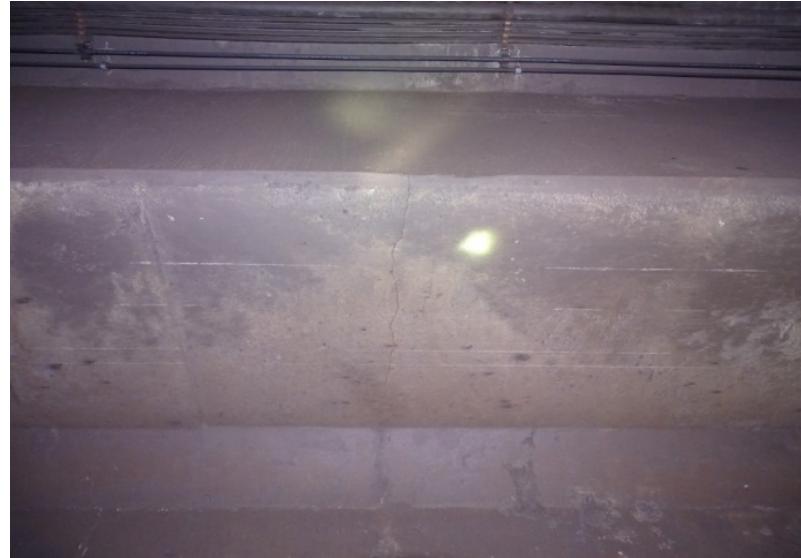
Photograph No. 302
Station 77+10 - vertical crack in east walkway.

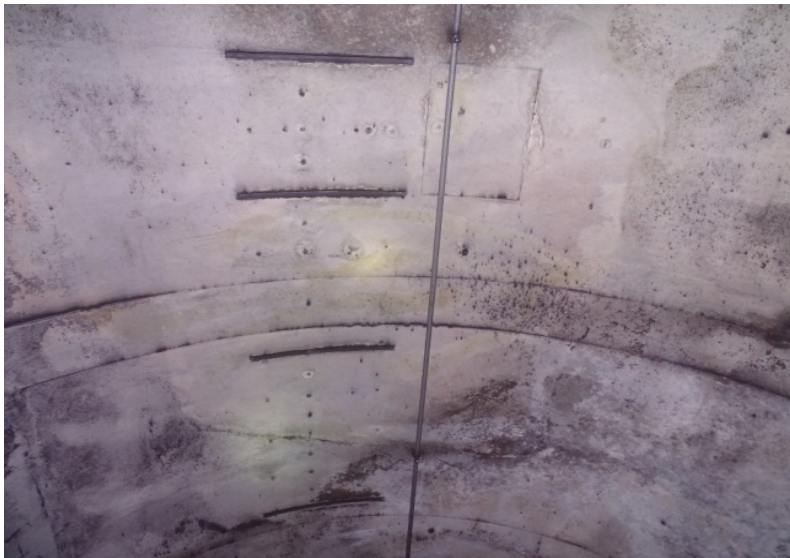
Photograph No. 303
Station 77+20 - transverse crack in ceiling.

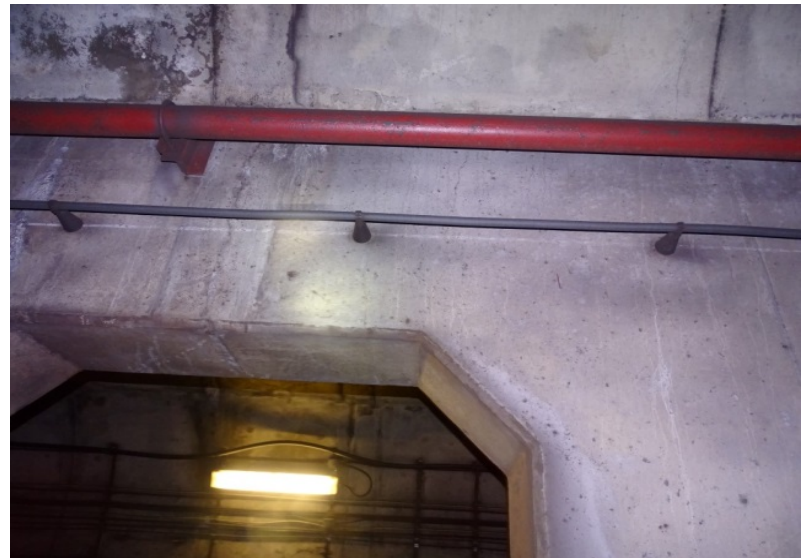
Photograph No. 304
Station 77+20 - vertical crack above west arch.

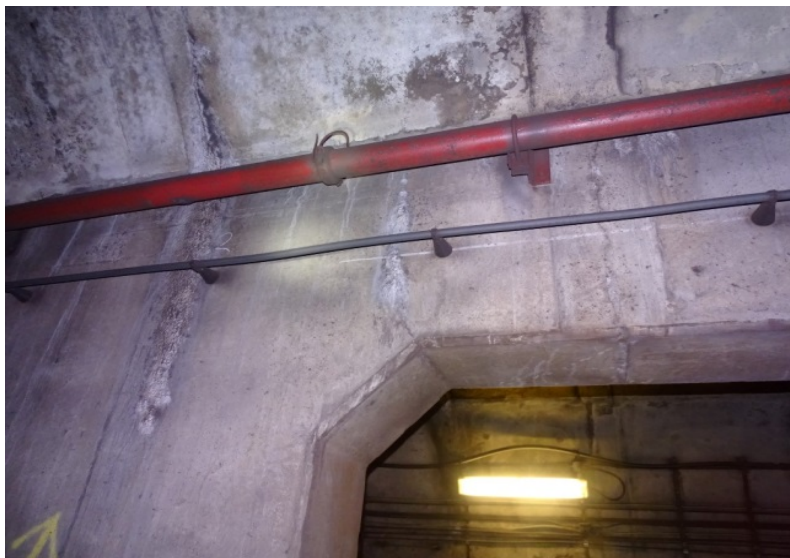
Photograph No. 305
Station 77+21 - vertical crack and efflorescence above west arch.

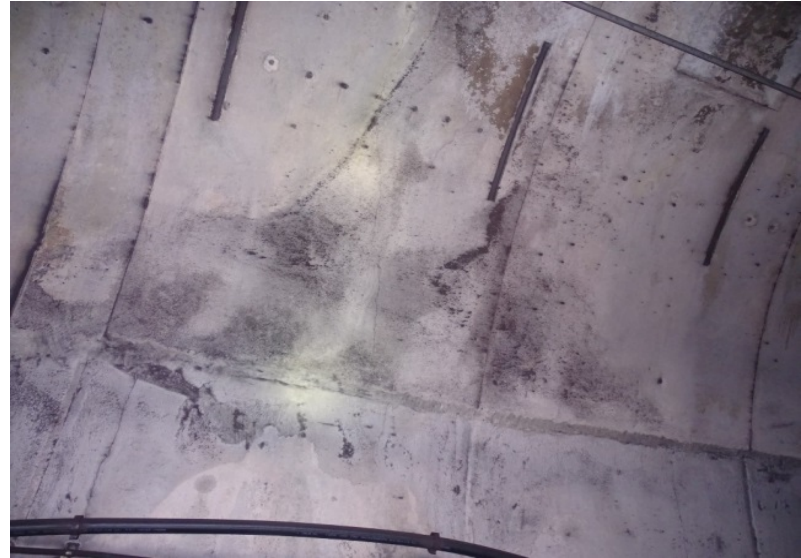
Photograph No. 310
Station 77+22 - vertical crack in east wall.

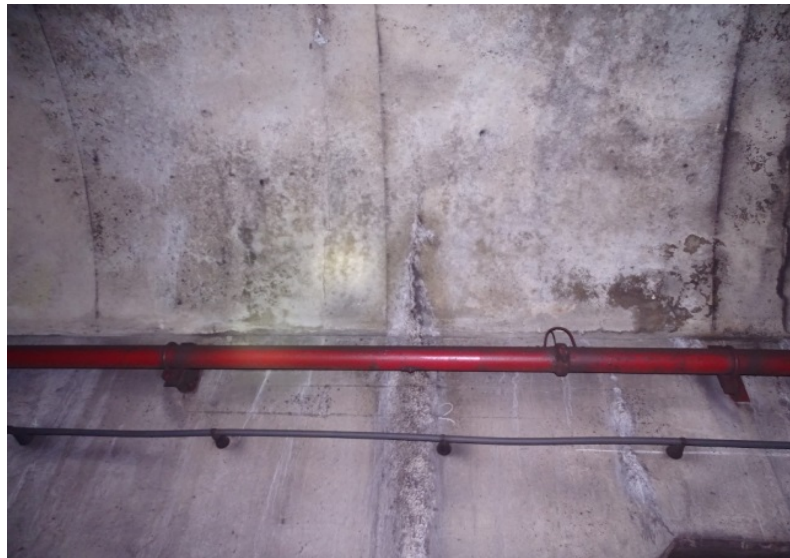
Photograph No. 311
Station 77+25 - vertical crack in west wall.

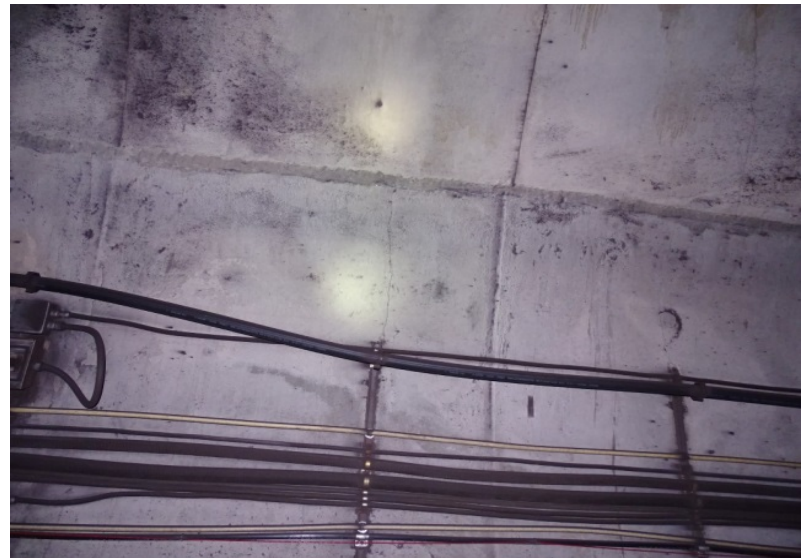
Photograph No. 312
Station 77+28 - vertical crack in east wall.

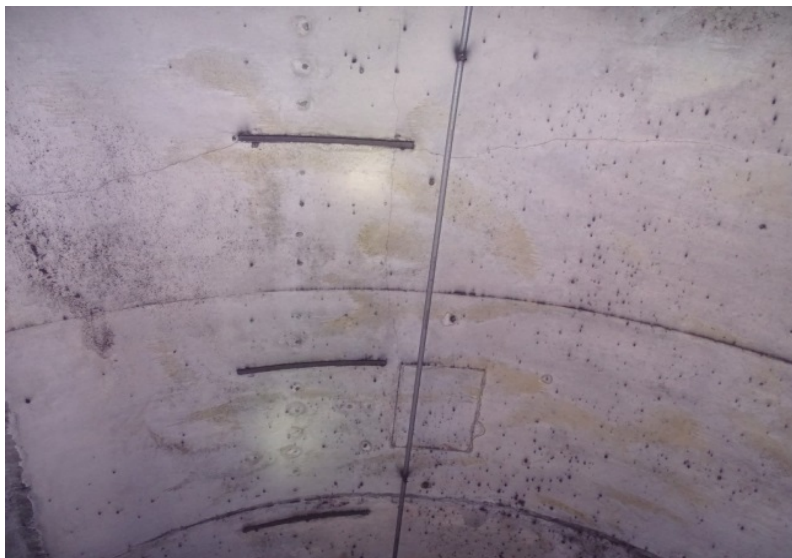
Photograph No. 313
Station 77+30 - transverse crack in ceiling.

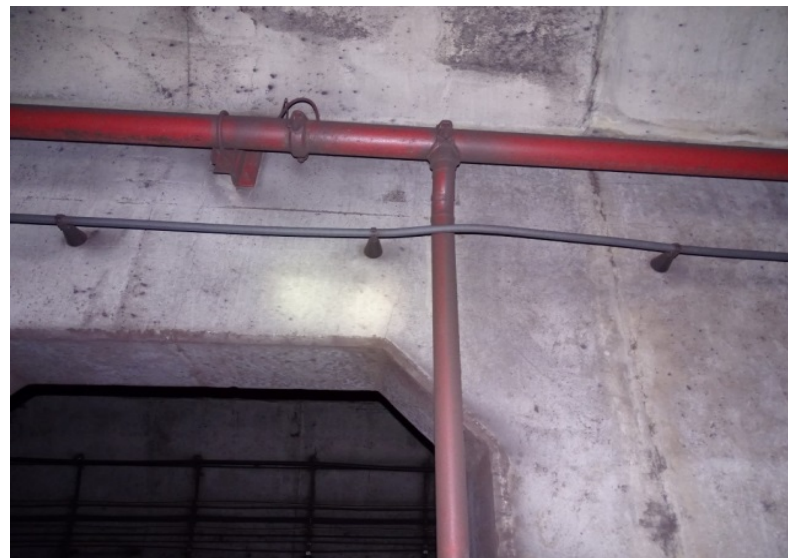
Photograph No. 318
Station 77+41 - vertical crack above west arch.

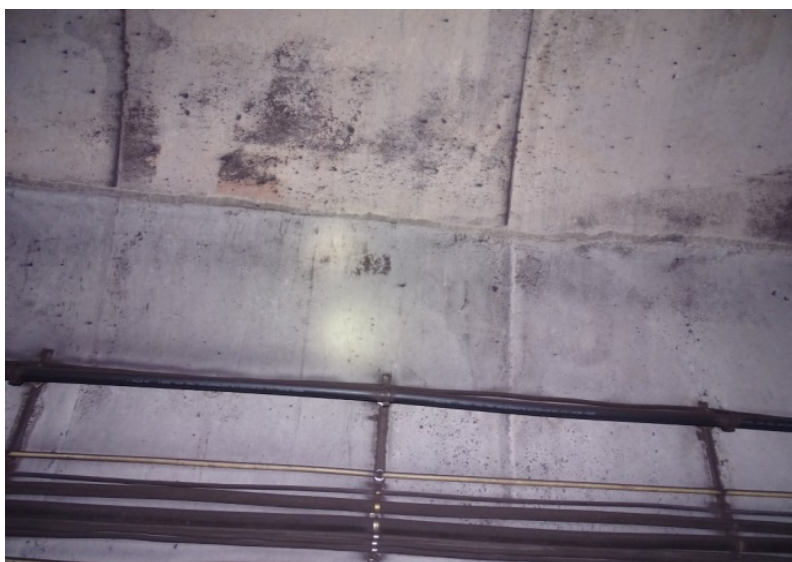
Photograph No. 319
Station 77+48 - vertical crack in east wall.

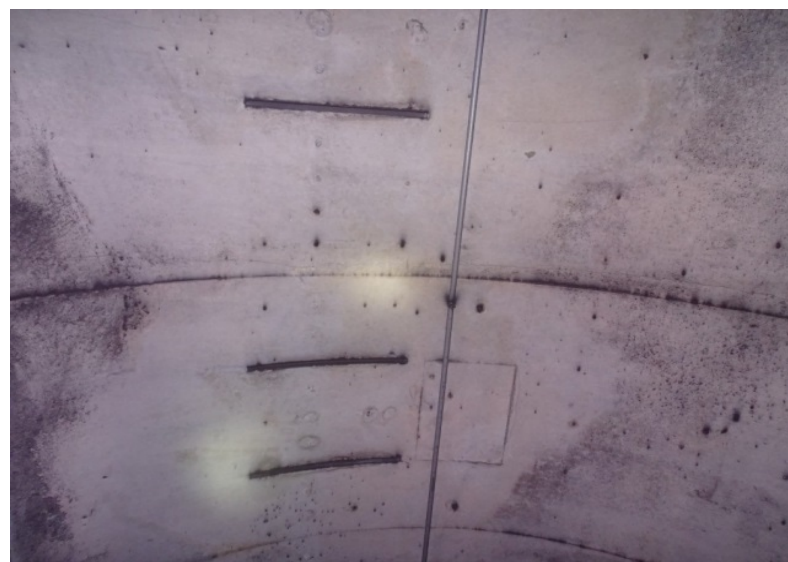
Photograph No. 320
Station 77+50 - transverse crack in ceiling.

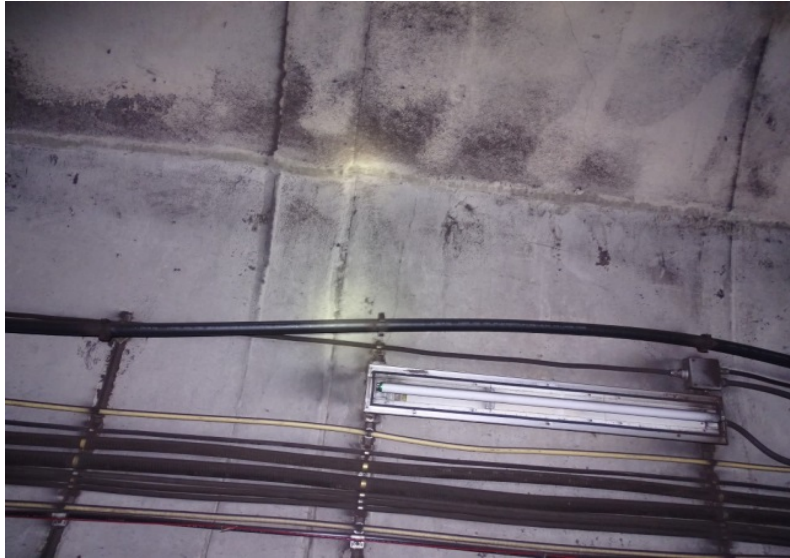
Photograph No. 325
Station 77+61 - vertical crack in ceiling.

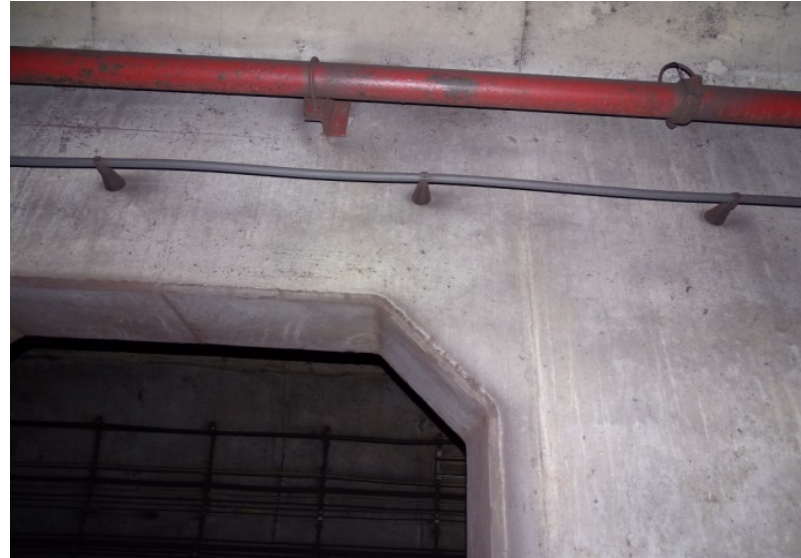
Photograph No. 326
Station 77+66 - vertical crack above west arch.

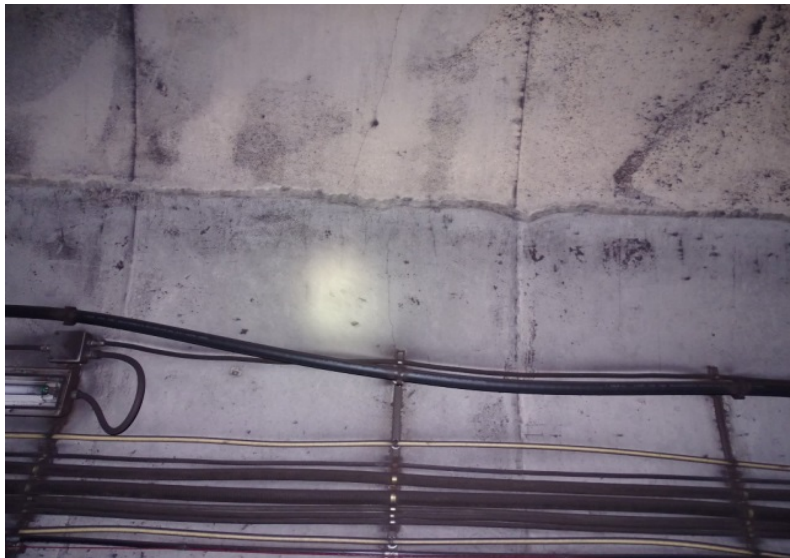
Photograph No. 327
Station 77+70 - vertical crack in east wall.

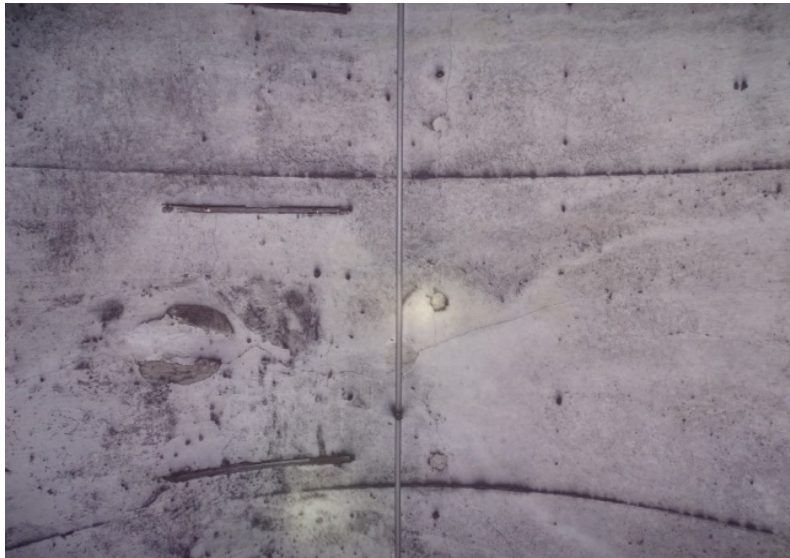
Photograph No. 333
Station 77+85 - crack in ceiling.

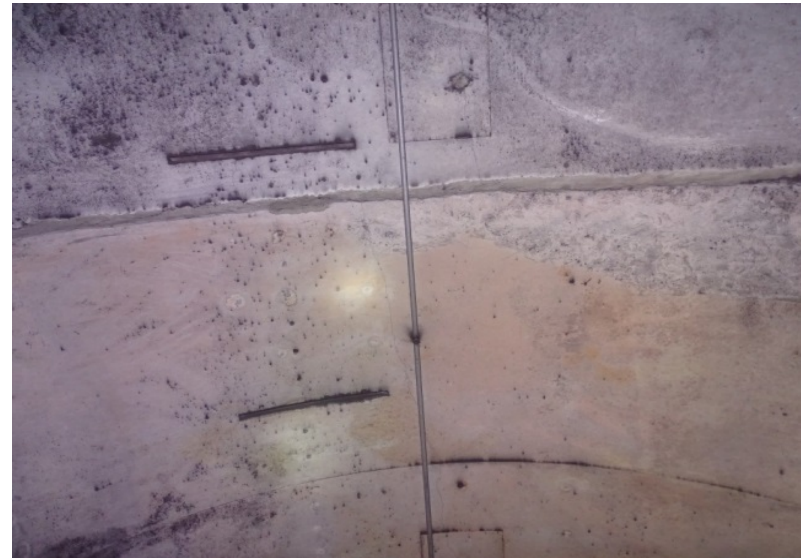
Photograph No. 334
Station 77+90 - crack in ceiling.
