**Report of Preconstruction Condition
Survey Services**

**ADJACENT PROPERTIES TO
THE WHARF – PHASE I
WASHINGTON, DC**

ECS PROJECT NO. 37:1306

OCTOBER 6, 2014

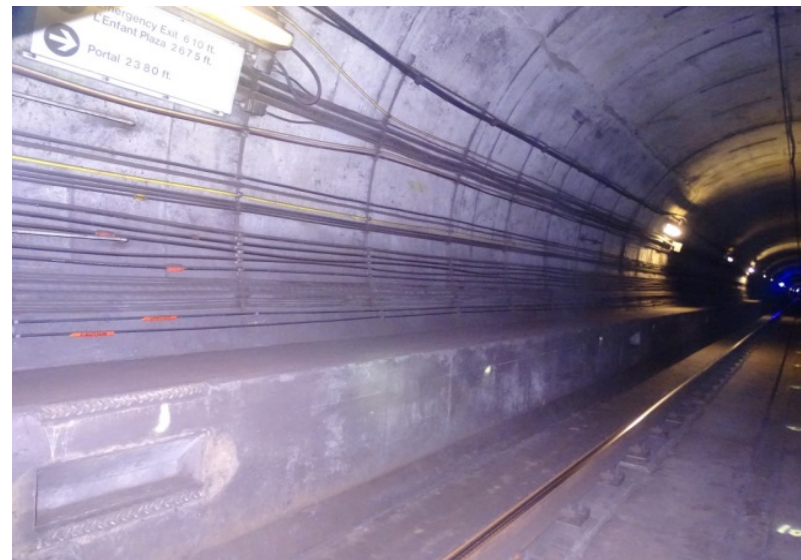
Photograph No. 336
Station 78+00, east wall.

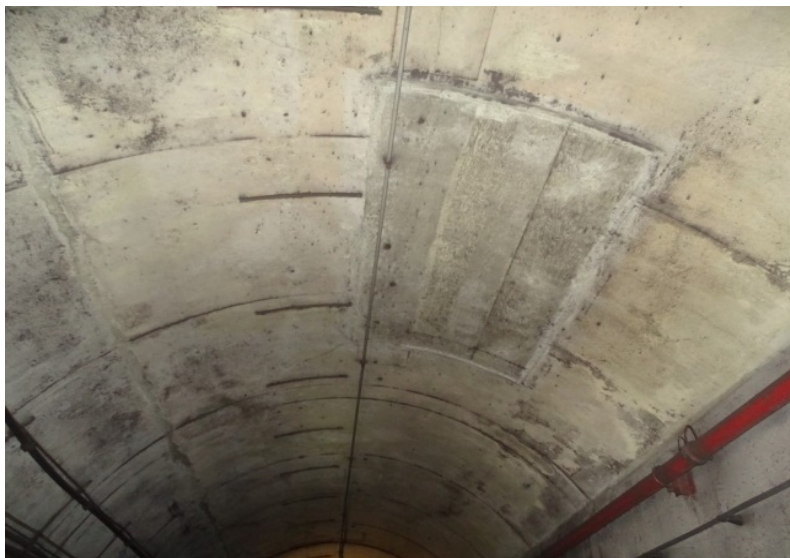
Photograph No. 337
Station 78+00, ceiling.

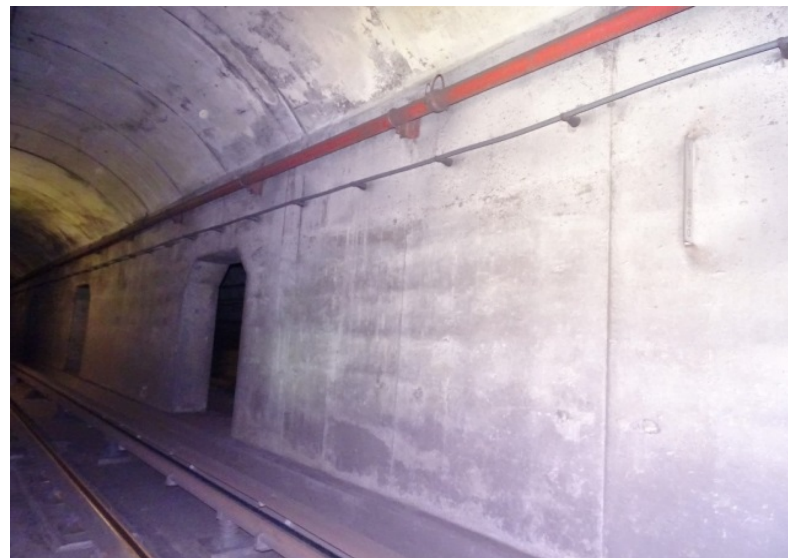
Photograph No. 338
Station 78+00, west wall.

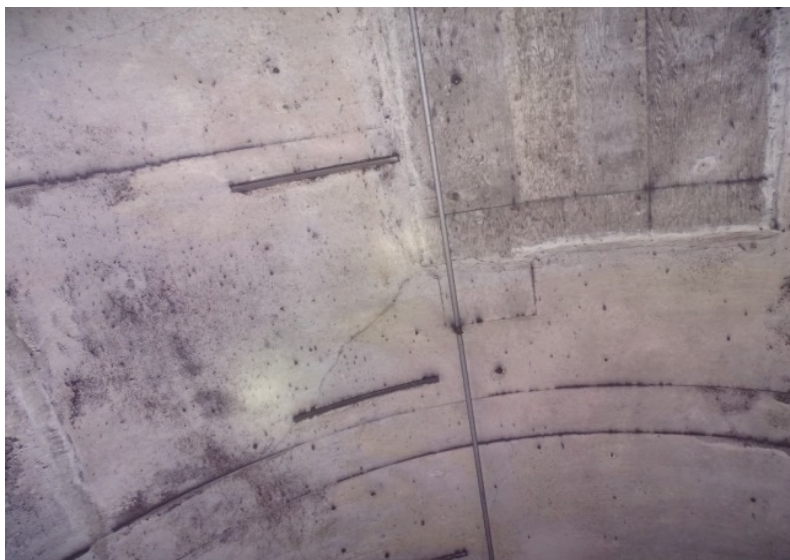
Photograph No. 339
Station 78+12 - crack in ceiling.

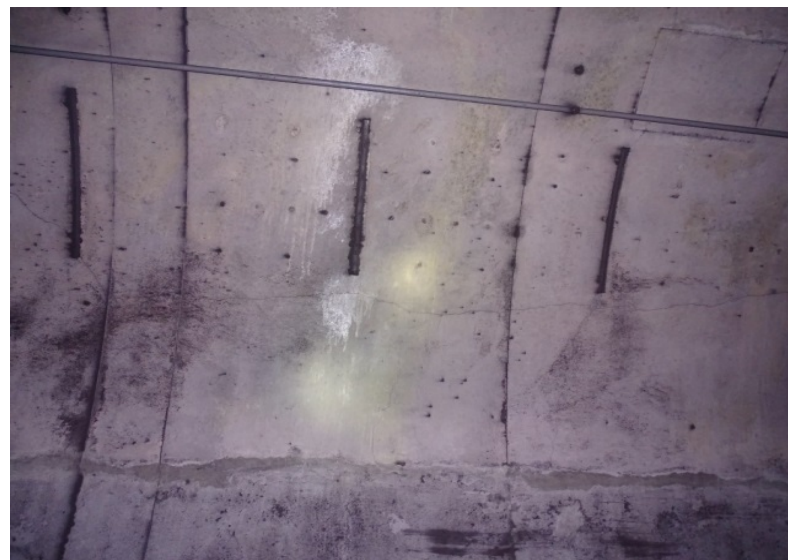
Photograph No. 340
Station 78+18 - transverse crack in east wall.

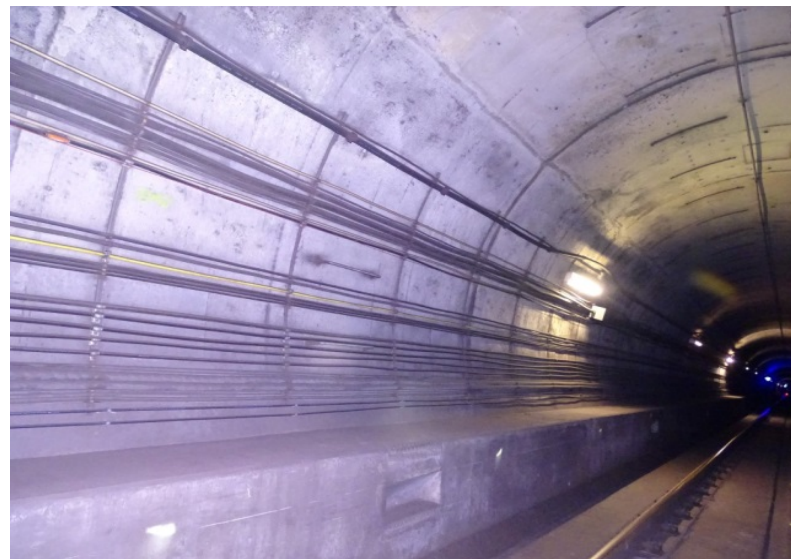
Photograph No. 342
Station 78+20, east wall.

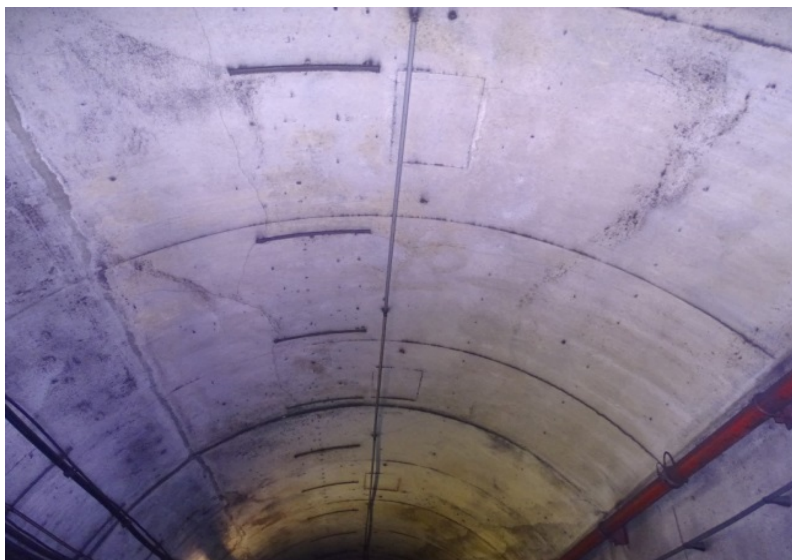
Photograph No. 343
Station 78+20, ceiling.

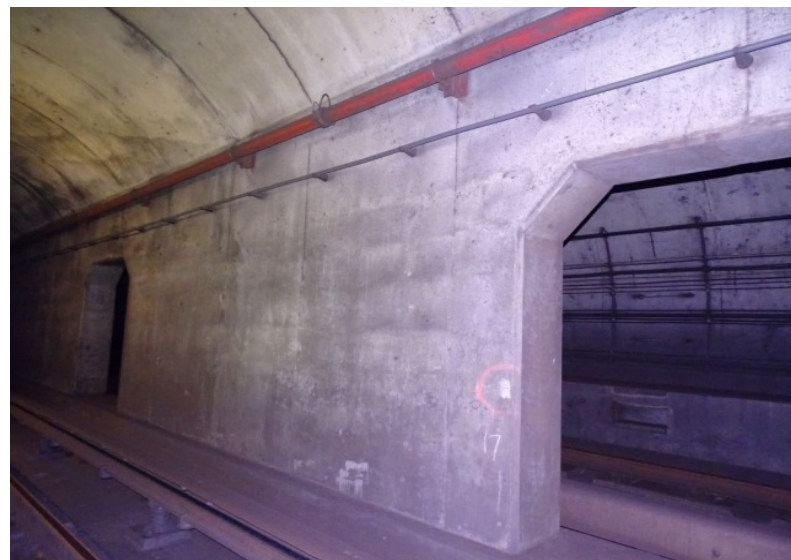
Photograph No. 344
Station 78+20, west wall.

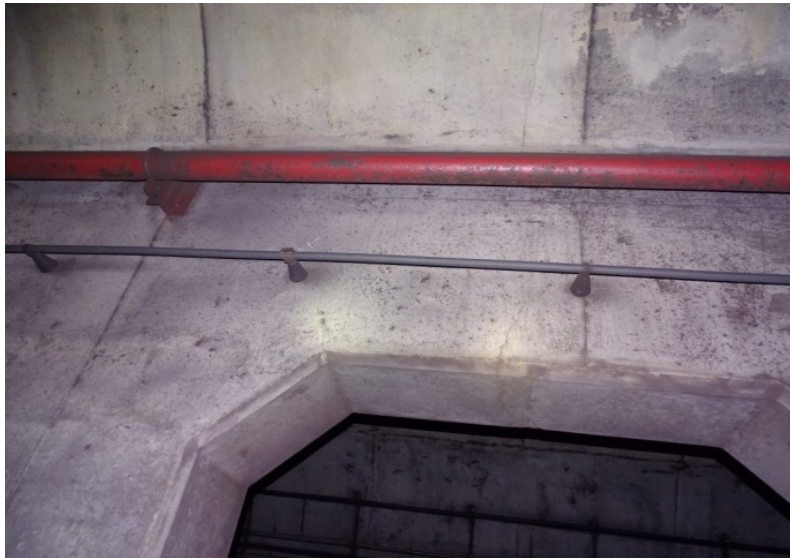
Photograph No. 345
Station 78+20 - vertical crack above west arch.

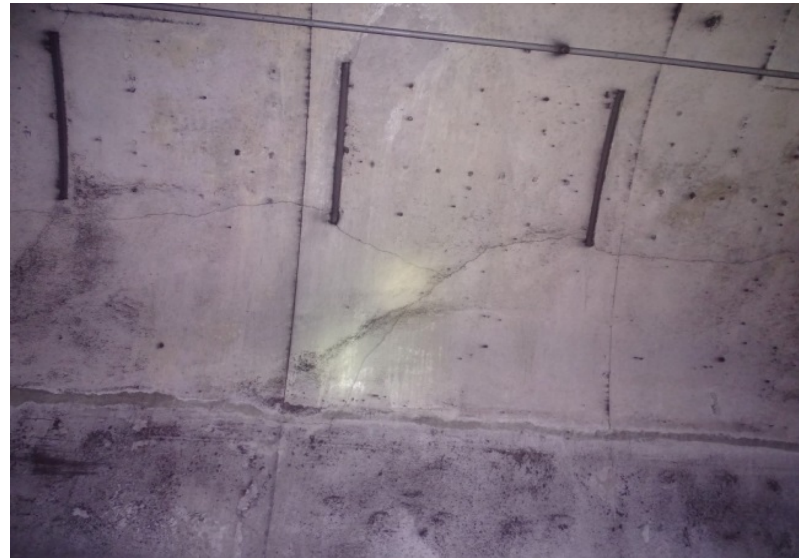
Photograph No. 346
Station 78+25 - transverse crack in east wall.

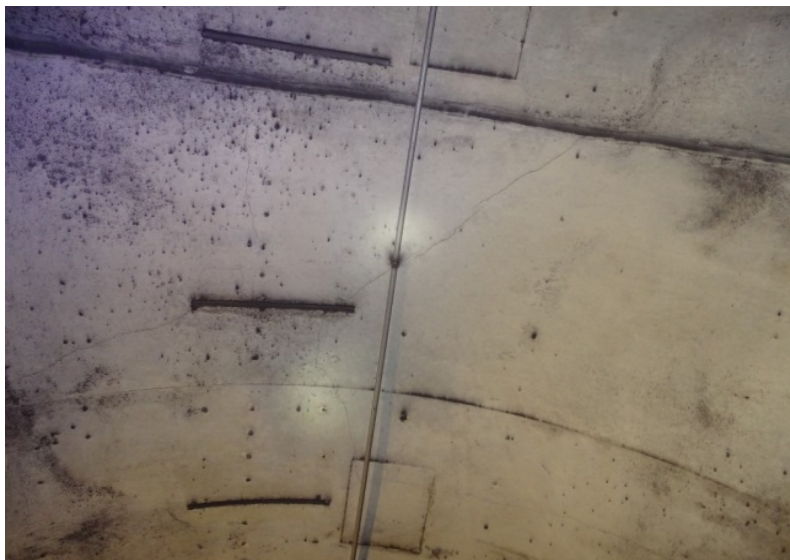
Photograph No. 347
Station 78+35 - crack in ceiling.

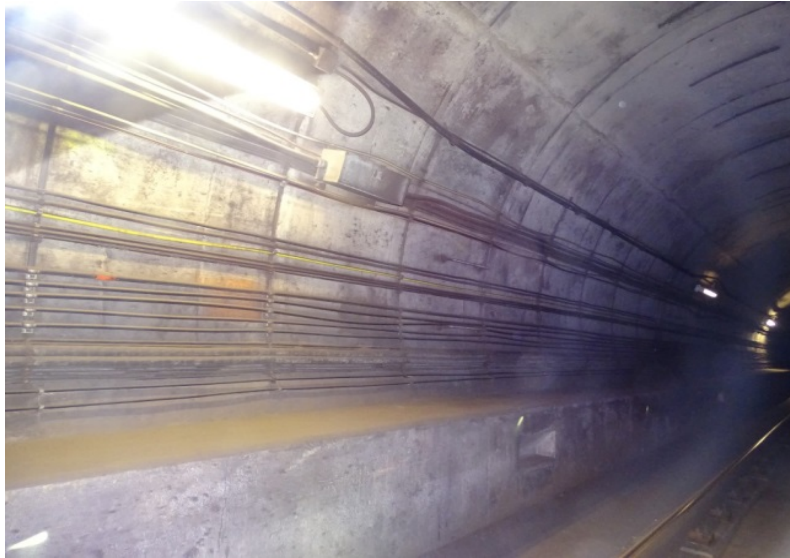
Photograph No. 349
Station 78+40, east wall.

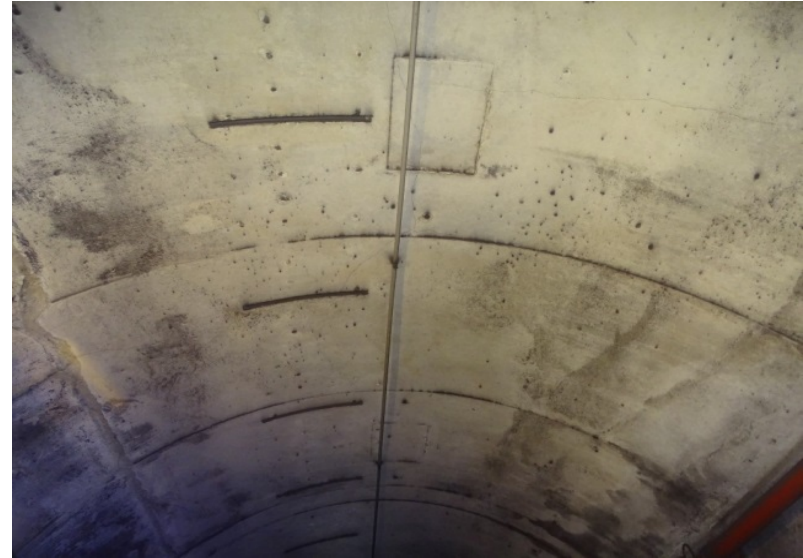
Photograph No. 350
Station 78+40, ceiling.

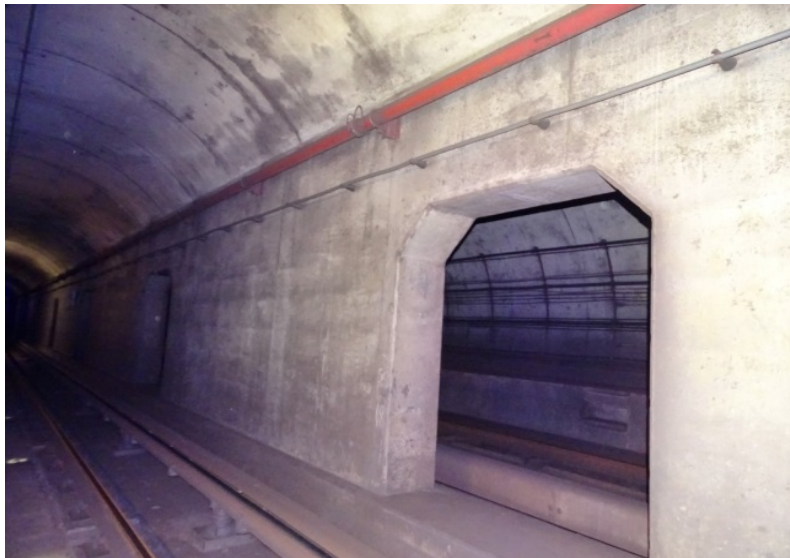
Photograph No. 351
Station 78+40, west wall.

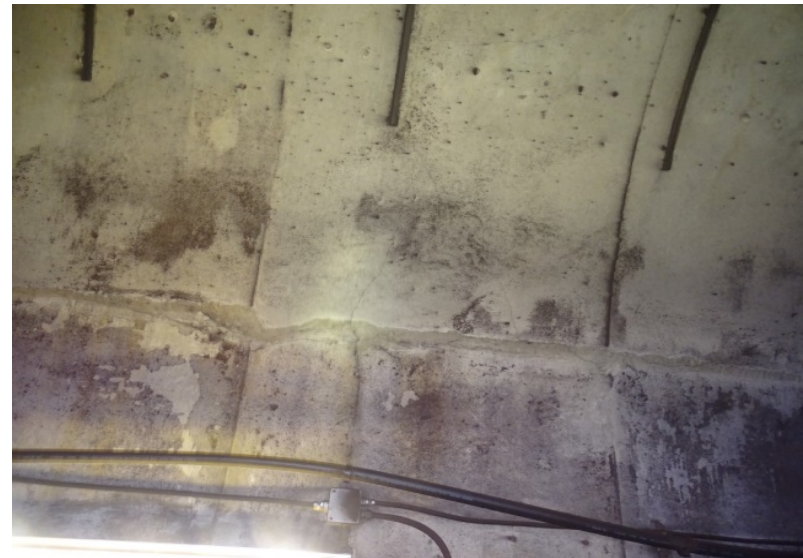
Photograph No. 352
Station 78+43 - vertical crack in east wall.

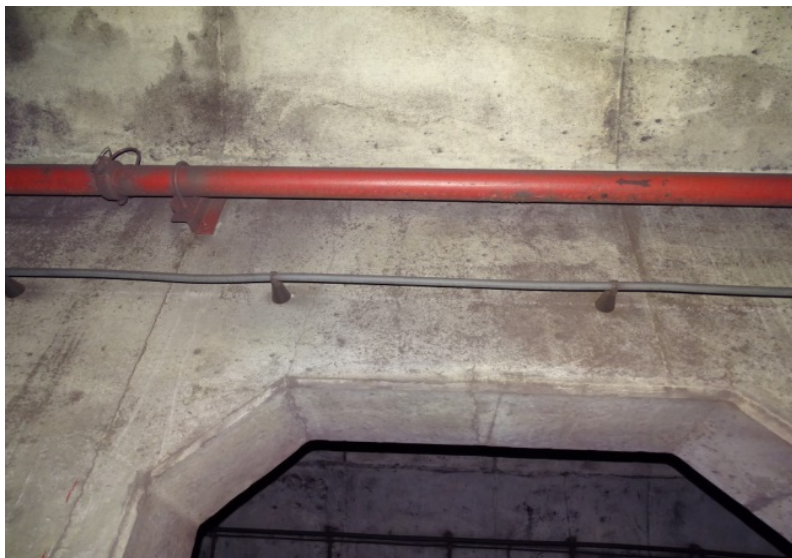
Photograph No. 353
Station 78+43 - vertical cracks above west arch.

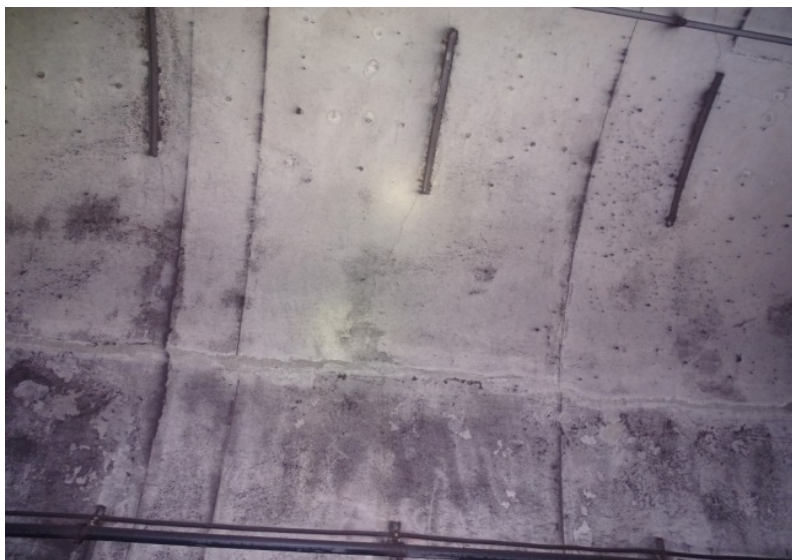
Photograph No. 355
Station 78+57 - crack in east wall.

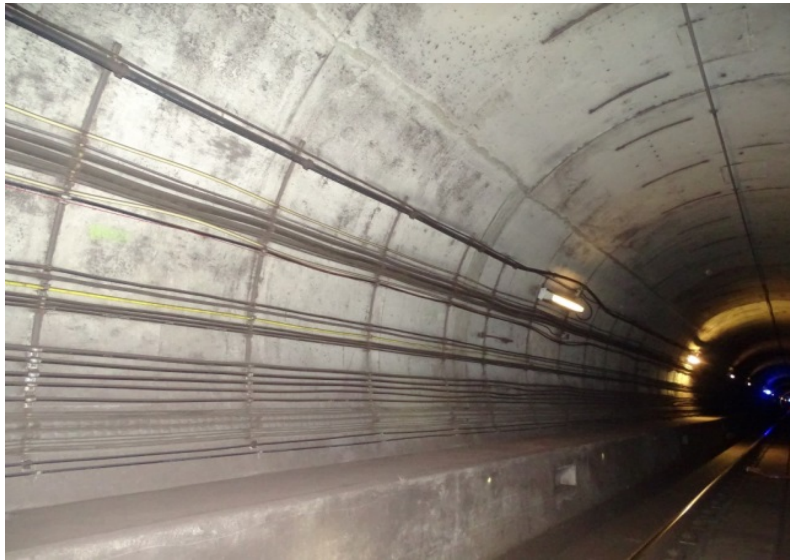
Photograph No. 357
Station 78+60, east wall.

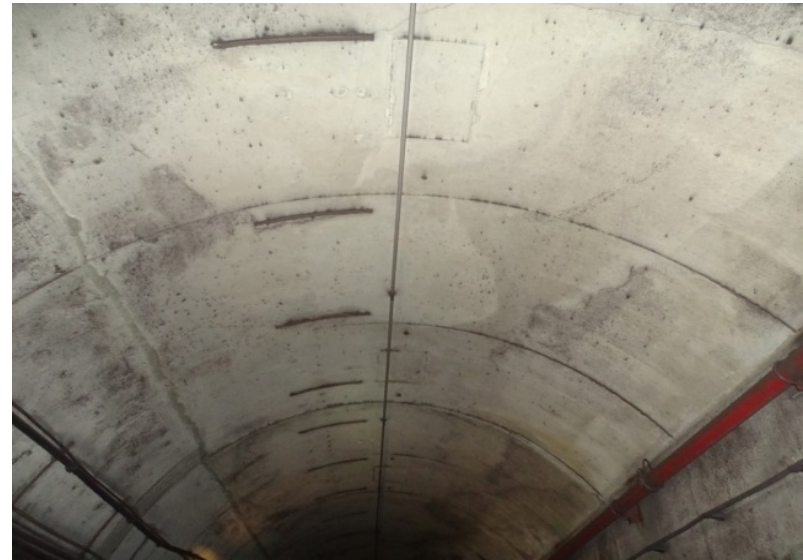
Photograph No. 358
Station 78+60, ceiling.

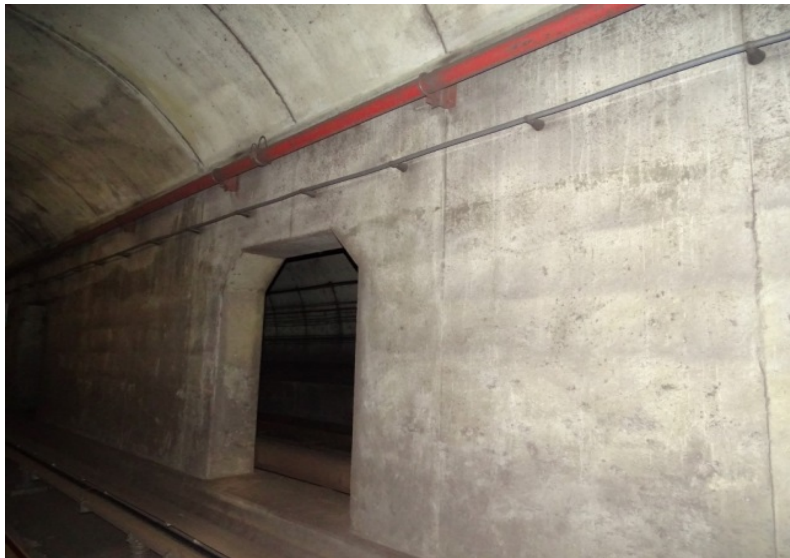
Photograph No. 359
Station 78+60, west wall.

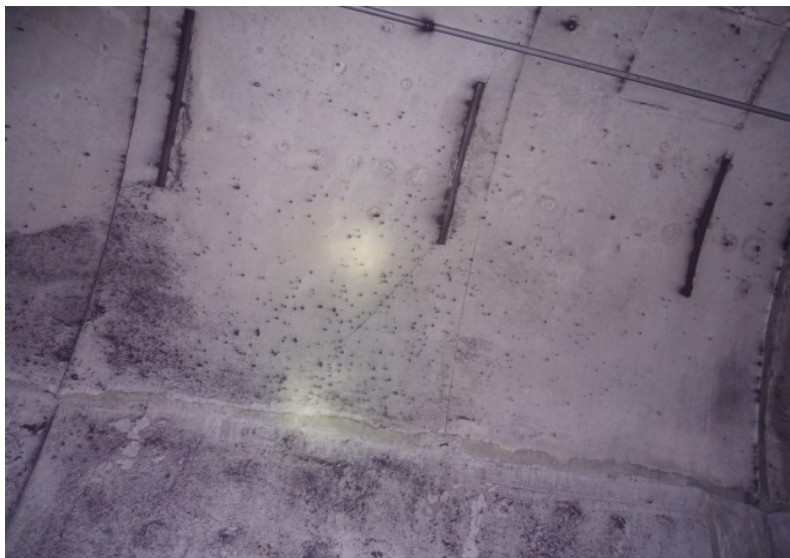
Photograph No. 361
Station 78+67 - crack in east wall.

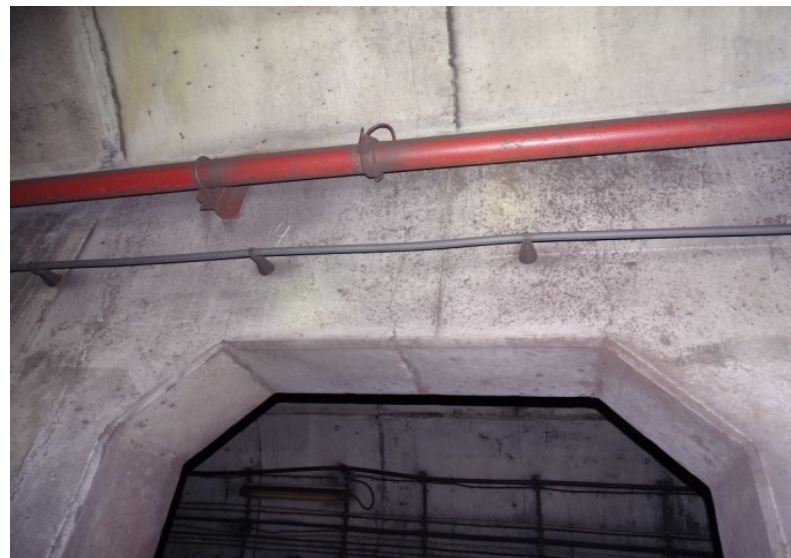
Photograph No. 362
Station 78+70 - vertical cracks above west arch.

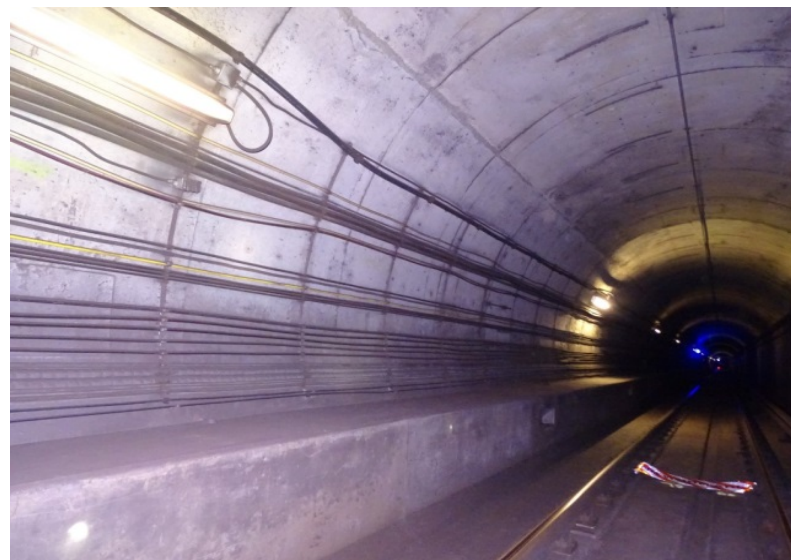
Photograph No. 364
Station 78+80, east wall.

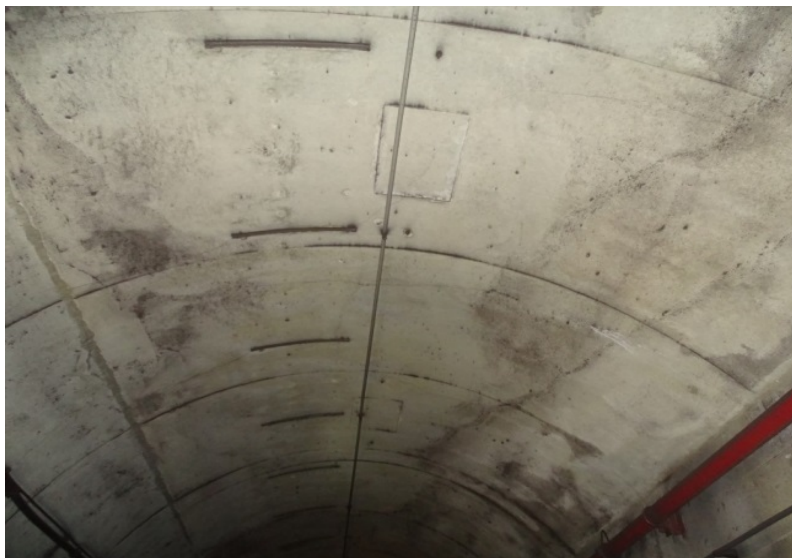
Photograph No. 365
Station 78+80, ceiling.

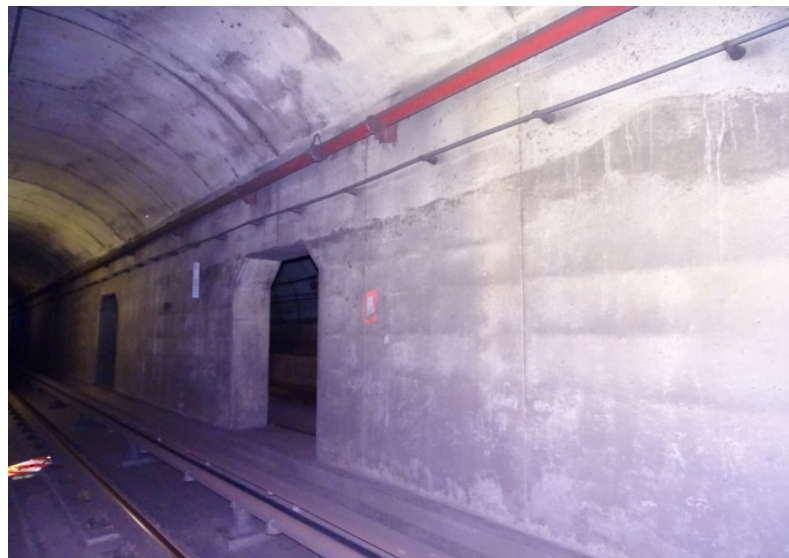
Photograph No. 366
Station 78+80, west wall.

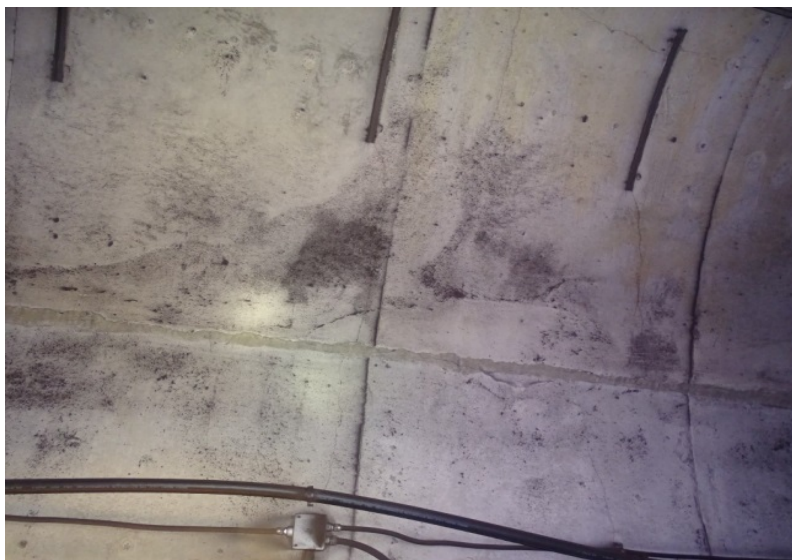
Photograph No. 367
Station 78+82 - vertical crack on east wall.

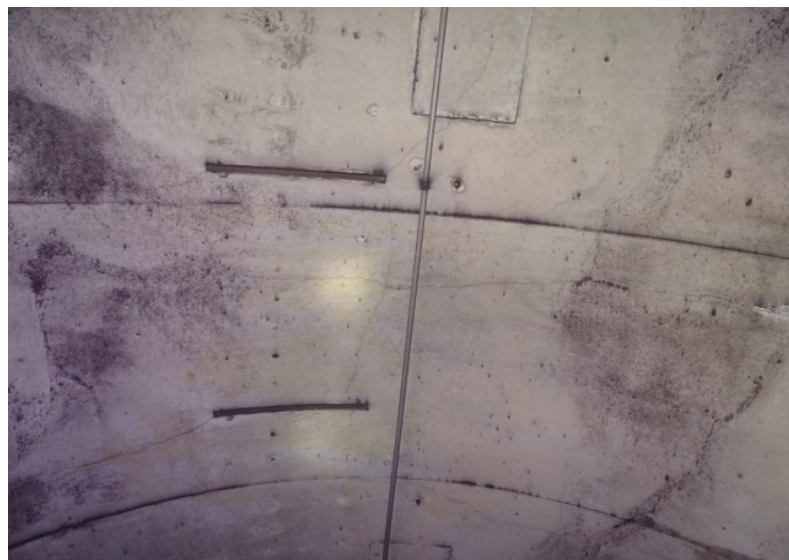
Photograph No. 368
Station 78+85 - crack in ceiling.

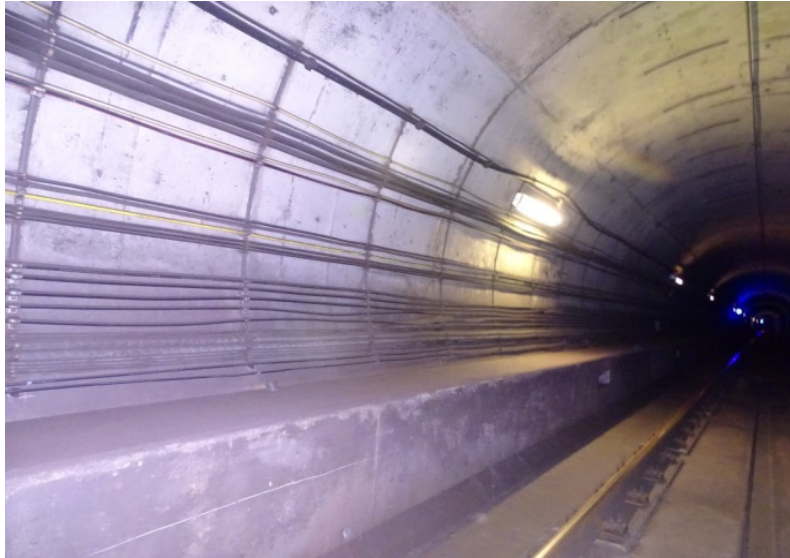
Photograph No. 373
Station 79+00, east wall.

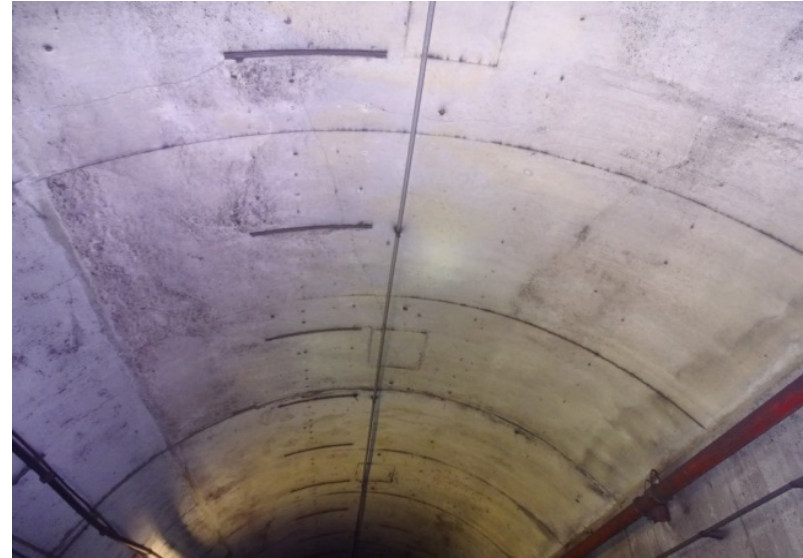
Photograph No. 374
Station 79+00, ceiling.

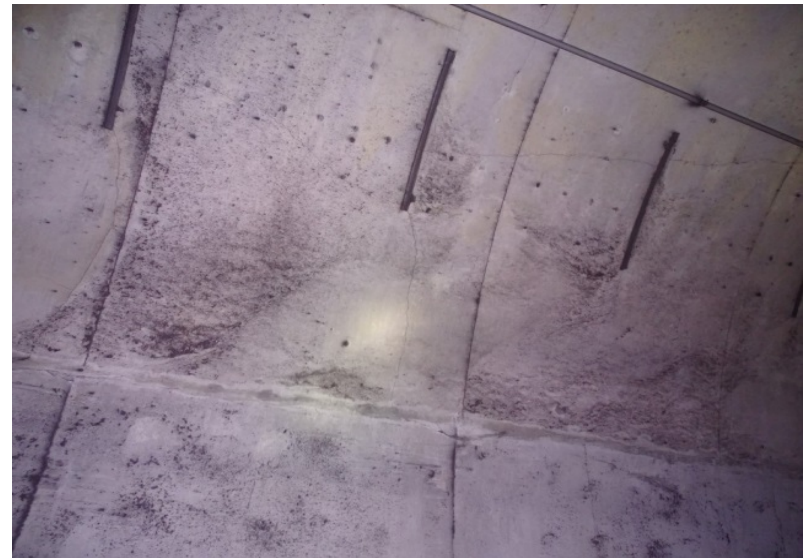
Photograph No. 375
Station 79+00, west wall.

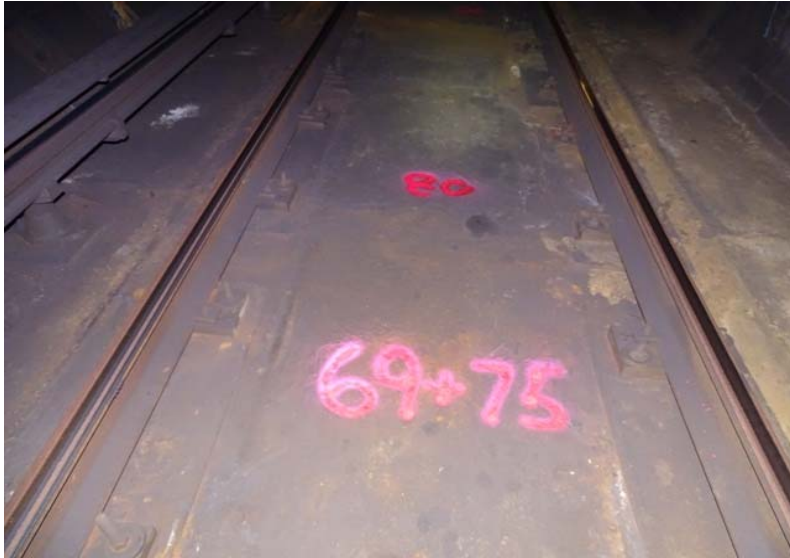
Photograph No. 1
Station 69+70, track bed.

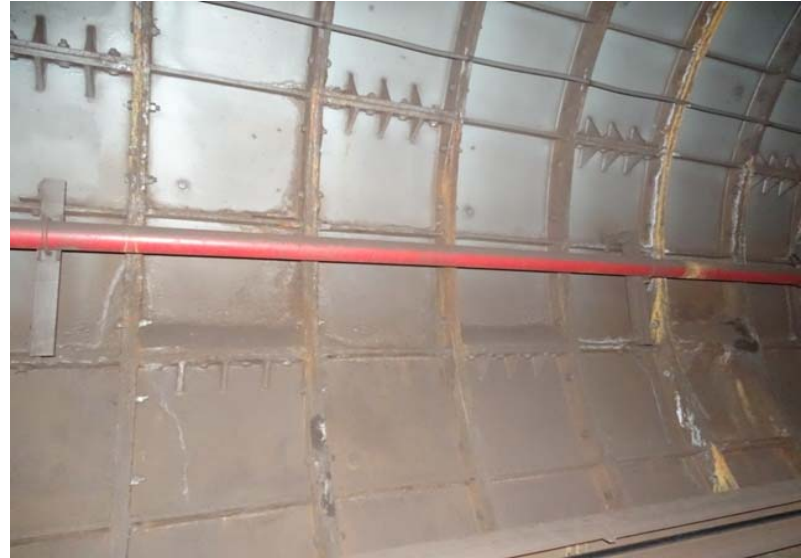
Photograph No. 2
Station 69+70, east wall.

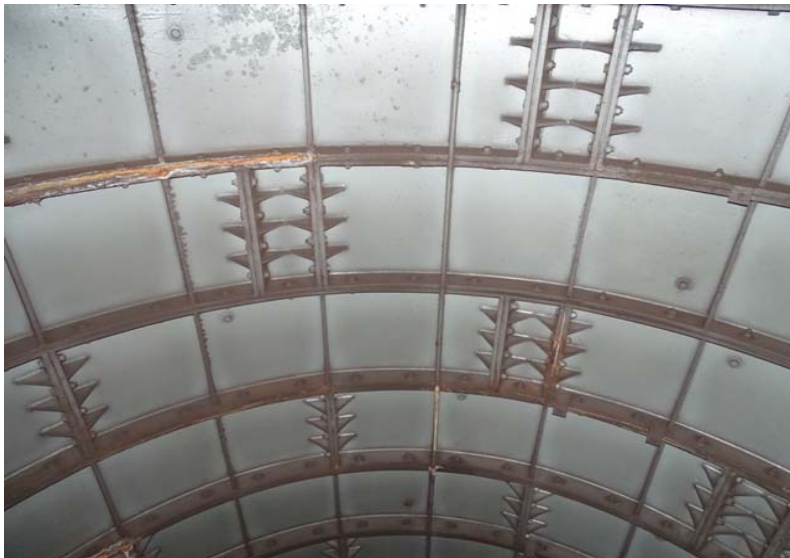
Photograph No. 3
Station 69+70, ceiling.

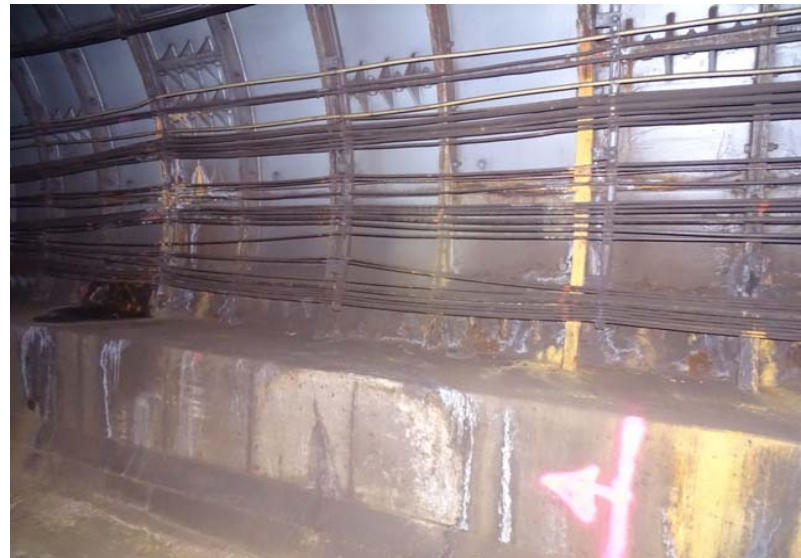
Photograph No. 4
Station 69+70, west wall.

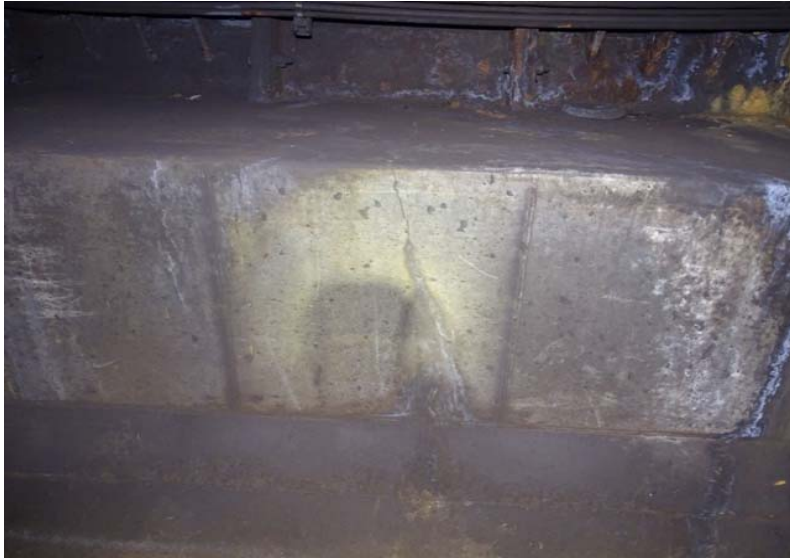
Photograph No. 5
Station 69+70 - crack in the concrete catwalk.

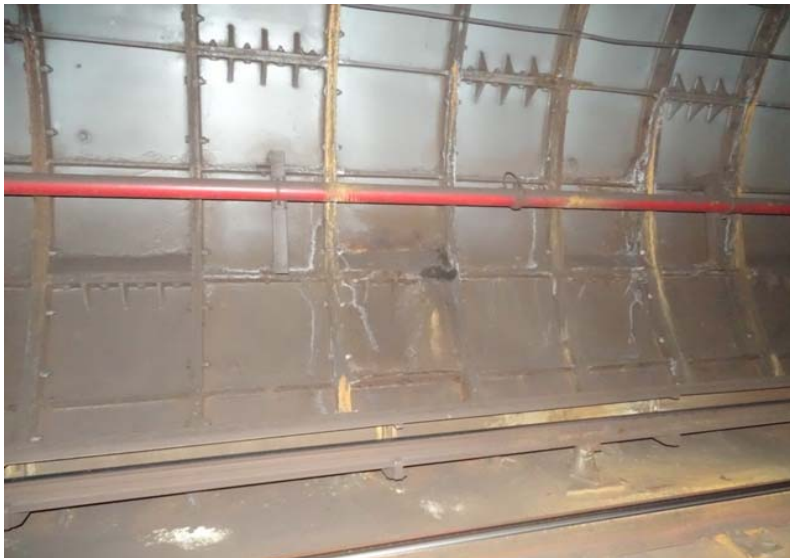
Photograph No. 7
Station 69+80, east wall.

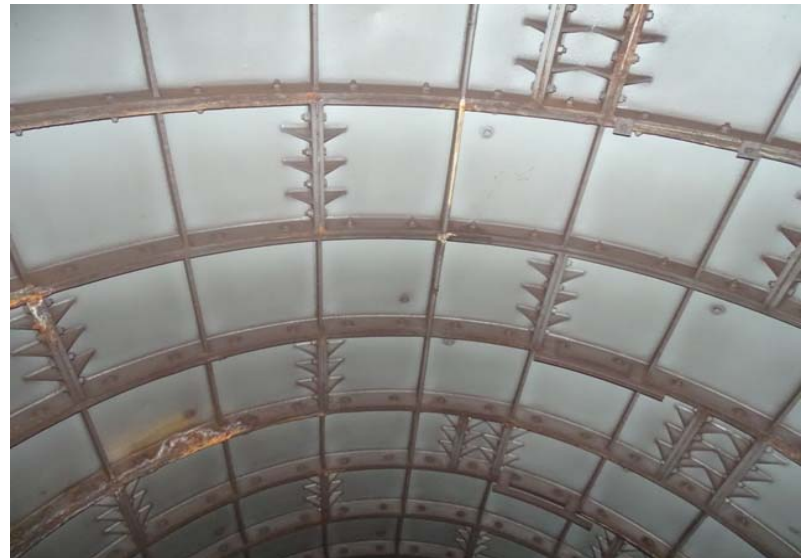
Photograph No. 8
Station 69+80, ceiling.

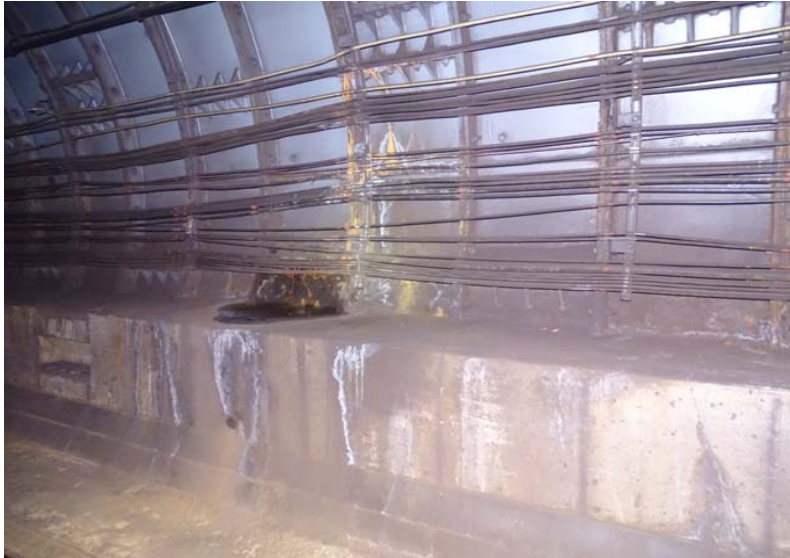
Photograph No. 9
Station 69+80, west wall.

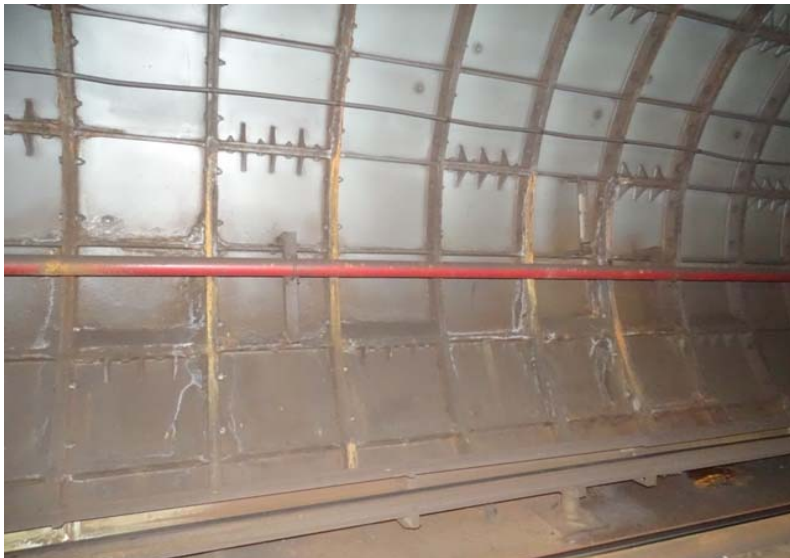
Photograph No. 11
Station 69+90, east wall.

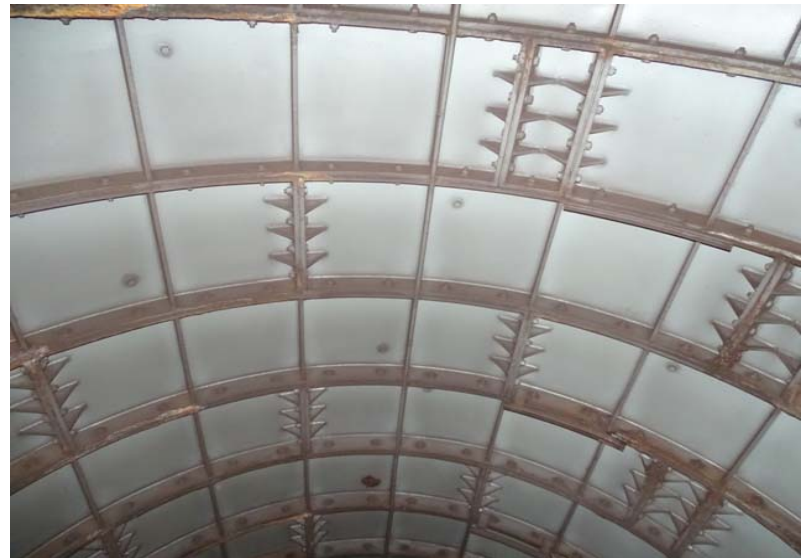
Photograph No. 12
Station 69+90, ceiling.

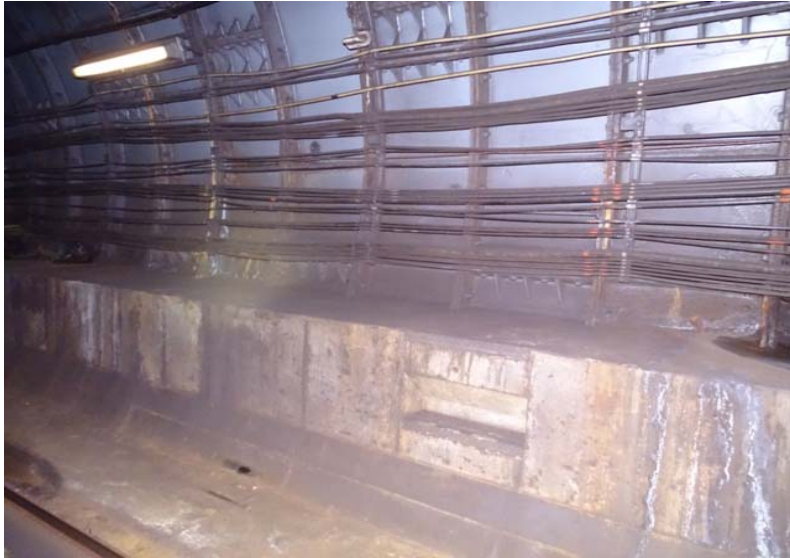
Photograph No. 13
Station 69+90, west wall.

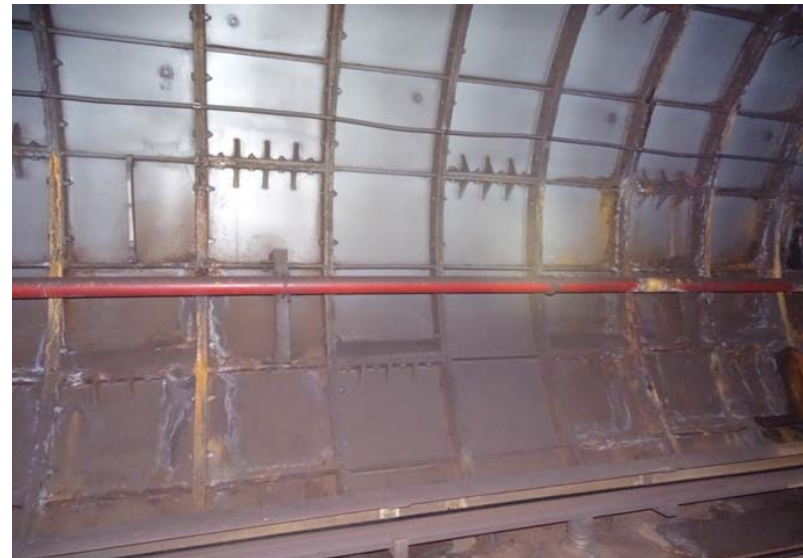
Photograph No. 16
Station 70+00, east wall.

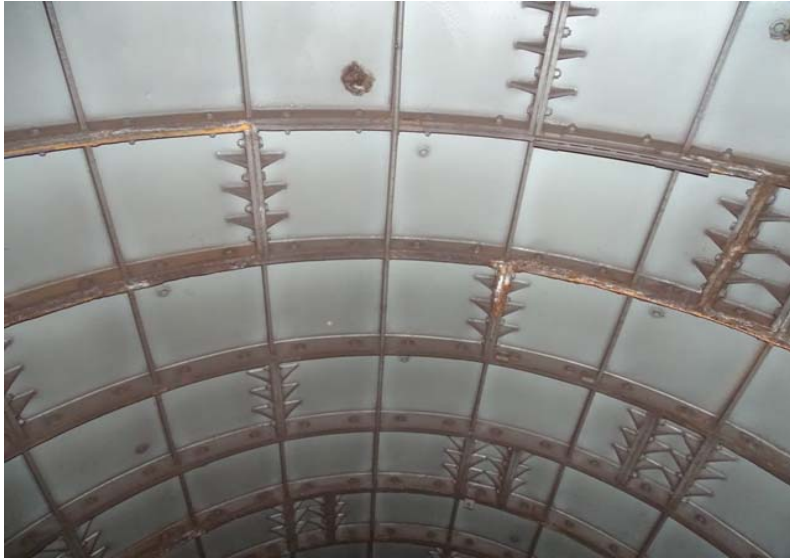
Photograph No. 17
Station 70+00, ceiling.

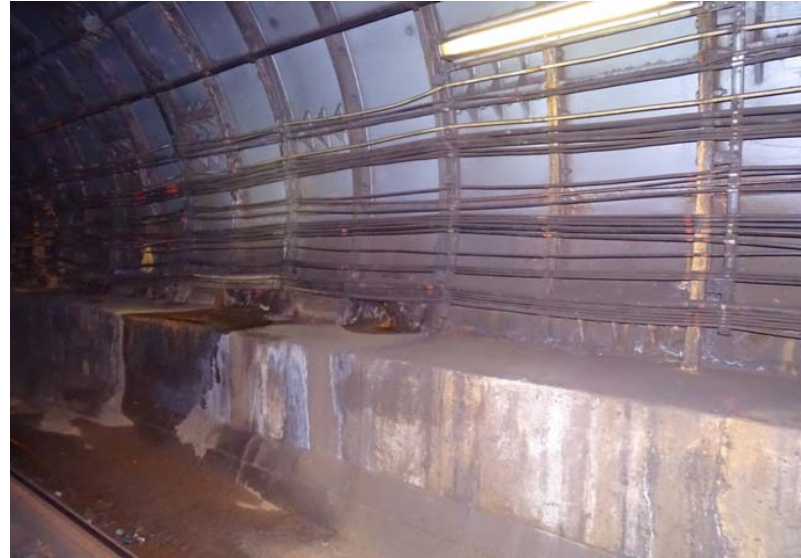
Photograph No. 18
Station 70+00, west wall.

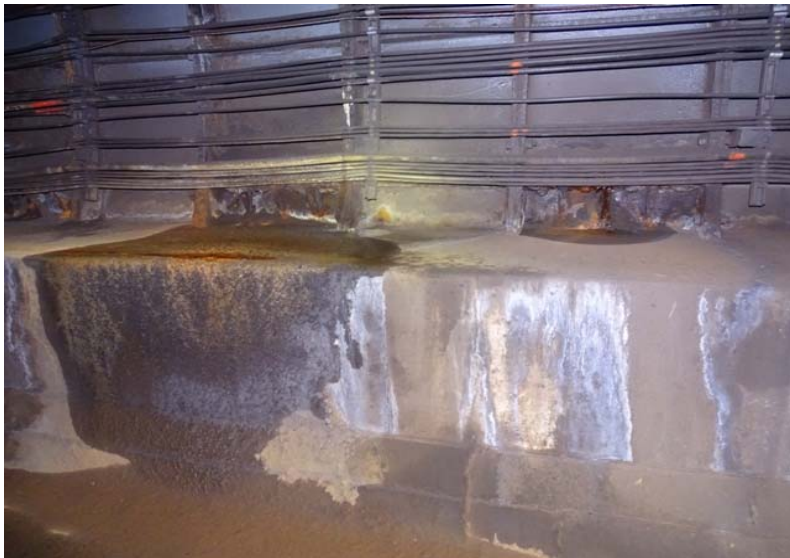
Photograph No. 19
Station 70+00 - active leaks, stains, and efflorescence on the west wall.

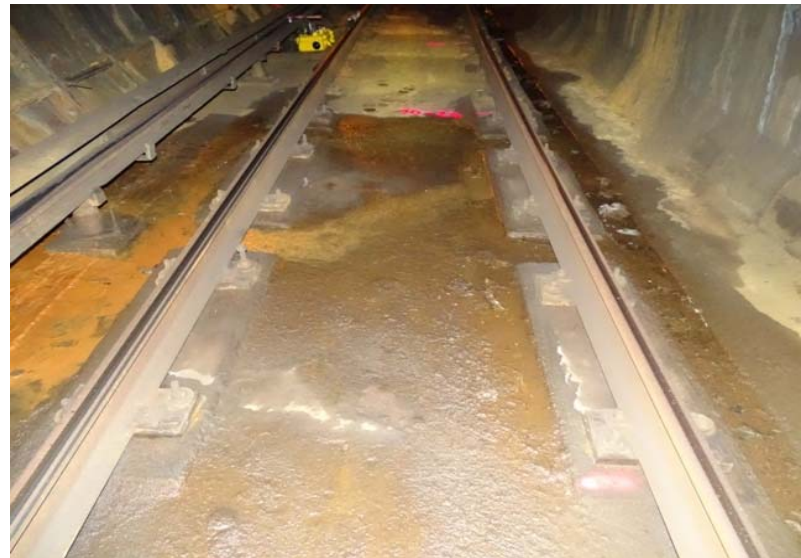
Photograph No. 20
Station 70+10, track bed.

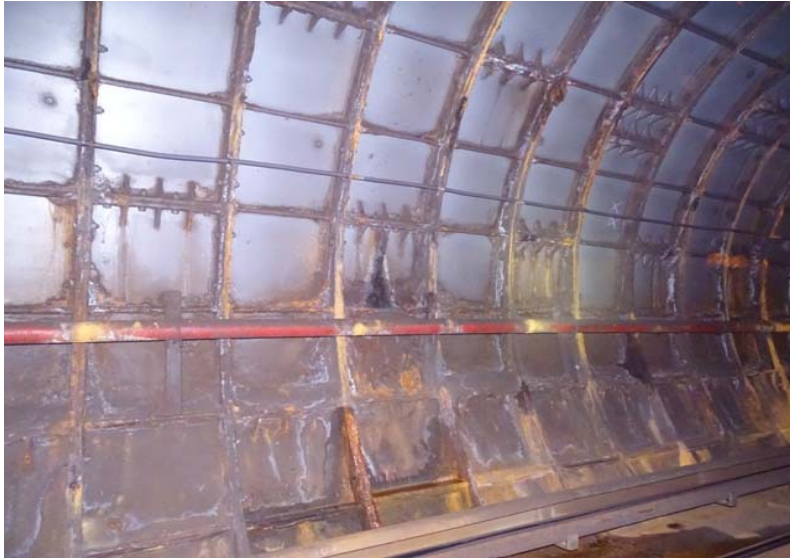
Photograph No. 21
Station 70+10, east wall.

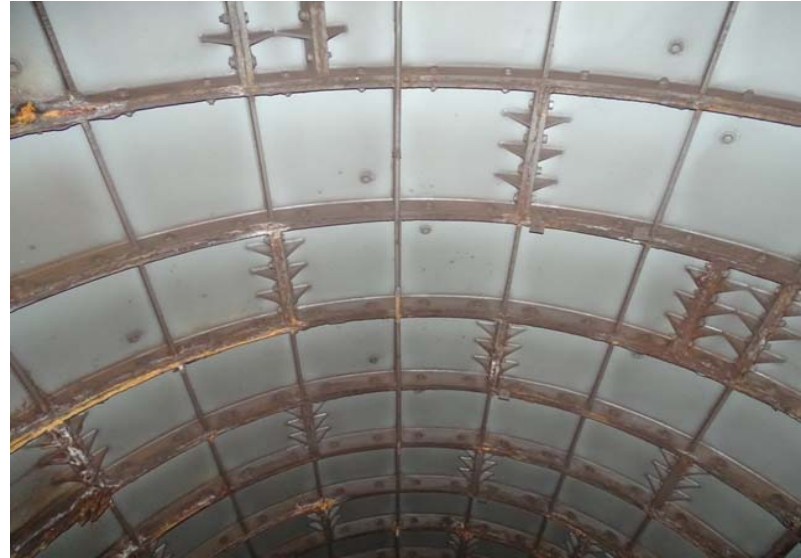
Photograph No. 22
Station 70+10, ceiling.

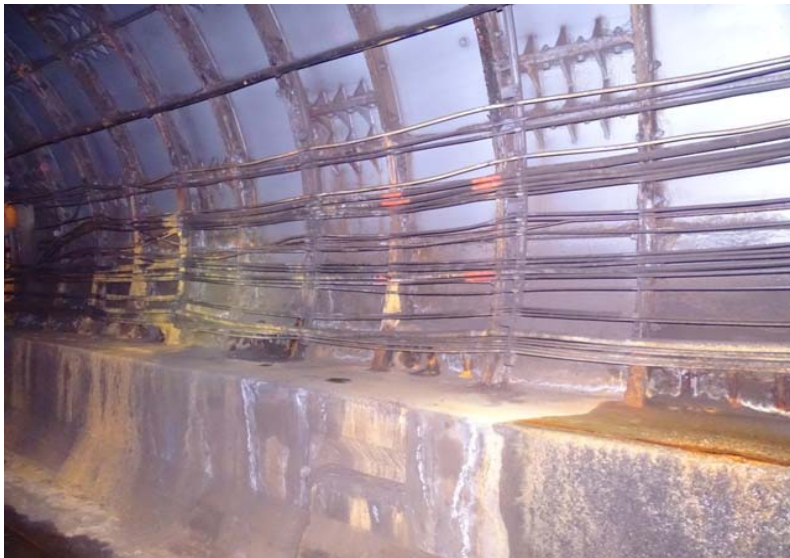
Photograph No. 23
Station 70+10, west wall.

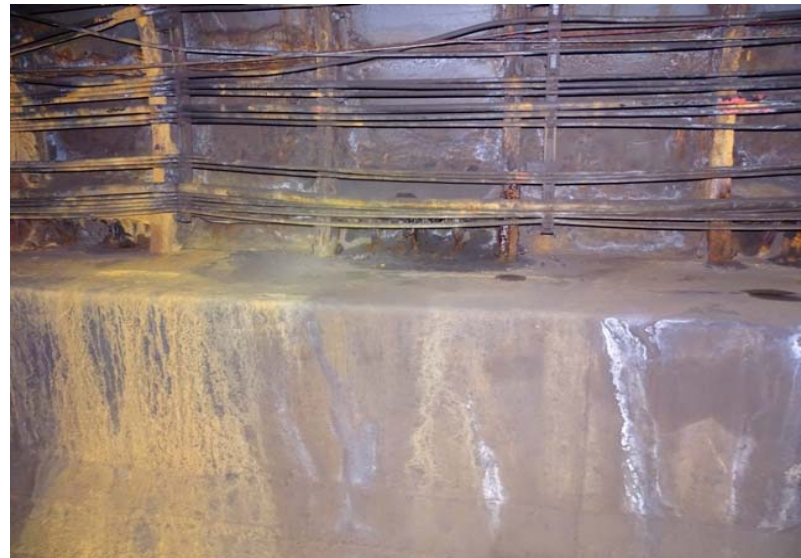
Photograph No. 24
Station 70+10 - stains and efflorescence on the west wall.

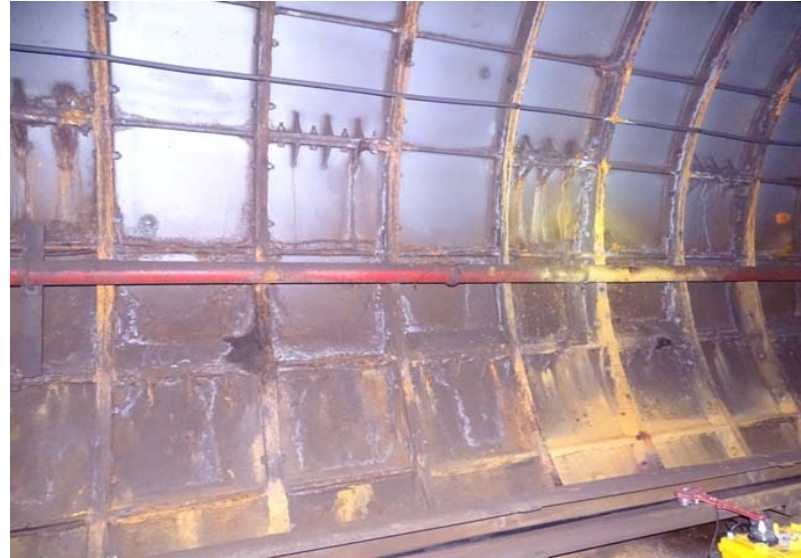
Photograph No. 26
Station 70+20, east wall.
