**Report of Preconstruction Condition
Survey Services**

**ADJACENT PROPERTIES TO
THE WHARF – PHASE I
WASHINGTON, DC**

ECS PROJECT NO. 37:1306

OCTOBER 6, 2014

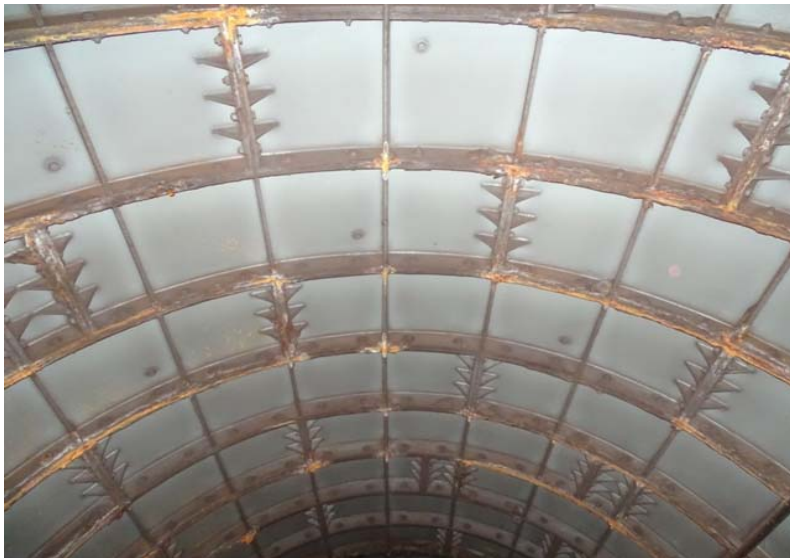
Photograph No. 27
Station 70+20, ceiling.

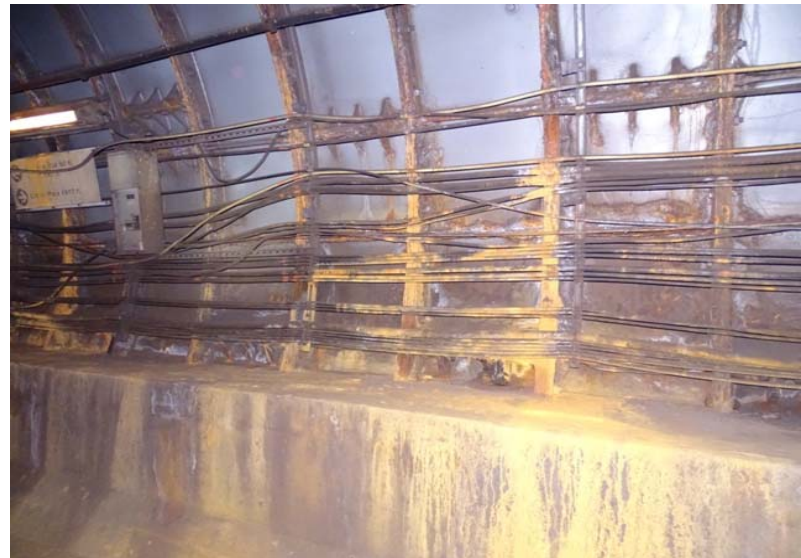
Photograph No. 28
Station 70+20, west wall.

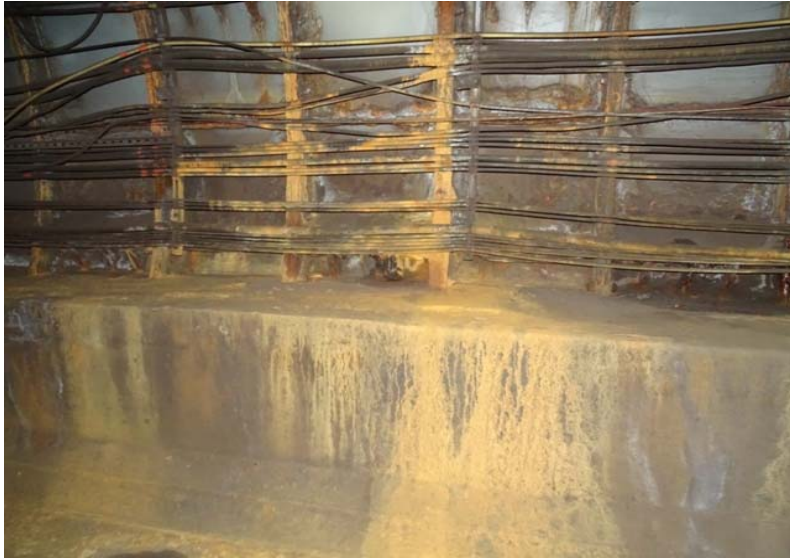
Photograph No. 29
Station 70+20 - stains and efflorescence on the west wall.

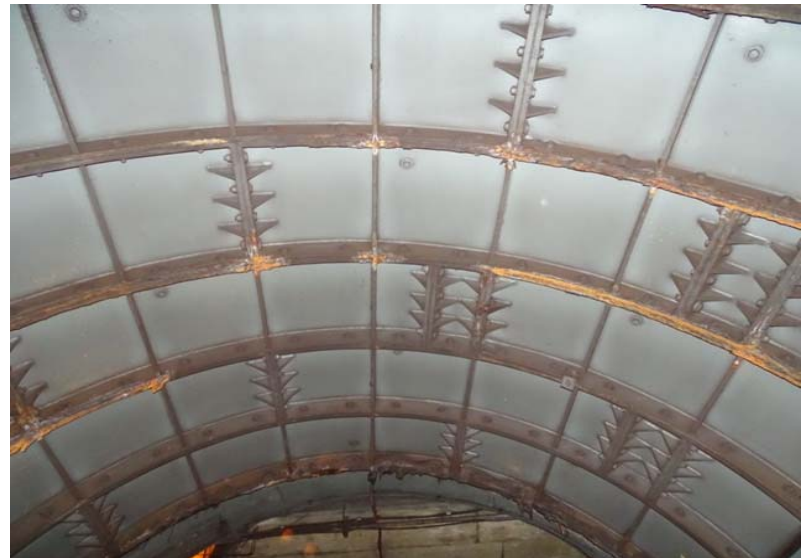
Photograph No. 32
Station 70+30, ceiling.

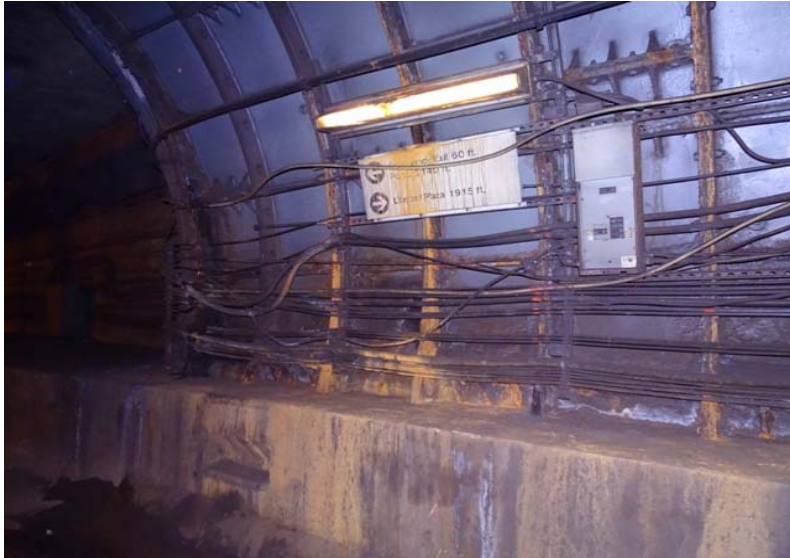
Photograph No. 33
Station 70+30, west wall.

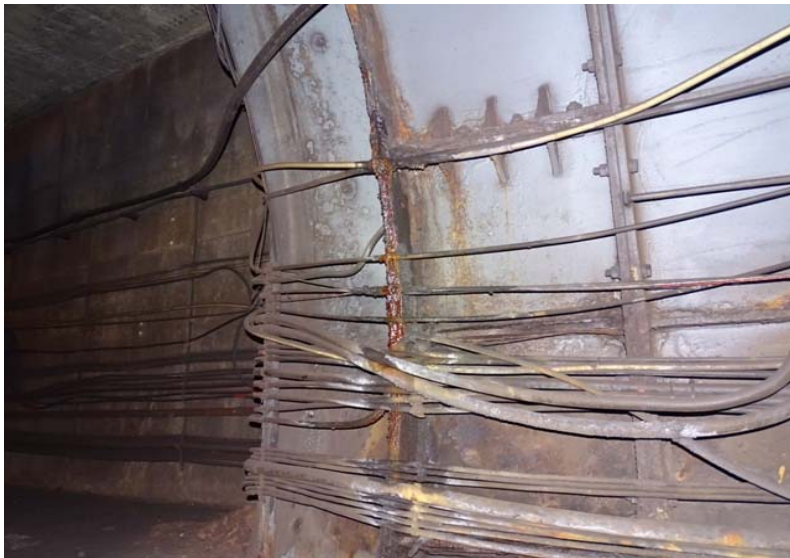
Photograph No. 35
Station 70+30 - active leak, stains, and corrosion on the west wall.

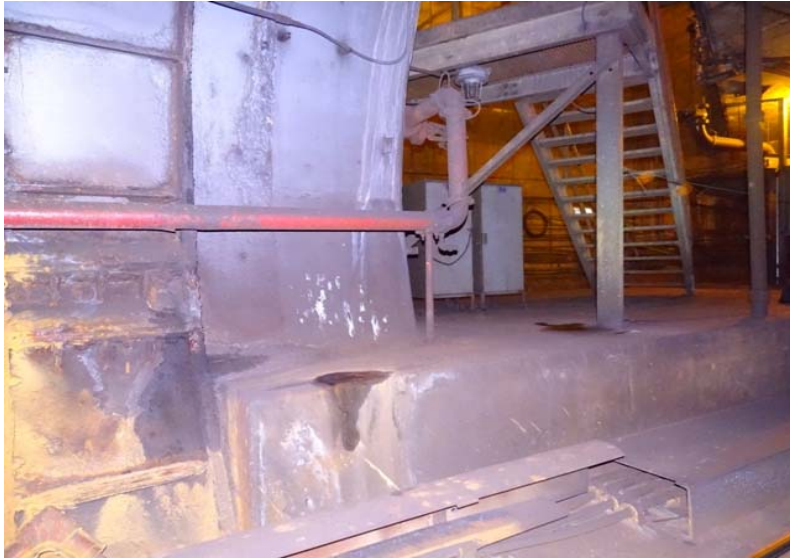
Photograph No. 37
Station 70+40, east wall.

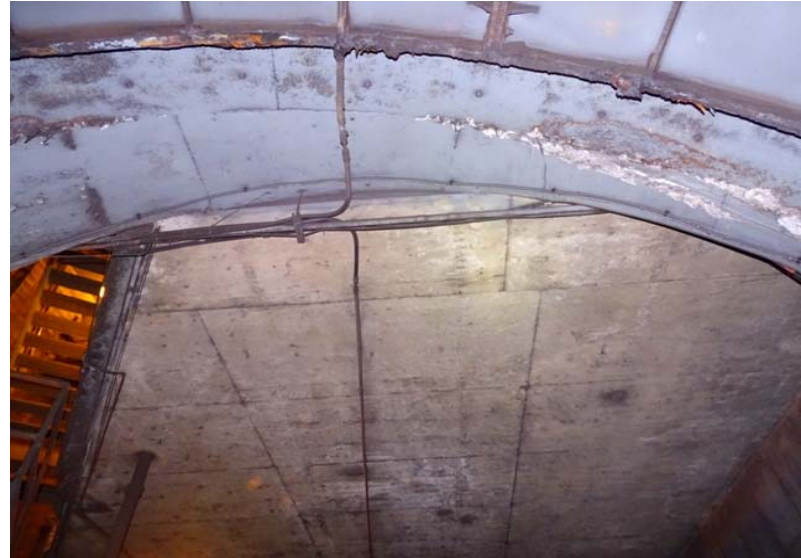
Photograph No. 38
Station 70+40, ceiling.

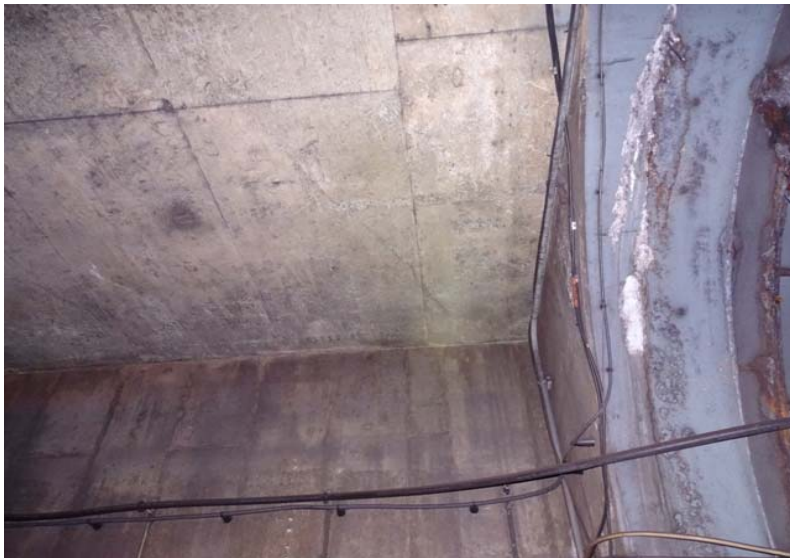
Photograph No. 39
Station 70+40, ceiling, looking west.

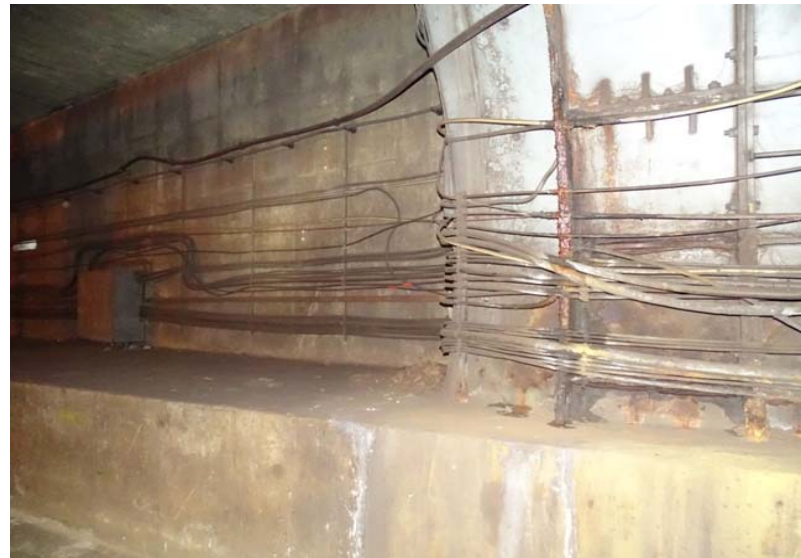
Photograph No. 40
Station 70+40, west wall.

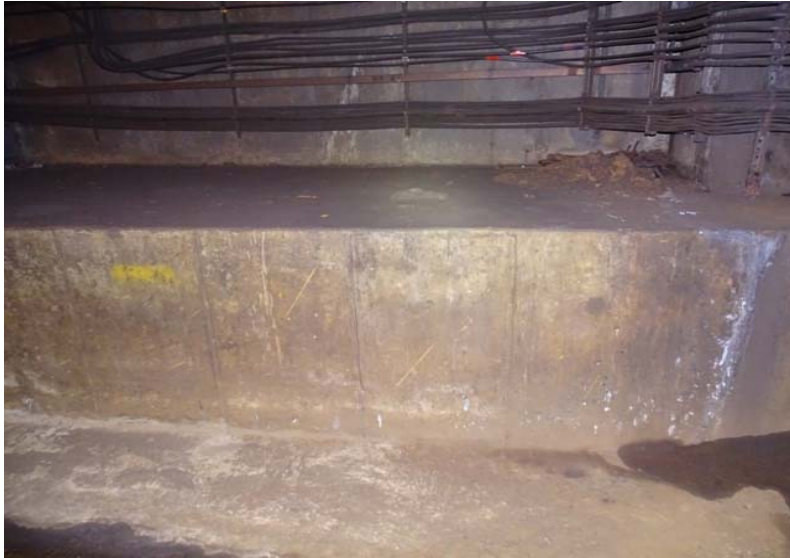
Photograph No. 41
Station 70+40, west catwalk.

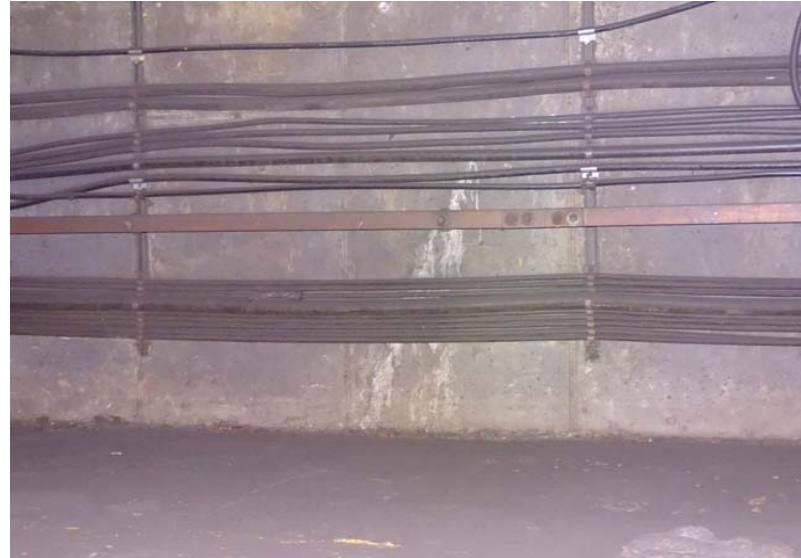
Photograph No. 42
Station 70+40 - crack and efflorescence on the west wall.

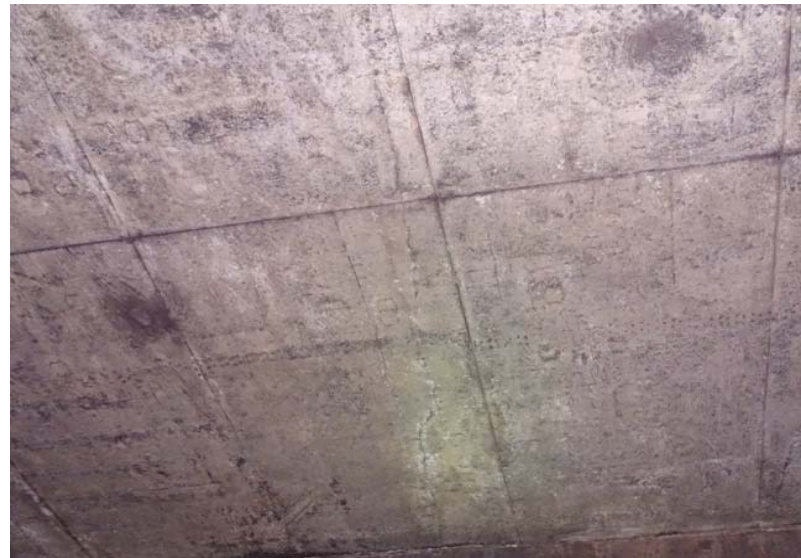
Photograph No. 52
Station 70+60 - crack on the ceiling, looking west.

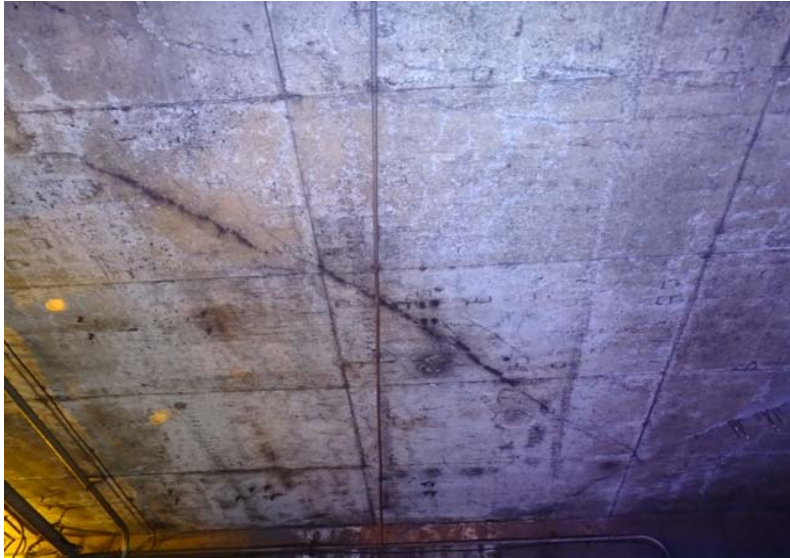
Photograph No. 57
Station 70+70, ceiling. Note the crack.

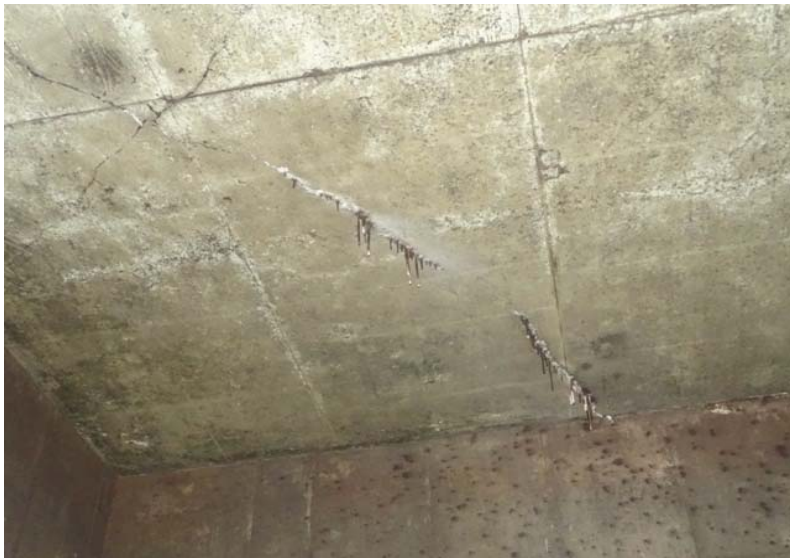
Photograph No. 63
Station 70+80 - crack and efflorescence on the ceiling.

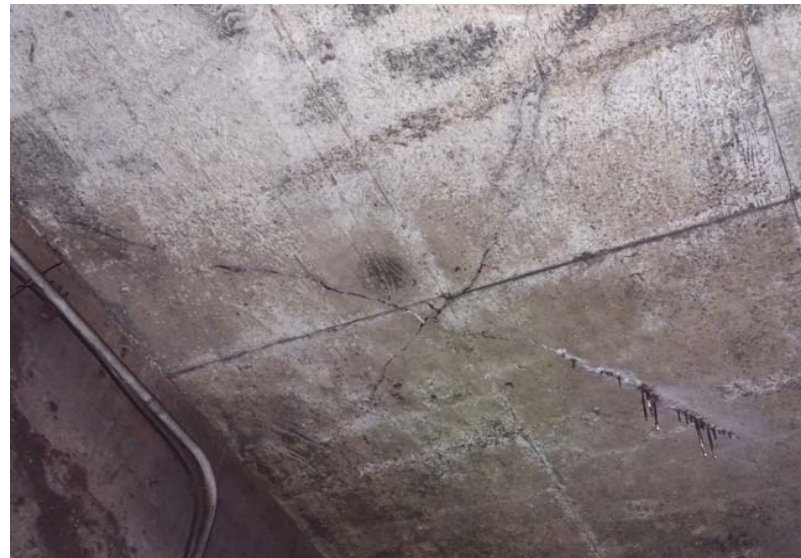
Photograph No. 64
Station 70+80 - cracks on the ceiling.

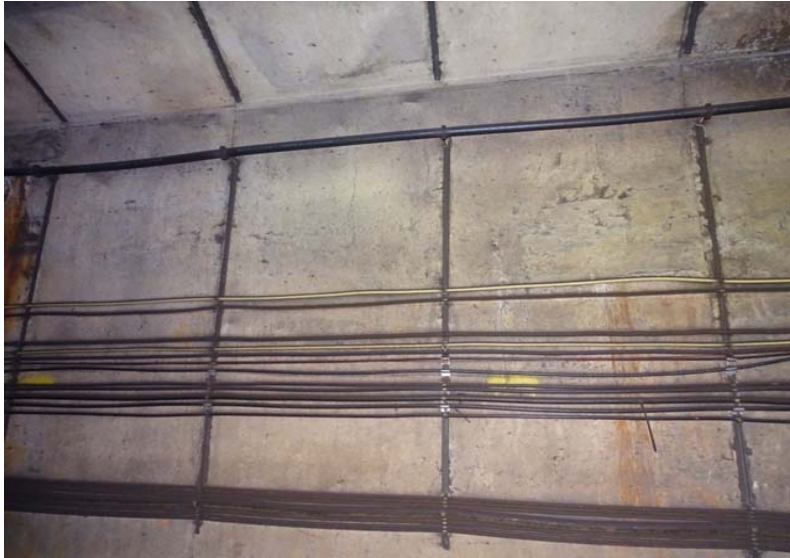
Photograph No. 80
Station 71+10, ceiling.

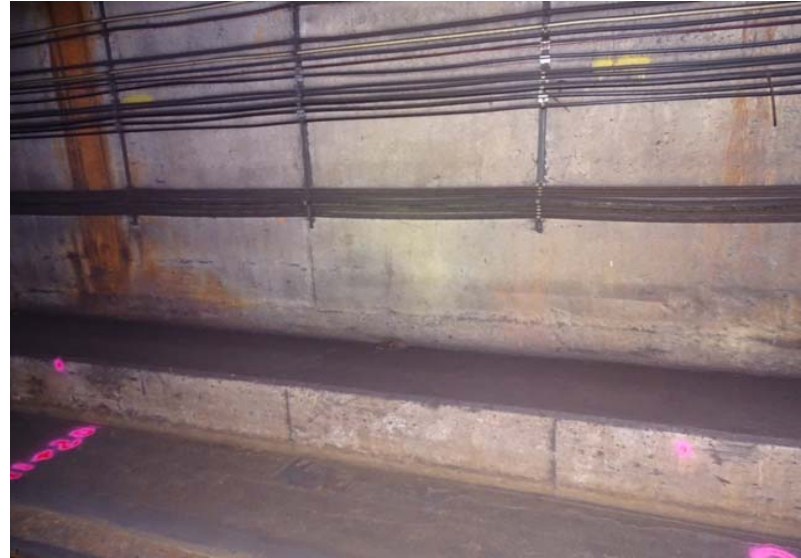
Photograph No. 81
Station 71+10, upper portion of west wall.

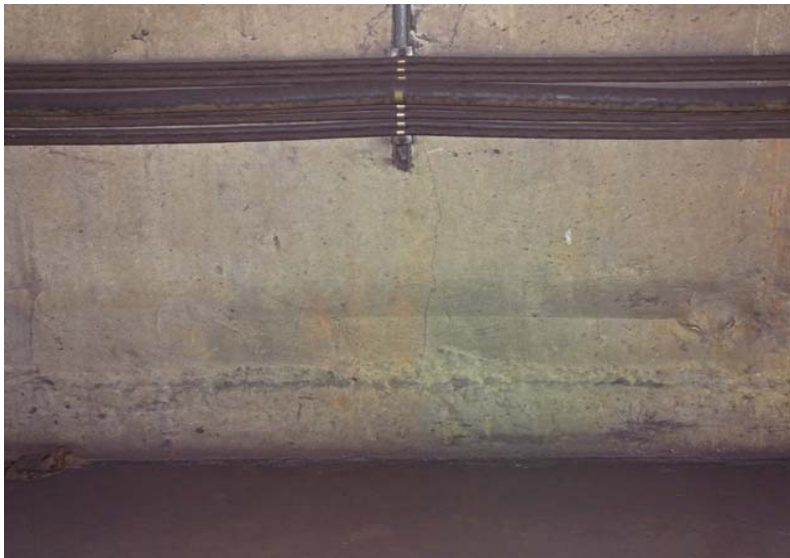
Photograph No. 82
Station 71+10, lower portion of west wall.

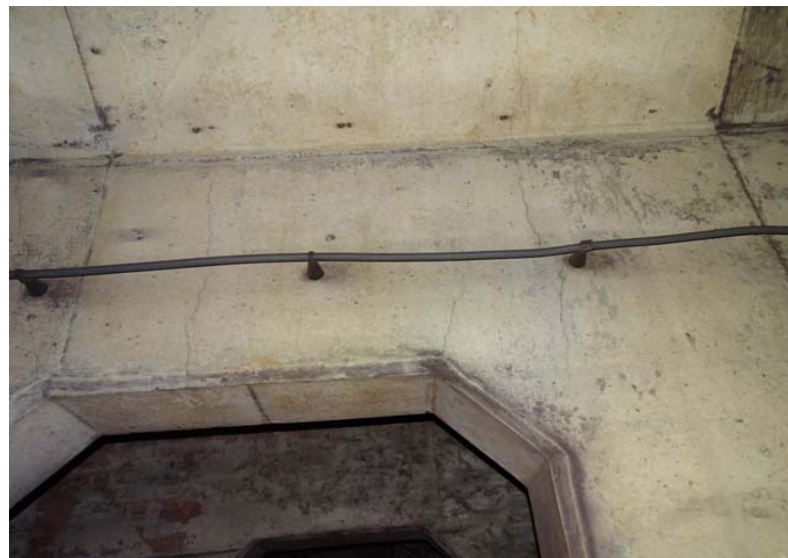
Photograph No. 85
Station 71+20, east wall.

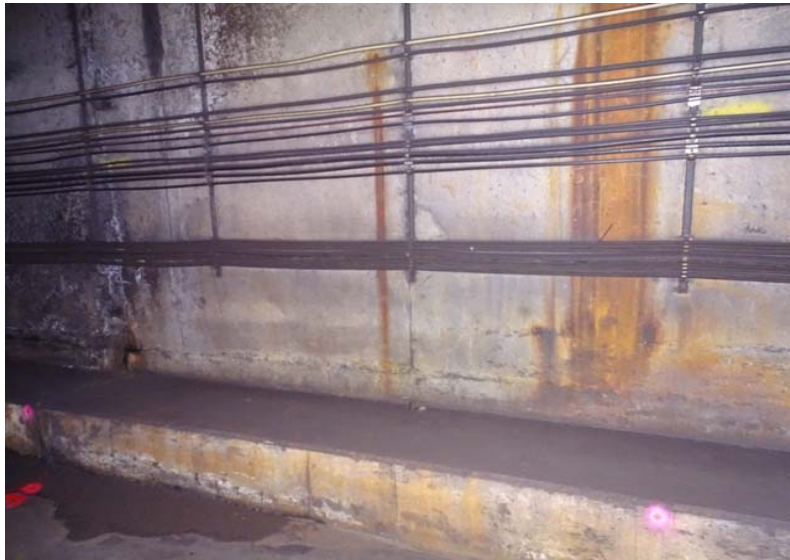
Photograph No. 88
Station 71+20, upper portion of west wall.

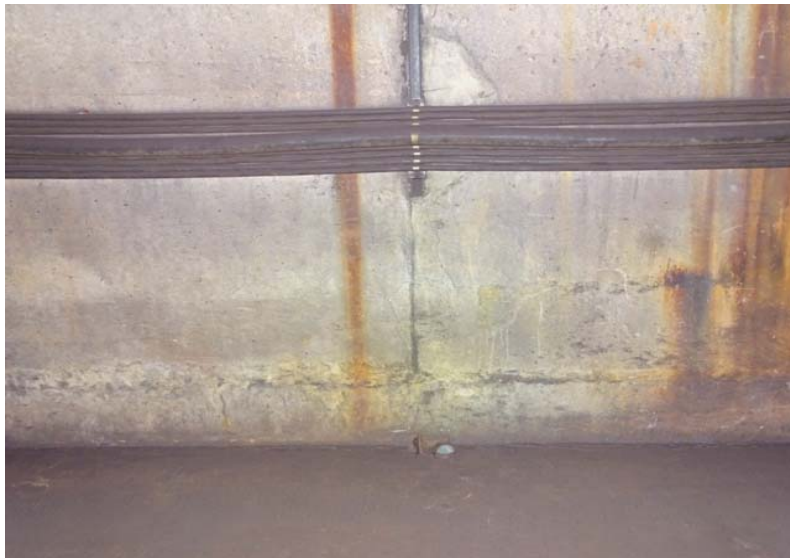
Photograph No. 90
Station 71+20 - stain and previous concrete repair on west wall.

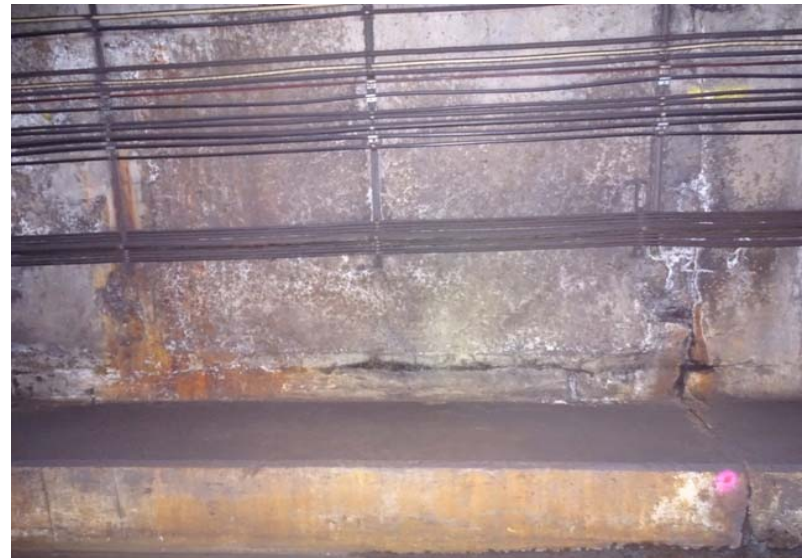
Photograph No. 95
Station 71+30, upper portion of west wall.

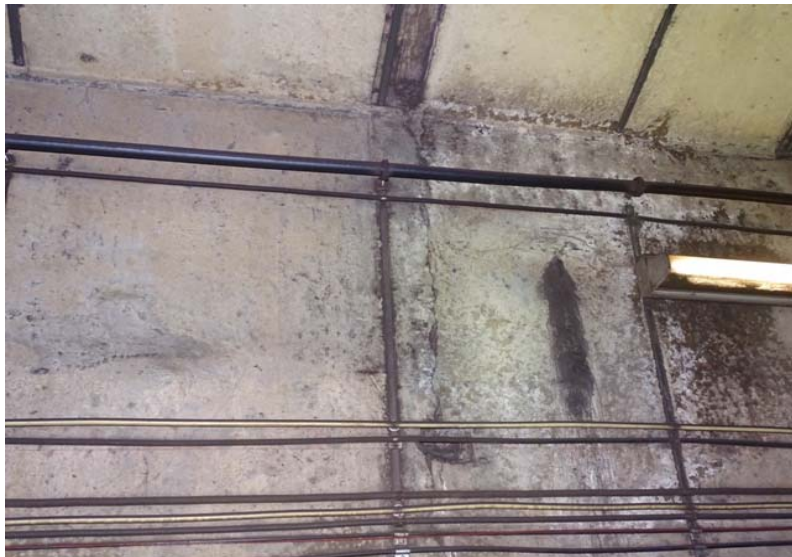
Photograph No. 97
Station 71+30 - crack and stains on the west wall.

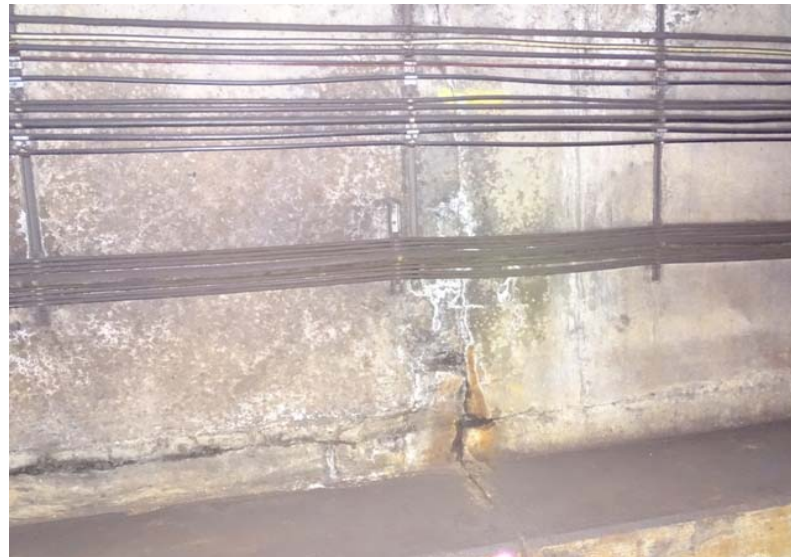
Photograph No. 98
Station 71+30 - crack and stains on the west wall.

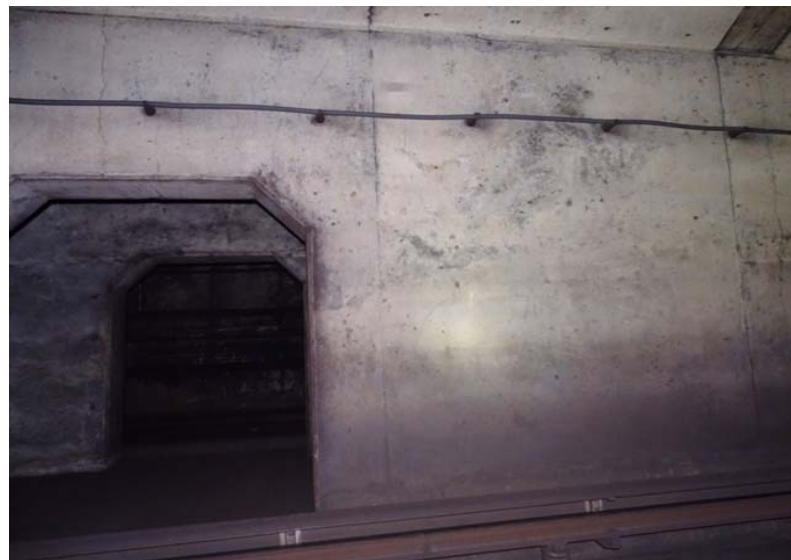
Photograph No. 100
Station 71+40, east wall.

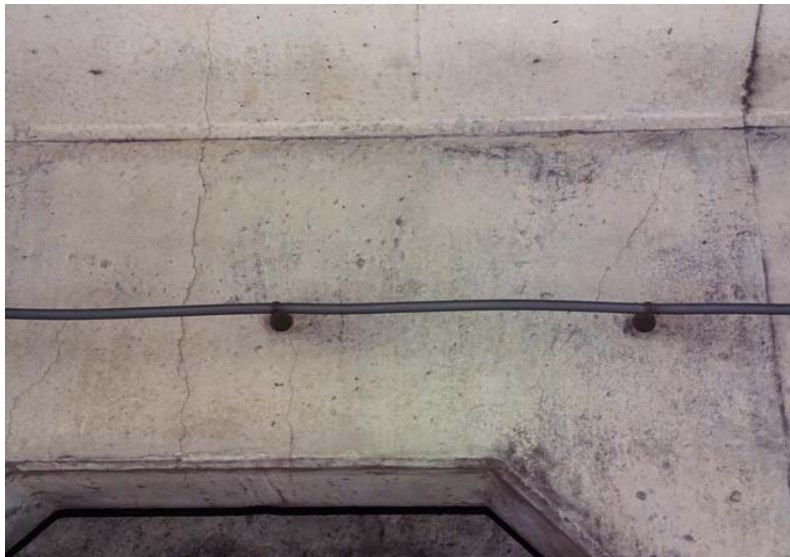
Photograph No. 101
Station 71+40 - cracks above east arch.

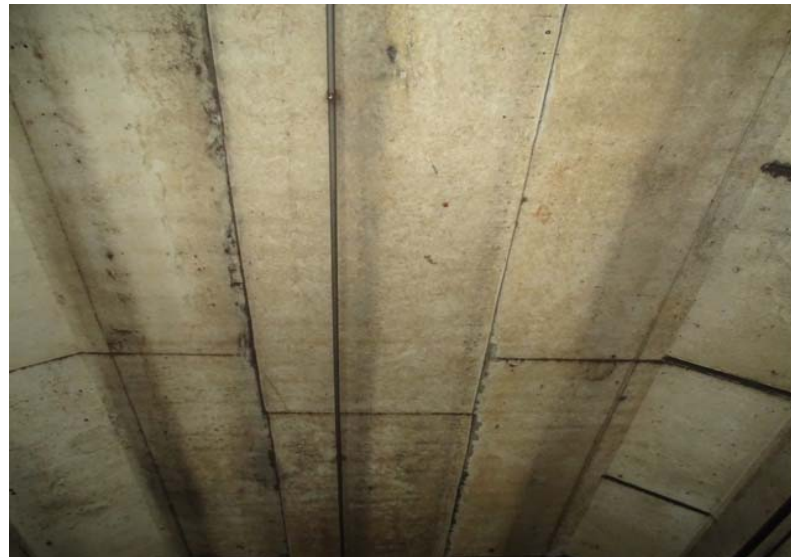
Photograph No. 102
Station 71+40, ceiling.

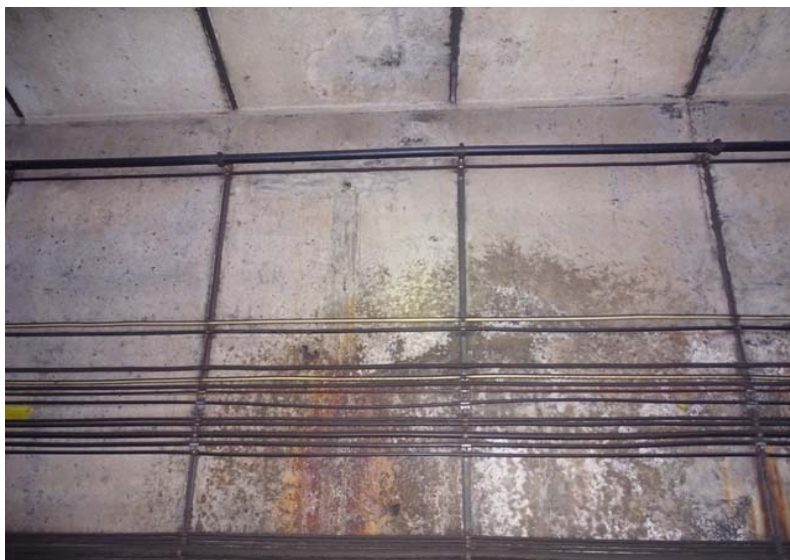
Photograph No. 103
Station 71+40, upper portion of west wall. Note the stains.

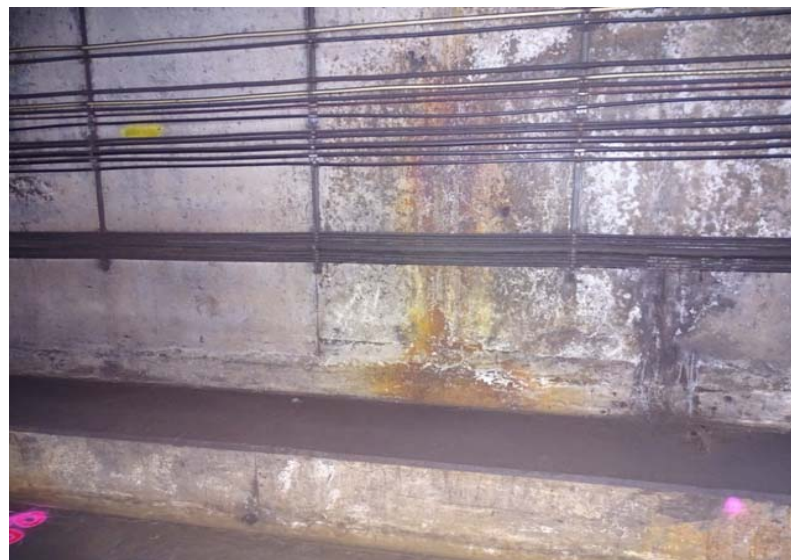
Photograph No. 104
Station 71+40, lower portion of west wall. Note the stains.

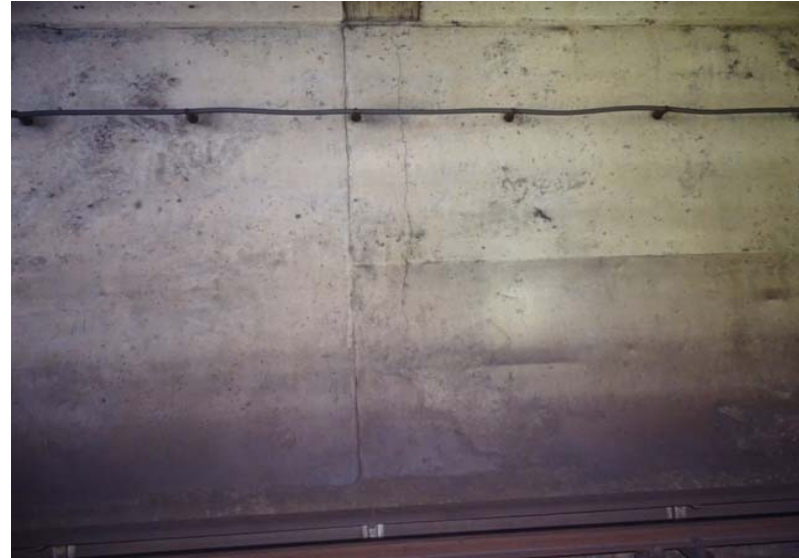
Photograph No. 106
Station 71+50, east wall.

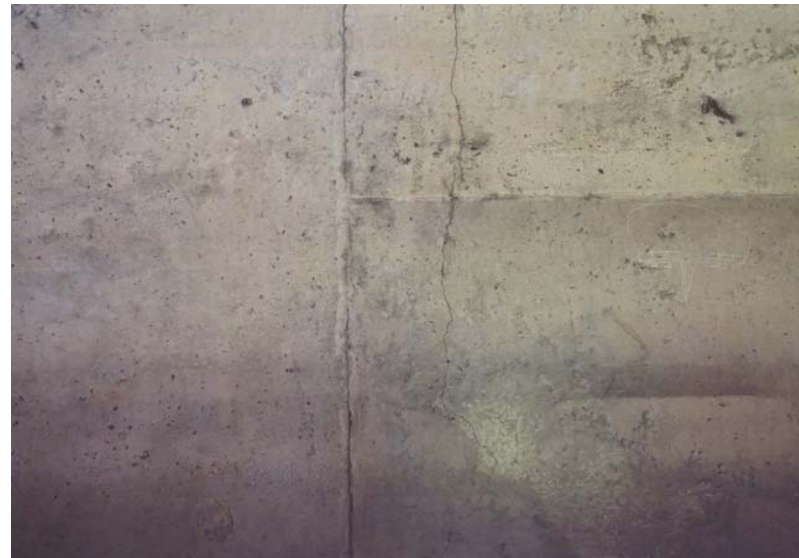
Photograph No. 108
Station 71+50 - crack on the east wall.

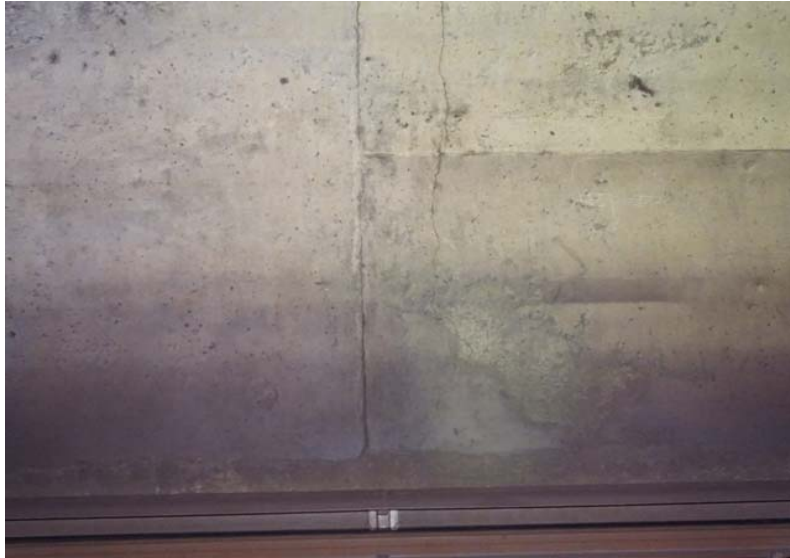
Photograph No. 109
Station 71+50 - crack on the east wall.

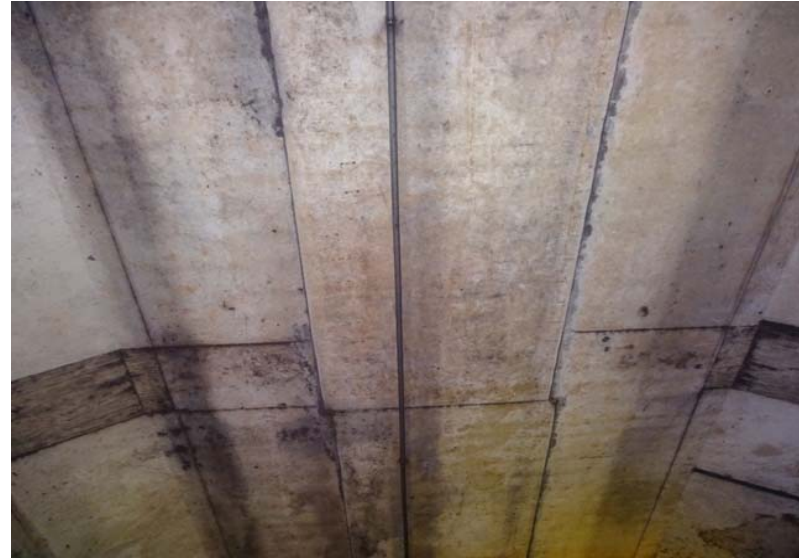
Photograph No. 110
Station 71+50, ceiling.

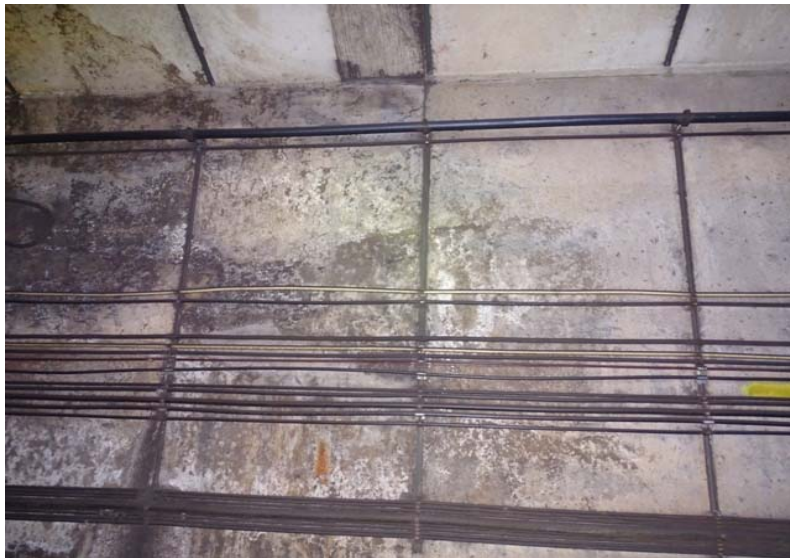
Photograph No. 111
Station 71+50, upper portion of west wall. Note the stains.

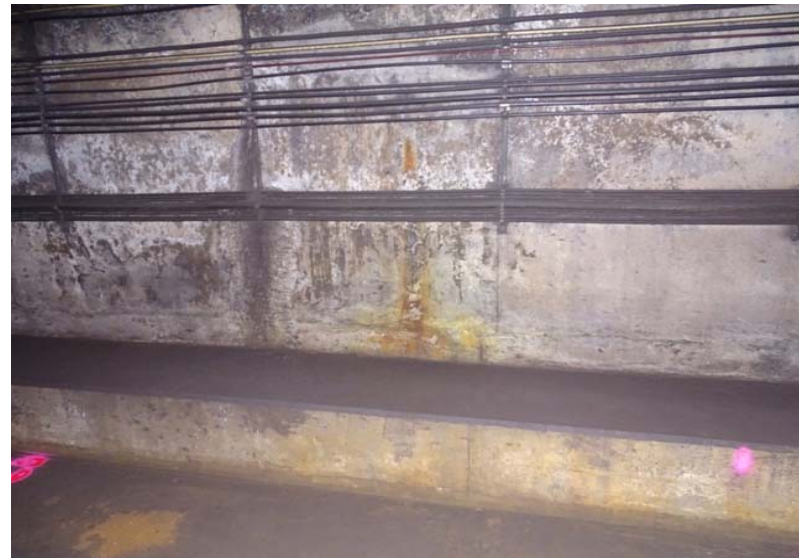
Photograph No. 112
Station 71+50, lower portion of west wall. Note the stains.

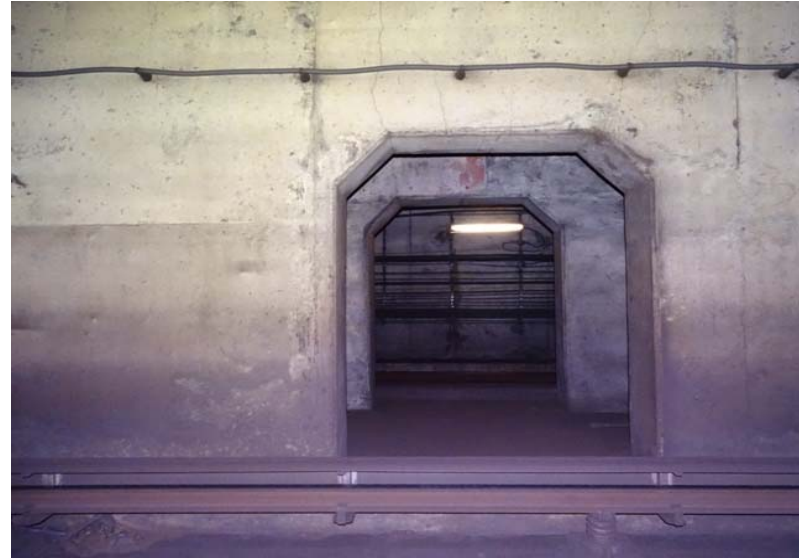
Photograph No. 114
Station 71+60, east wall.

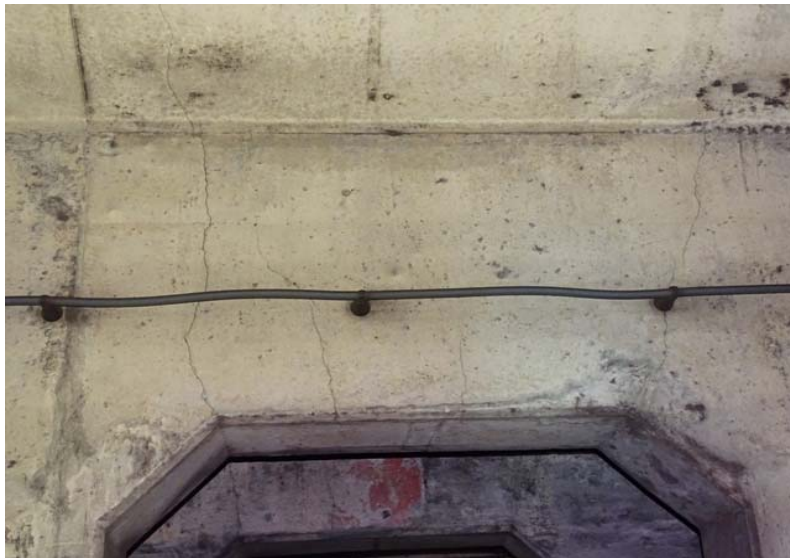
Photograph No. 115
Station 71+60 - cracks above east arch.

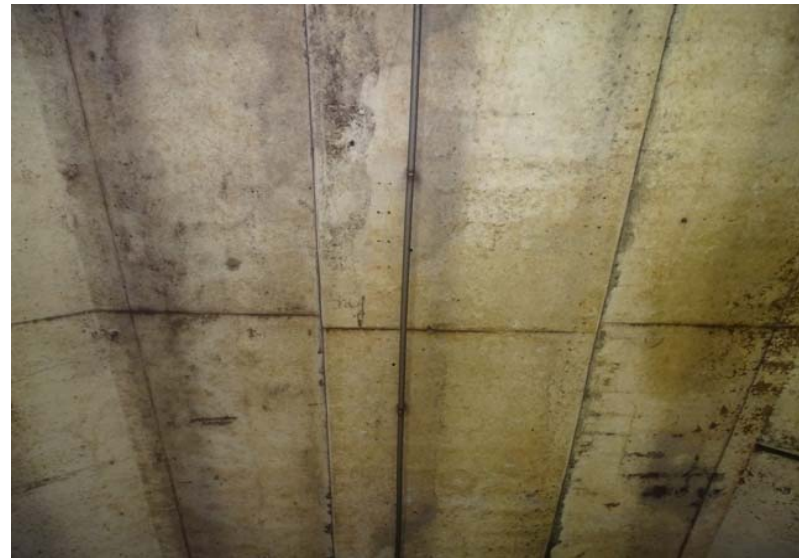
Photograph No. 116
Station 71+60, ceiling.

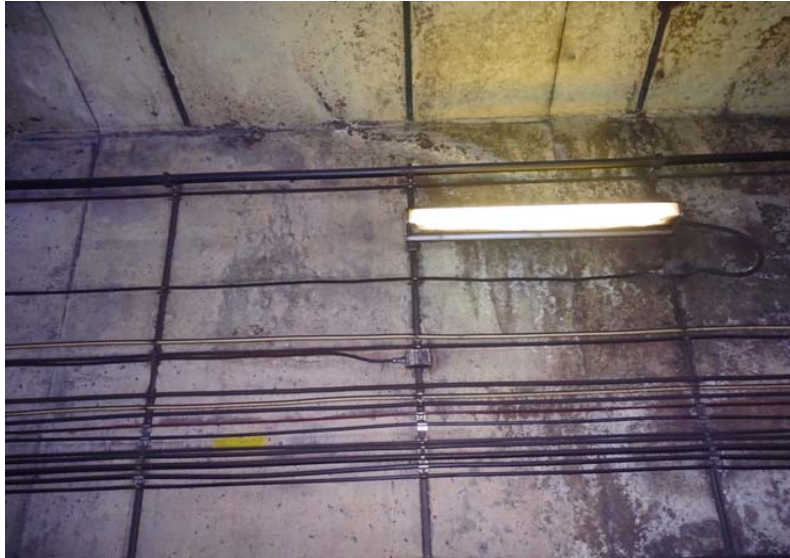
Photograph No. 117
Station 71+60, upper portion of west wall. Note the stains.

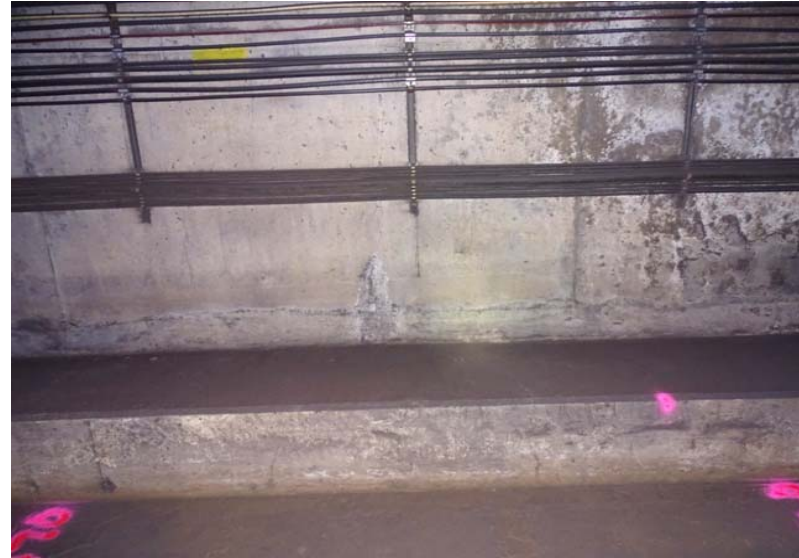
Photograph No. 118
Station 71+60, lower portion of west wall. Note the cracks and stains.

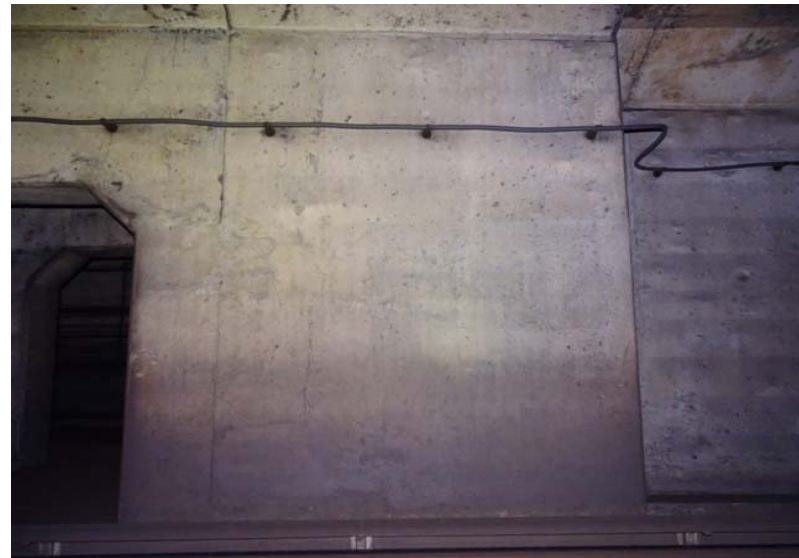
Photograph No. 120
Station 71+70, east wall.

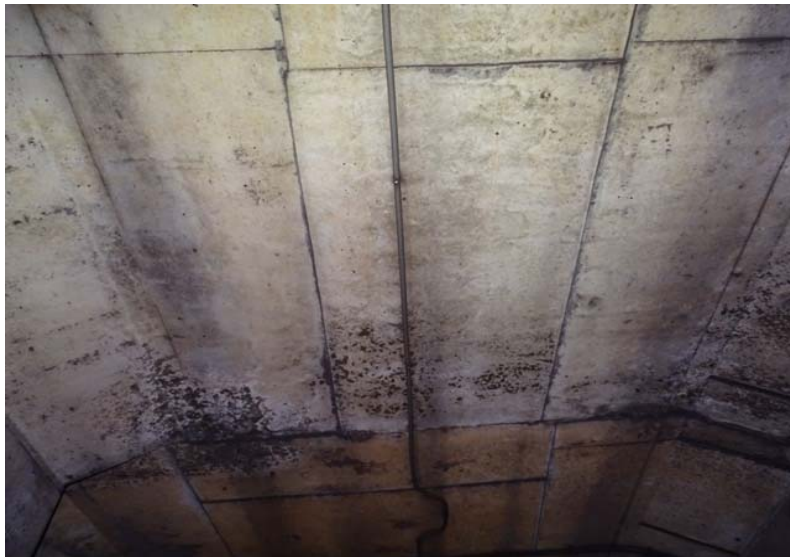
Photograph No. 121
Station 71+70, ceiling.

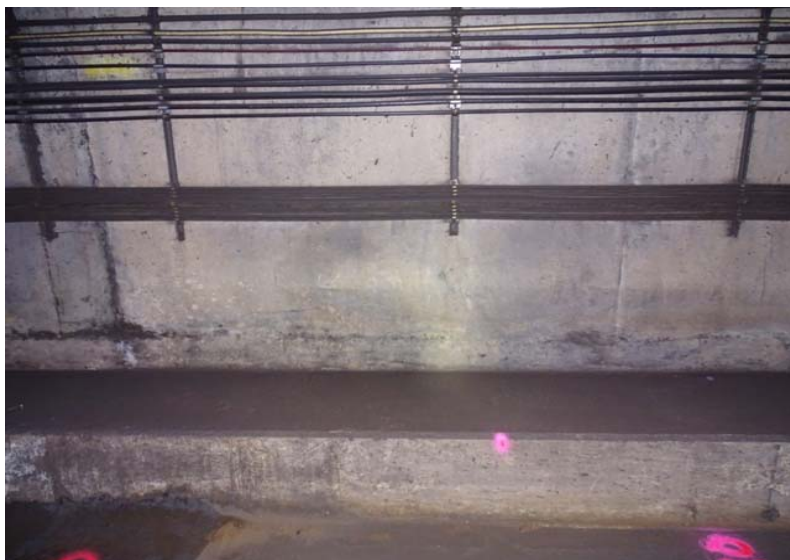
Photograph No. 122
Station 71+70, upper portion of west wall.

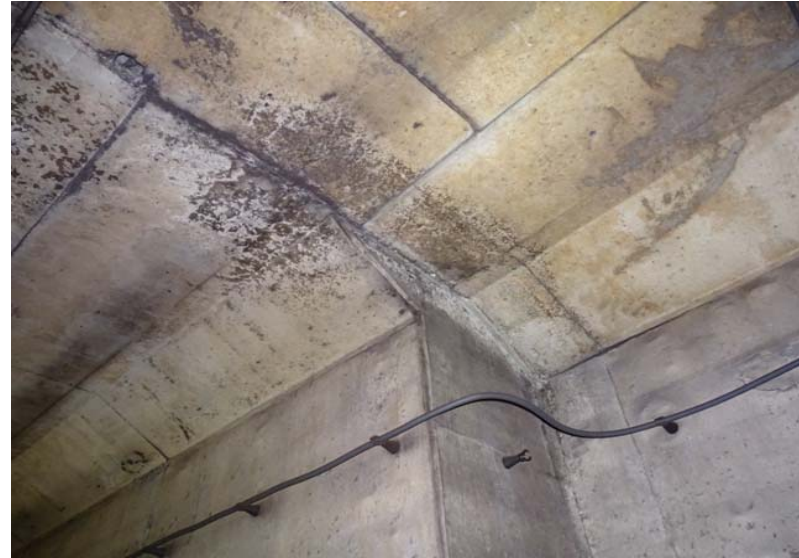
Photograph No. 125
Station 71+80, east wall.

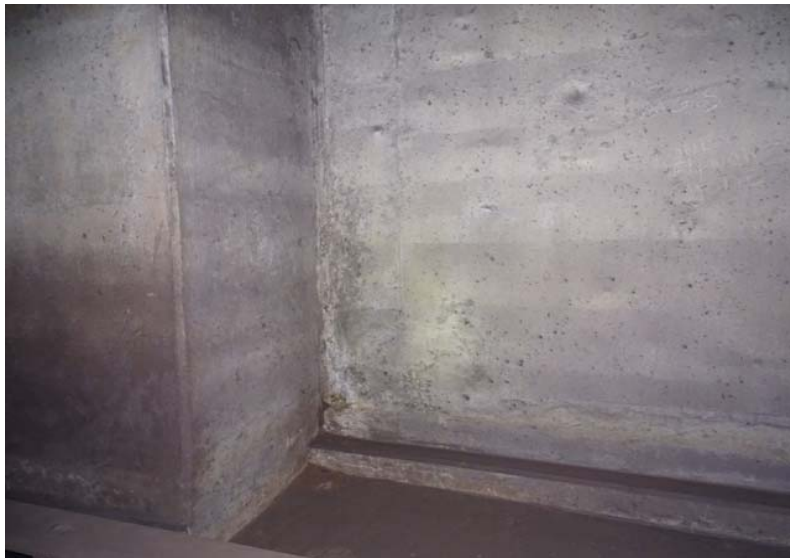
Photograph No. 126
Station 71+80 - stains and efflorescence at the upper portion of the east wall.

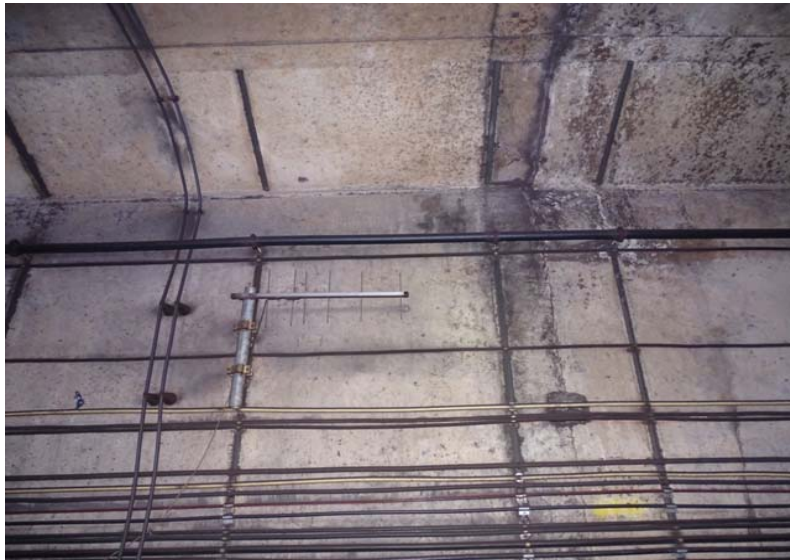
Photograph No. 128
Station 71+80, ceiling.

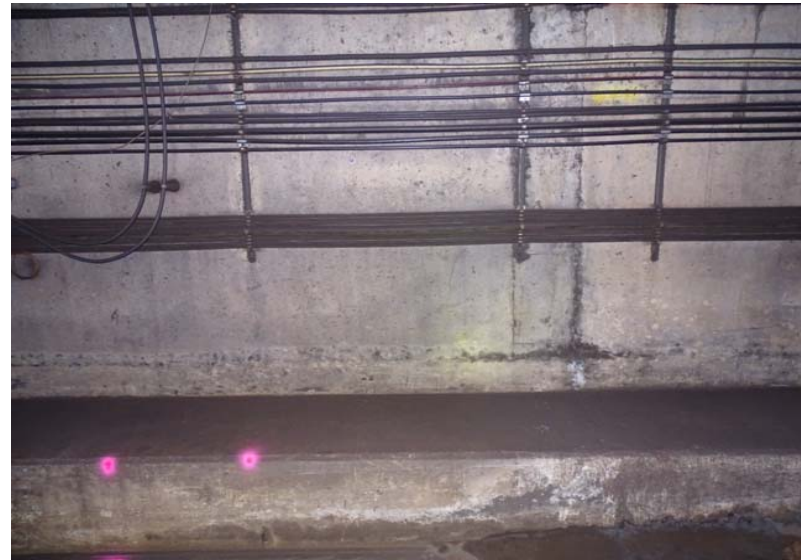
Photograph No. 129
Station 71+80, upper portion of west wall.

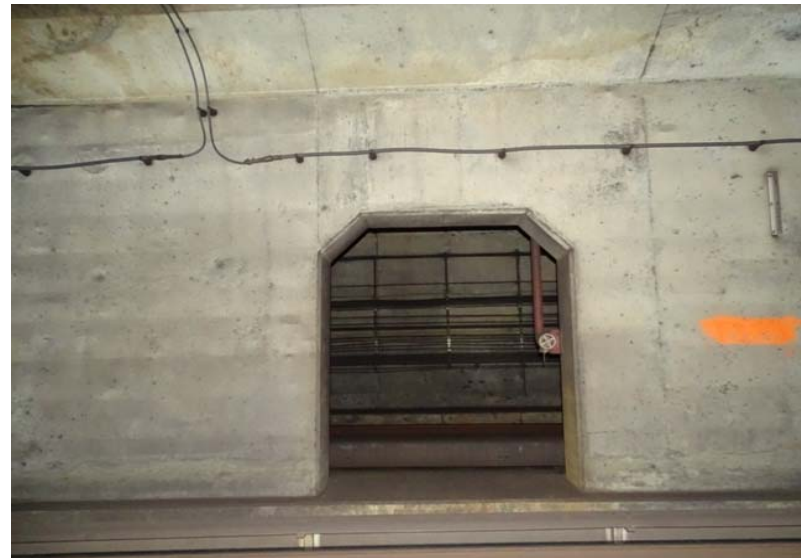
Photograph No. 131
Station 71+90, track bed.

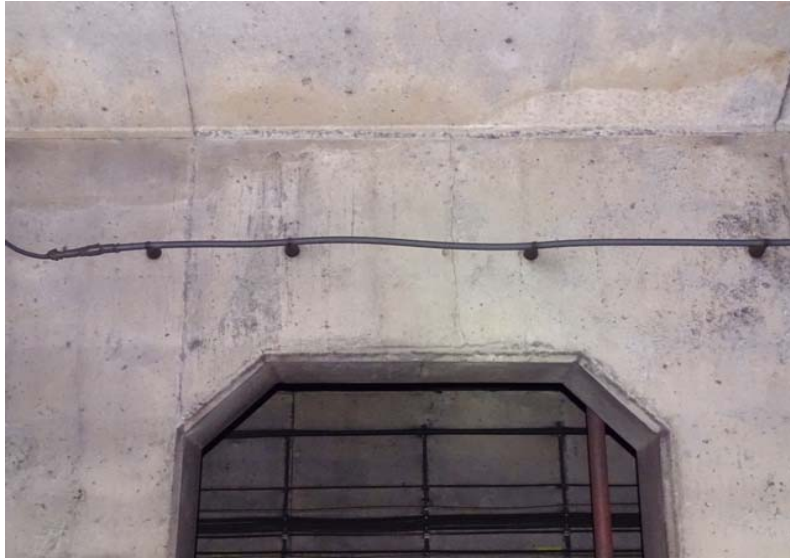
Photograph No. 132
Station 71+90, east wall.
